# 5. Condition survey

### 5.1 Condition of the existing building - externally

Groundschool, Irongate Farm

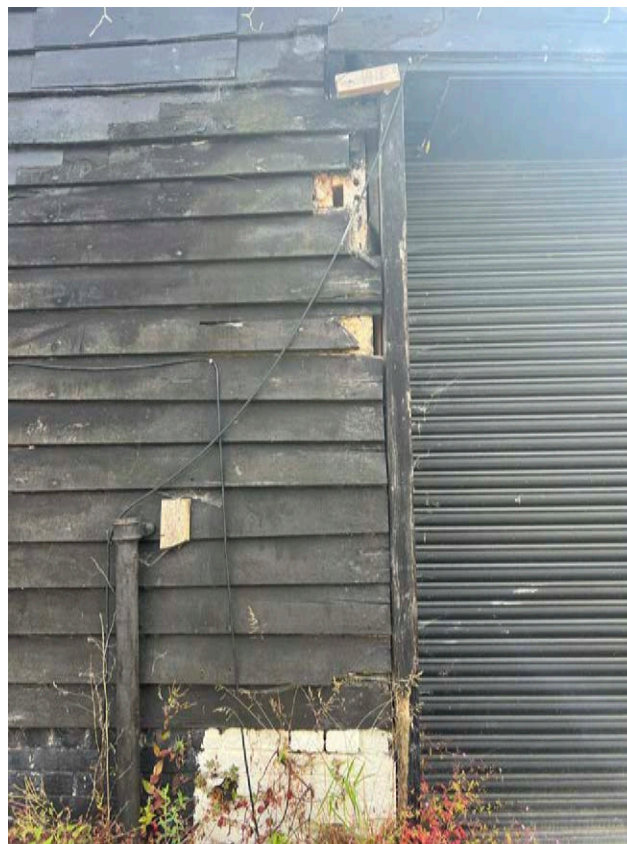
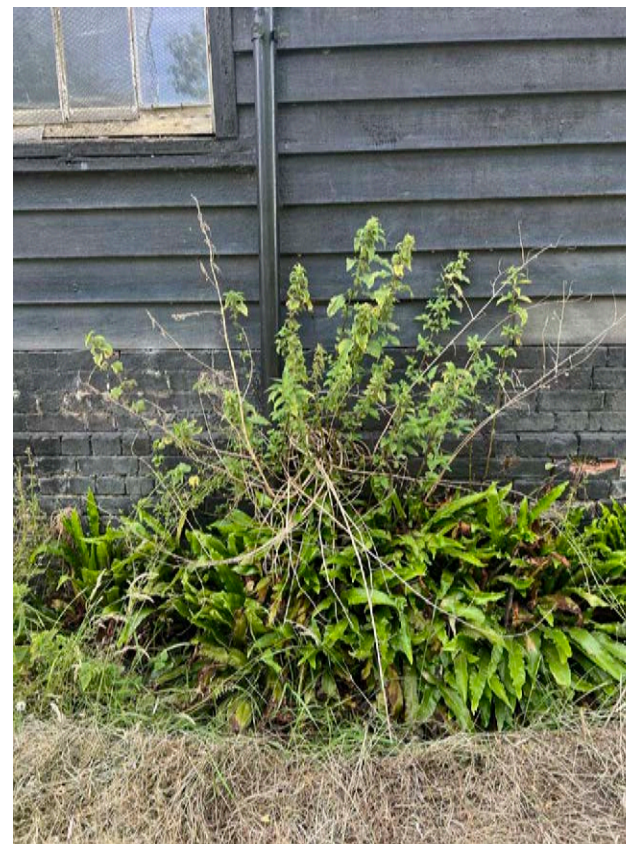
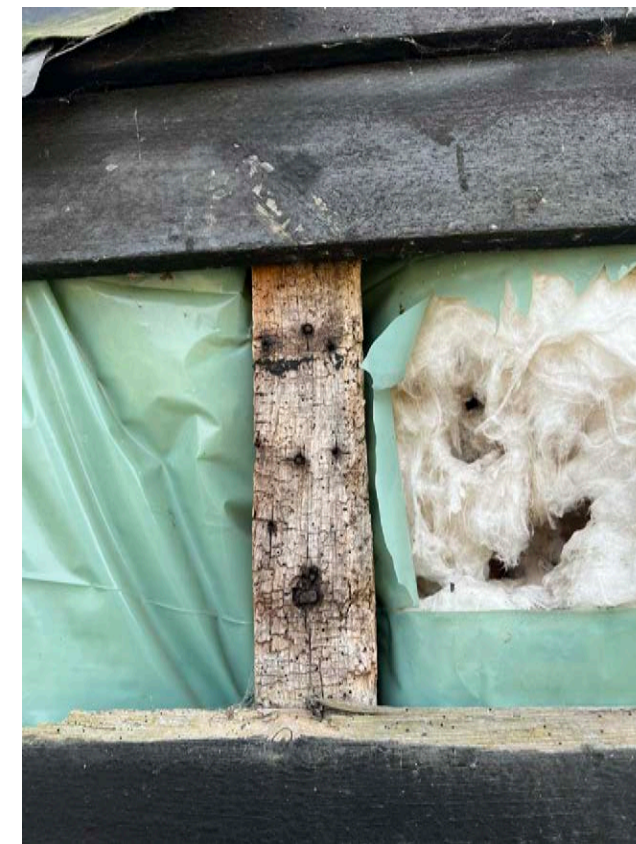
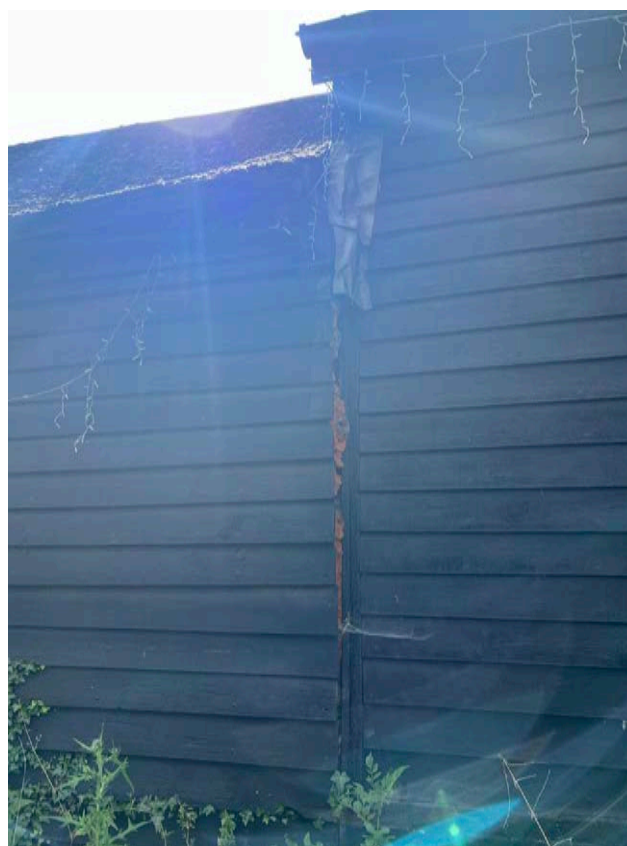
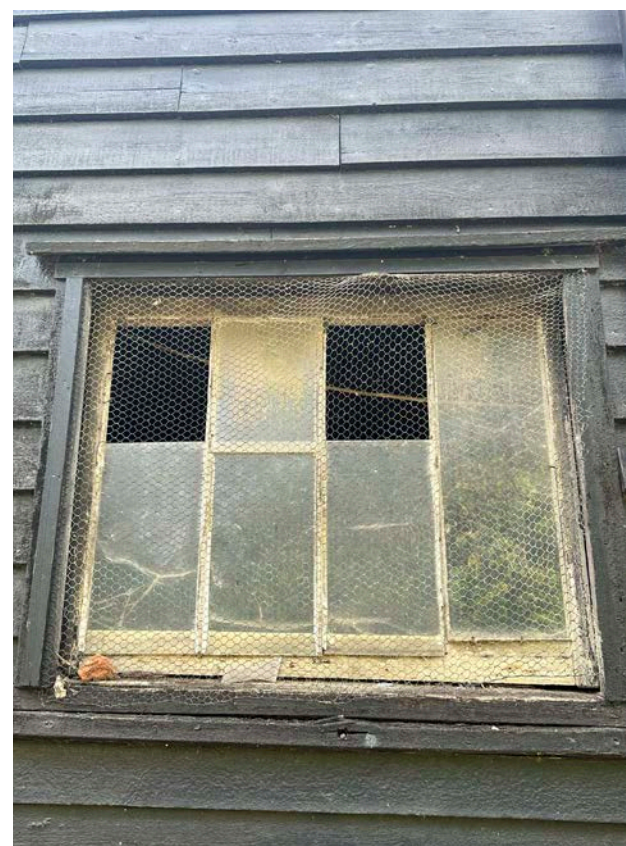
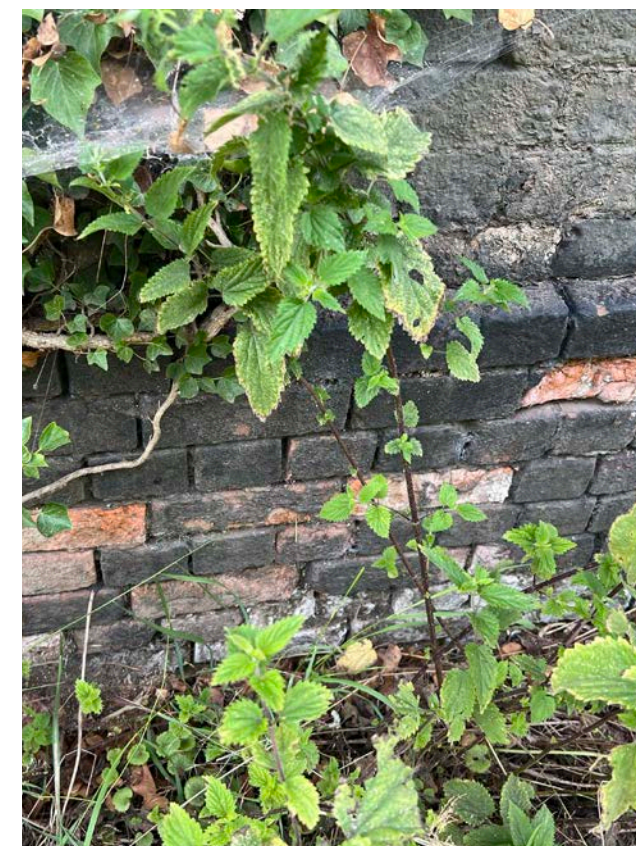
- Weatherboarding in a variable condition, evidence of decay from insect attack and weathering. Missing areas reveal damage to structure behind. Variety of finishes, paint, stain and possible historic tar-based coatings

- Metal framed windows are in poor condition with gaps around frames present. Repaired panes are perspex with animal wire over.
- Rainwater goods are damaged & bowed, some gutters are disconnected and downpipes discharge onto the ground

- Dwarf walls are painted externally with evidence of moisture damage including receding mortar, blown faces and efflorescence.
- Evidence of sitting water to the East elevation causing moss and vegetation growth, contributing to deterioration

- Metal roller shutters to large opening on North facade. Other external openings have no doors
- Evidence of movement between larger barn structure and smaller tiled extension to the south. Repairs attempted with flashings and expanding foam

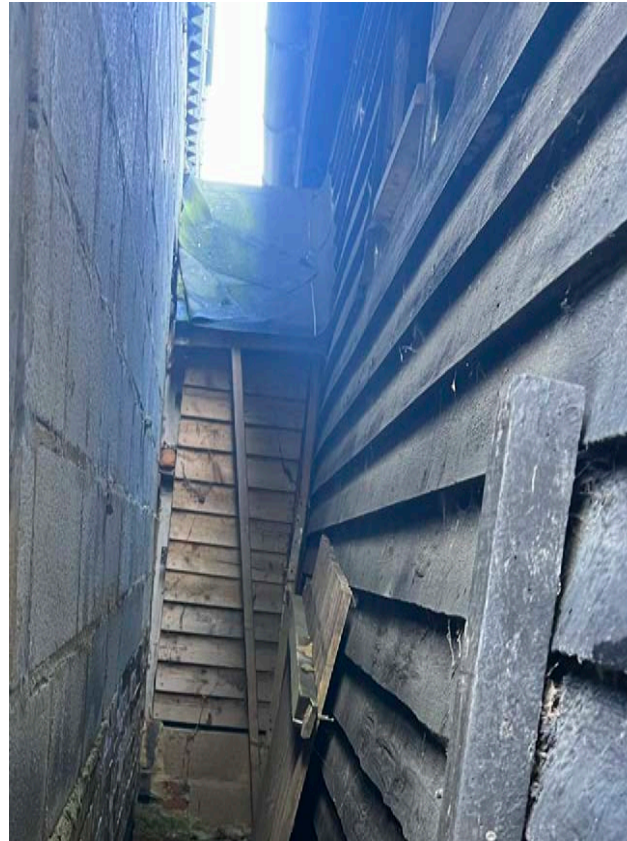
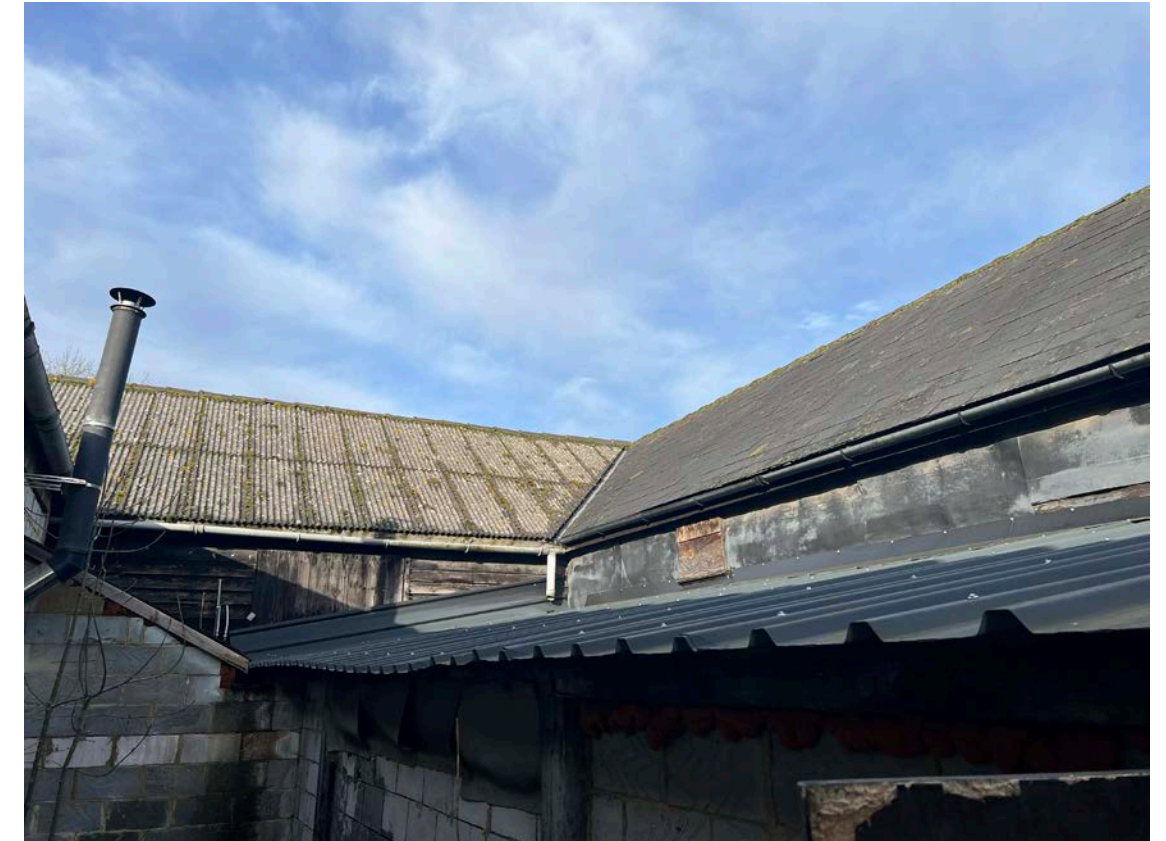
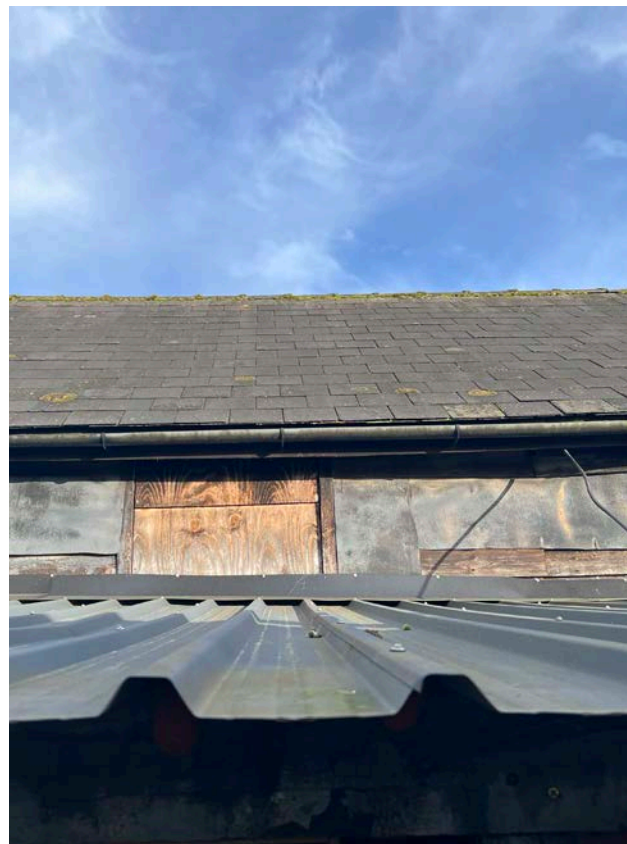
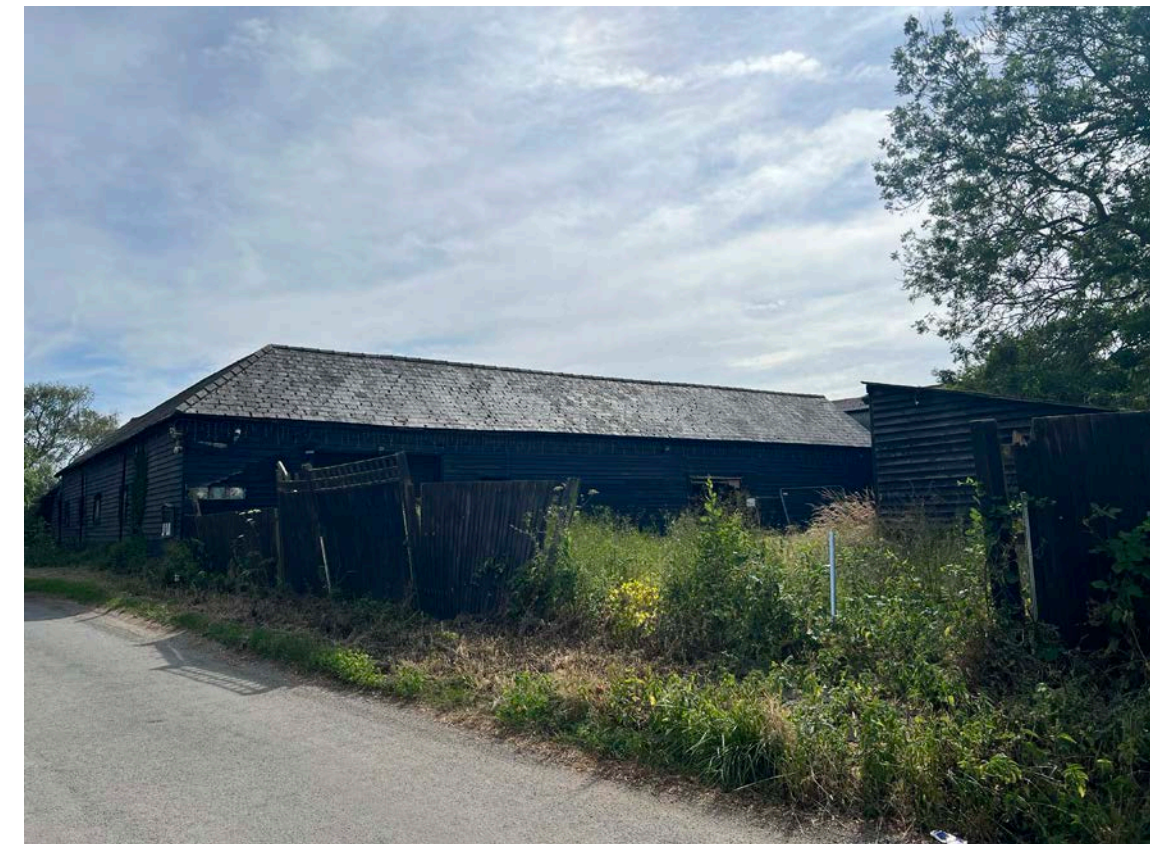
- Roof tiles and slates are in good with very few slips
- The southern roof pitch uses fiber-cement boards, likely containing asbestos
- West elevation connected to infill building has no visible weatherboarding externally, although presence can be seen internally. Plastic waterproofing membranes and plywood sheeting cover this elevation
- The souther elevation facing the concrete barn is weatherboarded, a connecting structures is uncoated weatherboard with a pitched roof with membrane over.

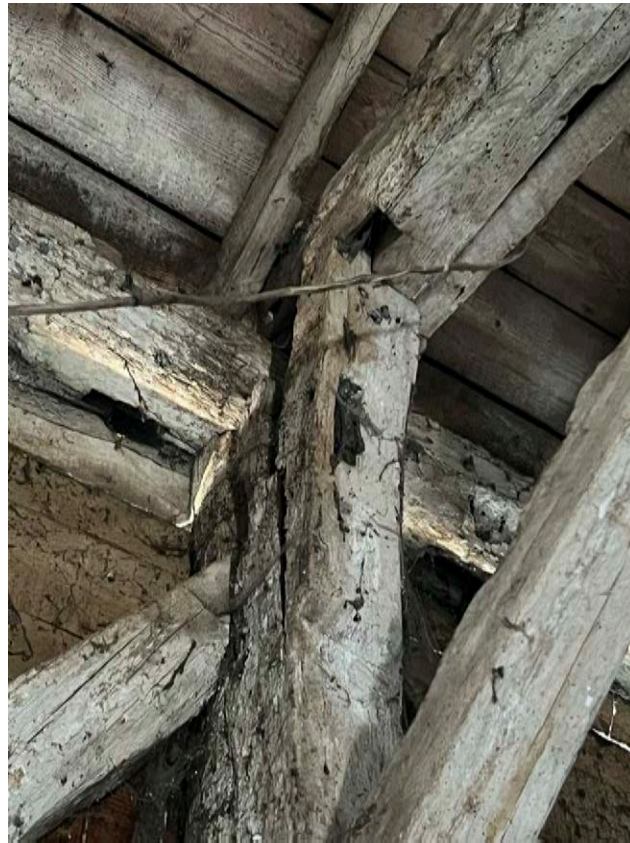
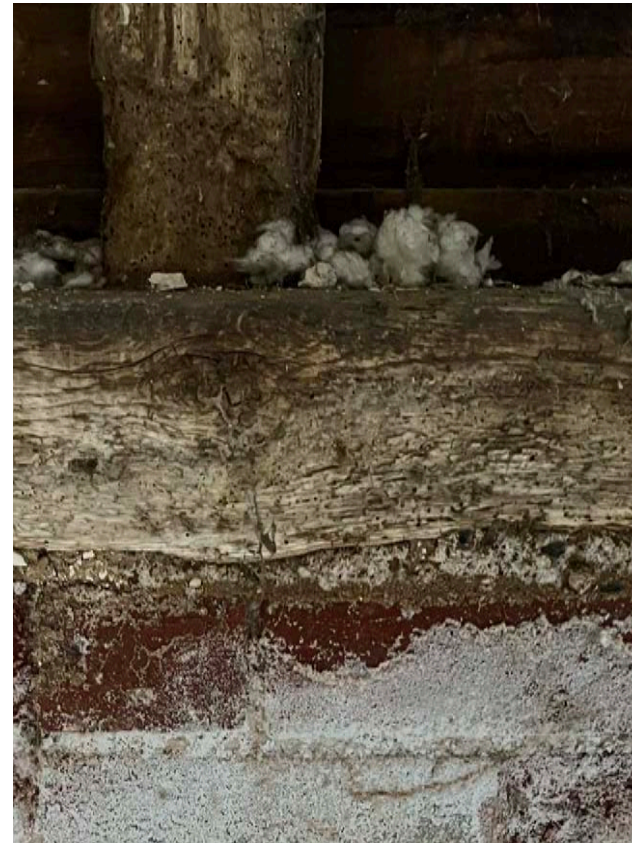
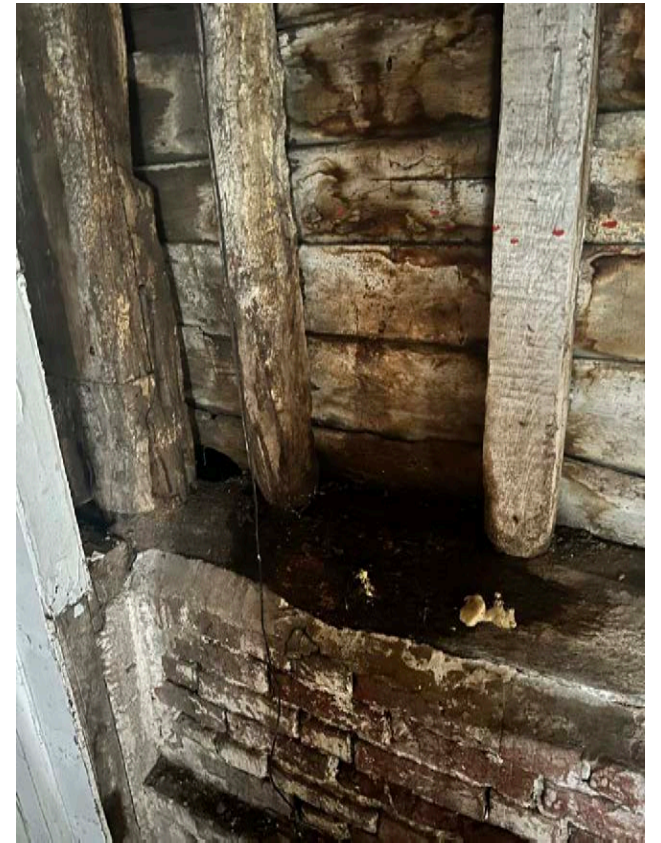
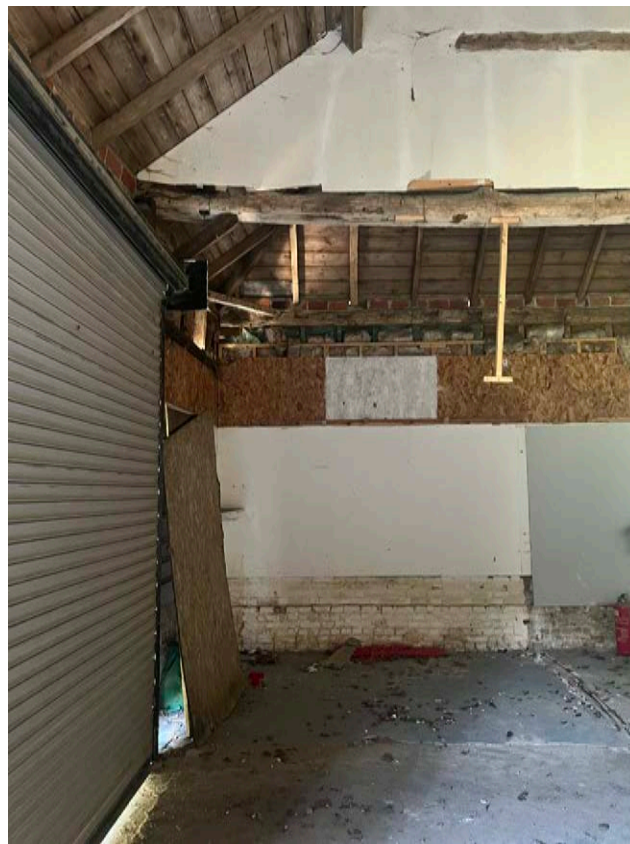
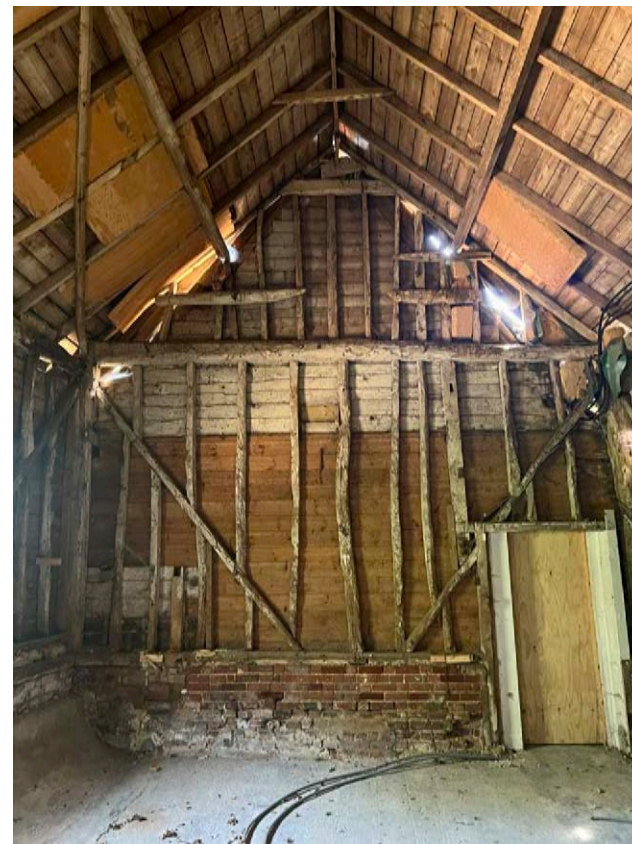
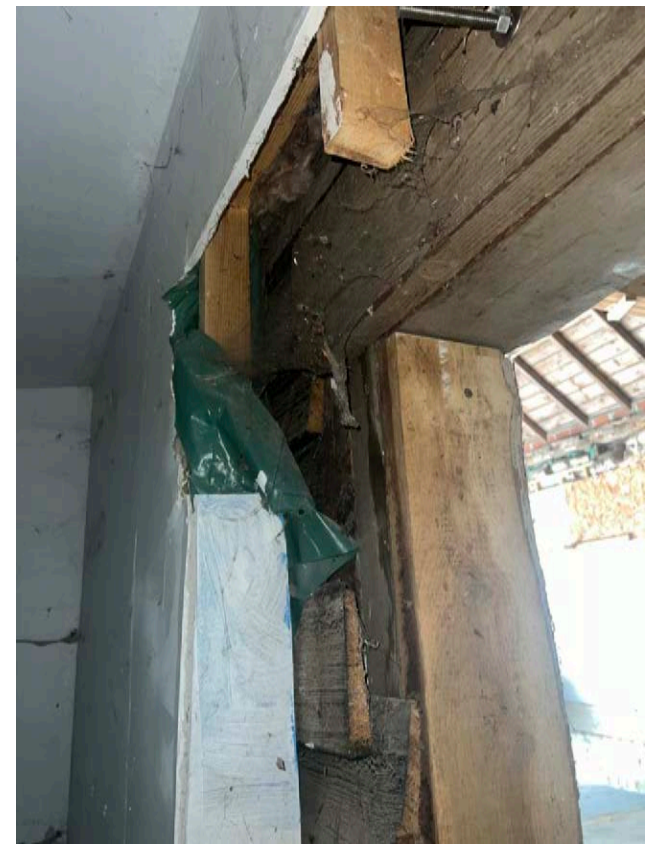
- The building has been subject to modern openings to connect the timber barn with adjacent concrete barn and a now derelict blockwork infill structure

- There is evidence of alterations to the existing concrete floor
- Evidence of damp, rot and fungus growth to the south corner, at the connection with the shorter barn section

- The cruck frames appear mostly original although are in poor condition with evidence of fracture & section loss due to insect attack and rot
- Some distortion to the frames, as a result of movement caused by joint or mechanical failure, or decay

- Insertion of insulation and plastic membranes likely to have contributed to deterioration
- The modern sawn timber rafters, purlins and sarking are in good condition

- Remains of concrete silage trough to the east wall
- Brickwork dwarf walls are in a variable condition, with some section in poor condition
- Receding mortar and evidence of efflorescence (although some areas of brickwork have been painted white) indicates moisture issues or damage from successive mucking out

- Historic openings are evident through areas of modern sawn timber wall posts on modern stock brickwork walls
- Areas of modern studwork and plasterboard
