# Baldock, St Mary's Church Hall, Bat Survey 2024

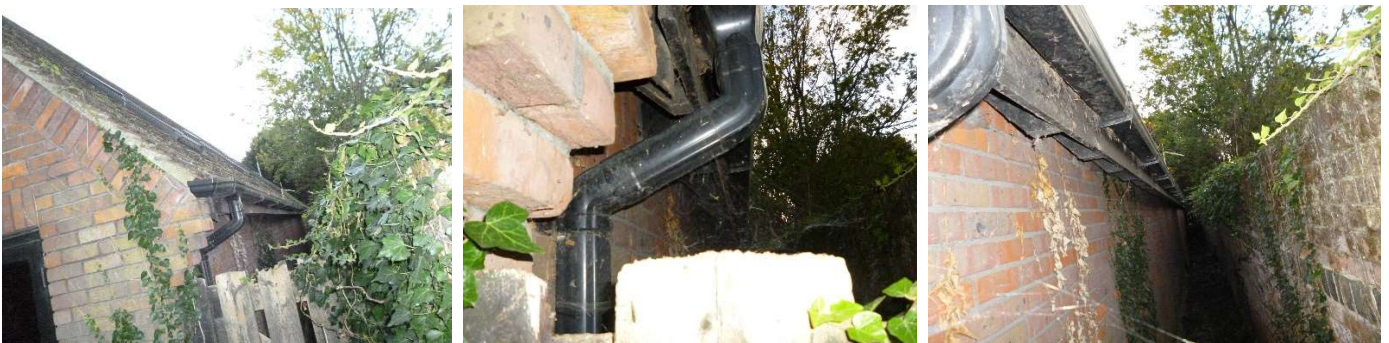
North side no obvious cavities or crevices; access difficult

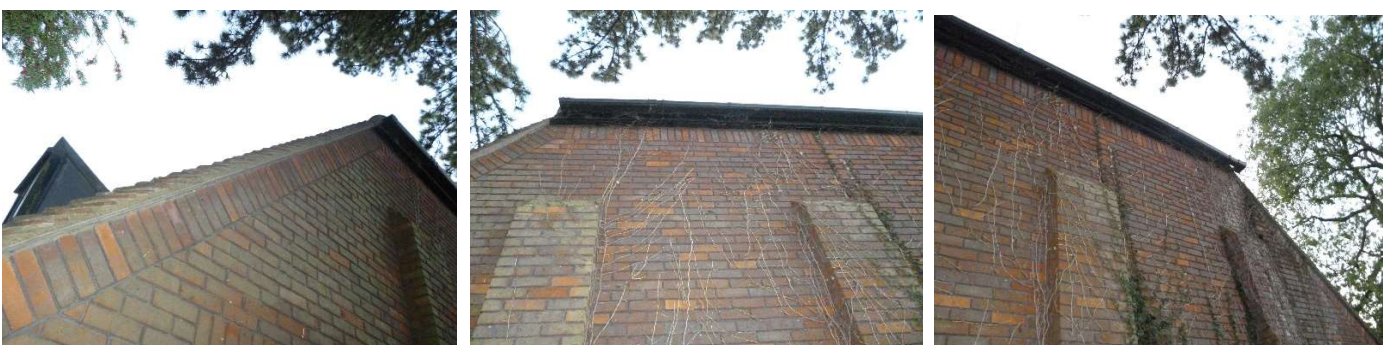
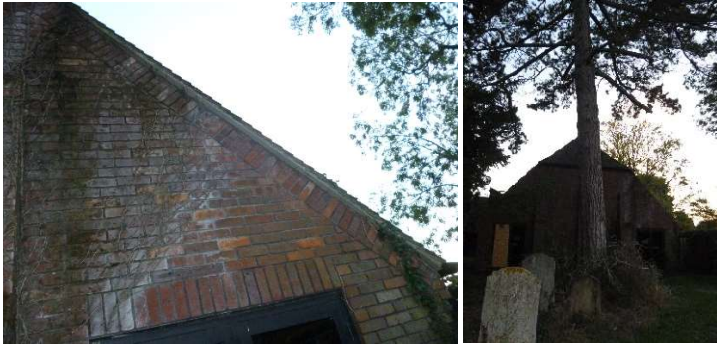
East elevation, no obvious cavities or crevices.

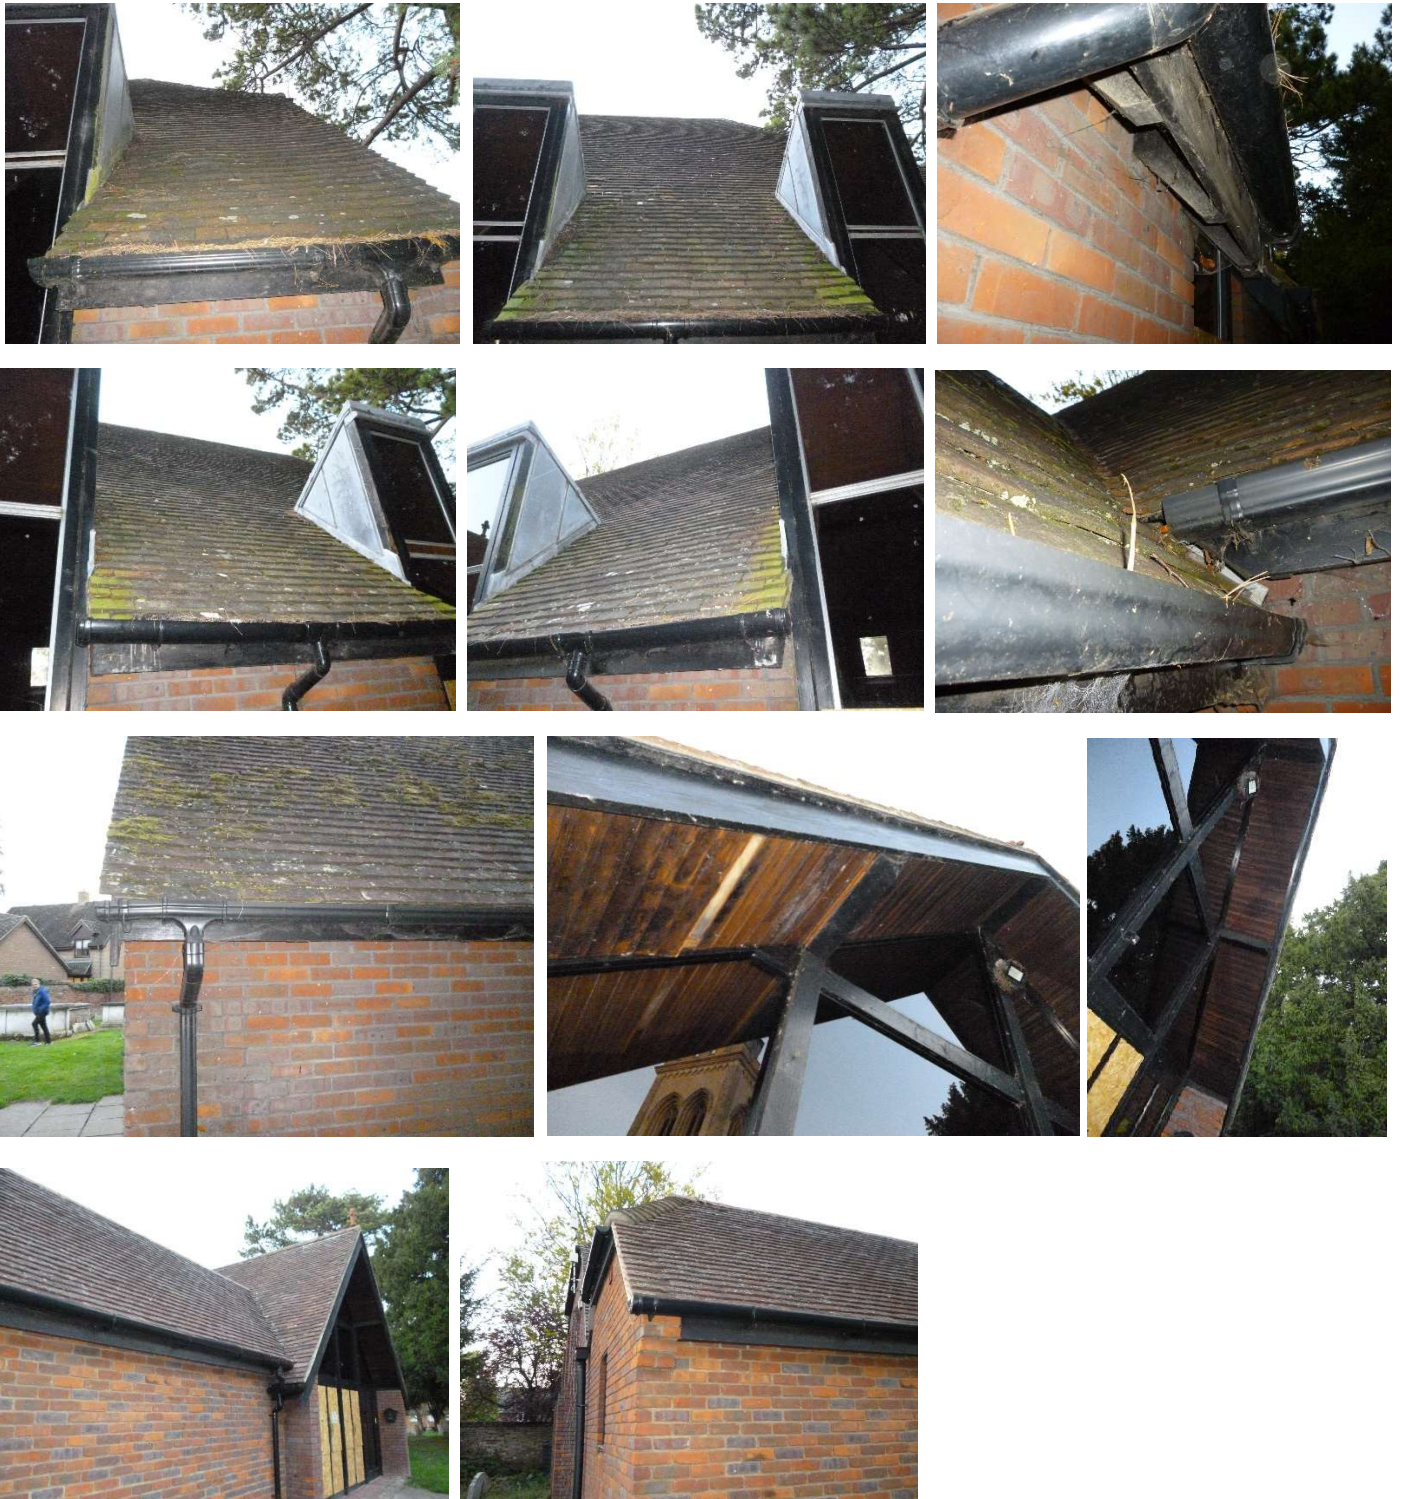
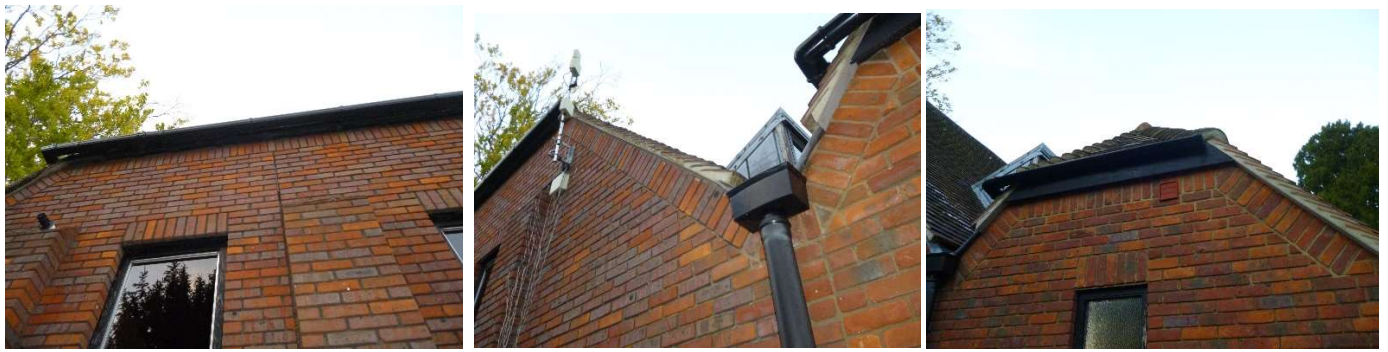
Western elevation also crevice and hollow free. All in very good condition.

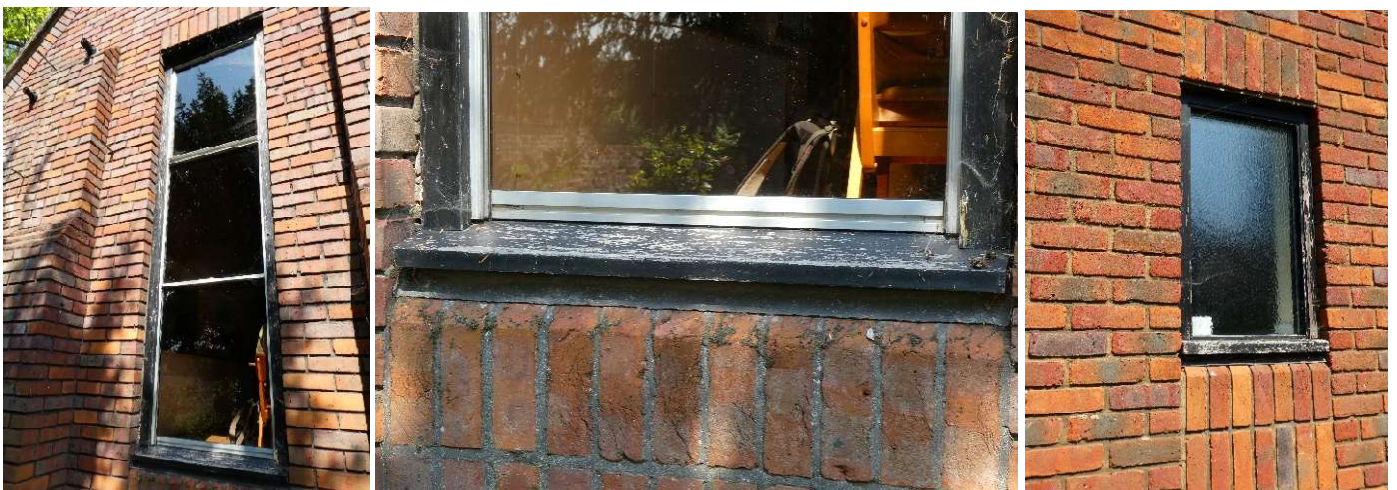
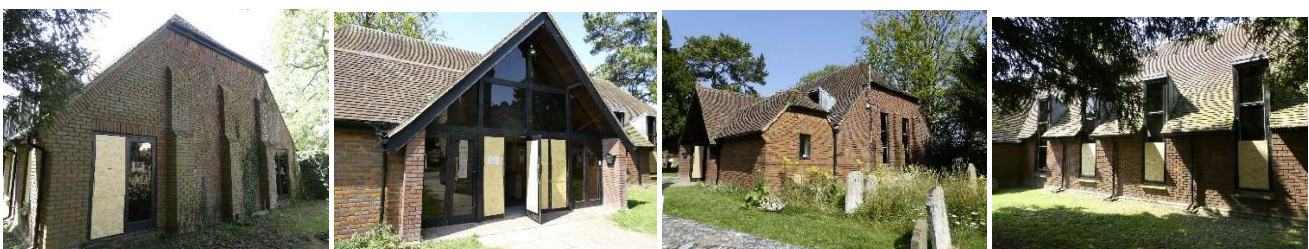
All windows and ledges checked for faeces and urine splatter etc.

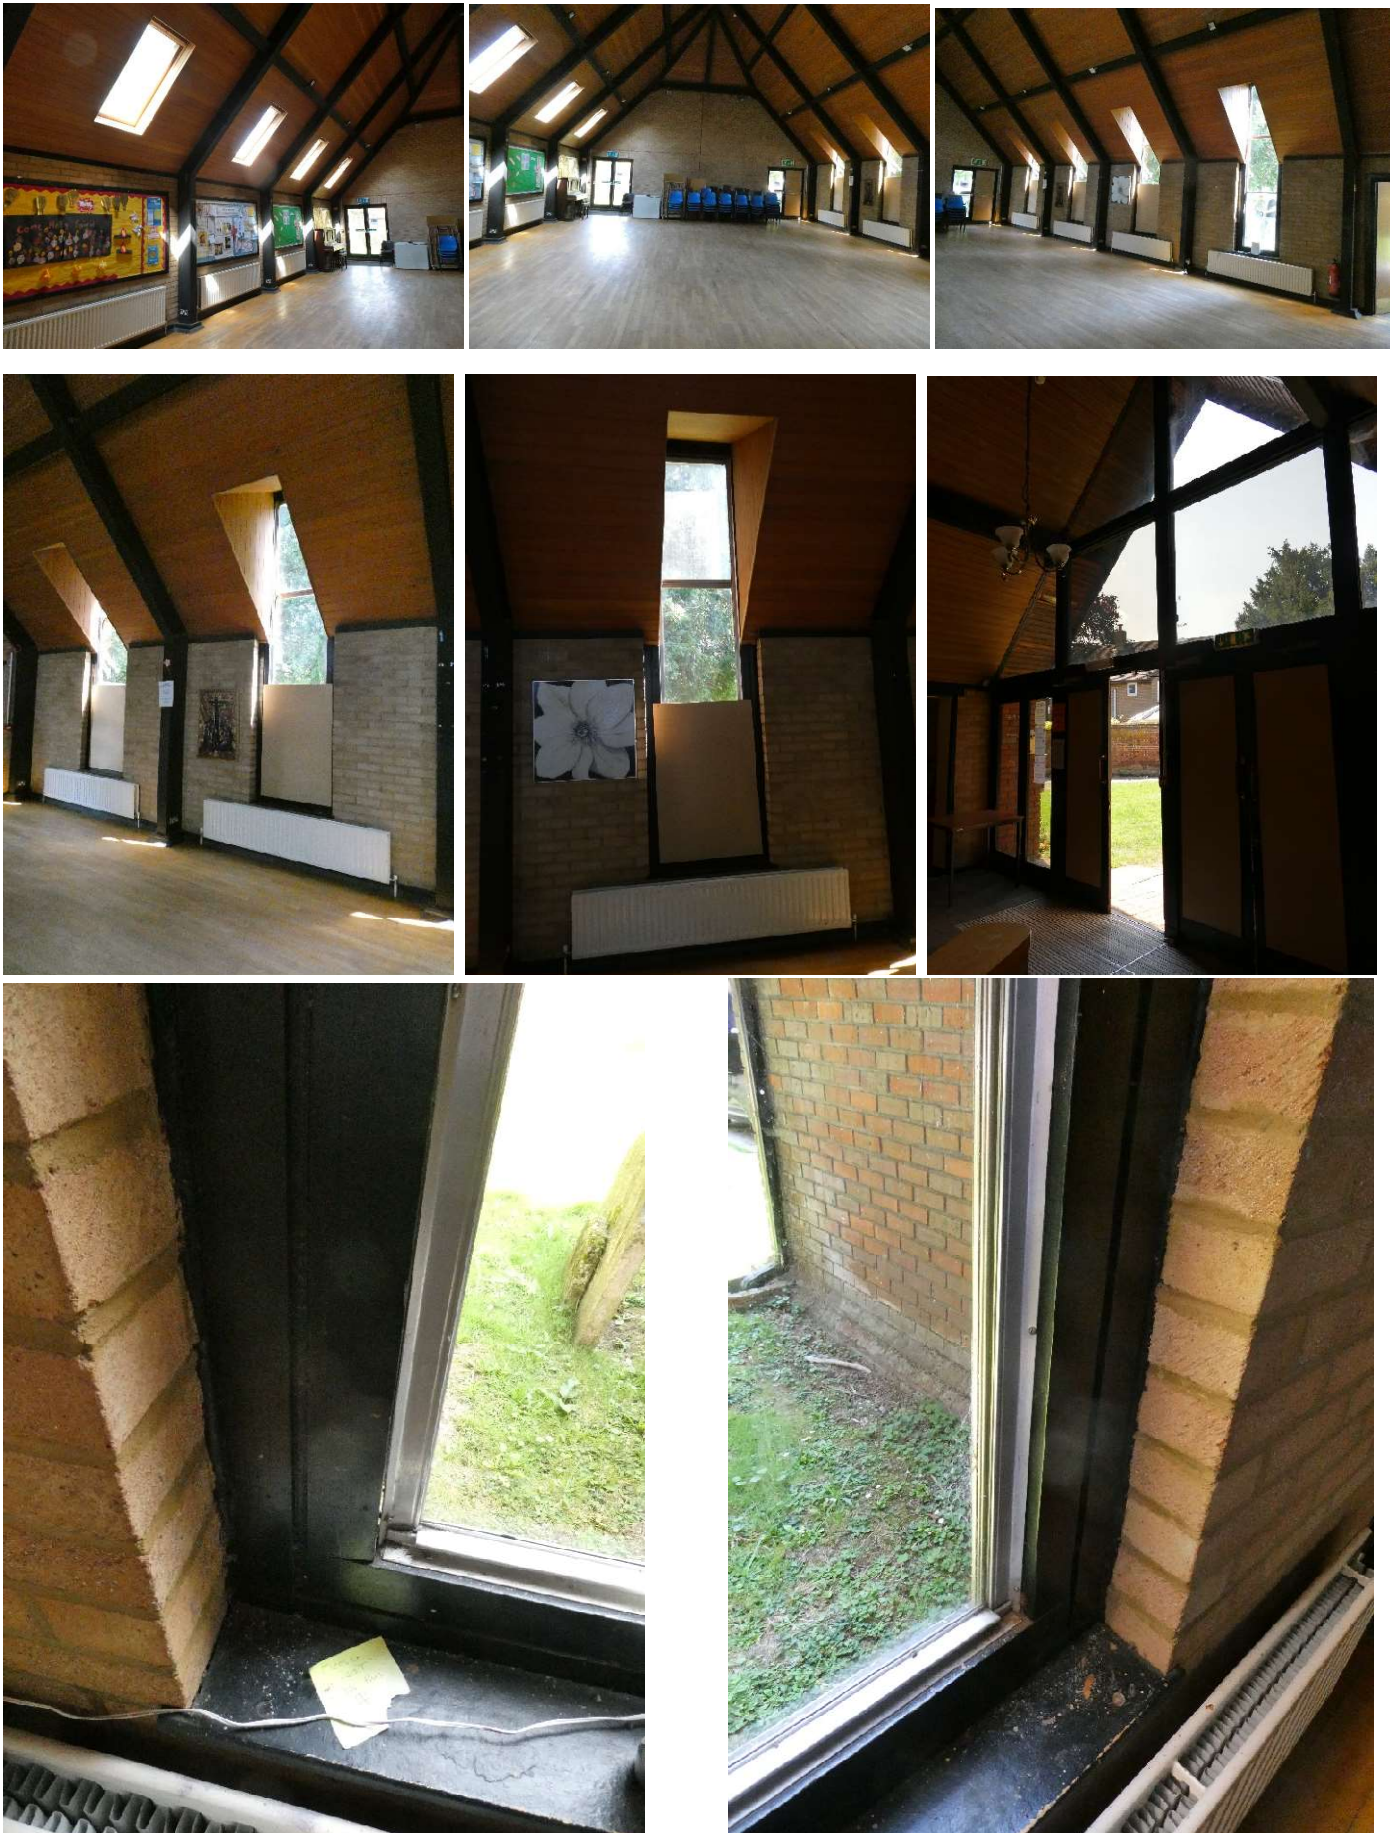
All joints still perfectly sealed

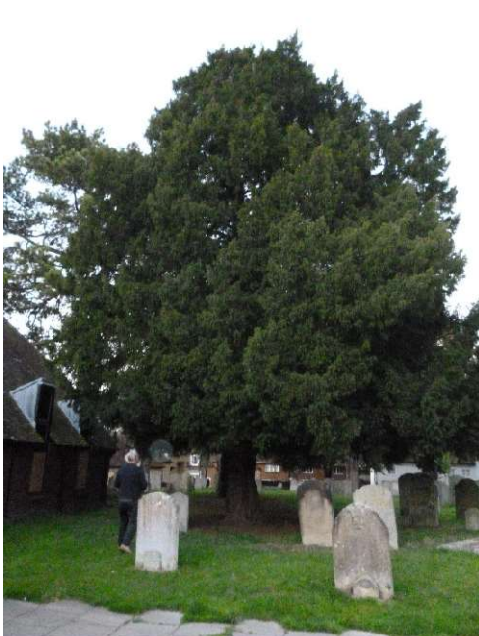
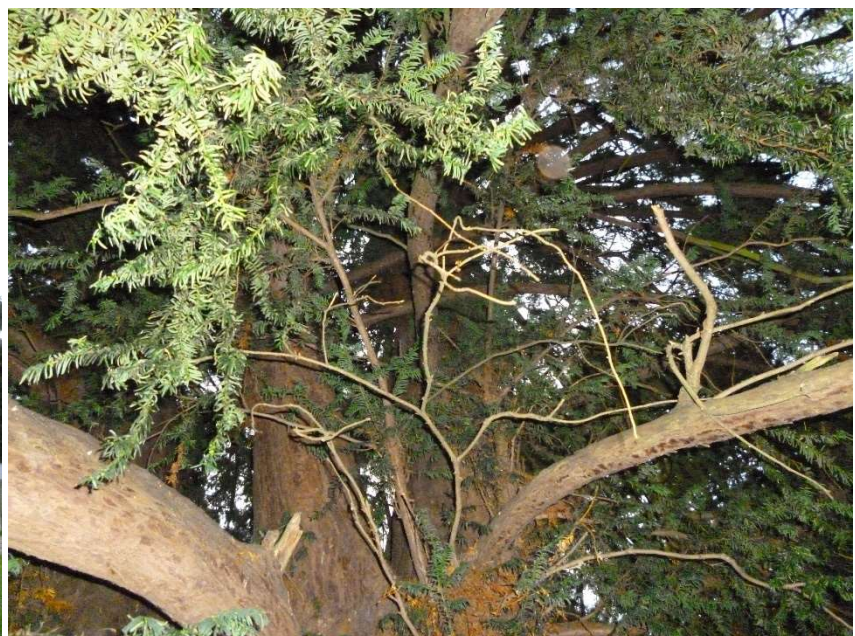
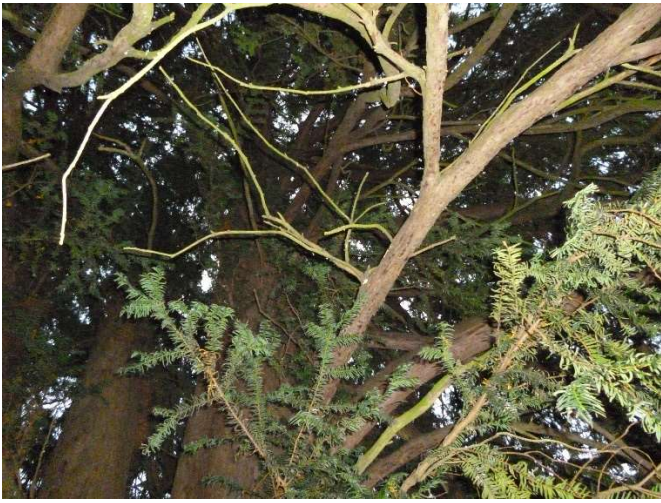
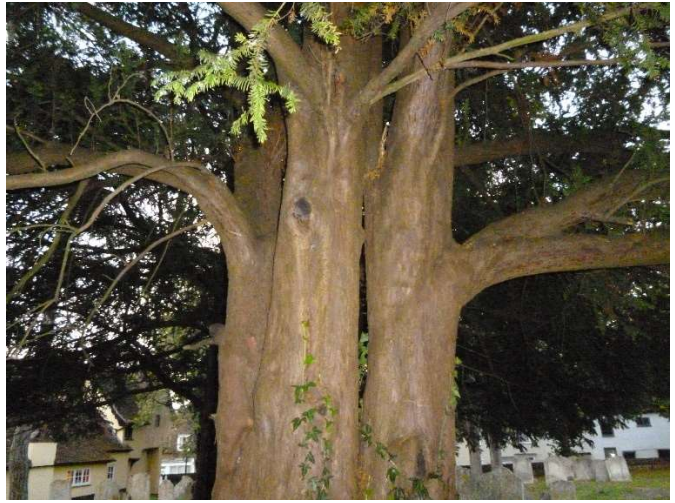
T1 various splits and bark peeling as is common in this species, but no obvious crevices or hollows. Potential suitability negligible.

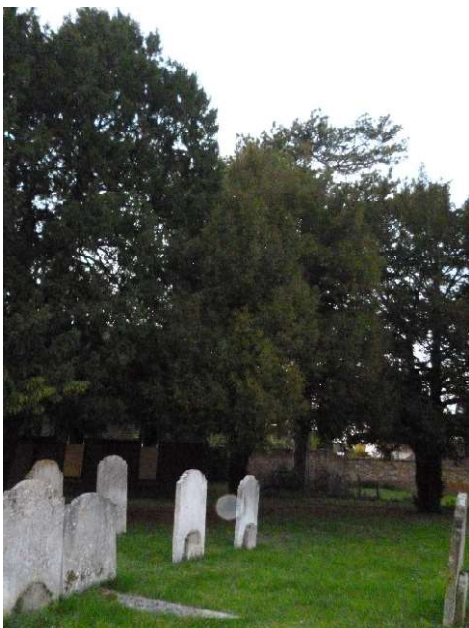
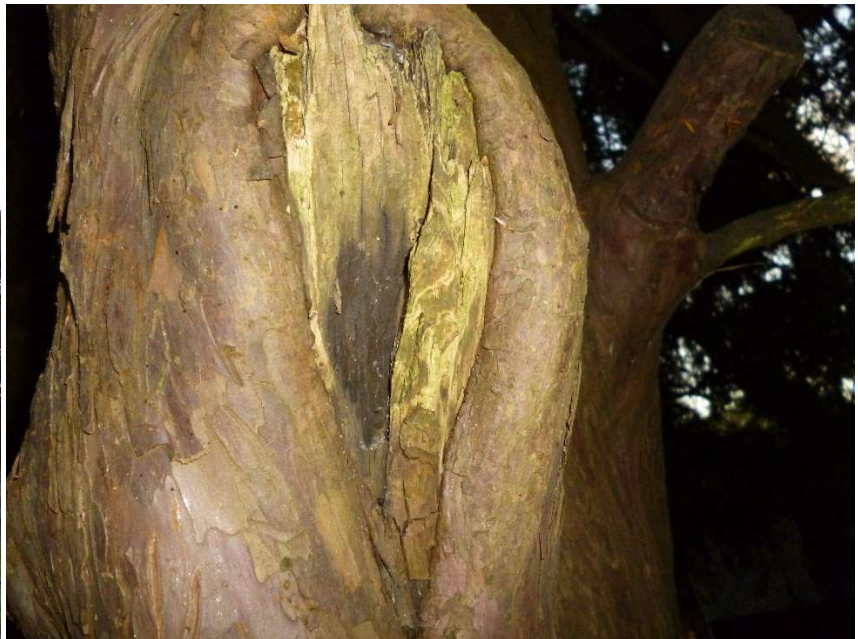
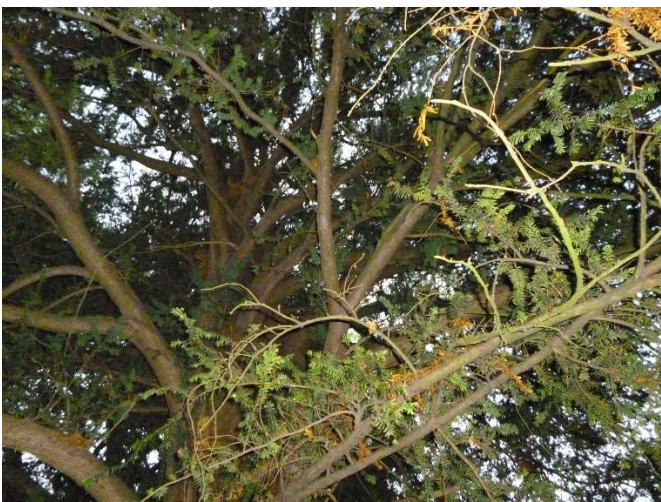
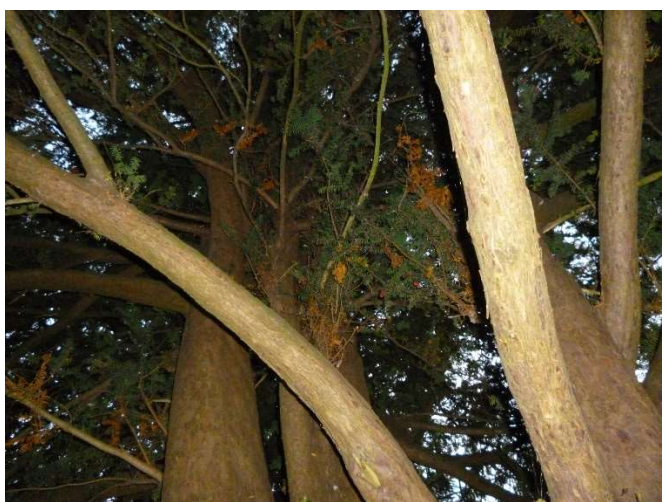
Tree T2, mostly sound without any obvious crevices or hollows. Historic limb failure has healed without issue, leaving no potential roosting features. Potential suitability negligible.

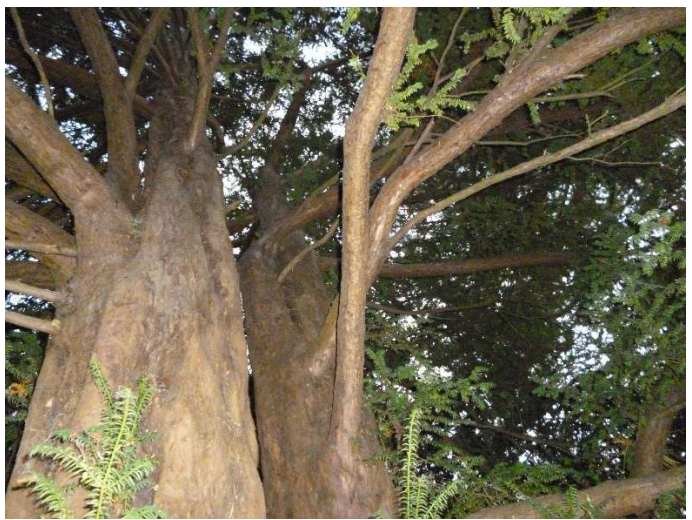
Tree T3, in good condition, no fissures, crevices or hollows visible from the ground. Epicormic growth ground. Epicormic growth causing no issues. Previous surgery appears to have been done to BS 3998: 2010. Potential suitability negligible.

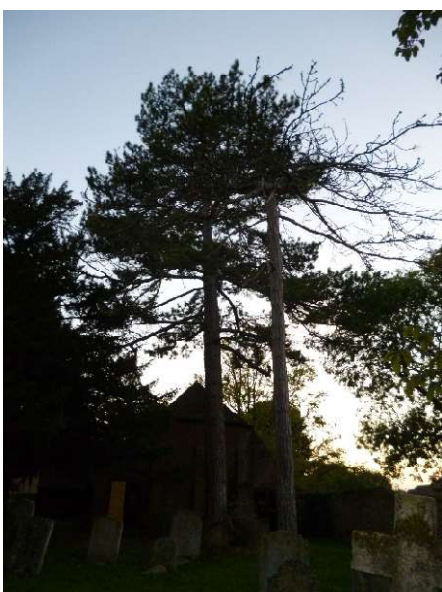
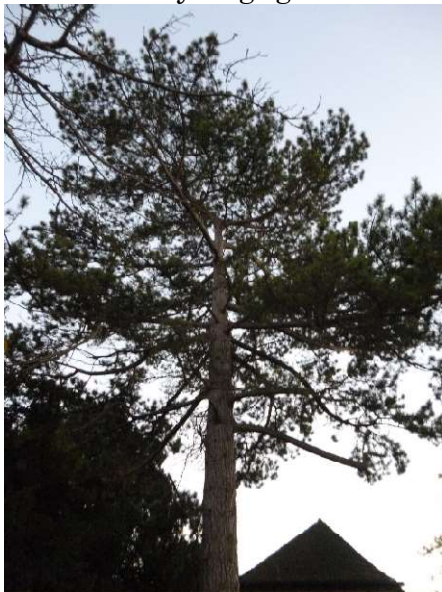
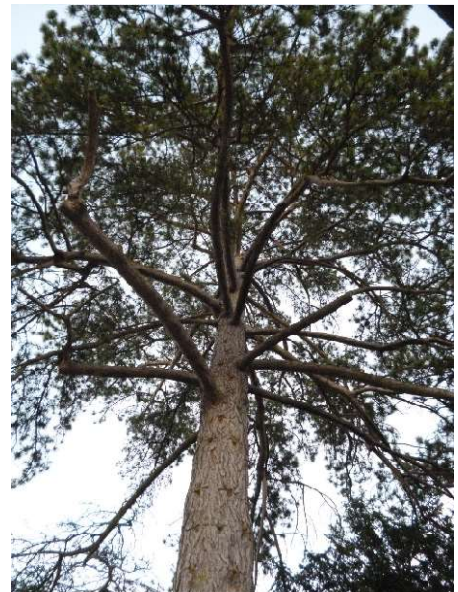
Tree T4, canopy open to apex, completely sound, no crevices or hollows, all exposed to the elements. Potential suitability negligible.

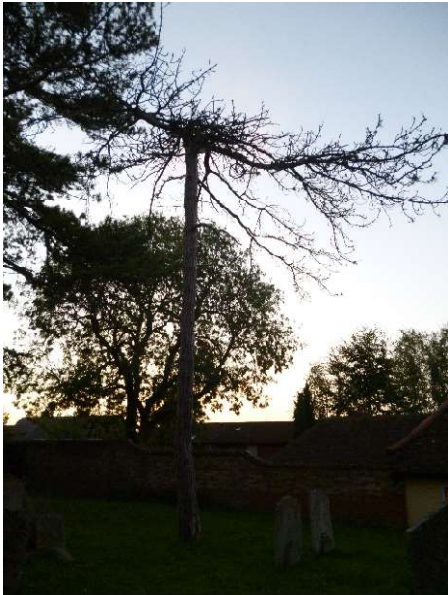
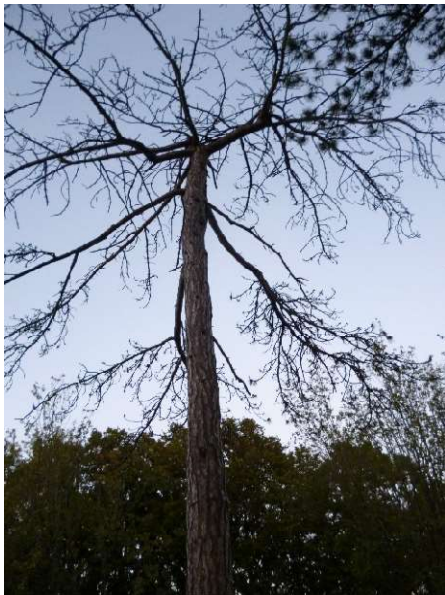
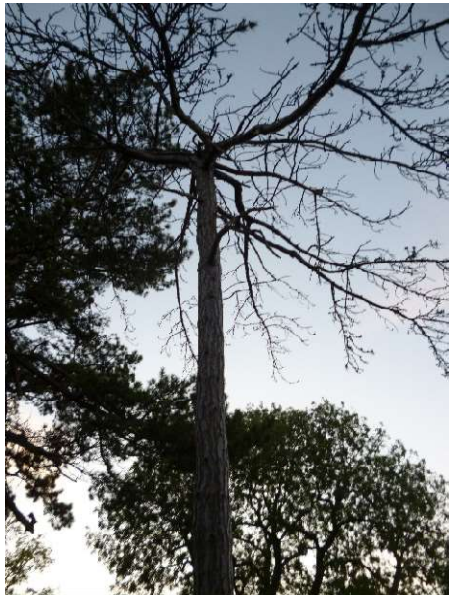
Tree T5 dead, at present there appear to be no roosting opportunities, even within the crown. As this tree is obviously dead and decaying, if left it could develop good potential roosting features in the mid to long term. On the date of the survey, potential suitability negligible.
