**Project Name:** Land Off Drovers Way - Pirton  
**Project Description:** CCTV Survey  
**Project Status:** Complete  
**Project Date:** 12/11/2025  
**Inspection Standard:** MSCC5 Sewers & Drainage GB (SRM5 Scoring)

# **EYES ON DRAINAGE**

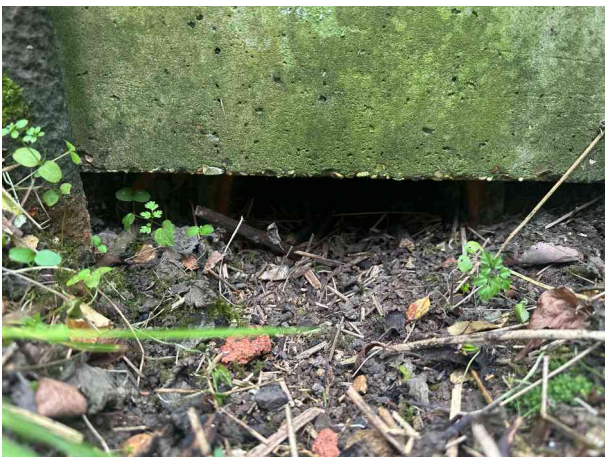
HW2 pipe soffit not visible

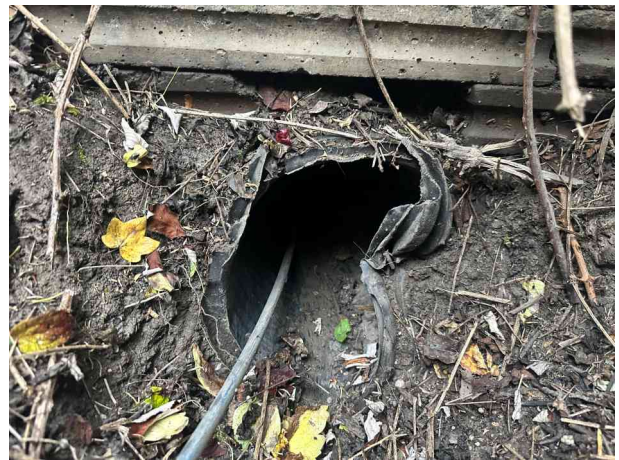
HW4 Outfall deformed

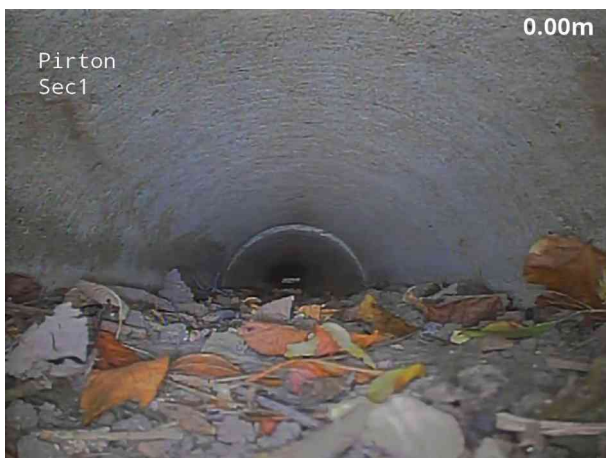
| Section | PLR | Grade | Description |
|---|---|---|---|
| 1 | HW1X | 4 | Settled deposits, fine, 40% cross-sectional area loss, finish |

<table><tr><td>0.00</td><td>OF</td><td>Start node, outfall, reference: HW1</td><td>00:00:00</td><td>1, 2</td><td></td><td></td></tr><tr><td>0.00 S01</td><td>DES</td><td>Settled deposits, fine, 40% cross-sectional area loss, start</td><td>00:00:25</td><td>3</td><td></td><td></td></tr></table>

3, 00:00:25, 0.00 m  
Settled deposits, fine, 40% cross-sectional area loss, start

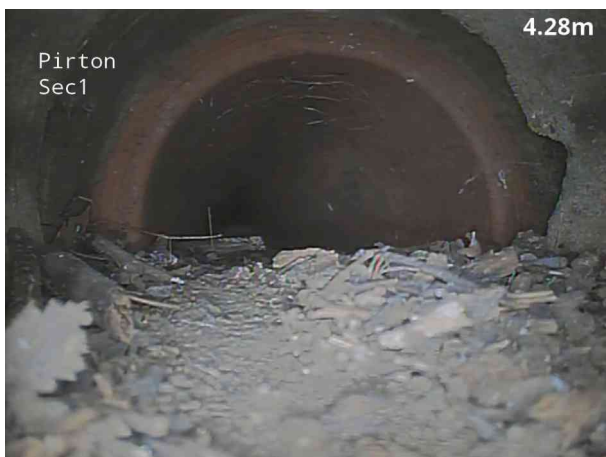
| Section | PLR | Grade | Description |
|---|---|---|---|
| 1 | HW1X | 5 | Hole in drain or sewer from 9 o'clock to 3 o'clock |

<table><tr><td>0.00</td><td>OF</td><td>Start node, outfall, reference: HW1</td><td>00:00:00</td><td>1, 2</td><td></td><td></td></tr><tr><td>4.50</td><td>H</td><td>Hole in drain or sewer from 9 o'clock to 3 o'clock</td><td>00:01:19</td><td>5</td><td></td><td>5</td></tr></table>

5, 00:01:19, 4.50 m  
Hole in drain or sewer from 9 o'clock to 3 o'clock

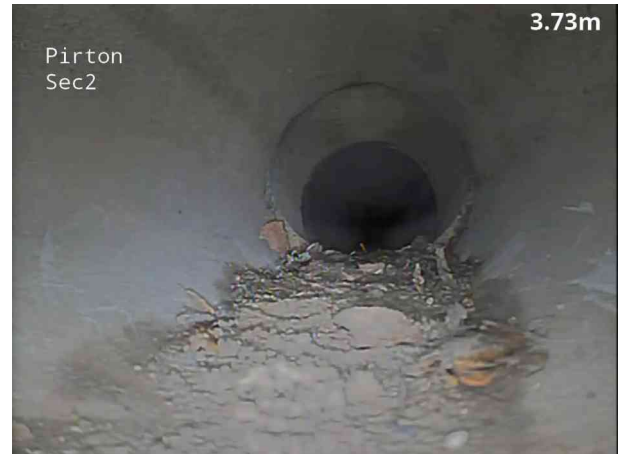
<table><tr> <td></td><td>0.00</td><td>OF</td><td>Start node, outfall, reference: HW3</td><td>00:00:00</td><td></td><td></td><td></td></tr><tr> <td></td><td>4.00</td><td>DER</td><td>Settled deposits, coarse, 10% cross-sectional area loss</td><td>00:00:35</td><td>2</td><td></td><td>3</td></tr></table>

2, 00:00:35, 4.00 m  
Settled deposits, coarse, 10% cross-sectional area loss

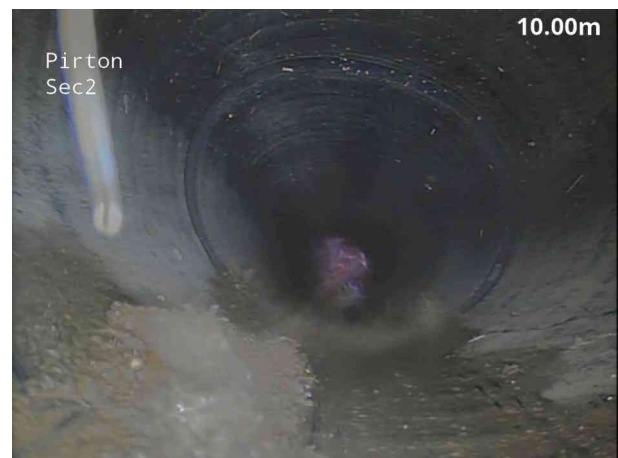
<table><tr> <td></td><td>0.00</td><td>OF</td><td>Start node, outfall, reference: HW3</td><td>00:00:00</td><td></td><td></td><td></td></tr><tr> <td></td><td>10.20</td><td>D</td><td>Deformed sewer or drain, 15%</td><td>00:02:08</td><td>4</td><td></td><td>5 / 3</td></tr></table>

4, 00:02:08, 10.20 m  
Deformed sewer or drain, 15%

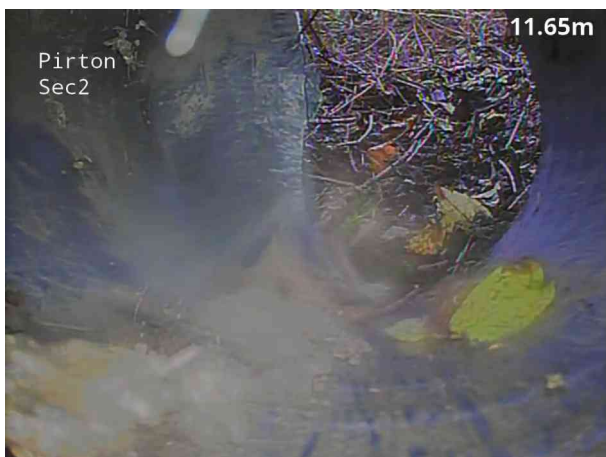
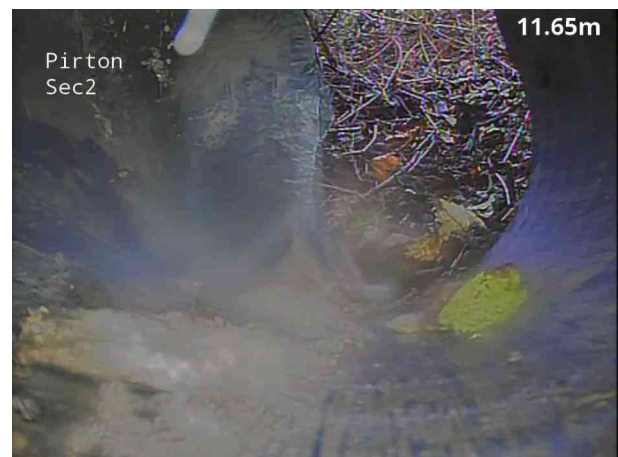
| Section | PLR | Grade | Description |
|---|---|---|---|
| 2 | HW3X | 4 | Deformed sewer or drain, 40% |

<table><tr> <td></td><td>0.00</td><td>OF</td><td>Start node, outfall, reference: HW3</td><td>00:00:00</td><td></td><td></td><td></td></tr><tr> <td></td><td>11.80</td><td>D</td><td>Deformed sewer or drain, 40%</td><td>00:01:39</td><td>5, 6</td><td></td><td>5 / 4</td></tr></table>

5, 00:01:39, 11.80 m  
Deformed sewer or drain, 40%

6, 00:01:39, 11.80 m  
Deformed sewer or drain, 40%

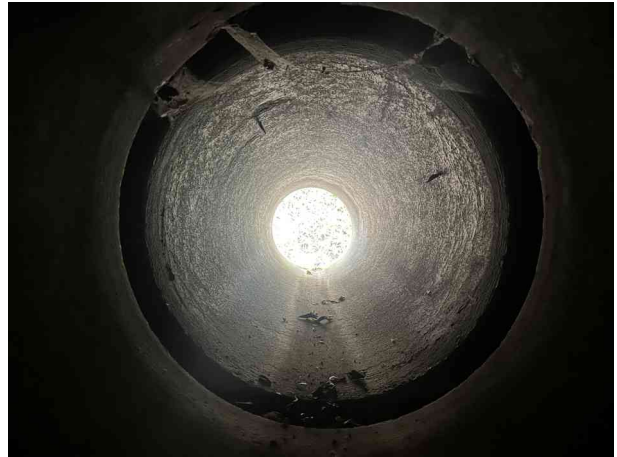
2, 6.00 m  
Open joint, medium

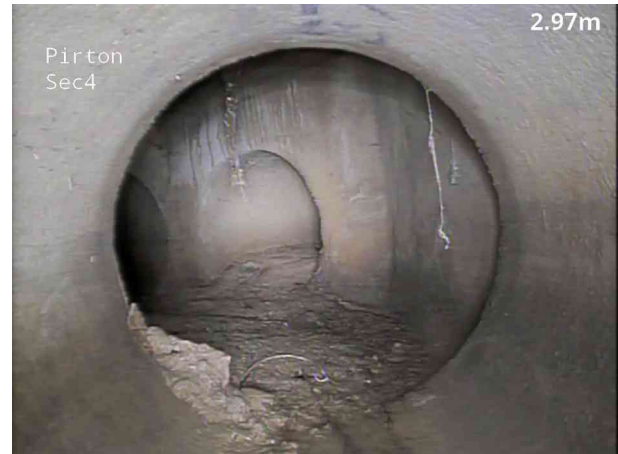
| Section | PLR | Grade | Description |
|---|---|---|---|
| 4 | SW1X | 3 | Settled deposits, fine, 10% cross-sectional area loss, finish |

2, 00:00:25, 3.20 m  
Settled deposits, fine, 10% cross-sectional area loss, finish

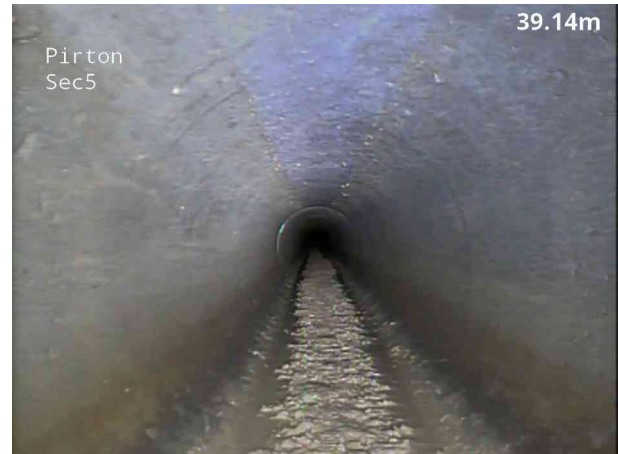
2, 00:03:15, 39.00 m  
Settled deposits, fine, 5% cross-sectional area loss, change

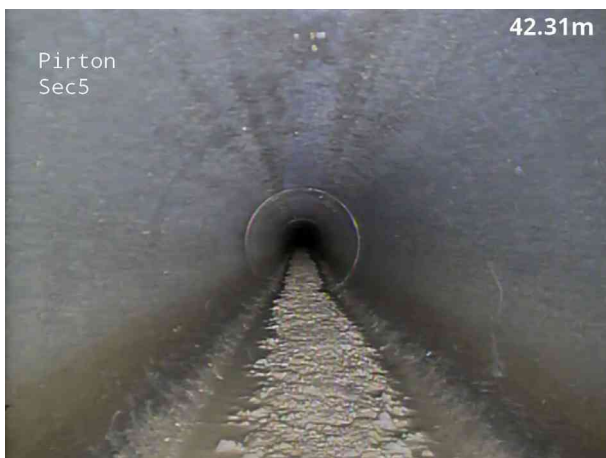
3, 00:04:38, 42.30 m  
Survey abandoned, Unable to continue, assumed cable drag

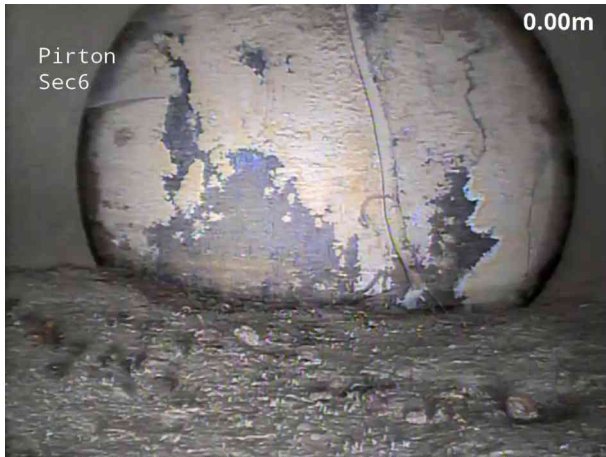
| Section | PLR | Grade | Description |
|---|---|---|---|
| 6 | BX | 3 | Settled deposits, fine, 10% cross-sectional area loss |

1, 00:00:00, 0.00 m  
Settled deposits, fine, 10% cross-sectional area loss

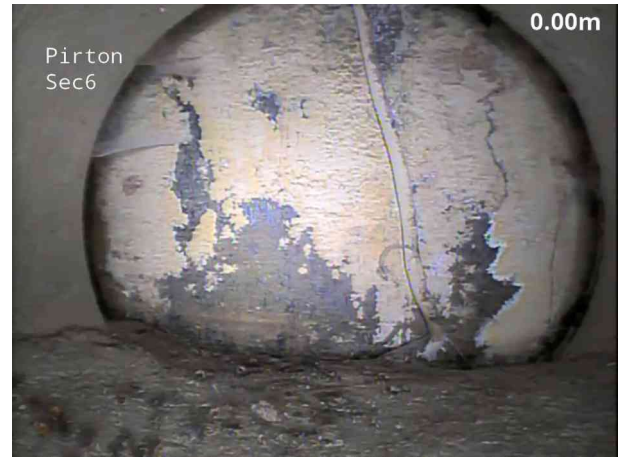
2, 00:00:16, 0.40 m  
Finish node, manhole, reference: B, Capped, assumed for future use
