# Heritage Statement

The Green Man, 5 High St, Hitchin, SG5 3AR

Job number 9319  
Revision A  
Issued by FP  
Date issued 20.07.26

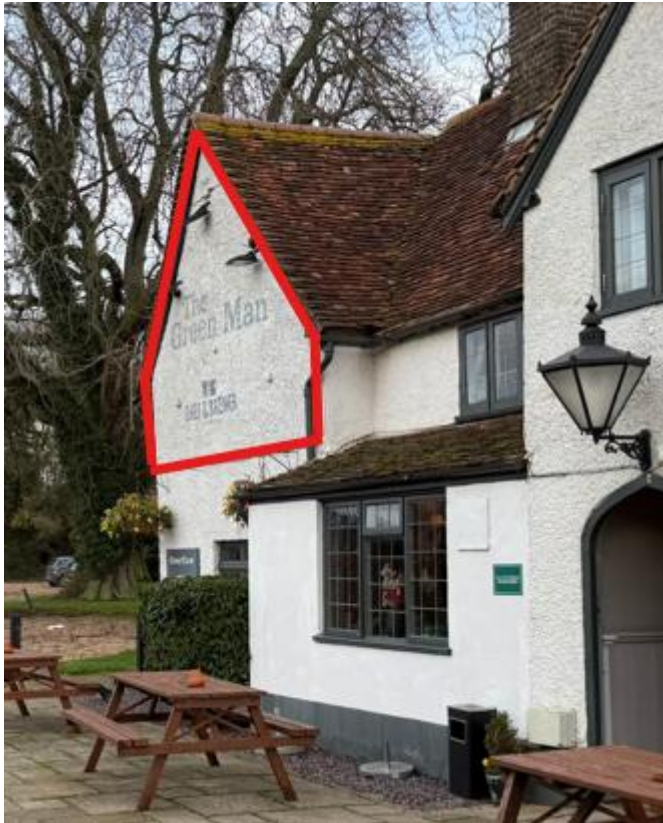
*Appendix A. Existing Front SW Elevation*

- 3.1 The timber frame to the front left gable end wall (*reference appendix. A* ) has been exposed following the careful removal of loose and unstable render. This has revealed the historic timber frame, allowing its condition to be fully inspected and assessed.
- 3.2 The proposal seeks to make the existing gable safe and structurally sound through a combination of carefully considered repairs to the historic timber frame. The works include splicing new oak sections into areas where the existing timber has significantly deteriorated (*reference appendix. B - I* ), installing new structural timbers to support and retain the historic framework, and rebuilding sections of the infill brickwork where required.

Once the structural repairs have been completed, the timber framework will be finished with wood fibre boarding and a lime-rendered finish before being externally decorated. This will match the existing finish of the remainder of the building, ensuring the repaired elevation is consistent with the building's historic appearance.

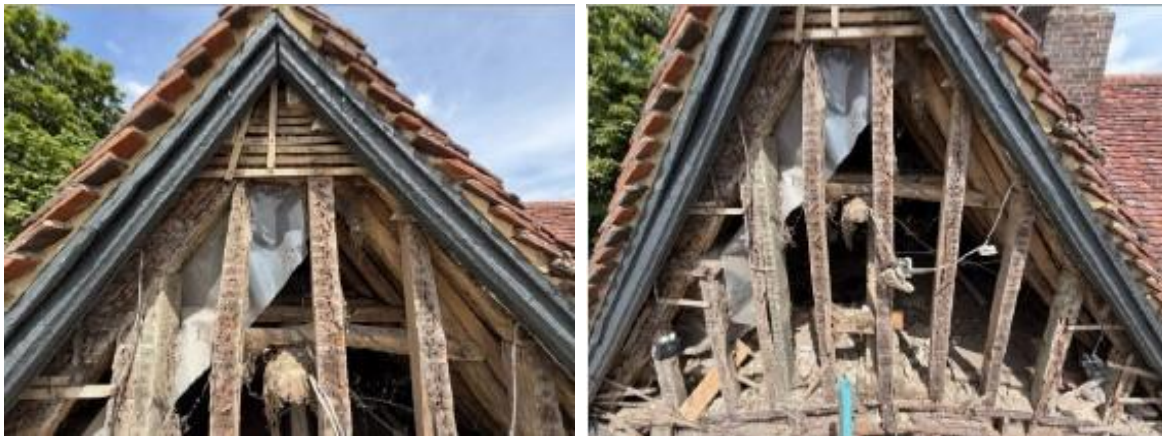
*Appendix B. Reference drawing 9319-01-03. Identified Issue 1.*

No vertical support to the central timber beam.

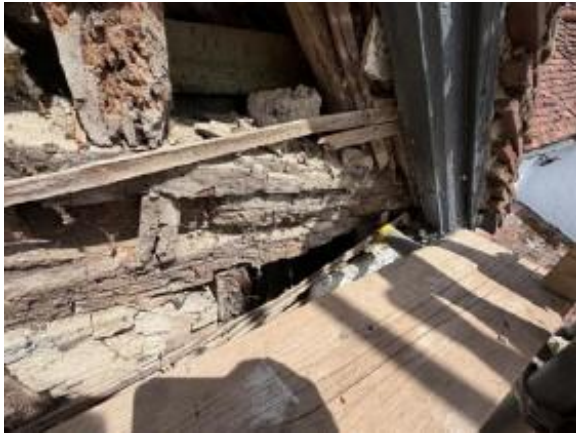
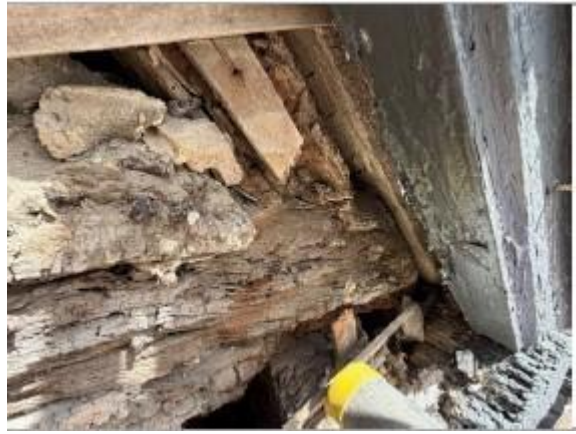
*Appendix C. Reference drawing 9319-01-03. Identified Issue 2.*

Eaves wall plate and the wall plate itself appears to have rotten through.

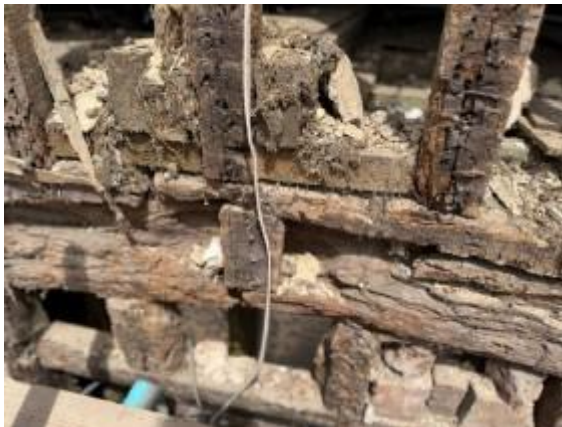
*Appendix D. Reference drawing 9319-01-03. Identified Issue 3.*

At eaves level there are large sections of the beam which have deteriorate so far that the timber is falling out.

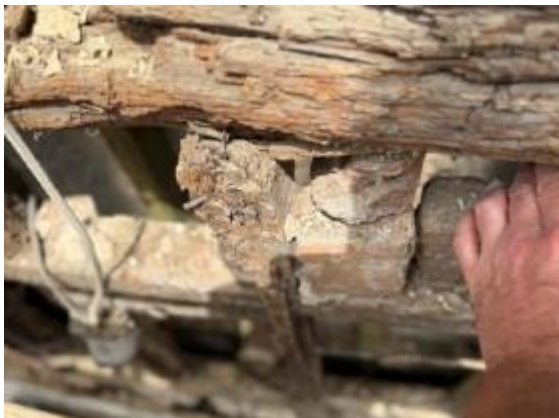
*Appendix E. Reference drawing 9319-01-03. Identified Issue 4.*

The timber of the window frame below has become dislodged from the curved timber beam and is freely moving.

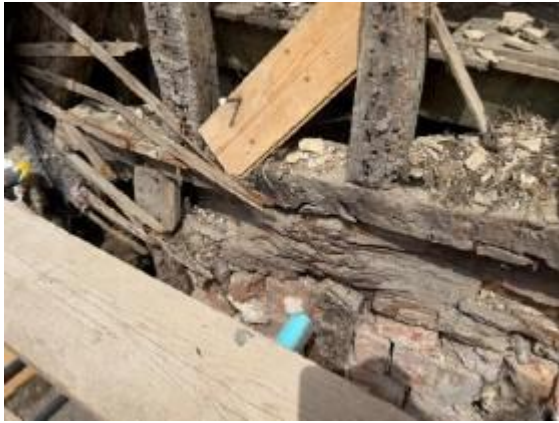
*Appendix F. Reference drawing 9319-01-03. Identified Issue 5.*

At eaves level there are large sections of the beam which have deteriorate so far that the timber is falling out.

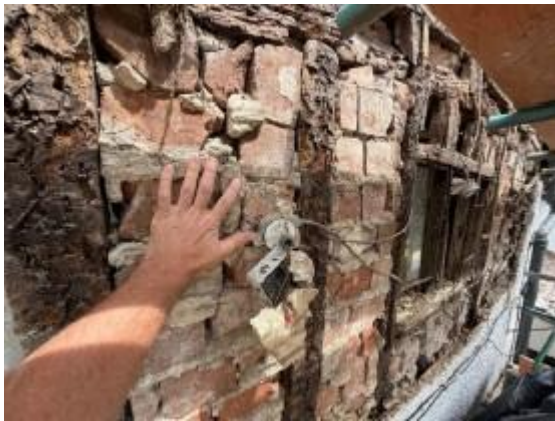
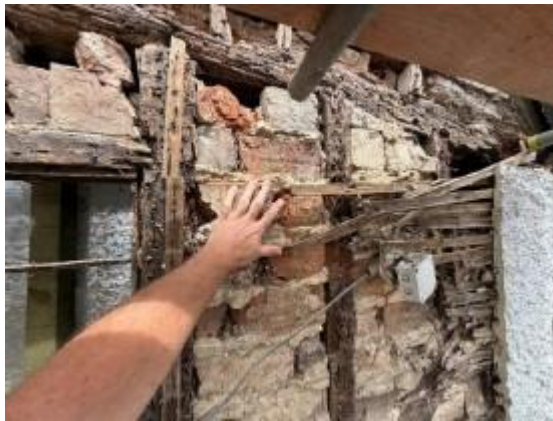
*Appendix G. Reference drawing 9319-01-03. Identified Issue 6.*

Existing brick infill panels are all loose and can be wrecked by hand.

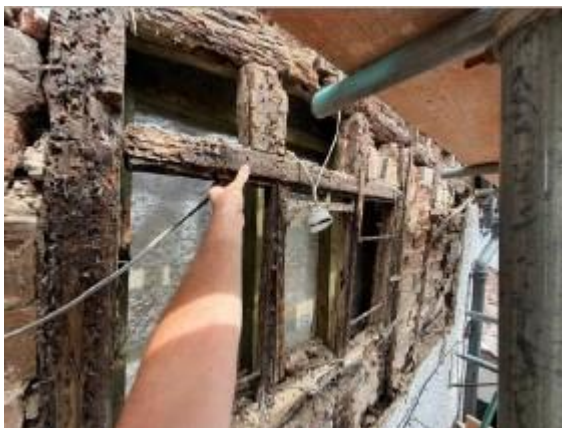
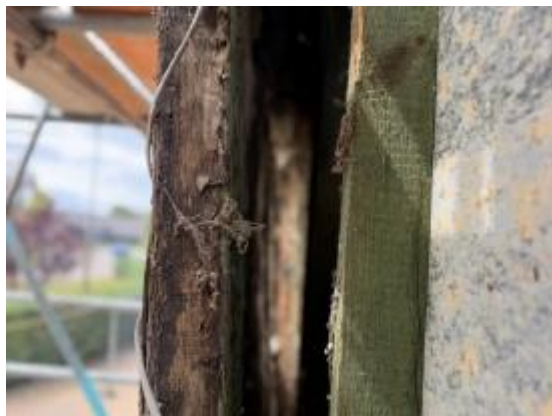
*Appendix H. Reference drawing 9319-01-03. Identified Issue 7.*

Existing brick infill panels are all loose and can be wrecked by hand.

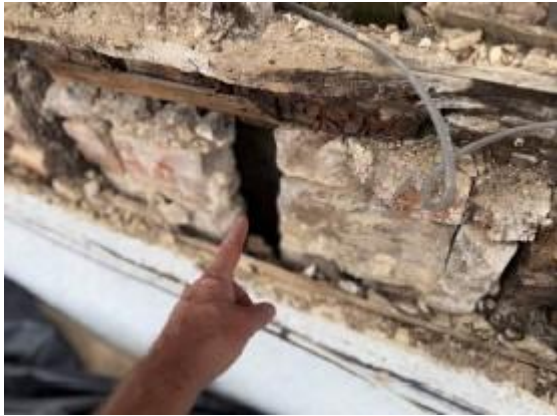
*Appendix I. Reference drawing 9319-01-03. Identified Issue 8.*

The central timber stud under the 1st floor window frame has completely rotten through and will need to be replaced with a new oak post.
