# Arboricultural Impact Assessment and Method Statement

**Site:** Hillcrest and Tussocks  
The Causeway  
Therfield  
SG8 9PP

**Date:** August 2026

**Reference:** TCTC-18755-D

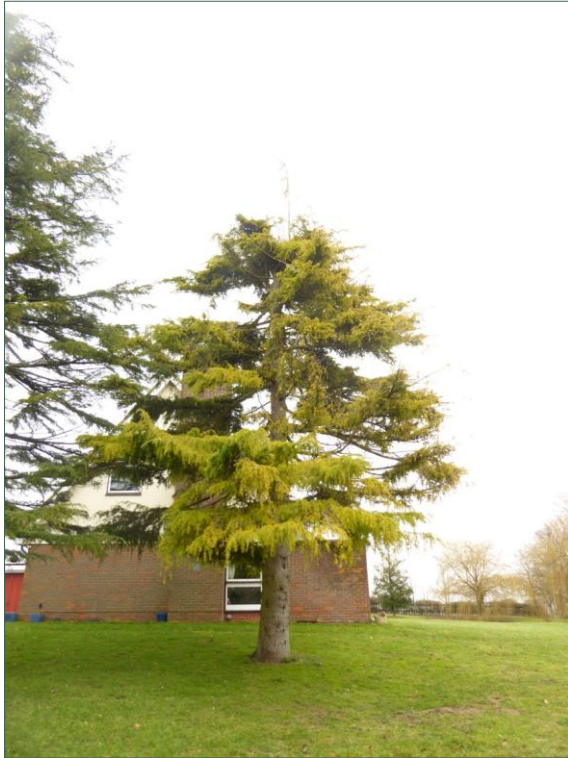
| Activity | Potential Impact | | | |
|---|---|---|---|---|
| | The long term retention of this tree is limited, it is in serious decline, along with other nearby cedar tree T58, and cannot be sustainably integrated into the development proposal without damage to roots. | | | |

TC1 (16.02.23) T58 cedar of low value, in decline

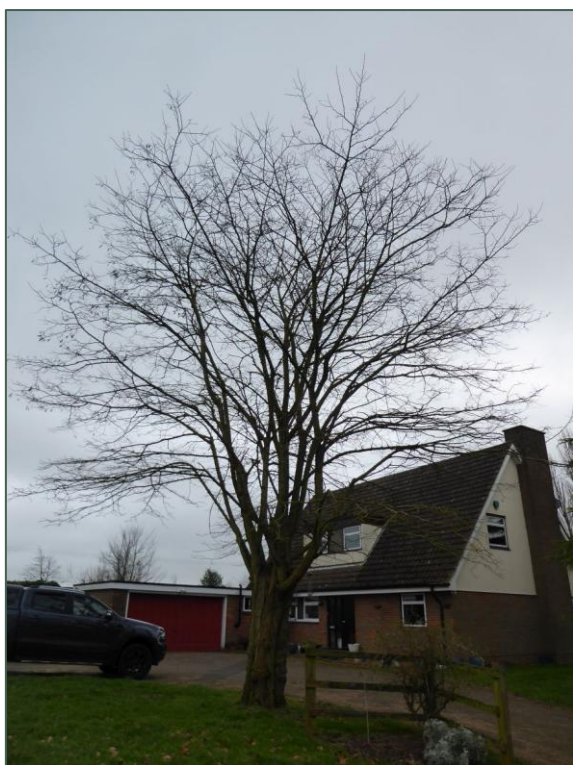
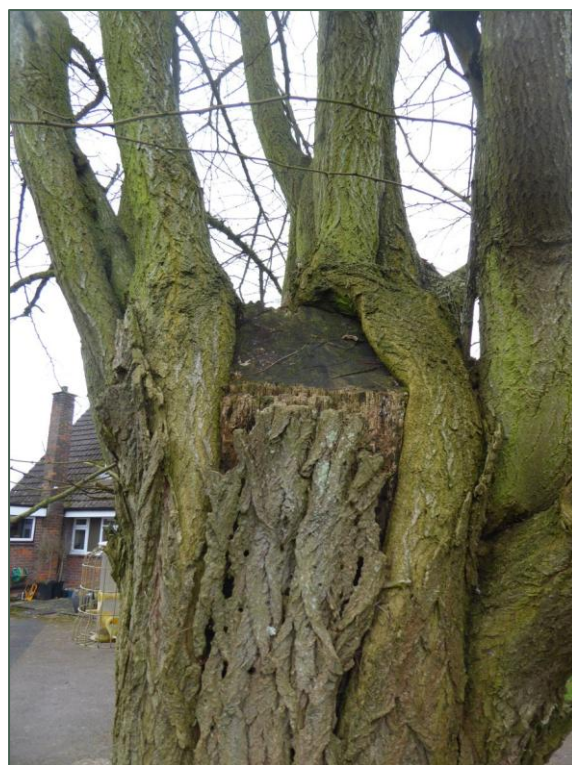
TC2 (16.02.23) T60 Acacia of low value, with poor crown structure and decay in main supporting stem

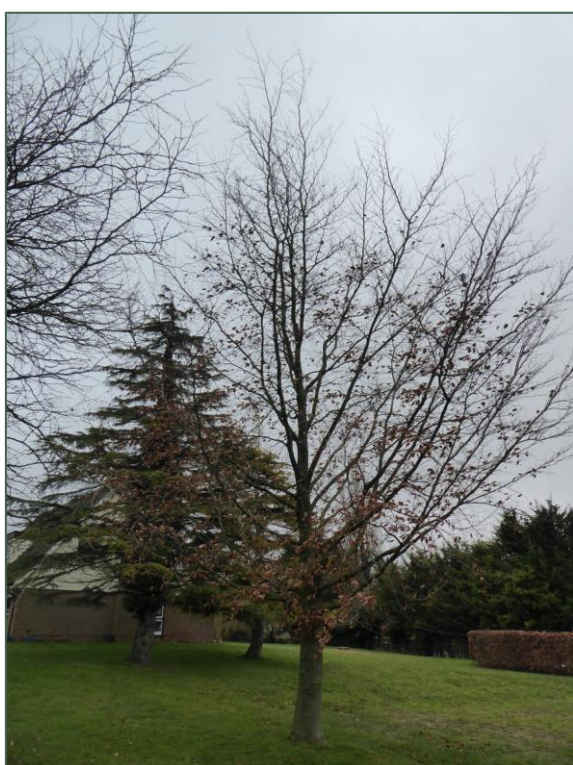
TC3 (16.02.23) T62 beech of moderate quality

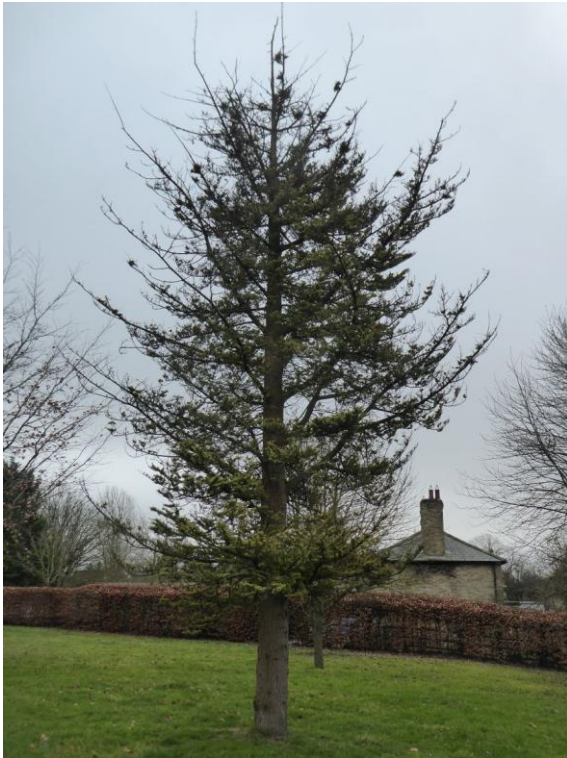
TC3 (16.02.23) T63 Cedar of poor value, in significant decline.
