**R & D for Asbestos containing materials at**

**Teaching Block  
Temple Dinsley  
School Lane  
Preston, Hitchin  
Hertfordshire, SG4 7RT**

SURVEY DATE; 10th August 2023

REFERENCE; ECB/5340

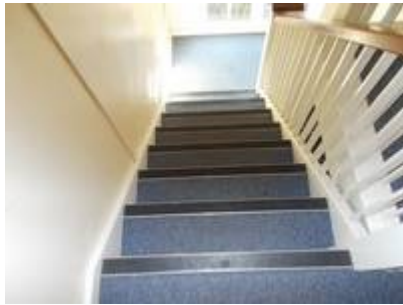
Location Ref: V01

Non asbestos vinyl staircase nosings  
throughout staicases.

No Action Required

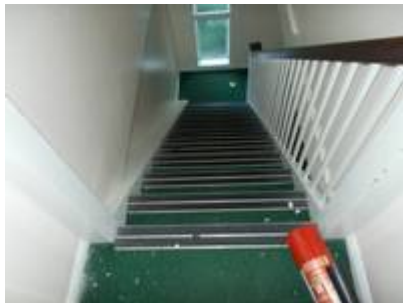
Location Ref: V02

Non asbestos vinyl staircase nosings  
throughout staicases.

No Action Required

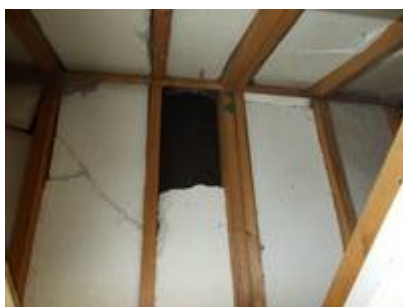
Location Ref: 1

Non asbestos bitumastic roof felts  
behind polystyrene insulation.

No Action Required

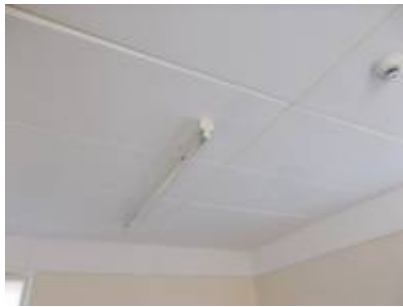
2

Non asbestos ceiling boards. Identical  
non asbestos boarding used in other  
areas.

No Action Required

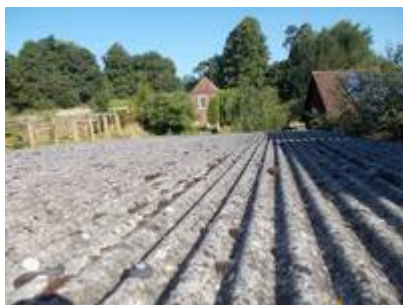
| Sample Date | Location Ref | Location ID | Drawing Reference | Area | Room | Asbestos Type | Product Name | Material Risk Score | Material Risk Band | Priority Risk Score | Comments | Action | Survey Type |
|---|---|---|---|---|---|---|---|---|---|---|---|---|---|
| 10/08/23 | 3 | 29448 | 2 | Main | External Garage | NADIS | Corrugated Roof Sheet | 0 | NADIS | N/A | Non asbestos corrugated roof sheets. | No Action Required | RDS |

No Action Required

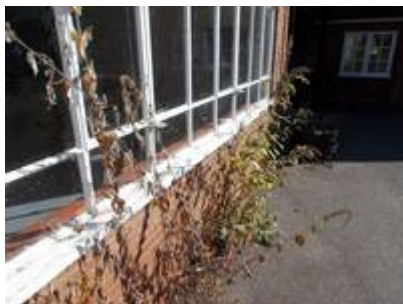
| Sample Date | Location Ref | Location ID | Drawing Reference | Area | Room | Asbestos Type | Product Name | Material Risk Score | Material Risk Band | Priority Risk Score | Comments | Action | Survey Type |
|---|---|---|---|---|---|---|---|---|---|---|---|---|---|
| 10/08/23 | 4 | 29449 | 2 | Main | External | NADIS | Putty | 0 | NADIS | N/A | Non asbestos putty around glazing. | No Action Required | RDS |

No Action Required

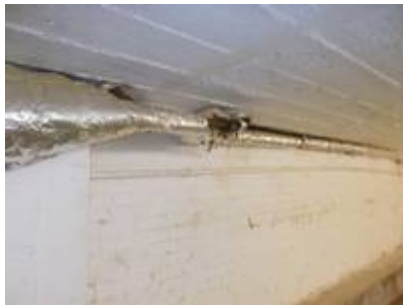
| Sample Date | Location Ref | Location ID | Drawing Reference | Area | Room | Asbestos Type | Product Name | Material Risk Score | Material Risk Band | Priority Risk Score | Comments | Action | Survey Type |
|---|---|---|---|---|---|---|---|---|---|---|---|---|---|
| 10/08/23 | 5 | 29450 | 3 | Main | Store | NADIS | Debris/Residue | 0 | NADIS | N/A | Non asbestos debris/residue to pipework insulation. No asbestos detected to walls. | No Action Required | RDS |

No Action Required

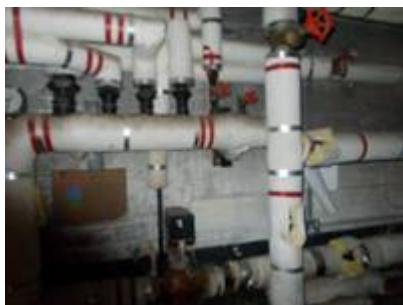
Non asbestos debris/residue to pipework  
insulation. Asbestos residue was  
previously identified to contain asbestos.  
No evidence that the areas have been  
cleaned. Recommend that these be  
environmental cleaned as a precaution.

Environmental clean by Licenced  
Contractor

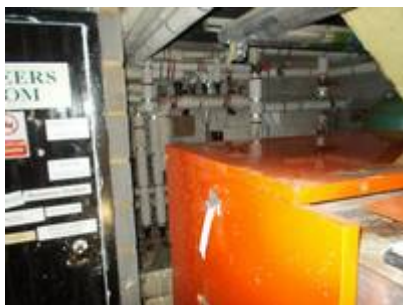
| Sample Date | Location Ref | Location ID | Drawing Reference | Area | Room | Asbestos Type | Product Name | Material Risk Score | Material Risk Band | Priority Risk Score | Comments | Action | Survey Type |
|---|---|---|---|---|---|---|---|---|---|---|---|---|---|
| 10/08/23 | V03 | 29452 | 3 | Main | Boiler room | Amosite & Chrysotile | Gasket | 5 | Low Risk | 3 | Presumed asbestos gaskets to pipework flanges. | Remove before refurbishment | RDS |

No visible damage

Remove before refurbishment
