### **Temple Dinsley Level 0, GA – Ground Floor – Common Areas – Entrance Hall**

Ground Floor Entrance Hall – Plan of Significance

**641-KS-06-MB-SH-A-90910 – P01****Temple Dinsley Level 0, GA – Ground Floor – Common Areas – Entrance Hall**

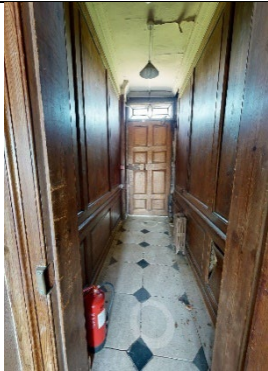
| Reference | Proposal | Significance of affected fabric | Impact | Reasoning and mitigation |
|---|---|---|---|---|
| A-Walls<br>WME-EH-<br>A.R2 | Repairs to timber panelling along north corridor. | High<br>Early C20 (1909)<br>Lutyens | Low<br>Impact<br><br>Benefit &<br>Enhance | <p>North corridor</p> <p>Remove all surface mounted electrical fixtures on timber panelling. Carry out repairs to make good all fixing holes/penetration holes.</p> |

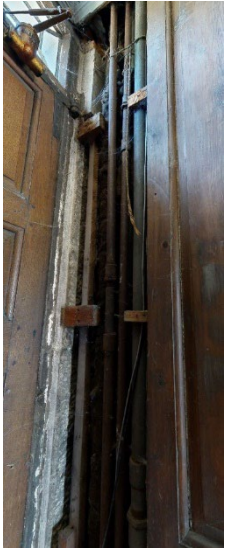
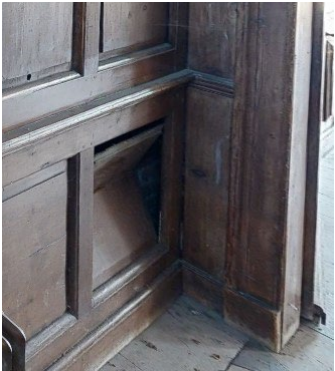
| Reference | Proposal | Significance of affected fabric | Impact | Reasoning and mitigation |
|---|---|---|---|---|
| | | | | <p>Electrical boxes</p> <p>Following removal of pipework/services reinstate new section of projecting timber between panelling and door to match opposite side of door.</p> <p>Broken lower panel</p> <p>Remove panel, rejoin and replace into position.</p> |

| Reference | Proposal | Significance of affected fabric | Impact | Reasoning and mitigation |
|---|---|---|---|---|
| | | | | Repairs to all damaged timber, holes, dents and surface scratches to be filled and the existing surface prepared to receive new painted finish.<br><br>The proposed panelling finish will be restored to the original 1909 Lutyens painted finish and will comply with Building Regulations Part B1 requirements. |

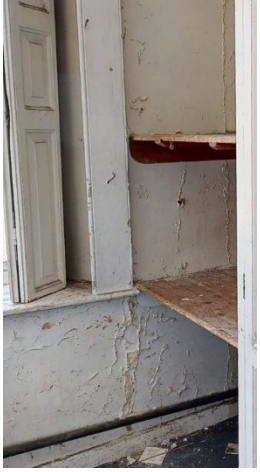
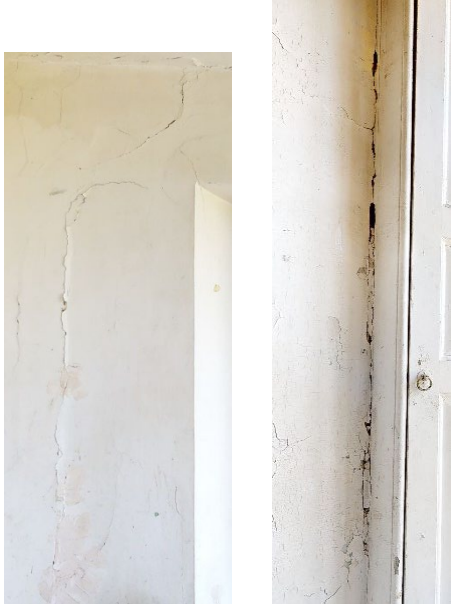
| Reference | Proposal | Significance of affected fabric | Impact | Reasoning and mitigation |
|---|---|---|---|---|
| A-Walls<br>WME-EH-A.R3 | Remove area of damp plaster at low level including skirtings on north wall and damaged plaster on west wall of former wc | Moderate-Low<br>Possible lime plaster with some gypsum repairs | Low Impact<br><br>Benefit | <p>North wall of wc</p> <p>Cause of damp ingress to be investigated and rectified. Existing plaster will need to be removed to allow wall to dry out.</p> <p>West wall of wc &amp; junction with timber shutter housing</p> <p>Rake out cracks and filler.</p> <p>Repairs to be carried out with lime-based plaster. Loose/peeling areas of existing</p> |

| Reference | Proposal | Significance of affected fabric | Impact | Reasoning and mitigation |
|---|---|---|---|---|
| | | | | paint finish to be scraped back and wall to be prepared to provide a smooth finish for redecoration with a breathable paint. |

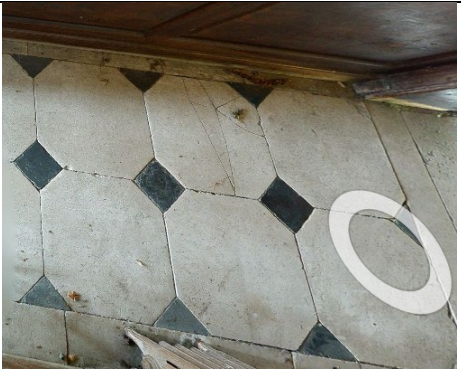
| Reference | Proposal | Significance of affected fabric | Impact | Reasoning and mitigation |
|---|---|---|---|---|
| B-Floors<br>WME-EH-<br>B.R2 | Repairs to stone tiles in north corridor | High<br>Early C20<br>1909 Lutyens | Low<br>Impact<br><br>Benefit & Enhance | <p>Broken stone tile</p> <p>Broken tile to be carefully lifted for conservation repair. Substrate to be inspected and made even and level. Re-bed tile and repair cracks with suitable filler colour to match stone.</p> <p>Surface of tiles to be cleaned and polished.</p> |

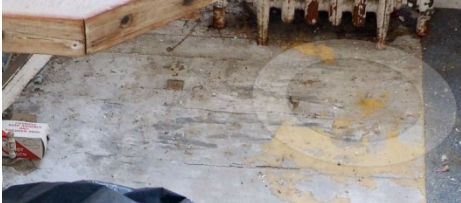
| Reference | Proposal | Significance of affected fabric | Impact | Reasoning and mitigation |
|---|---|---|---|---|
| B-Floors<br>WME-EH-<br>B.P1 | Existing floorboards to former wc to be lifted to allow inspection of joists (?) | Moderate-Low<br>C20 timber boards<br>(?) | Low<br>Impact | <p>Timber boards to be carefully lifted to allow inspection of joists/floor void and any repairs/remedial works carried out. Floor void to be insulated (?) Existing boards to be replaced and new floor finish tbc</p> |

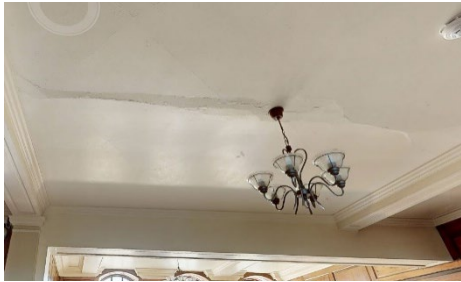
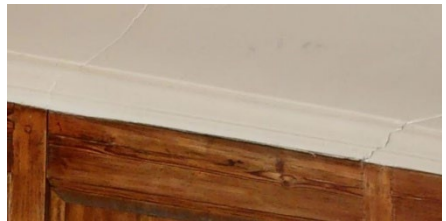
| Reference | Proposal | Significance of affected fabric | Impact | Reasoning and mitigation |
|---|---|---|---|---|
| C-Ceilings<br>WME-EH-<br>C.R1 | Repairs to cracks in lath and plaster ceiling. | High<br>C18 and Early 20<br>Lutyens | Moderate<br>- Low<br>Impact<br><br>Benefit & Enhance | <p>Cracking to entrance Hall ceiling</p> <p>Deflection to likely to have been caused by removal of partition at ground floor and</p> |

| Reference | Proposal | Significance of affected fabric | Impact | Reasoning and mitigation |
|---|---|---|---|---|
| | | | | <p>installation of partitions at 1<sup>st</sup> floor enclosing Lutyens staircase to attic.</p> <p>Investigation of floor structure from above and remedial strengthening intervention to floor/partitions to be designed by structural engineer in consultation with Conservation Officer.</p> <p>Lath and plaster ceiling to be pinned back to joists. Joints to be raked back, filled with lime plaster and decorated.</p> <p>All other areas of cracking to Entrance Hall ceiling are to be investigated and repaired as necessary.</p> <p>Cracks in plaster coving to be repaired with filler and redecorated.</p> <p>The proposed structural repairs are necessary to prevent further damage to the floor, partitions and ceiling finishes and will restore the integrity of the internal space.</p> |

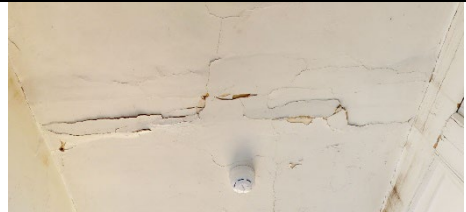
| Reference | Proposal | Significance of affected fabric | Impact | Reasoning and mitigation |
|---|---|---|---|---|
| C-Ceilings<br>WME-EH-<br>C.R2 | Repairs to lath and plaster ceiling | High-Moderate<br>Early C20 (1909)<br>Lutyens | Low<br>Impact | <p>Lath and plaster ceiling</p> <p>Damage to ceiling has been caused by removal of partition. Existing plaster to be pinned back and ceiling underdrawn to provide required fire protection to stairs above.</p> <p>Existing ceiling will be retained behind new plasterboard ceiling lining to comply with Building Regulations Part B</p> |

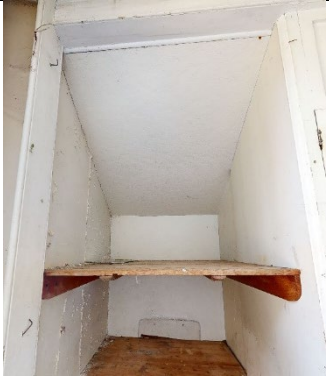
| Reference | Proposal | Significance of affected fabric | Impact | Reasoning and mitigation |
|---|---|---|---|---|
| C-Ceilings<br>WME-EH-<br>C.R3 | Remedial works to soffit and wall linings to recess | Low<br>C20<br>alteration/additions | Low<br>Impact | <p>Existing recess</p> <p>Existing lining materials to be investigated and removed/retained as necessary to comply with compartmentation requirements. Additional linings to be installed/fixed below existing lining to form fire rated separation between former wc and staircase above to comply with Building Regulations Part B.</p> |

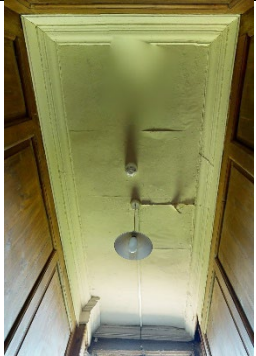
| Reference | Proposal | Significance of affected fabric | Impact | Reasoning and mitigation |
|---|---|---|---|---|
| C-Ceilings<br>WME-EH-<br>C.P4 | Removal of paper from lath and plaster ceiling and lining with plasterboard. | | | <p>Ceiling to north corridor</p> <p>Remove paper lining and under-draw existing lath and plaster with plasterboard to provide required compartmentation to 1<sup>st</sup> floor accommodation.</p> <p>Intervention is necessary to comply with Building Regulations Part B. Existing ceiling will remain in place.</p> |

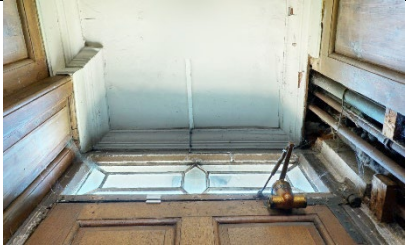
| Reference | Proposal | Significance of affected fabric | Impact | Reasoning and mitigation |
|---|---|---|---|---|
| C-Ceilings<br>WME-EH-<br>C.R5 | Repair to timber coving | High<br>Early C20 (1909)<br>Lutyens | | <p>Missing coving above north exit door</p> |

| Reference | Proposal | Significance of affected fabric | Impact | Reasoning and mitigation |
|---|---|---|---|---|
| | | | | Reinstate coving as part of panelling repairs described under EHA.R2 to match opposite detail. |

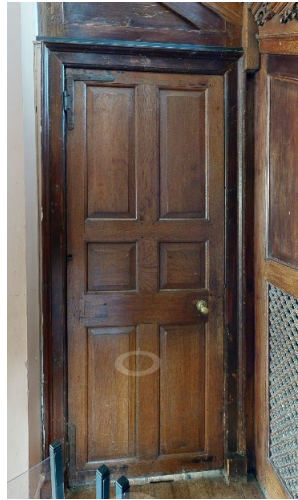
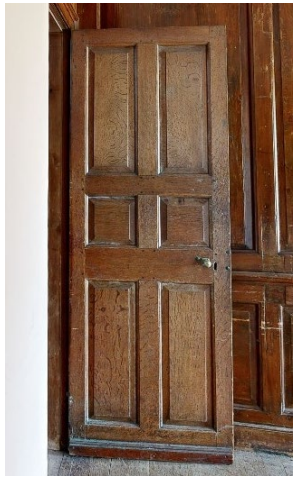
| Reference | Proposal | Significance of affected fabric | Impact | Reasoning and mitigation |
|---|---|---|---|---|
| D-Doors<br>WME-EH-D.R1 | Oak panelled internal doors to be refurbished and redecorated. | High<br>C18 and EC20<br>(1909) Lutyens | Low<br>Impact<br><br>Enhance | <p>Door to understairs room<br/>WME-EH-FD01</p> <p>Door to north exit corridor<br/>WME-EH-FD02</p> <p>Doors to be removed from frames and existing ironmongery removed. Surface of doors, linings and architraves to be lightly sanded to remove existing finish. Upgrade to be fire doors. Flame retardant and breathable varnish to be applied. Door to be re-hung with all original ironmongery/lock cases of historic value and modern security fittings tbc.</p> |

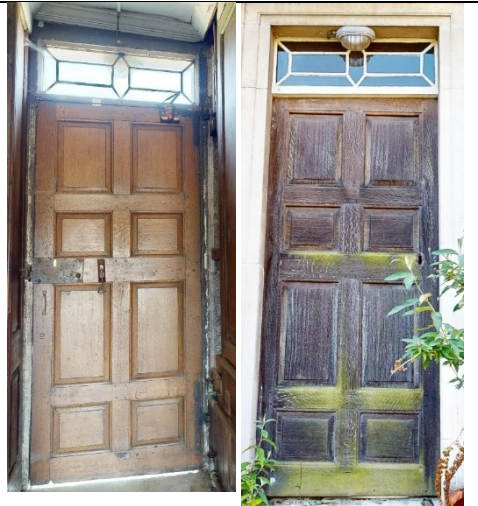
| Reference | Proposal | Significance of affected fabric | Impact | Reasoning and mitigation |
|---|---|---|---|---|
| D-Doors<br>WME-EH-D.R2 | Oak panelled external entrance door to be refurbished | High<br>C18 | Low<br>Impact<br><br>Benefit | <p>North external door, internal and external views</p> <p>WME-EH-D03</p> <p>Door to be removed from frame and existing ironmongery removed and set aside.</p> <p>Internal side of door to be lightly sanded to remove existing finish. Fill all holes &amp; dents with wood wax to match oak. Apply flame retardant breathable varnish(?)</p> <p>Remove external light. Conservation repairs to holes left open following removal of ironmongery. External surface to be cleaned and lightly sanded to remove algae and restore surface suitable for application of exterior quality oil suitable for oak.</p> <p>Door to be re-hung with all original ironmongery/lock cases of historic value and modern security fittings tbc.</p> <p>Glazed lead light panel at head of door appears to be in good condition and will be retained. Proposal to line internally with toughened glass panel for security purposes (?) will maintain internal view and daylight and will not affect the glazing. Fixing details tbc</p> <p>The oak door and all remaining historic ironmongery will be retained. The door will be</p> |

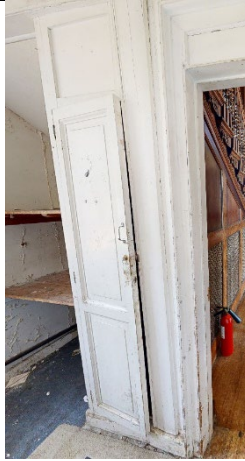
| Reference | Proposal | Significance of affected fabric | Impact | Reasoning and mitigation |
|---|---|---|---|---|
| D-Doors<br>WME-EH-D.R3 | Repairs and redecoration to cupboard door | Moderate-Low<br>Early C20 (1909)<br>Lutyens / C20<br>timber panelled door | Low<br>Impact<br><br>Enhance | <p>Cupboard door with timber panel over</p> <p>Door and surrounding timber linings to be prepared to receive new flame retardant breathable paint finish.</p> <p>Existing linings to inside of cupboard to be investigated and removed/retained as necessary to comply with compartmentation requirements. Additional linings to be installed/fixed below existing lining to form fire rated separation between cupboard and staircase above to comply with Building Regulations Part B.</p> |

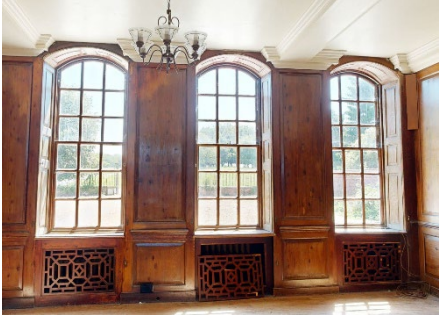
| Reference | Proposal | Significance of affected fabric | Impact | Reasoning and mitigation |
|---|---|---|---|---|
| E-Windows<br>WME-EH-E.R1 | Renovation of 3no C20 timber sash windows and oak shutters | High Early C20 (1909) Lutyens | Low<br>Impact<br><br>Benefit & Enhance | <p>3no sash windows within Entrance Hall</p> <p>WME W03, W04 &amp; W05</p> <p>The existing timber multi-pane sash windows and shutters will be repaired/renovated/redecorated, internally with a flame retardant breathable varnish, external paint finish tbc. Splice repairs to be carried out where required. Resin for more localised repair. Perished putty replacement. Easing of window as required. Original sash fasteners and shutter knobs and hinges to be retained for re-use. New security ironmongery to comply with building regulations where required tbc. The repairs will improve the appearance and longevity of the window.</p> |

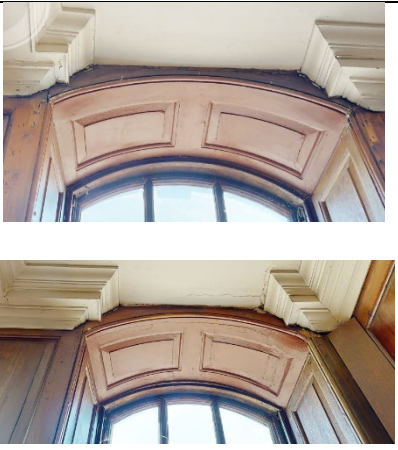
| Reference | Proposal | Significance of affected fabric | Impact | Reasoning and mitigation |
|---|---|---|---|---|
| | | | | <p>2no of 3 head panels over sash windows in Entrance Hall</p> <p>Curved timber head panels are to be carefully removed and inspected individually to ascertain the extent of damage and whether the panels can be salvaged. If repair is possible the paint finish and areas of filler are to be removed and the panels reformed using new timber splice repairs and resin for more localised repair.</p> <p>If any of the panels are beyond repair they are to be reformed using new timber to match existing.</p> <p>It is likely that the damage to the panels has been caused by water ingress through the external south wall. The construction cavity between the head of the window and the 1<sup>st</sup> floor is to be inspected for signs of damp and an ingress route. Remedial action is to be taken to prevent further damage prior to replacement of timber panels.</p> <p>New/repared panels are to be finished with a flame retardant breathable paint to match the wall panelling.</p> |

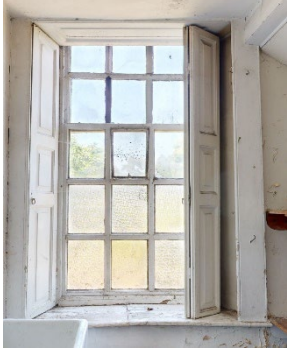
| Reference | Proposal | Significance of affected fabric | Impact | Reasoning and mitigation |
|---|---|---|---|---|
| E-Windows<br>WME-EH-E.R3 | Renovation of timber sash window and shutters to WC north wall. | High<br>Early C20 (1909)<br>Lutyens | High | <p>Timber sash to wc WME-EH-W07</p> <p>Painted timber multi-pane sash window, with central hinged opening light in steel frame. Window frame, sashes, shutters &amp; shutter housing, and head panel to be repaired/renovated/redecorated as necessary.</p> <p>Existing window board to be inspected and repaired/replaced according to condition.</p> <p>Glass to be inspected and repaired/replaced as necessary.</p> <p>Splice repairs to be carried out where required. Resin for more localised repair.</p> <p>Perished putty replacement. Easing of window as required. Original sash fasteners, shutter knobs and hinges to be retained for re-use.</p> <p>Existing paint finish to internal side of window and surrounding linings/joinery to be prepared for new paint finish.</p> <p>External paint finish to windows tbc.</p> <p>New security ironmongery to comply with building regulations where required tbc.</p> <p>The repairs will improve the appearance and longevity of the windows.</p> |

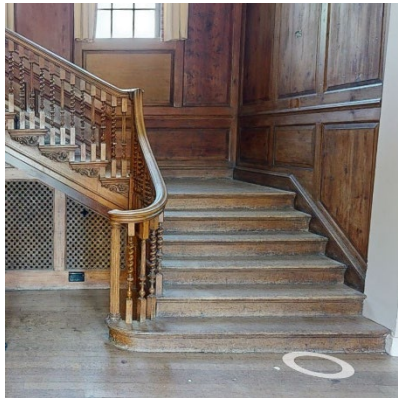
| Reference | Proposal | Significance of affected fabric | Impact | Reasoning and mitigation |
|---|---|---|---|---|
| H-Stairs<br>WME-EH-H.P1 | | | | <p>Oak stair is to be inspected to ensure stability and any repairs/strengthening works carried out as necessary.</p> |

| Reference | Proposal | Significance of affected fabric | Impact | Reasoning and mitigation |
|---|---|---|---|---|
| | | | | <p>Foot of Main Entrance stair</p> <p>Surface to treads/risers/balusters/handrail and decorative screen below 2<sup>nd</sup> flight is to be lightly sanded back and suitably prepared for new breathable and flame retardant varnish finish.</p> <p>The repairs will improve the appearance and longevity of the staircase and will comply with Building Regulations B1.</p> |

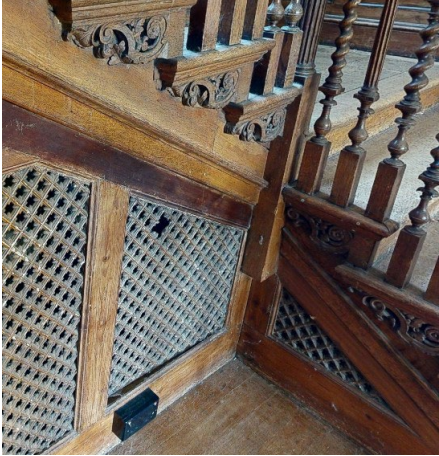
| Reference | Proposal | Significance of affected fabric | Impact | Reasoning and mitigation |
|---|---|---|---|---|
| H-Stairs<br>WME-EH-H.R1 | Repair of hole in decorative screen below 2 <sup>nd</sup> flight. | Early C20 (1909) Lutyens | Low Enhance | <p>Damage to decorative screen below 2<sup>nd</sup> flight</p> <p>Hole to be repaired with matching timber infill.</p> <p>The repair will improve the appearance of the staircase.</p> <p>Note: Screens to be carefully removed to allow investigation of void space below stairs. Any services to be removed. Building Inspector to confirm requirement of linings behind open screen.</p> |

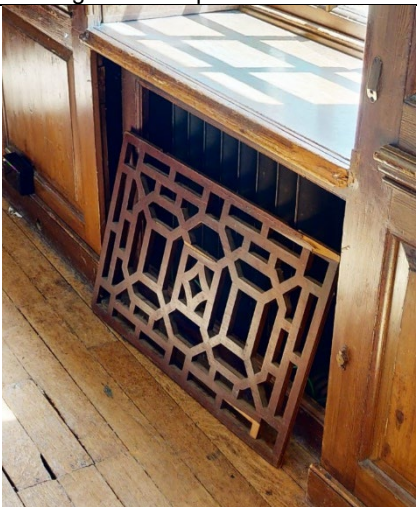
| Reference | Proposal | Significance of affected fabric | Impact | Reasoning and mitigation |
|---|---|---|---|---|
| J-Internal fixtures and fittings<br>WME-EH-J.D1/R1 | Renovation / removal of C20 cast iron wall mounted radiator | Neutral | Neutral Impact | |

| Reference | Proposal | Significance of affected fabric | Impact | Reasoning and mitigation |
|---|---|---|---|---|
| | | | | <p>C20 cast iron radiators to be removed or renovated (?)</p> <p>Radiators to be removed and replaced or restored and replaced in existing location or relocated within new layout as required.</p> |

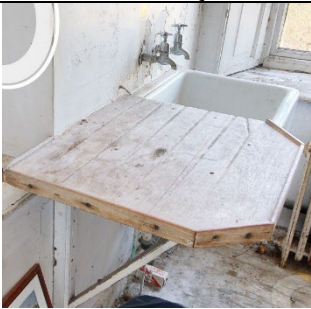
| Reference | Proposal | Significance of affected fabric | Impact | Reasoning and mitigation |
|---|---|---|---|---|
| J-Internal fixtures and fittings WME-EH-J.D3 | Removal C20 butler's sink and taps, wooden drainer and associated pipework and drainage | Neutral | Neutral Impact | <p>Butler's sink &amp; drainer</p> <p>There is evidence that a wc was located within the recess adjacent to the north wall. It is proposed that a new wc is re-</p> |

| Reference | Proposal | Significance of affected fabric | Impact | Reasoning and mitigation |
|---|---|---|---|---|
| | | | | <p>installed in this space to serve the entrance area for visitors to the building.</p> <p>Removal of the existing sink and fittings and replacement with an appropriately sized new basin and fittings will return the room to use.</p> |

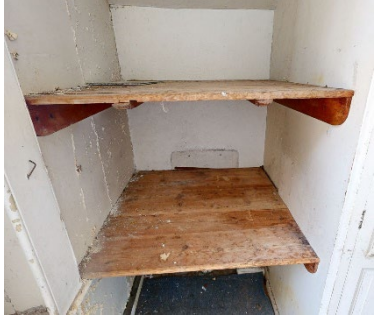
| Reference | Proposal | Significance of affected fabric | Impact | Reasoning and mitigation |
|---|---|---|---|---|
| J-Internal fixtures and fittings WME-EH-J.D4 | Removal C20 shelving from recess | Low C20 additions | Low Impact Enhance | <p>C20 shelving</p> <p>Shelving to be removed to allow installation of sanitaryware</p> |

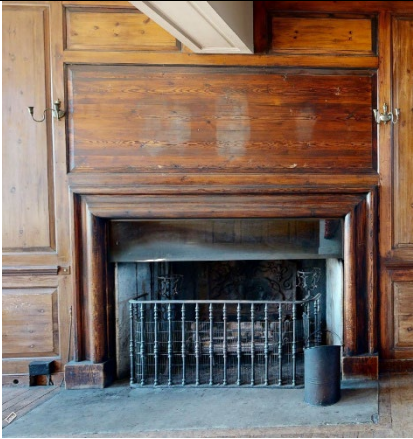
| Reference | Proposal | Significance of affected fabric | Impact | Reasoning and mitigation |
|---|---|---|---|---|
| N-Fireplaces WME-EH-N.R1 | Repairs to Entrance Hall fireplace | Moderate-Low Post 1909 Lutyens | Neutral Impact | <p>Entrance Hall fireplace</p> <p>The fireplace will be retained. A CCTV inspection of the flue will be carried out to ensure structural stability and any necessary repairs carried out. The chimney will be fitted with a ventilated cap. Carry out conservation repair to large chip to the RHS corner of the hearth stone.</p> |

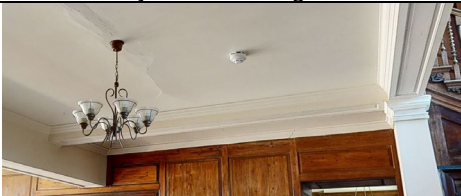
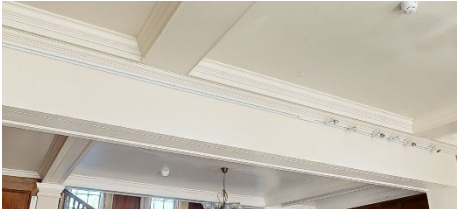
| Reference | Proposal | Significance of affected fabric | Impact | Reasoning and mitigation |
|---|---|---|---|---|
| R-Fire and Soundproofing<br>WME-EH-R.P1 | Confirmation of approved escape routes to inform specification of surface finishes to existing timber on escape routes. | Low | Low Impact | <br><br> <p>Pillars and downstand beams in entrance Hall.</p> <p>Existing timber panelling, floor finish and stairs are to have surface finishes applied that comply with Building Regulations requirements for surface spread of flame.<br/>Investigate construction of pillars at base of stairs.<br/>Pillars and downstand beam casings are to be lined or have surface treatment applied as necessary that complies with Building Regulations requirements for protection to elements of structure.</p> |
