# **CAMBRIDGE ASBESTOS REMOVAL LTD**

**R & D for Asbestos containing materials at**

**Gazebo  
Temple Dinsley  
School Lane  
Preston, Hitchin  
Hertfordshire, SG4 7RT**

REFERENCE; ECB/5343

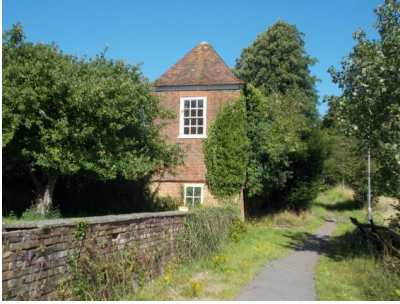
29431

No asbests was detected and no  
samples were taken.

No Action Required
