**Supporting Information for Listed Building Consent  
Application  
Survey and Method Statement**

Youngloves Farm, Southern Green, Hertfordshire, SG9 0SP

Date: 28<sup>th</sup> July 2024

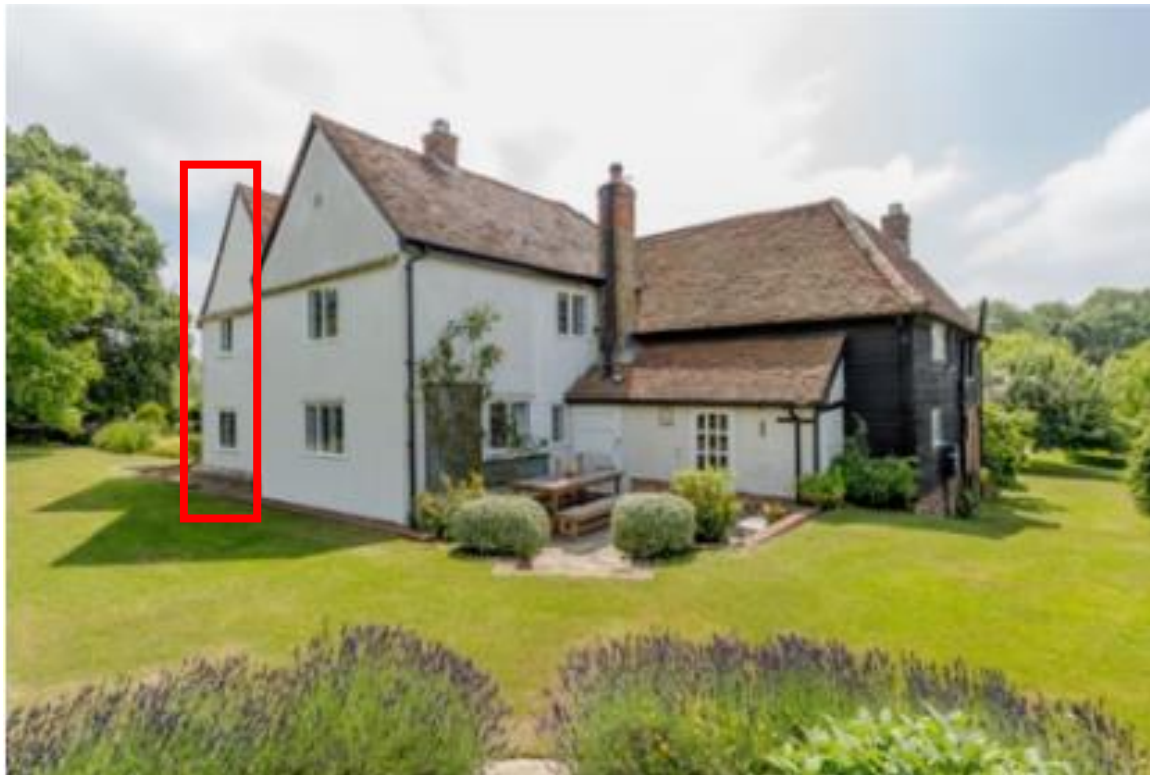
Figure 1 - Existing House showing elevation to be repaired

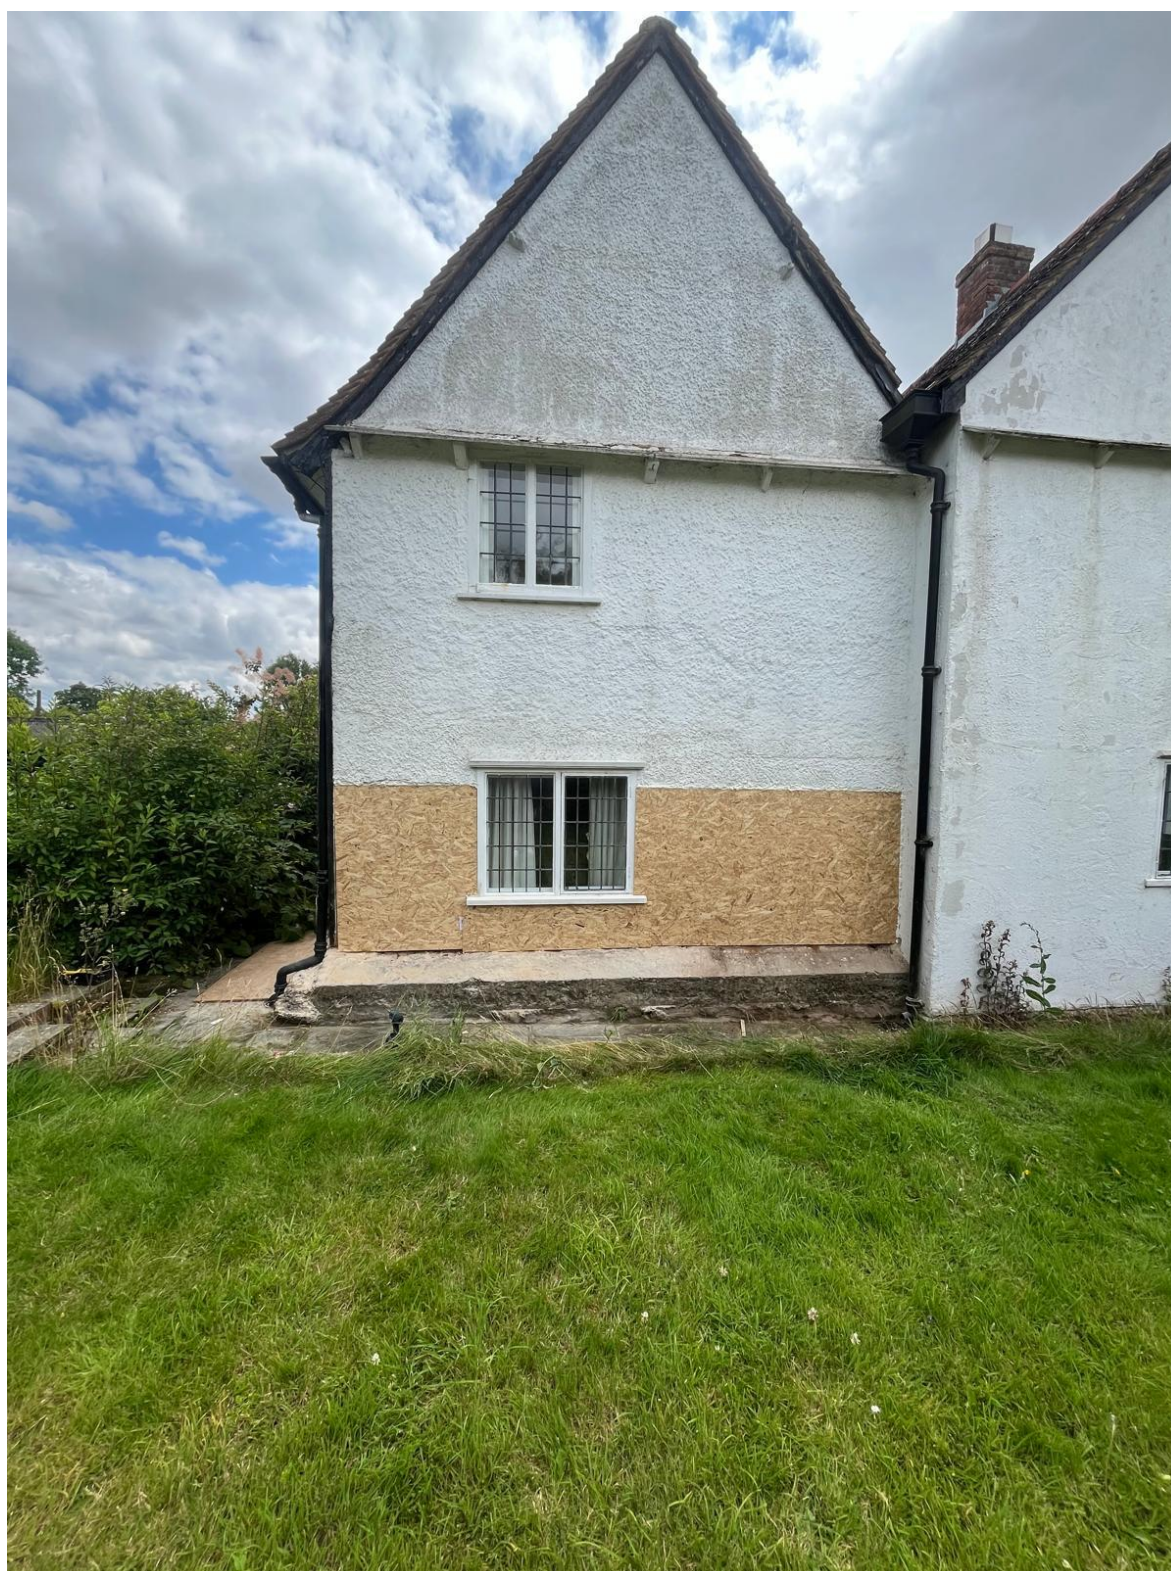
Figure 2 - Photo of North Elevation taken on 22nd July 2024

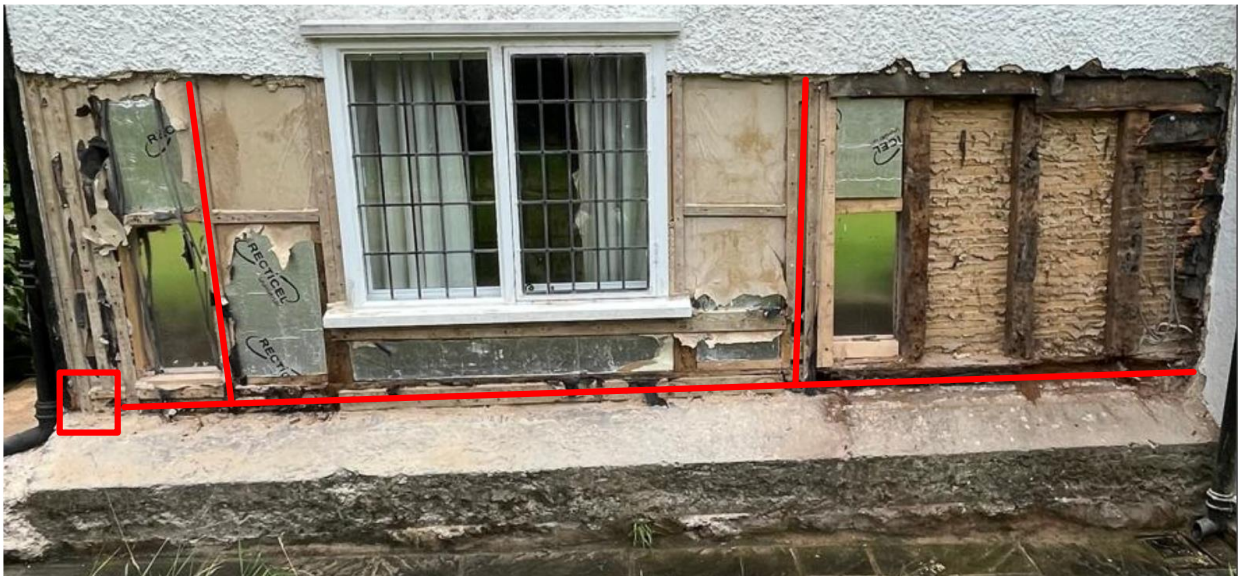
- a. The sole plate has perished over time and holds no structural integrity; estimation that over 50% of the timber.
- b. The sole plate is also under sized for the building and is not supporting the main posts.
- c. The sole plate appears to have a baseline dimension of 7 inches by 6 inches.
- d. The sole plate sits on a combination of existing brick plinth and what is believed to be concrete.
- e. In total, there are 7 studs that have been exposed by 1.2m from sole plate level.
- f. 2 stud which are modern softwood will be replaced with oak studs
- g. 1 main post which is in good condition but will need to be connected to the sole plate using appropriate connections.

**Figure 3: North Elevation with Render removed approximately 1.2m from sole plate**

The problem areas are shown outlined in red border. Any areas/timber with no colour code are timbers or structures that will not be remediated and left as found.

- replace the full sole plate
- replace 2 studs
- Introduce 1 new stud after stud 7
- Connect the main post into the new sole plate
- Rebuild plinth wall
