## DESIGN ACCESS AND HERITAGE STATEMENT

FOR REPAIRS AND REINSTATEMENT WORKS AT

MANOR FARM, GRAVELEY

July 2026

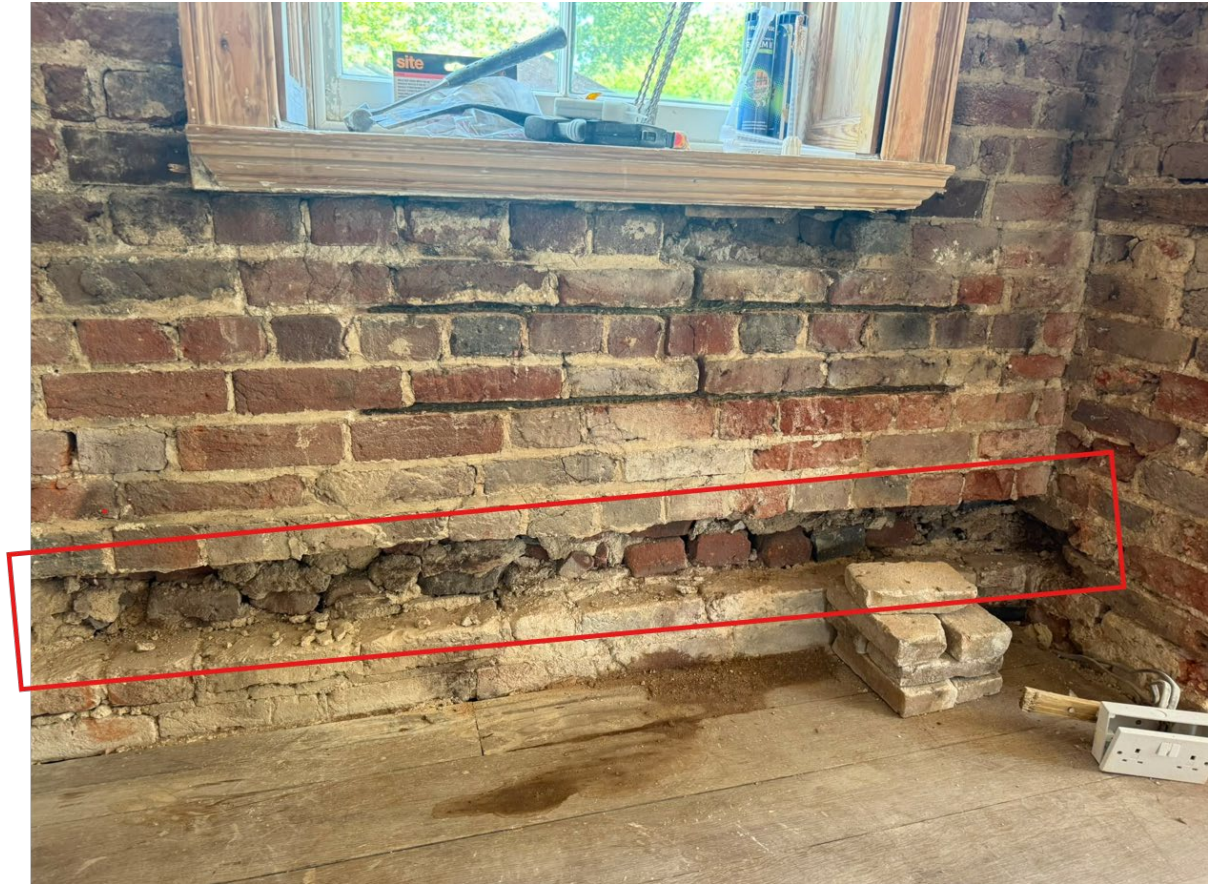
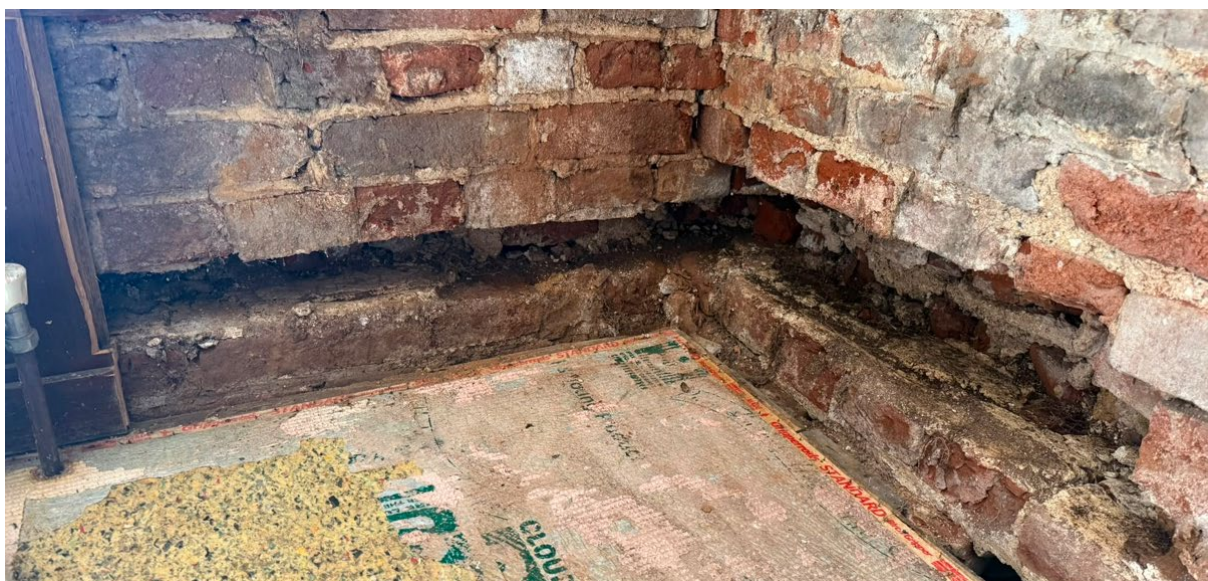
1. Ground Floor, Main Range: Internal face of external masonry walls. Removal of decayed embedded timbers and replacement with suitable reclaimed soft red brick, sized to match historic. Laid in NHL2 lime mortar

Above and below show areas where embedded timbers have decayed within the brickwork. Above in the East bay below the Victorian window and Below in the south west corner of the west bay:

| | Proposal | Significance of affected fabric | Impact | Reasoning / mitigation /recording |
|---|---|---|---|---|
| 1. | Ground Floor, Main Range:<br>Internal face of external masonry walls. Remove remains of decayed embedded timbers and replace with suitable reclaimed soft red brick, sized to match historic. Laid in NHL2 lime mortar | High | Neutral | Due to historic and possibly ongoing damp issues, the embedded timbers are largely missing, with small areas of highly friable remains. It is unlikely that replacing the timber will be a durable repair. Previous generations have also tried and failed to deal with the elevated moisture levels to this area of building fabric. We believe that soft red brick laid in a lime mortar would be the 'best fit' repair for this situation. |

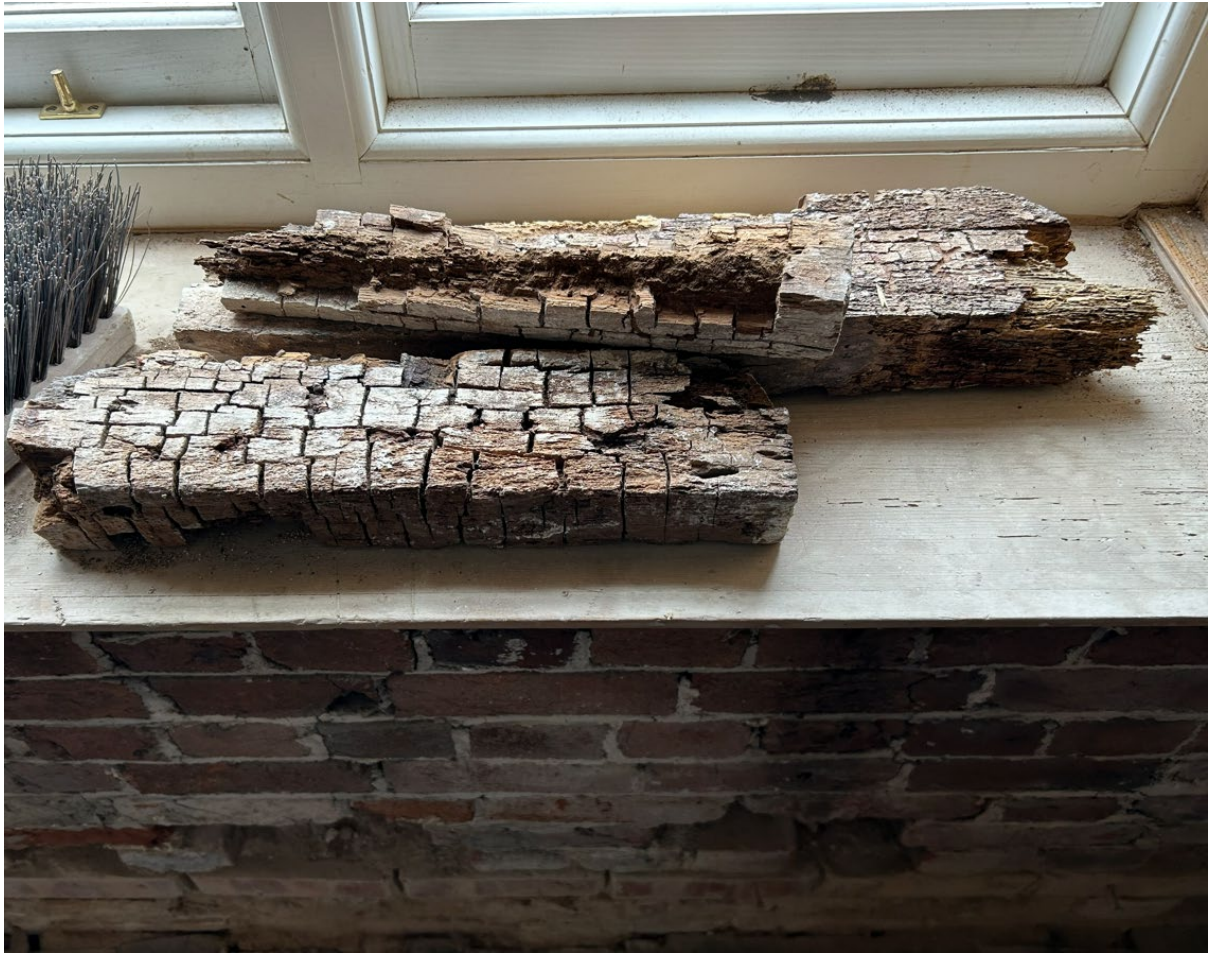
Remains of some of the embedded timbers:

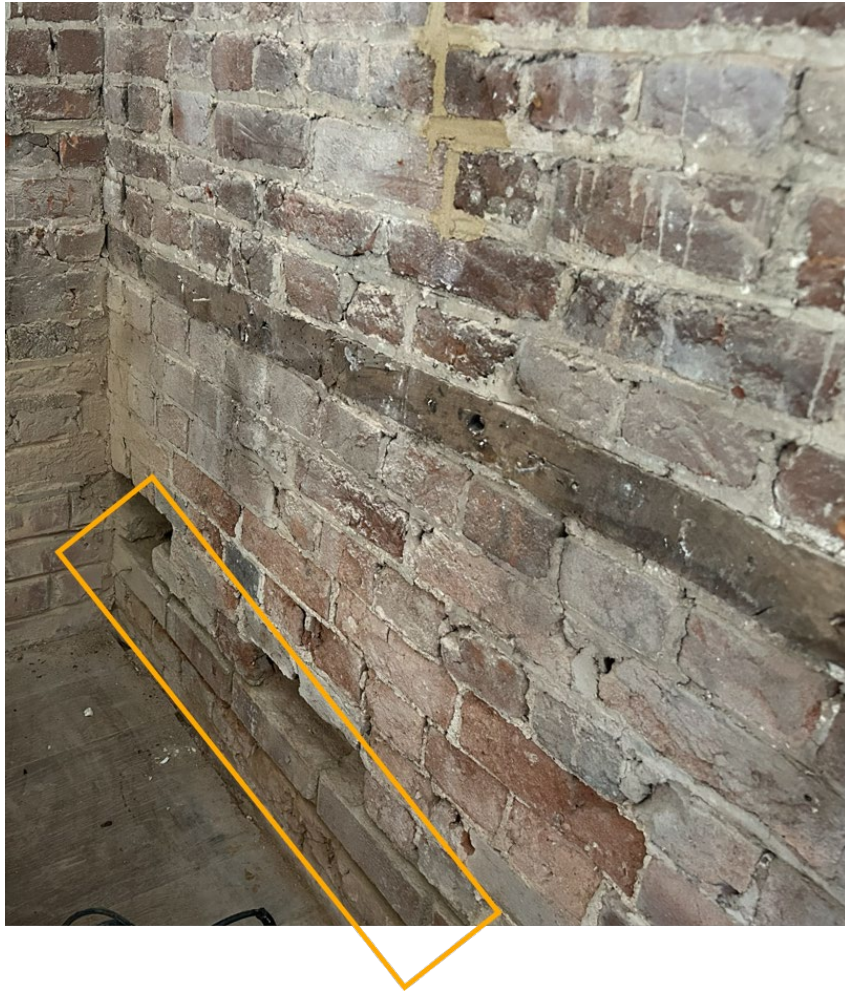
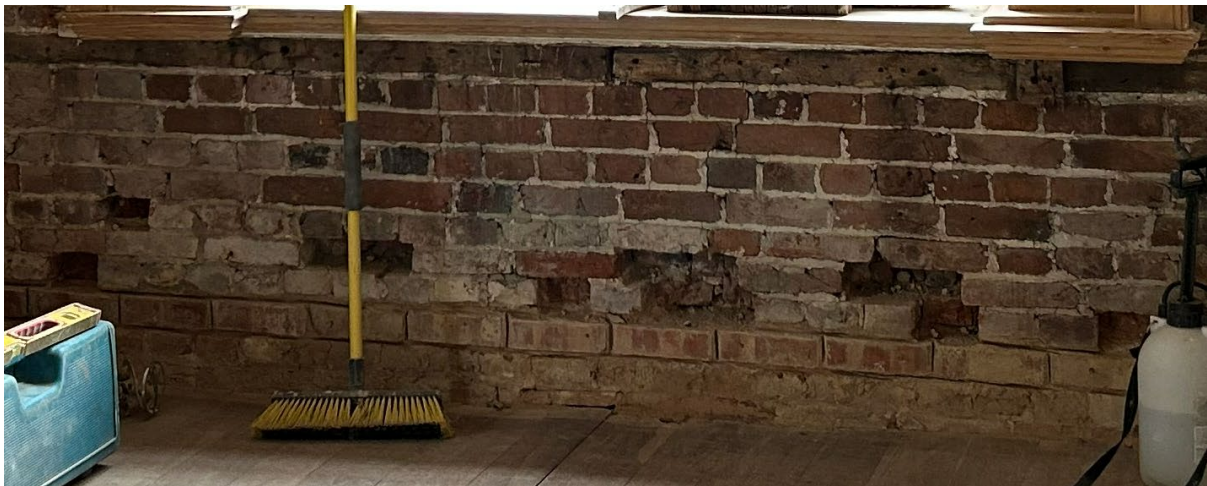
2. and 3. Removed engineering bricks and process of removing cement mortar using hand tools

| | Proposal | Significance of affected fabric | Impact | Reasoning / mitigation /recording |
|---|---|---|---|---|
| 2. | Ground Floor, Main Range:<br>Internal face of external masonry walls – remove cement mortar from previous 'repairs'. Replace with NHL2 mortar mix. | Low | Positive | The cementitious mortar is trapping moisture and hastening the decay of embedded timbers and indeed original brickwork. To be raked out using hand tools and replaced with a lime mortar. |
| 3. | Ground Floor, Main Range:<br>Internal face of external masonry walls – remove single course of glazed engineering bricks in southeast corner and associated cement mortar. Replace with soft red bricks, sized to match, laid in NHL2 mortar. | Low | Positive | These may have been installed in an attempt to manage the moisture issues in this part of the building, but they appear to be exacerbating the issue. These impervious bricks will be carefully taken out using hand tools and replaced with suitable soft red bricks laid in a lime mortar (NHL2) |

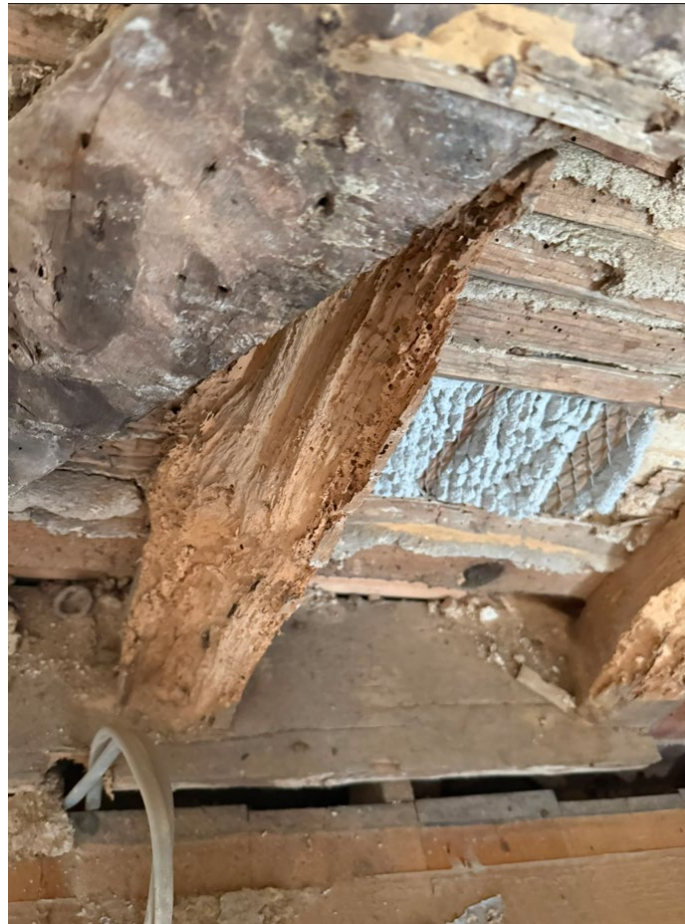
4. Ground Floor, Main Range: dividing wall between bays. Behind the timber panelling the wall was in poor condition. Opening up works showed that the stud wall was poorly constructed and in poor repair with significant decay. Modern gypsum plaster on EML was also found many areas of the wall.

| | Proposal | Significance of affected fabric | Impact | Reasoning / mitigation /recording |
|---|---|---|---|---|
| 4. | Ground Floor, Main Range:<br>dividing wall between bays. Make structurally sound with new soleplate and header-plate with studs as necessary. Use kiln dried oak. Omit Victorian door opening and enlarge opening adjacent to Stair Tower | Moderate | Positive | <p>This dividing wall fouls with the original stair tower. The alterations to the wall will allow the Stair Tower to be fully open at ground floor and reconnect the two ground floor rooms. Although not originally structural, and in very poor condition, with some studs little more than frass and no soleplate, there is some evidence that some support is now taken by this wall. The wall currently bears on the infill masonry to the basement, laid between the floor joists.</p> <p>The new frame will be left exposed, clearly legible as a modern intervention whilst acknowledging the Victorian intervention. The larger opening adjacent to the stair tower</p> |

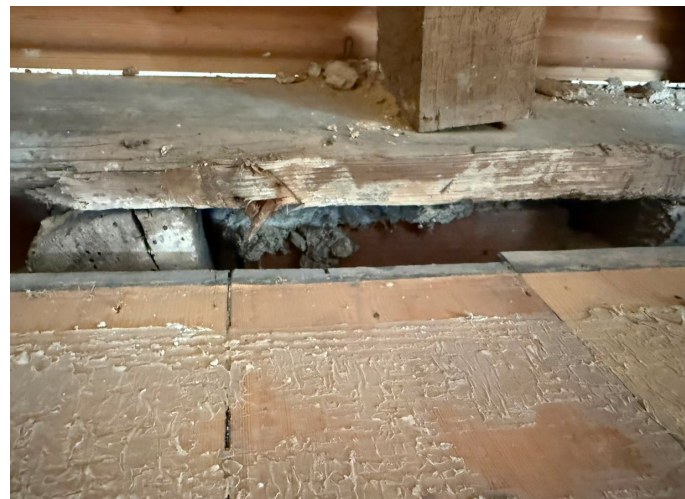
The current base of the dividing wall is a board, partially missing, which rests on the brick infill between the basement joists.

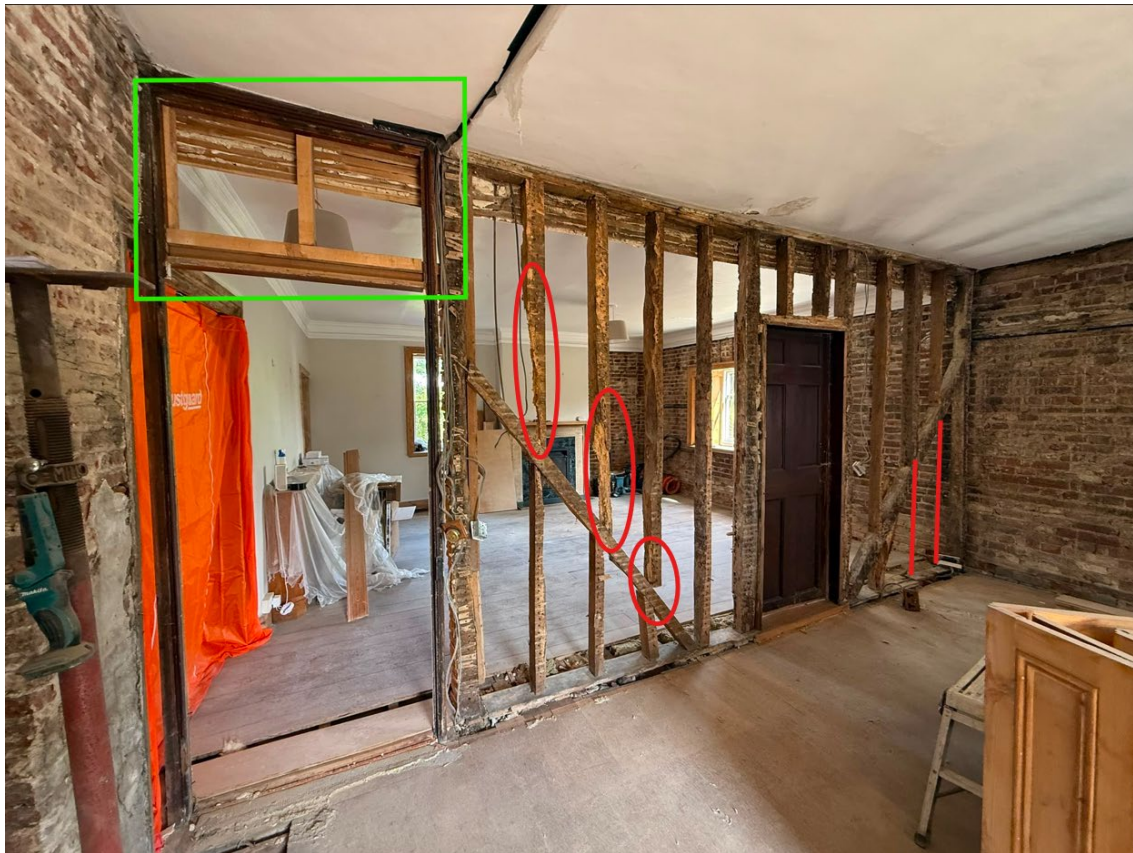
5. Internal to west room – omit reinstatement of timber cladding – retain any viable historic cladding for possible reuse within the building.

| | Proposal | Significance of affected fabric | Impact | Reasoning / mitigation /recording |
|---|---|---|---|---|
| 5. | Ground Floor, Main Range:<br>Internal to west room – omit reinstallation of timber cladding – retain any viable historic cladding for possible reuse within the building. | Low | Positive | <p>From carefully removing the timber panelling to review the structural issues behind, it has become apparent that the installation is modern. It was likely installed when the underpinning was carried out to the external west wall (late C20th). Large parts of the panelling are of modern constructions, with clear deterioration from elevated moisture levels on both old and new alike.</p> <p>The panelling was not originally made for the room, but the exact date of its first introduction is unclear.</p> <p>An embedded ornately carve timber has been found behind the panelling. It is proposed that, although not in its original position, this beam is left exposed (see item 6.).</p> <p>Viable historic panels will be carefully stored for possible reuse within the building.</p> |

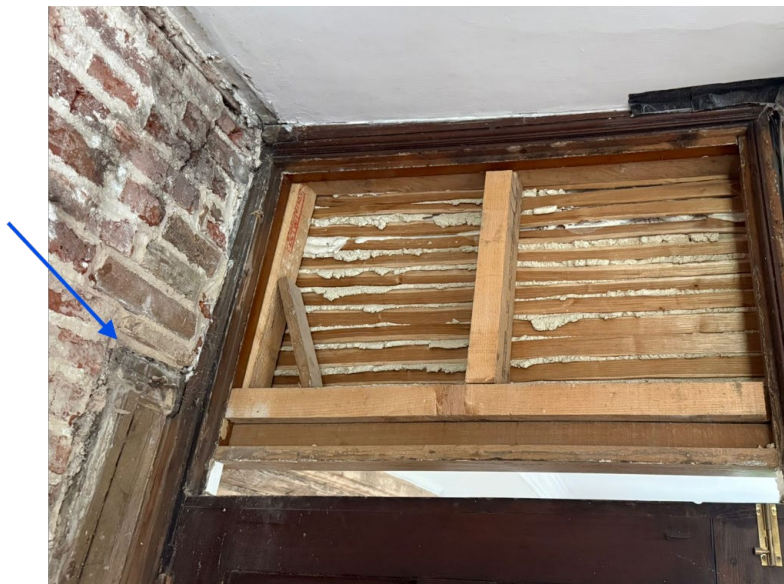
East wall of Living Room: Green denotes C21st fabric; red shows missing or badly damaged studs. Note that the 'soleplate' is a board resting on brick infill to the ceiling joists of the basement below.

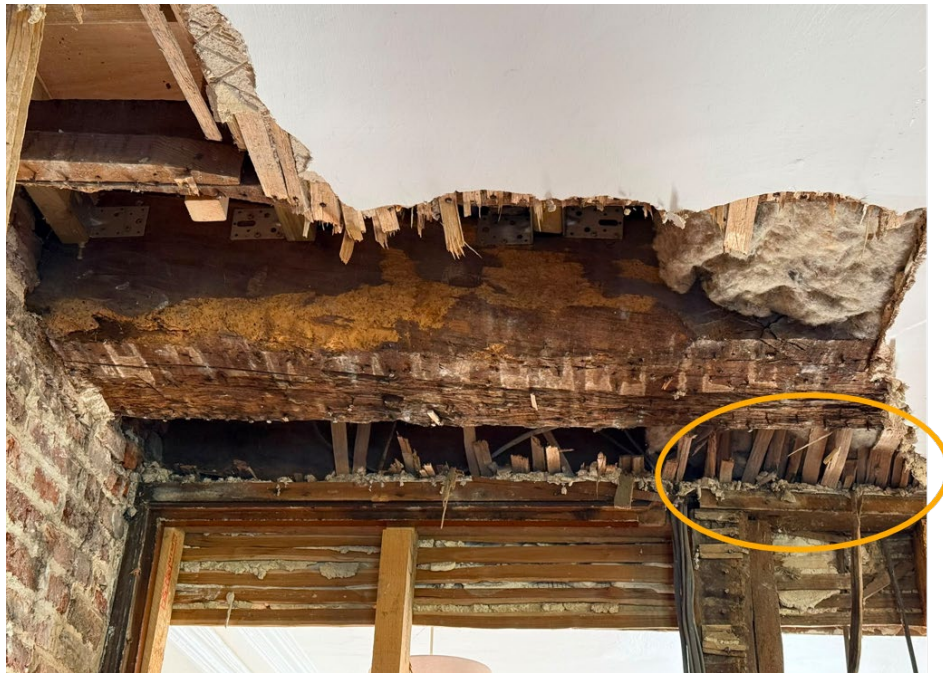
The modern doorway obstructs the decorated access to the stair tower. By not reinstating this doorway and leaving a larger opening within the dividing wall, the stair tower will be clearly legible.

The lath and plaster runs above the dividing walls (which is not in line with axial beam) clearly denoting this as a fairly modern intervention.

The very modern studs and door which partially obscure the stair tower access and the brick repairs found behind the timber panelling suggest that the panelling may have been installed in the late C20th using a mixture of historic and modern cladding. The proposal is to not to reinstall the cladding but that any historic elements are retained for possible reuse on site.

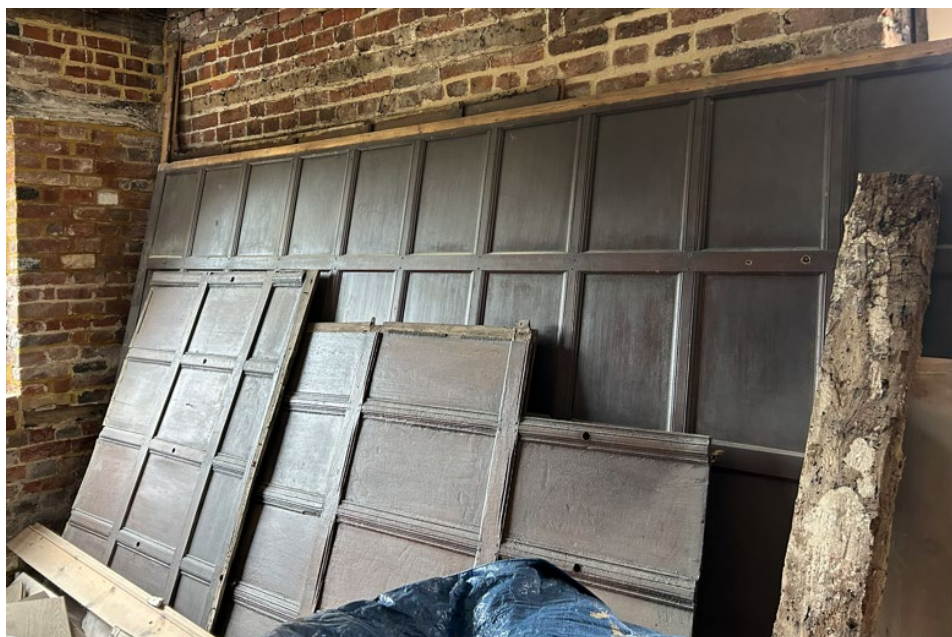
A large piece of modern panelling sits in front of some historic panels which have been cut and amended to suit the room.

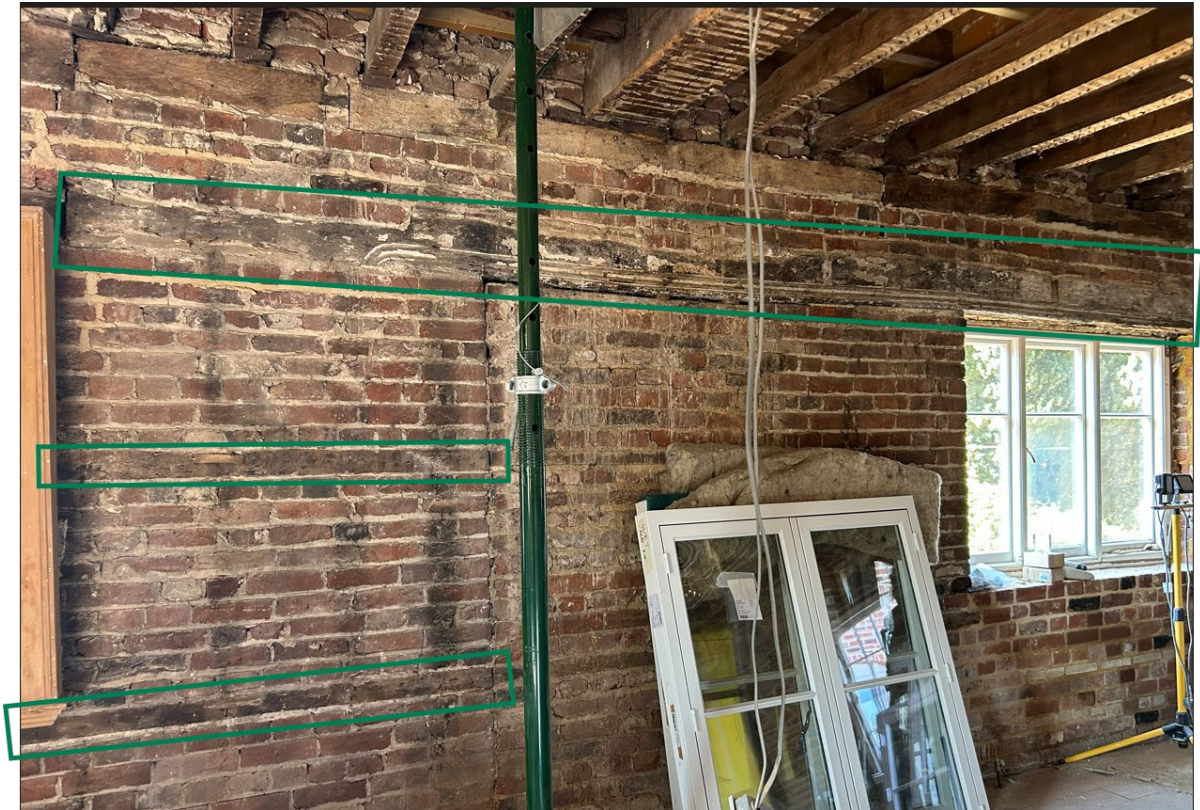
6. Internal masonry walls – lime plaster and skim leaving decorated beam in south wall exposed and other embedded timbers within the masonry (note the Georgian Doorway has been bricked up)

| | Proposal | Significance of affected fabric | Impact | Reasoning / mitigation /recording |
|---|---|---|---|---|
| 6. | Ground Floor, Main Range:<br>Internal masonry walls – lime plaster and skim leaving decorated beam in south wall exposed and other embedded timbers within the masonry | Moderate | Positive | <p>Although not in its original position, it is likely that this beam has been reused from the house, possibly from the documented 'part demolished' area of the house. Its ornate decoration and length suggest that the house was of very high status.</p> <p>It is proposed that the masonry is lime plastered with a site mixed plaster of hydrated lime and sharp sand with synthetic fibres. The topcoat will be Limecote from Best of Lime.</p> |

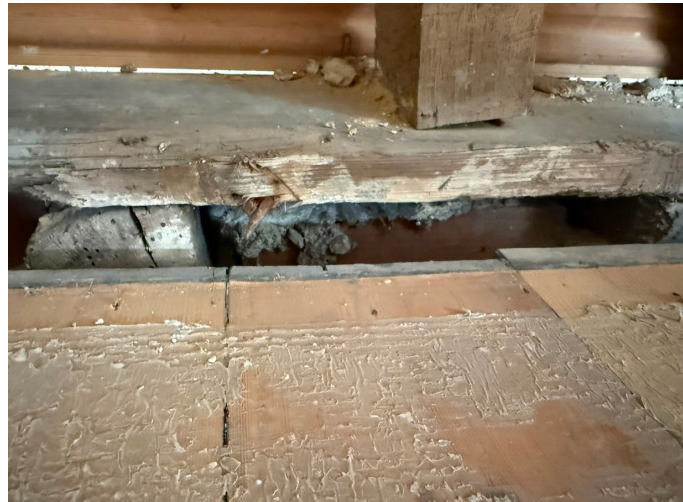
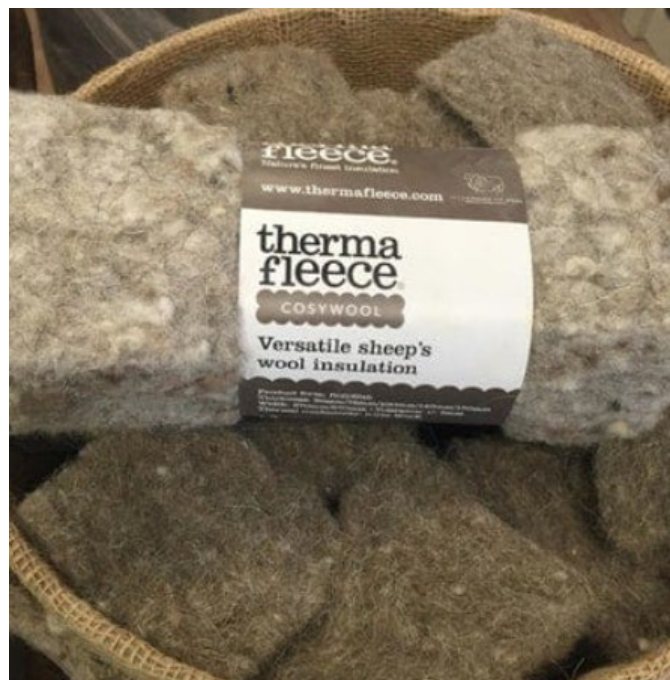
There is very limited ventilation to the existing suspended floor above the West Bay, with only one of the existing ventilation bricks connecting to the under floor void. The improvement of this will help manage the moisture that is getting trapped within the building fabric. It is proposed that 4no. black cast iron ventilation bricks will be used along the south and west elevations. Both rooms have modern floorboards. There is level difference of approximately 40mm. It is proposed that the modern boards to the west bay are lifted, sheep's wool batts on nets between the joists are installed, along with a vapour open airtightness membrane, and the flooring re-laid at the same height as the East Bay.

7. Ground Floor, Main Range: Internal floor – raise modern floor of west room to match east room. Introduce sheep's wool insulation and ensure void below is properly ventilated.

| | Proposal | Significance of affected fabric | Impact | Reasoning / mitigation /recording |
|---|---|---|---|---|
| 7. | Ground Floor, Main Range:<br>Internal floor – raise floor of west room to match east room. Introduce sheep's wool insulation and ensure void below is properly ventilated. | Moderate | Positive | <p>There is a modern floor construction to the east bay which sits over the basement below. This is some 40mm higher than the floor in the west bay. Note that this is also an inserted floor and has some limited ventilation below. The proposal includes insulating the floor with sheep's wool above the ventilation, and improving this ventilation to limit</p> |

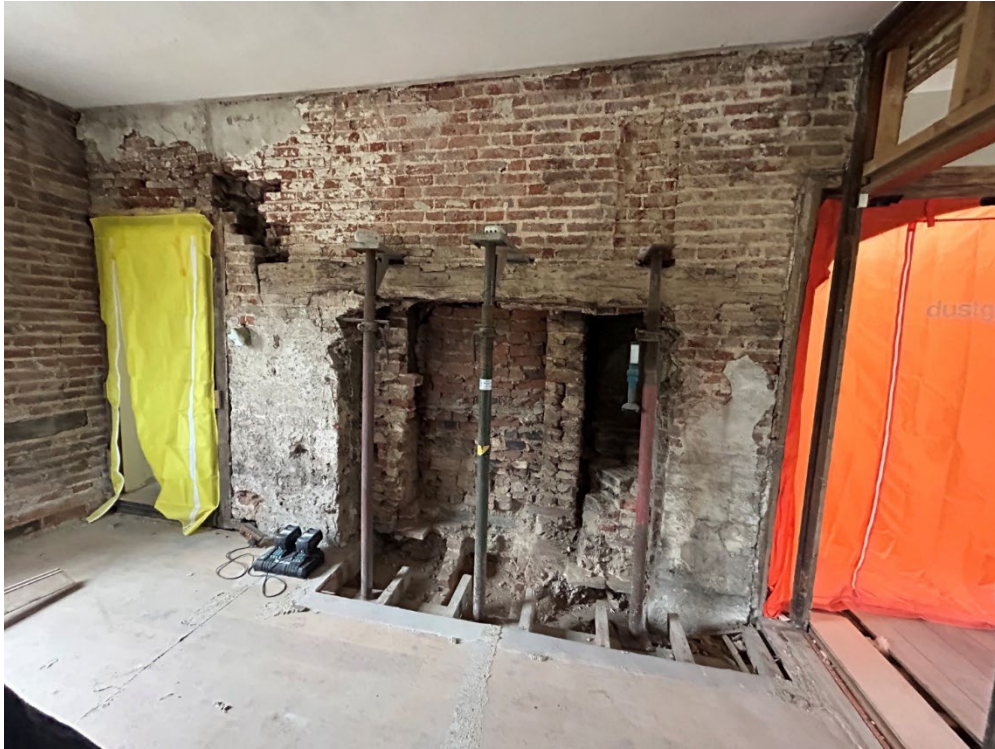
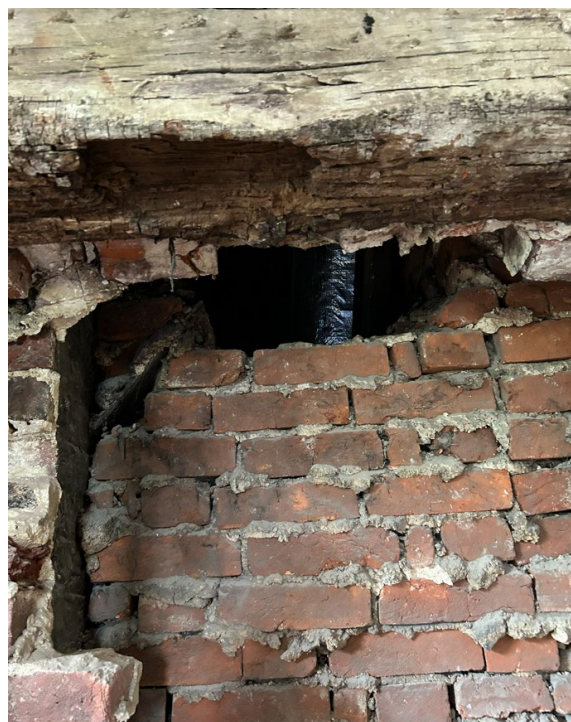
On the removal of the modern timber panelling, the original hearth was revealed. Two phases of reduction were carried out before the being completely blocked and the hearth switched to serve the Snug on the north side. This work appears to be Late Victorian, which also ties in with the hearth to west bay (later rebuilt at low level), and the construction of the Snug, labelled as 'Harness Room' in the plan from 1912 (as item 6 of this document). There is also evidence that the floor has been raised significantly. The later brickwork was built off no foundations, merely bricks on edge at approx. 300mm centres. Unfortunately, much of this later masonry was falling down when the panelling was removed. The brickwork forming the hearth to the Snug was in turn built off the later hearth and is not structurally sound. The bressummer is a large, reused timber with a large tenon joint at the east end and mortices along its length. Many of these are badly decayed. The bressummer and brickwork above have been propped temporarily.

8. Original Fireplace – There are structural issues with brickwork missing on this corner. The bressummer is reused with mortice holes along its length, some with significant decay (bottom photo). Note that this beam shows a tenon cut to the RHS.

The back of the late C20th / early C21st hearth sits in the middle of the picture and is built of sleeper walls and joists which sit on earlier hearth pammments. There were two clear reductions in the fireplace on this south face, but the masonry partially collapsed and more was carefully taken down due to safety concerns. All viable historic material is being stored on site and will be used where possible on the necessary repairs.

It is proposed to take down all the unsafe brickwork down to the original hearth within the main range. Reinstate the Fireplace to the Main Range with a new Bressummer to tie-in with both adjacent doors, and reinstate the double brick arch below. Salvage any viable brick and tiles (bricks to be reused in any necessary repairs within the building). Both the Snug and the Main Range will benefit from a traditional style, double faced log burner.

| | Proposal | Significance of affected fabric | Impact | Reasoning / mitigation /recording |
|---|---|---|---|---|
| 8. | <p>Original Fireplace – reinstate to west room with the removal of any remaining, structurally unsound brickwork. Take ground down to solid base and pour a limecrete slab. Retain all viable material for reuse elsewhere. New hearth TBC – possible reuse of historic pammet. Replace decayed bressummer beam and lengthen slightly to tie-in with both adjacent doorways. Install necessary steel behind the bressummer to pick up the inserted withers within the chimney. To the fireplace, reinstate double brick arch below bressummer. Retain fireplace to the Snug so that both rooms can benefit from the single flue available. Lower the hearth in the Snug to match that in the west bay living room. Install baffle and new double sided log burner</p> | High | Positive | <p>The historic hearth is clearly legible within what remains of the later brickwork. There are two later phases of development, each time reducing the hearth and a third which see the complete closing of the hearth to the south and the introduction of a hearth to the Snug on the north side of the chimney. The first two areas of masonry were constructed off small dwarf walls, laid directly onto the original pamment hearth. The third change is then in turn built off the earlier interventions. This leaves all the later brickwork in this area in a perilous state. Much came down when the timber paneling was taken down, with more taken down before it fell.</p> <p>In addition to this, there are clear signs of structural issues with the bressummer and the brickwork adjacent to the doors to either side of the chimney breast. Note, it is likely that the west door was inserted possibly in the Georgian phase of works.</p> <p>Noted that the bressummer is a reused timber with large mortice holes along its length.</p> <p>There is now one functioning flue to this chimney. It is not feasible to introduce a second flue due to the historic withers within the chimney.</p> <p>The proposals as described deal with multifaceted issues when this element of the house is studied. We have prioritised structural stability with conservation the next most important element. We have also allowed for functionality, ensuring that all reception rooms have a functioning hearth, which will be used daily to heat the home.</p> |

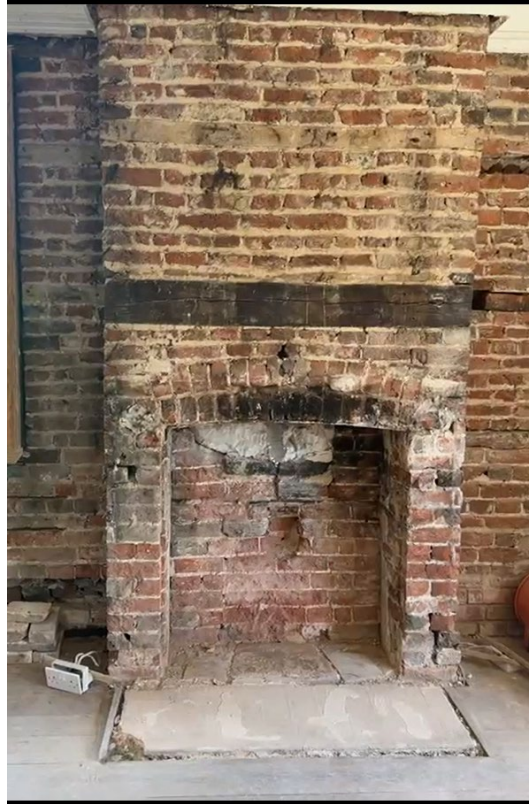
This fireplace is likely Georgian. On removal of the modern mantle, it is apparent that brick repairs are necessary. These will be carried out in NHL2 lime mortar and left exposed. It is proposed that a flue liner, baffle and log burner be installed.

9. East Fireplace – with modern fire surround, insert and masonry removed ready for repair to Georgian brickwork

| | Proposal | Significance of affected fabric | Impact | Reasoning / mitigation /recording |
|---|---|---|---|---|
| 9. | <p>East fireplace – repairs (as carried out to brickwork below inserted bressummer). Install flue liner, baffle and log burner</p> | Moderate | Neutral | <p>This fireplace, a Georgian addition has clearly had C20th adjustments with a reproduction hearth installed. The proposal includes the removal of the C20th masonry and the repair of</p> |

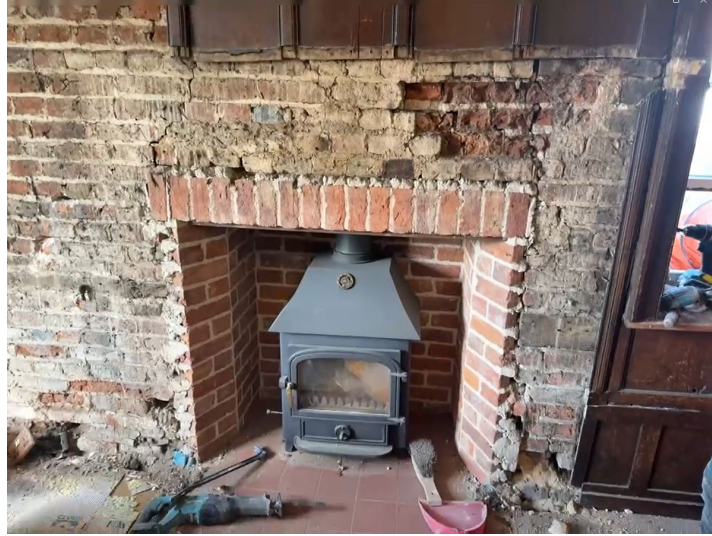
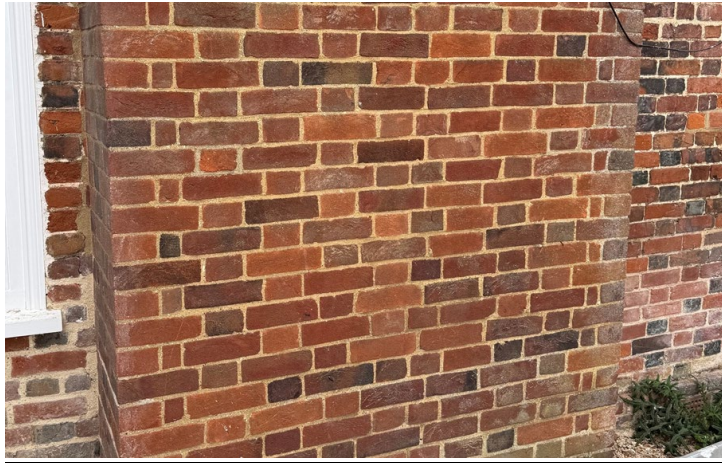
10. West fireplace – modern masonry and log burner to be removed. Chimney will service the approved extension to the west. NB brickwork repairs required in this area.

| | Proposal | Significance of affected fabric | Impact | Reasoning / mitigation /recording |
|---|---|---|---|---|
| 10. | West fireplace – brick up modern hearth in west bay and open-up to approved extension | Low | Neutral | This late Victorian chimney has been rebuilt at ground floor level, both internally and externally, in the late C20th. There is permission to open it up to the approved single storey extension to the west. The current Fireplace will be removed and filled in with a suitable masonry. Brickwork will not be toothed in so that the change is clearly legible at the back of the new west facing hearth. |

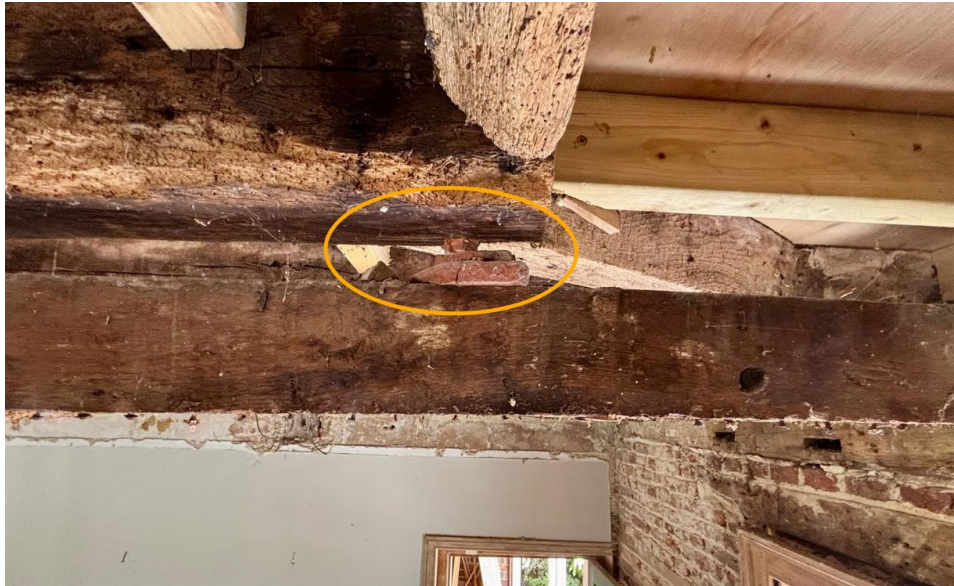
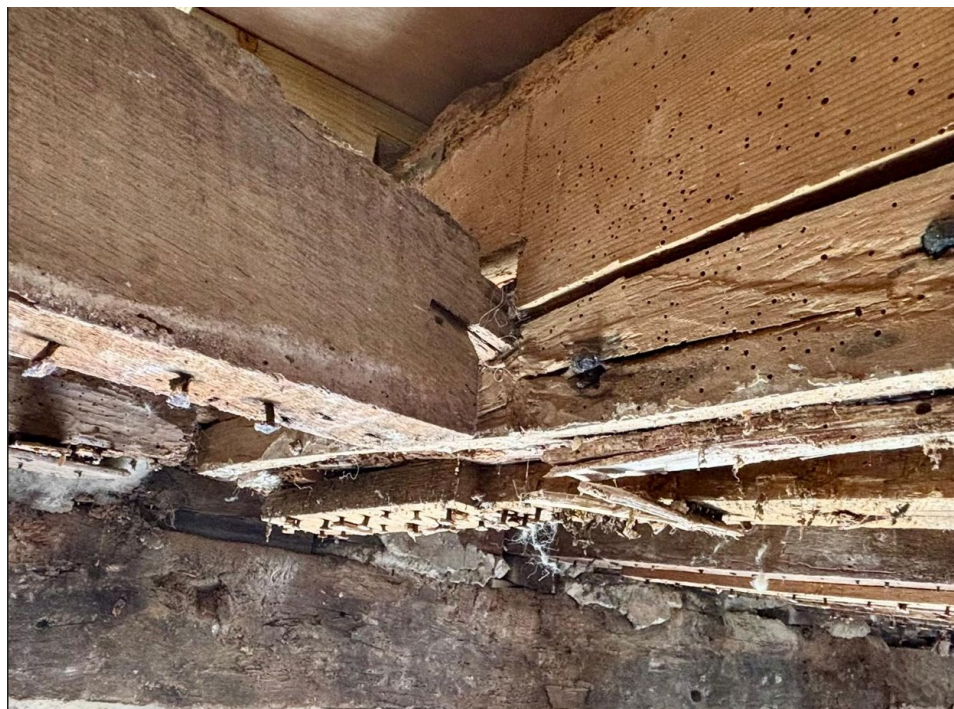
At the East end of the building, it is clear that there was significant change/extension to the building. The ceiling pattern changes and is more ad hoc and has been repaired several

times. There are tenons loose from their joints and decay throughout. Proposal is to make good existing timbers with splice repairs along with steel cleats where splicing is not viable. Infill between the ceiling joists with savolit board and lime plaster as elsewhere.

11. Main Range 1<sup>st</sup> floor joist and ground floor ceiling joist repair and installation of new ceiling. Repairs are mostly needed at the east end of the Main Range. There appears to have been a reduction in the fireplace above which has left an unusual arrangement. What was the primary structure is propped by the ceiling structure below. Some tenons have slipped and there are signs of active beetle attack especially in the softwood timbers.

| | Proposal | Significance of affected fabric | Impact | Reasoning / mitigation /recording |
|---|---|---|---|---|
| 11. | Main range ceiling: To repair joists as necessary and to leave the joists exposed with savolit board and lime plaster between | Moderate | Neutral | <p>The structural repairs are necessary and will be carried out using splicing and sistering techniques. Replacing timbers like for like will only be used where absolutely necessary.</p> <p>By leaving the structure exposed helps to explain the construction history of the room. The clear addition to the east bay, and the large axial beams are explicit that the use of the house has changed over time.</p> |
