| Tree ID | 2 |
| Tag No | 4093 |
| Common Name | Cherry species |

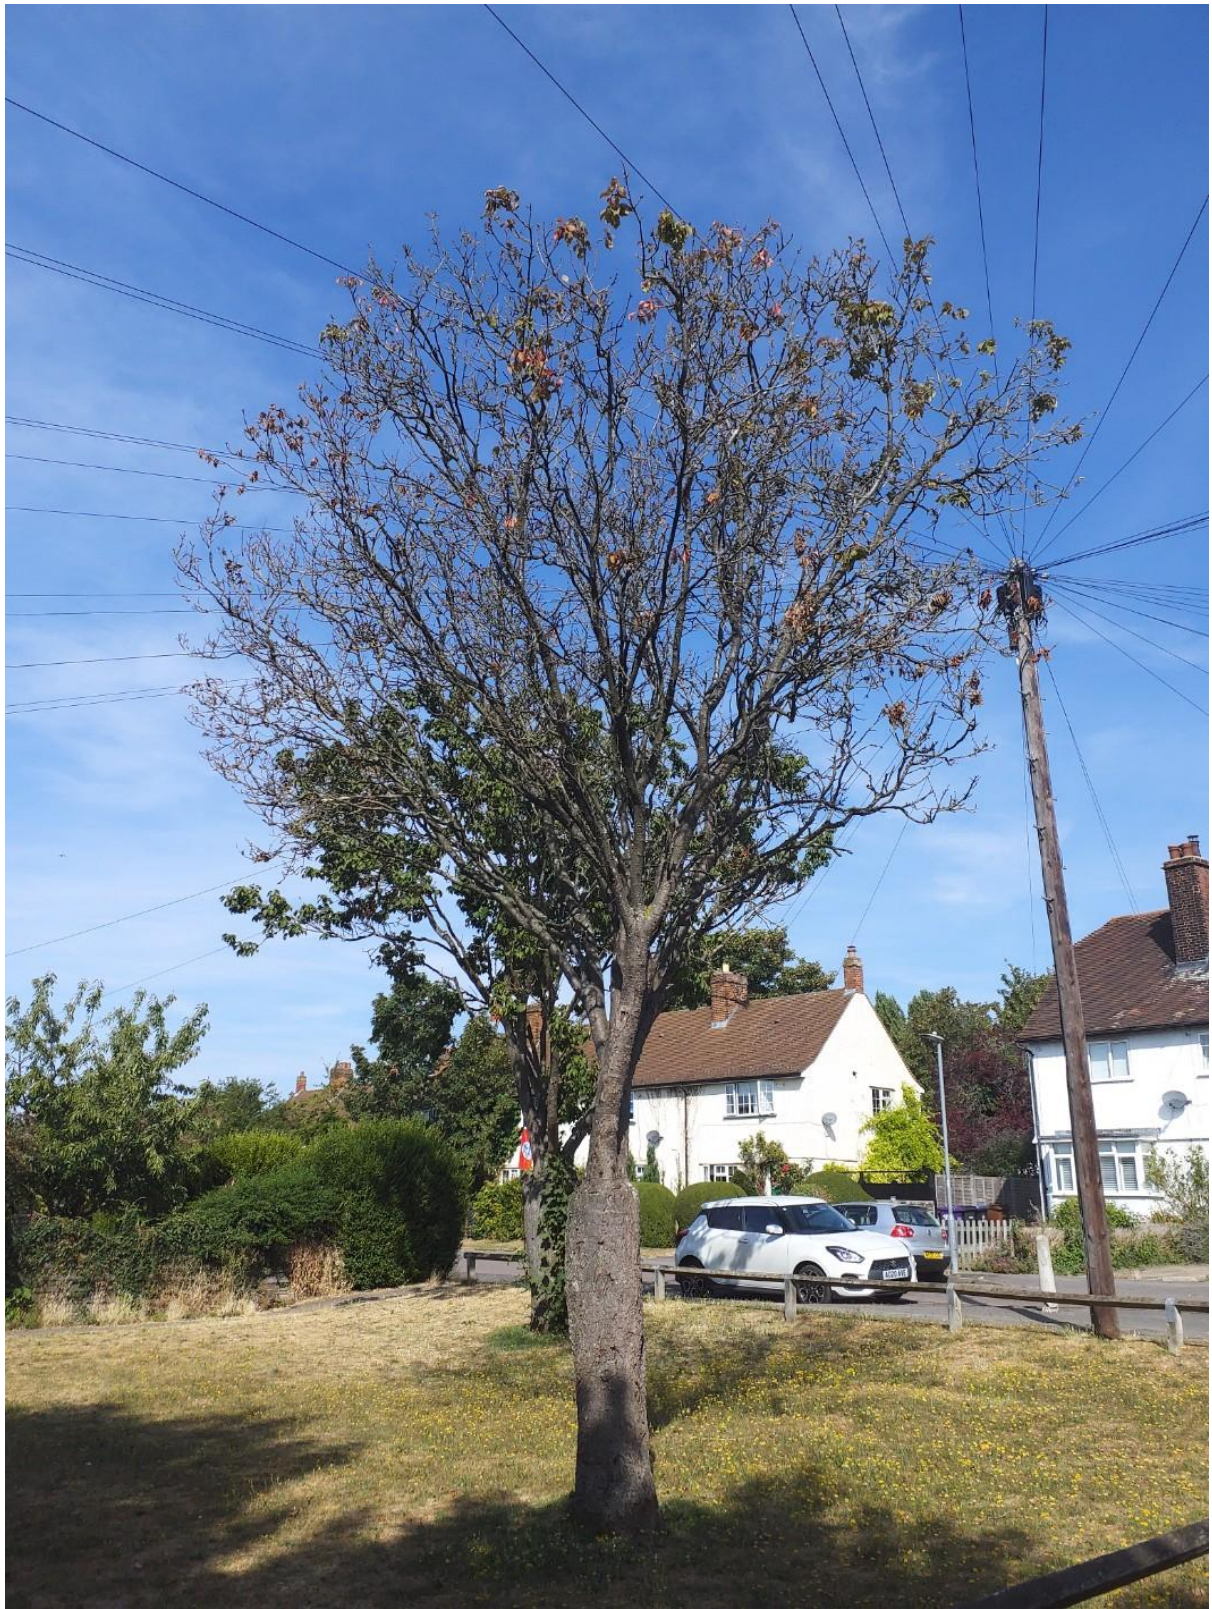
| Physiological Condition | Poor |
| Structural Condition | Fair |

| Observation Comments | Mower damage to basexand surface roots. Exudate on main stem. Crown has died back with less than 5% foliage. |
| Root/Base Observations | Mechanical Damage to Roots |
| Trunk Observations | Strimmer/Mower Damage, Exudate |
| Crown Observations | Dieback, Major Dead Wood |

| Works Required | Yes |
