**The White Horse, Kimpton**  
**Condition Report**  
December 2024

## 1.0 EXECUTIVE SUMMARY

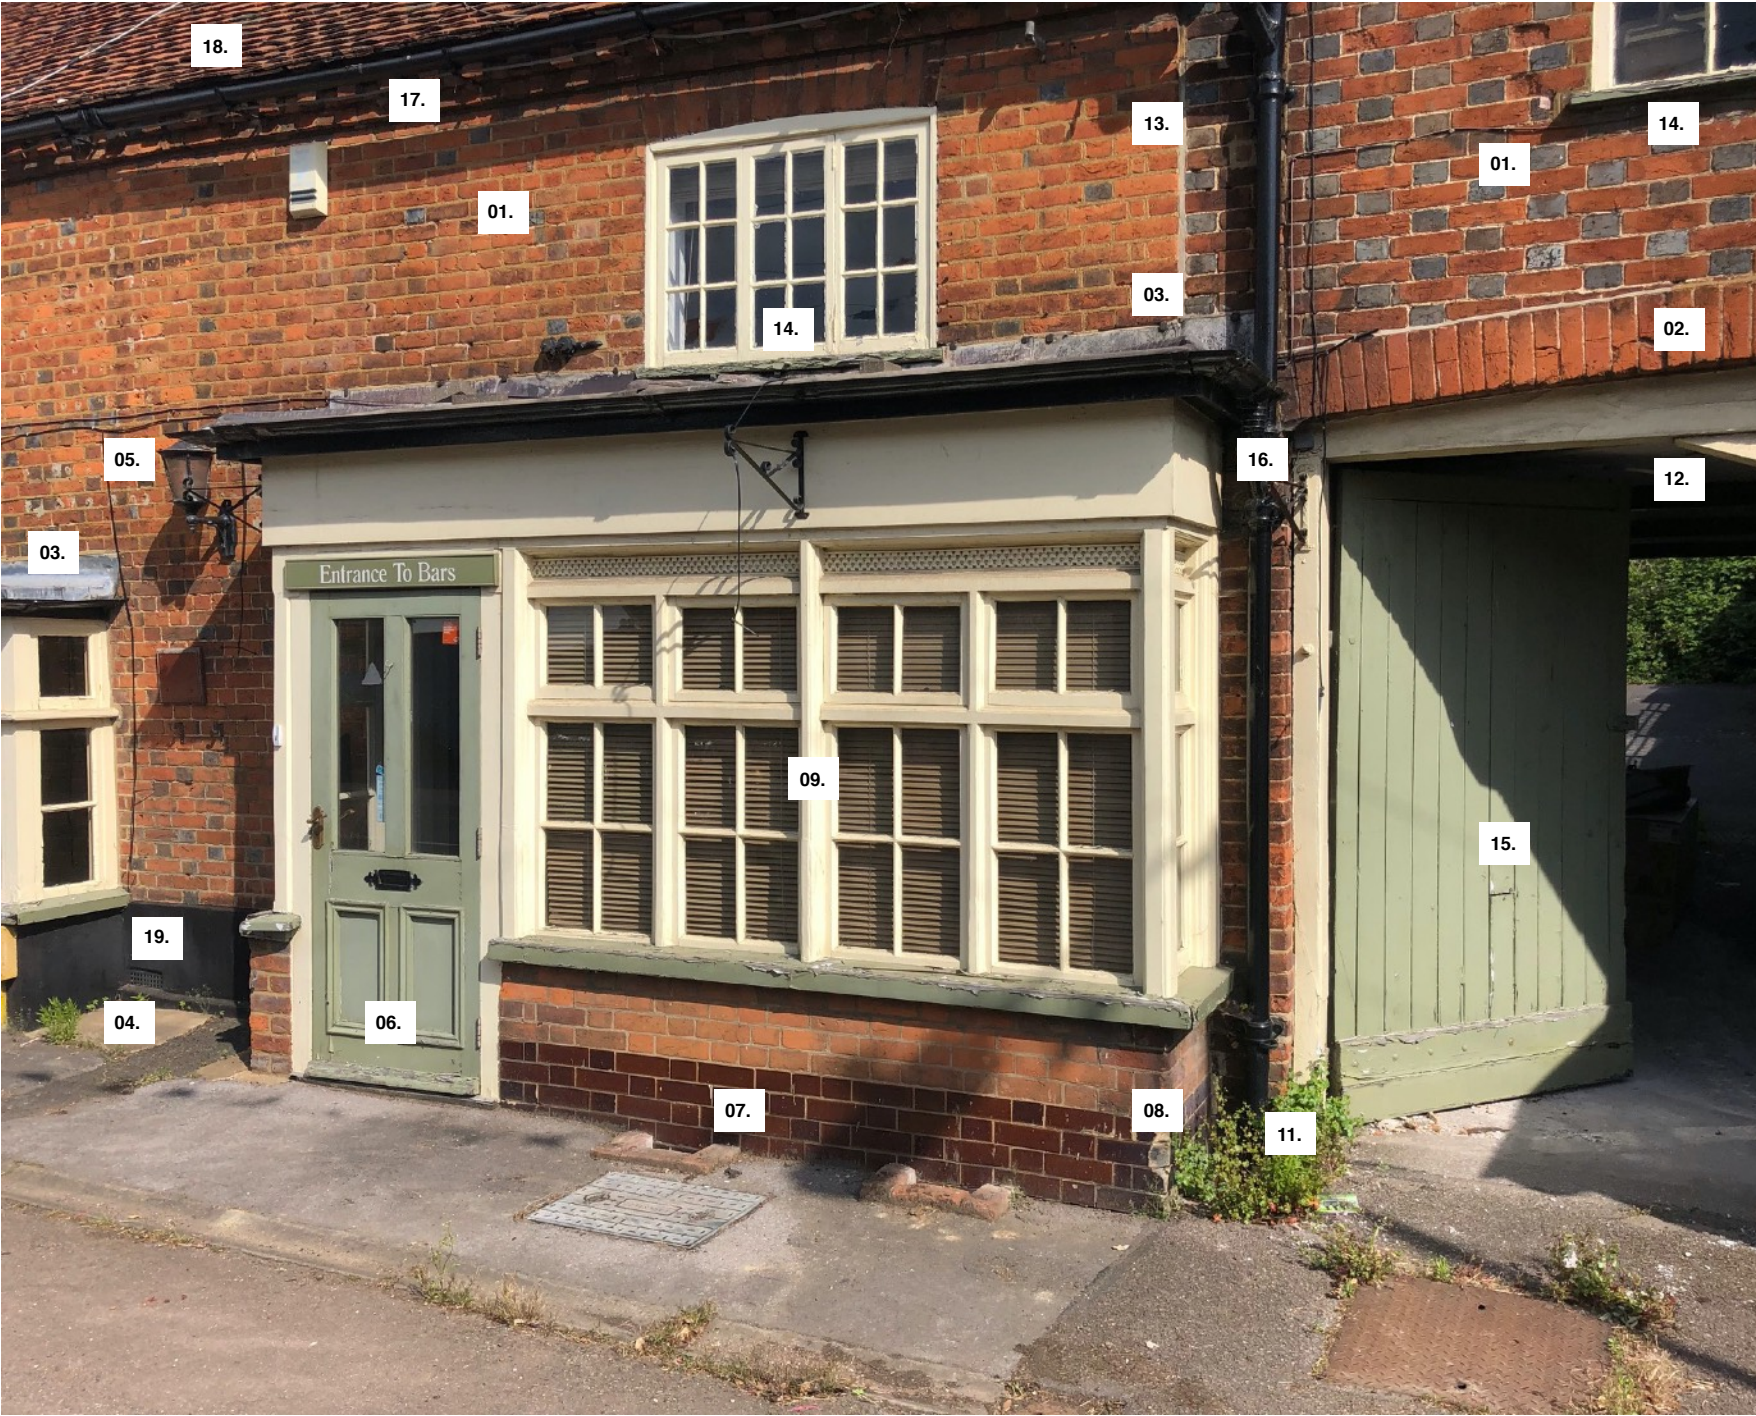
External: Front Elevation (South Facing)

01. Flush pointed Flemish bond brick with burnt headers in reasonable condition with isolated delaminated bricks to be surveyed in further detail. Provenance of existing brick to be determined. Bowing evident in part of facade. Allow for mortar sampling and testing in accordance with BS 4551: 2005 + A2:2013 Methods of Test for Mortar to determine original mortar mix to allow matching.

02. Flush pointed brickwork to segmental arch in fair condition with several bricks requiring isolated replacement.
03. Existing lead flashings and flat roof in poor condition and not in accordance with LDA standards.

04. Existing cast iron solum grilles. Fair condition.
05. Existing cabling and ferramenta to be surveyed in detail with M&E engineer.
06. Painted glazed timber entrance door. Poor condition.

07. Flemish bond glazed brick base course in good condition. Missing and blocked solum vents.
08. Impact damage observed to external brick corner.
09. Painted square headed timber window bays in fair condition with minor sections of rotten timber observed. Painted metal ventilation grilles to high level. Cill beyond repair.

10. 8/8 painted timber sash and case window. Fair condition with minor rot observed.
11. Clear vegetation to determine location, type and condition of existing gully outlet to ascertain remedial works.

12. Plasterboard soffit to archway subject to moisture ingress. Poor condition.
13. Existing cementitious pointing to former party wall joint. Poor condition.

14. Existing timber casement windows in poor condition. Cills beyond repair.
15. Existing painted and timber boarded gate. Poor to fair condition.
16. Existing cast iron rainwater goods. Poor to fair condition. Replacement and isolated repair required following detailed survey.

17. Brick corbel detail - isolated delamination to brickwork.
18. Single lap clay roof tiles on sloping timber rafters with bedded clay ridges displaying evidence of ridge timber deflection. Poor condition. Several broken and slipped tiles observed with evidence of falling tiles to hard standing.

19. Sand: cement render band boast and fractured with evidence of moisture ingress. Poor condition.

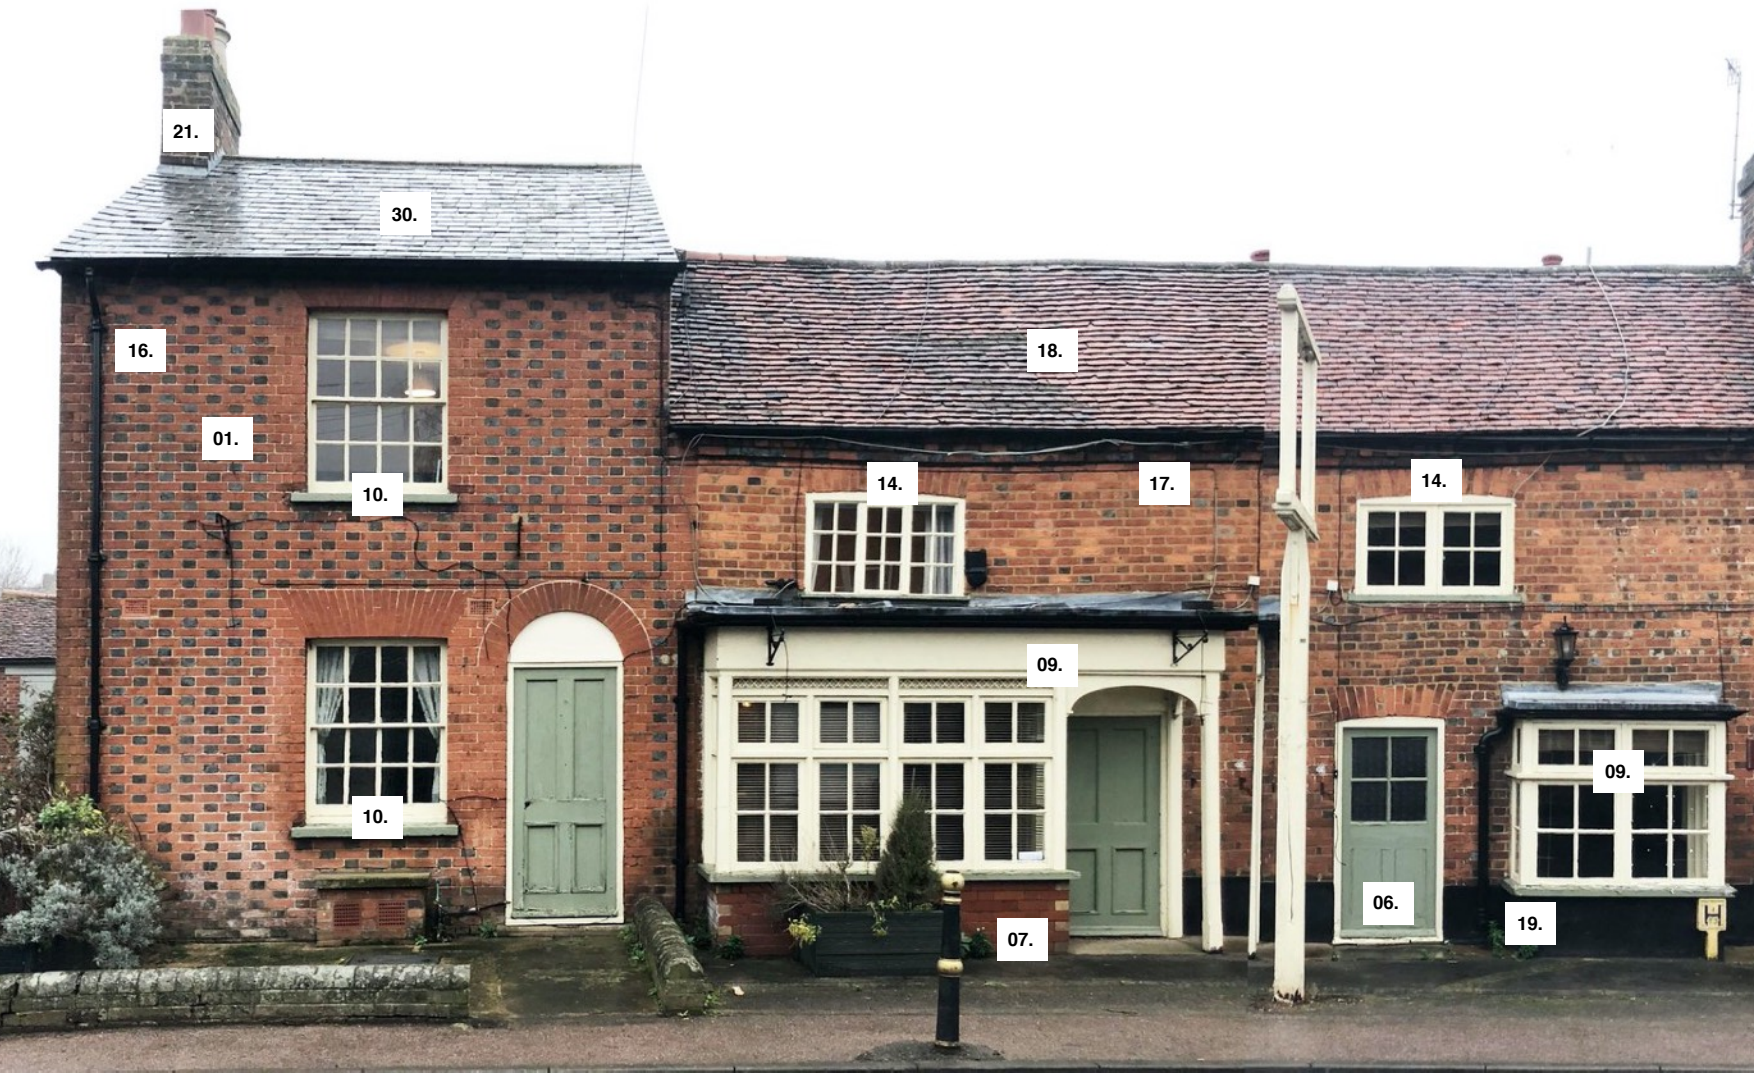
**External: Front Elevation (South Facing)**

01. Flush pointed Flemish bond brick with burnt headers in reasonable condition with isolated delaminated bricks to be surveyed in further detail. Provenance of existing brick to be determined. Bowing evident in part of facade. Allow for mortar sampling and testing in accordance with BS 4551: 2005 + A2:2013 Methods of Test for Mortar to determine original mortar mix to allow matching.

02. Flush pointed brickwork to segmental arch in fair condition with several bricks requiring isolated replacement.
03. Existing lead flashings and flat roof in poor condition and not in accordance with LDA standards.

04. Existing cast iron solum grilles. Fair condition.
05. Existing cabling and ferramenta to be surveyed in detail with M&E engineer.
06. Painted glazed timber entrance door. Poor condition.

07. Flemish bond glazed brick base course in good condition. Missing and blocked solum vents.
08. Impact damage observed to external brick corner.
09. Painted square headed timber window bays in fair condition with minor sections of rotten timber observed. Painted metal ventilation grilles to high level. Cill beyond repair.

10. 8/8 painted timber sash and case window. Fair condition with minor rot observed.
11. Clear vegetation to determine location, type and condition of existing gully outlet to ascertain remedial works.

12. Plasterboard soffit to archway subject to moisture ingress. Poor condition.
13. Existing cementitious pointing to former party wall joint. Poor condition.

14. Existing timber casement windows in poor condition. Cills beyond repair.
15. Existing painted and timber boarded gate. Poor to fair condition.
16. Existing cast iron rainwater goods. Poor to fair condition. Replacement and isolated repair required following detailed survey.

17. Brick corbel detail - isolated delamination to brickwork.
18. Single lap clay roof tiles on sloping timber rafters with bedded clay ridges displaying evidence of ridge timber deflection. Poor condition. Several broken and slipped tiles observed with evidence of falling tiles to hard standing.

19. Sand: cement render band boast and fractured with evidence of moisture ingress. Poor condition.

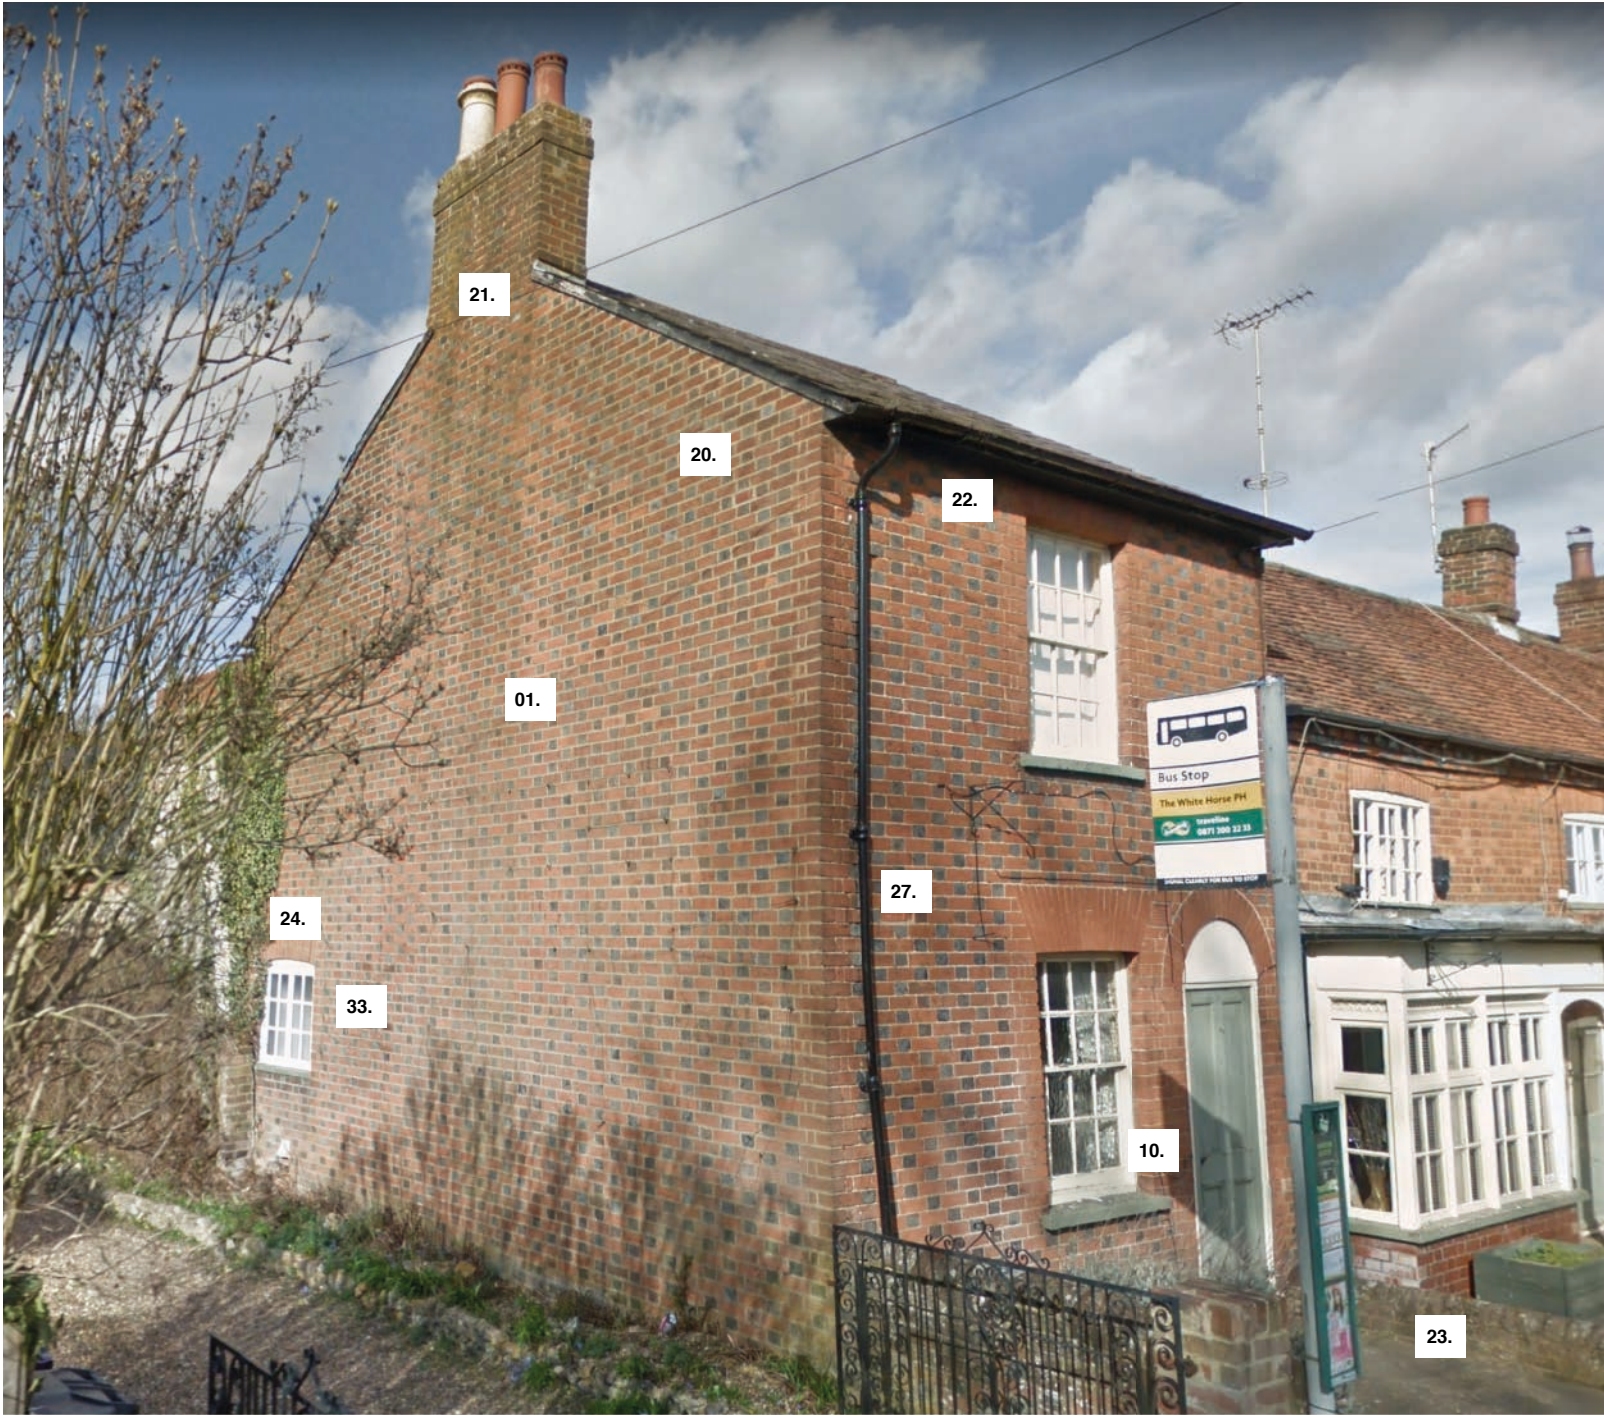
**External: Gable Elevation (West Facing)**

- 19. Flush pointed Flemish bond brick with burnt headers in good condition. Allow for mortar sampling and testing in accordance with BS 4551: 2005 + A2:2013 Methods of Test for Mortar to determine original mortar mix to allow matching.
- 20. Existing timber verge boards in poor condition.
- 21. Detailed survey of chimney breasts and pots subject to scaffold access at commencement of works to inspect flashings, flaunchings and other components. Evidence of loose mortar, missing or loose flashings and delaminated brickwork throughout.
- 22. Existing timber soffit boards in poor condition.
- 23. Evidence of efflorescence to brick base courses.
- 24. Creeping vegetation.

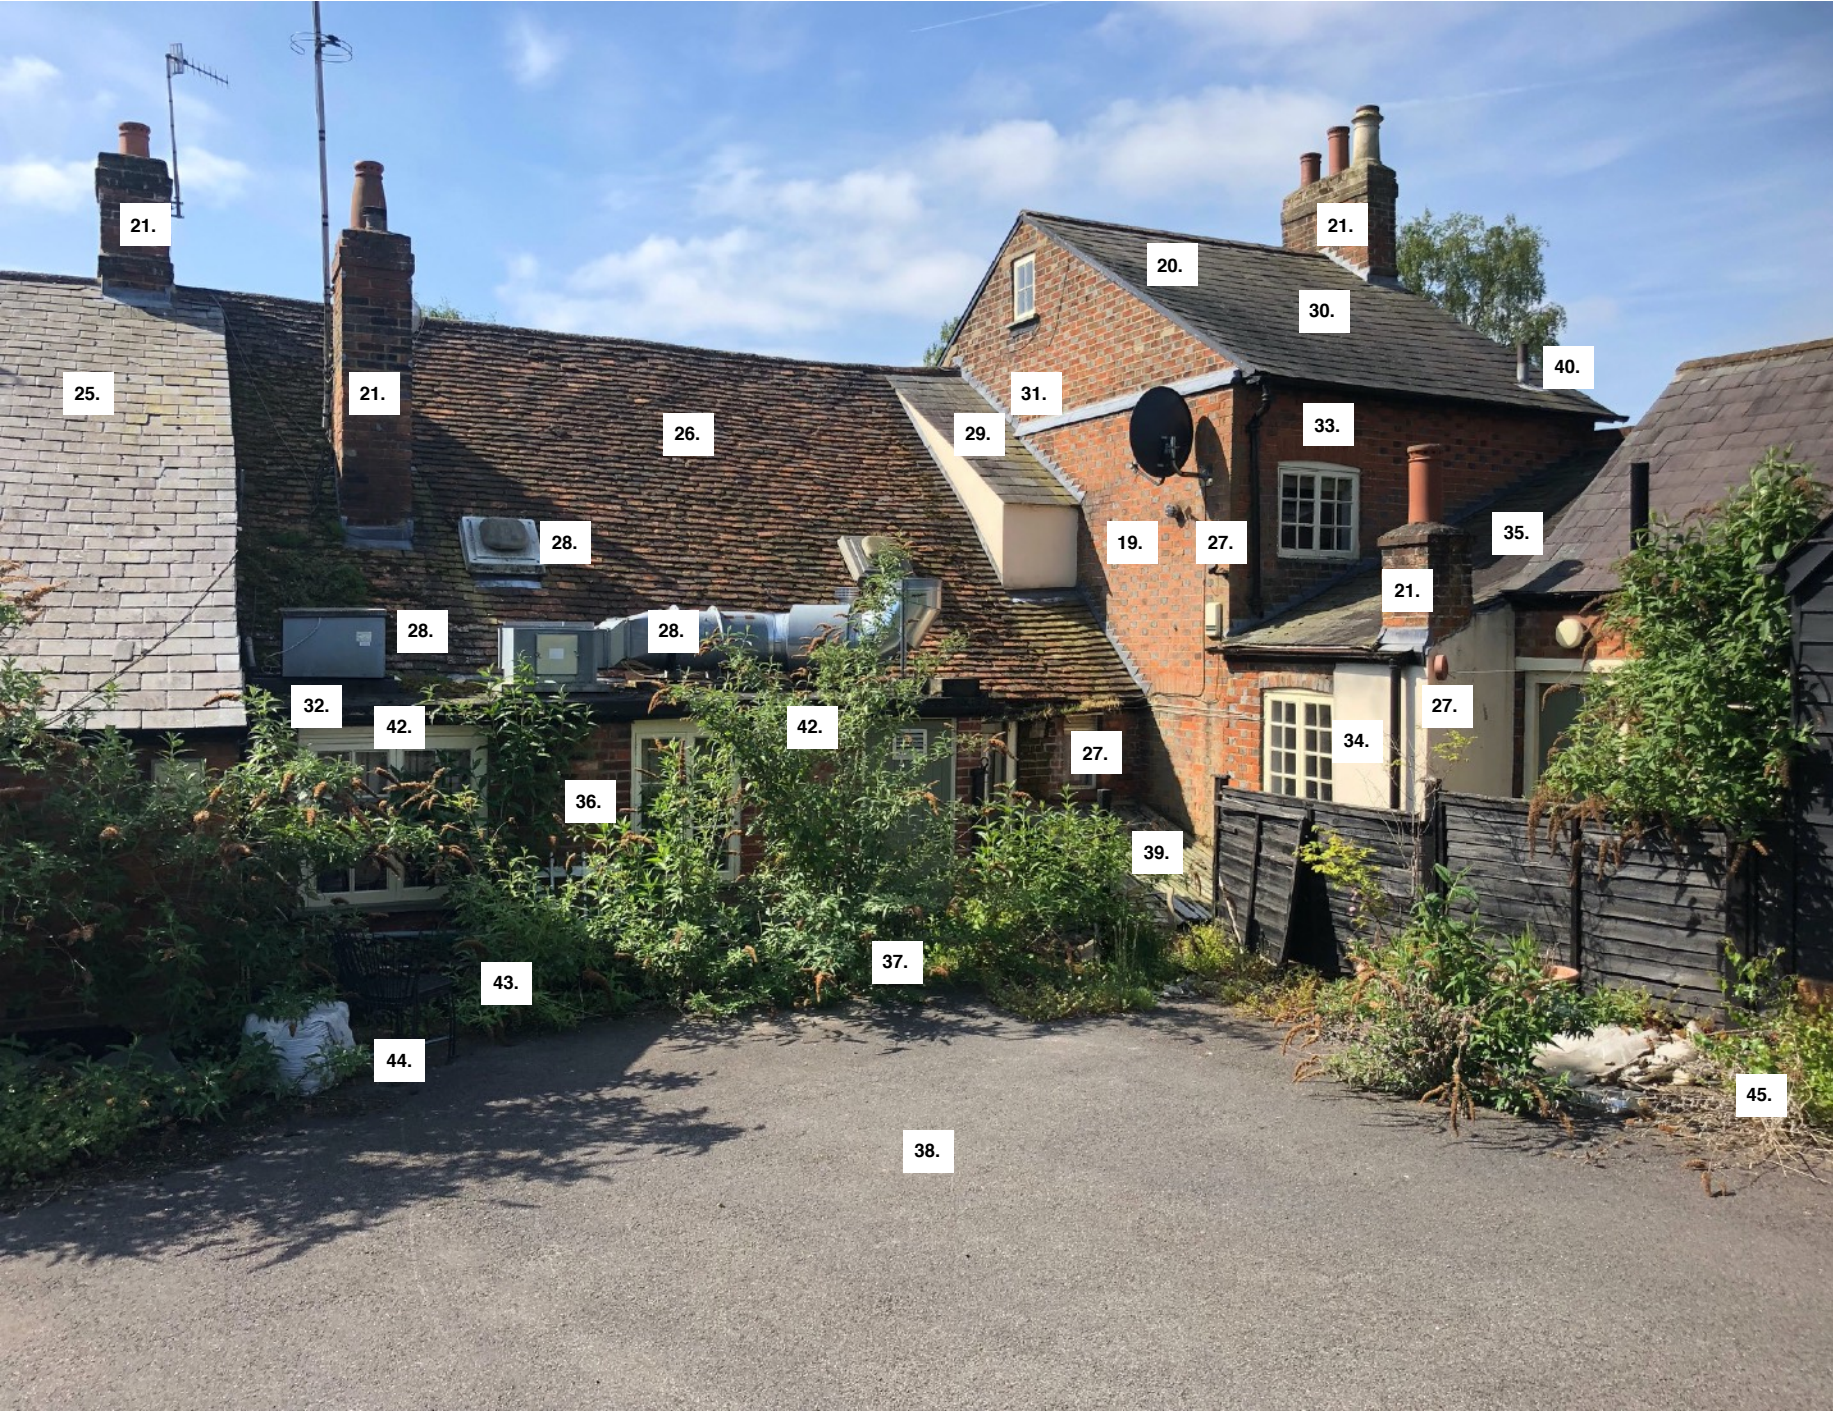
**External: Rear Elevation (North Facing)**

25. Cat slide slate roof with ridge tiles in poor condition with slipped and broken slates.
26. Single lap clay roof tiles on sloping timber rafters with bedded clay ridges displaying evidence of ridge timber deflection. Poor condition with biological growth, some delamination and evidence of sagging to roof timbers. Several broken and slipped tiles observed with evidence of falling tiles to hard standing.

27. Existing cast iron rainwater goods. Very poor condition requiring replacement.
28. Redundant mechanical extraction plant supported on existing, timber roof structure. Poorly flashed - source of water ingress.

29. Natural slate roof shed dormer with rendered walls and lead watertight flashing to clay tile roof. Fair condition.
30. Natural slate pitched roof with bedded clay ridge tiles in fair condition with evidence of sagging to roof timbers.

31. Lead weathering to brick gable. Fair condition.
32. Bituminous felt flat roof. Very poor condition with sagging and ponding observed.
33. Existing timber casement windows in poor condition.

34. Painted sand cement render over existing brickwork. Fair condition.
35. Natural slate mono-pitch roof with bedded clay ridge tiles in fair condition with evidence of sagging to roof timbers.

36. Flush pointed brick with burnt headers in poor condition with delaminated bricks and evidence of poor quality alterations.
37. Existing vegetation to be stripped back

38. Tarmac surfacing in poor condition.
39. Poorly fixed profile sheeting over historic basement stair access. Dangerous condition with evidence of water ingress.

40. Flashed pipework penetration to slate roof. Poor condition with evidence of bitumen repair.
41. Partially sand-cement rendered, stretcher bond brick gable to cat slide slate roof. Poor condition with unsympathetic waste pipe penetrations and small, timber casement window.

42. Timber lintels rotten and subject to structural failure.
43. Sand: cement render band fractured, boast and compromised by water ingress
44. Cellar access hatch corroded and dangerous. Evidence of water ingress from hard-standing.

45. Stained weatherboard on flush pointed brick base. Fair condition with evidence of delimitation to brick base course.

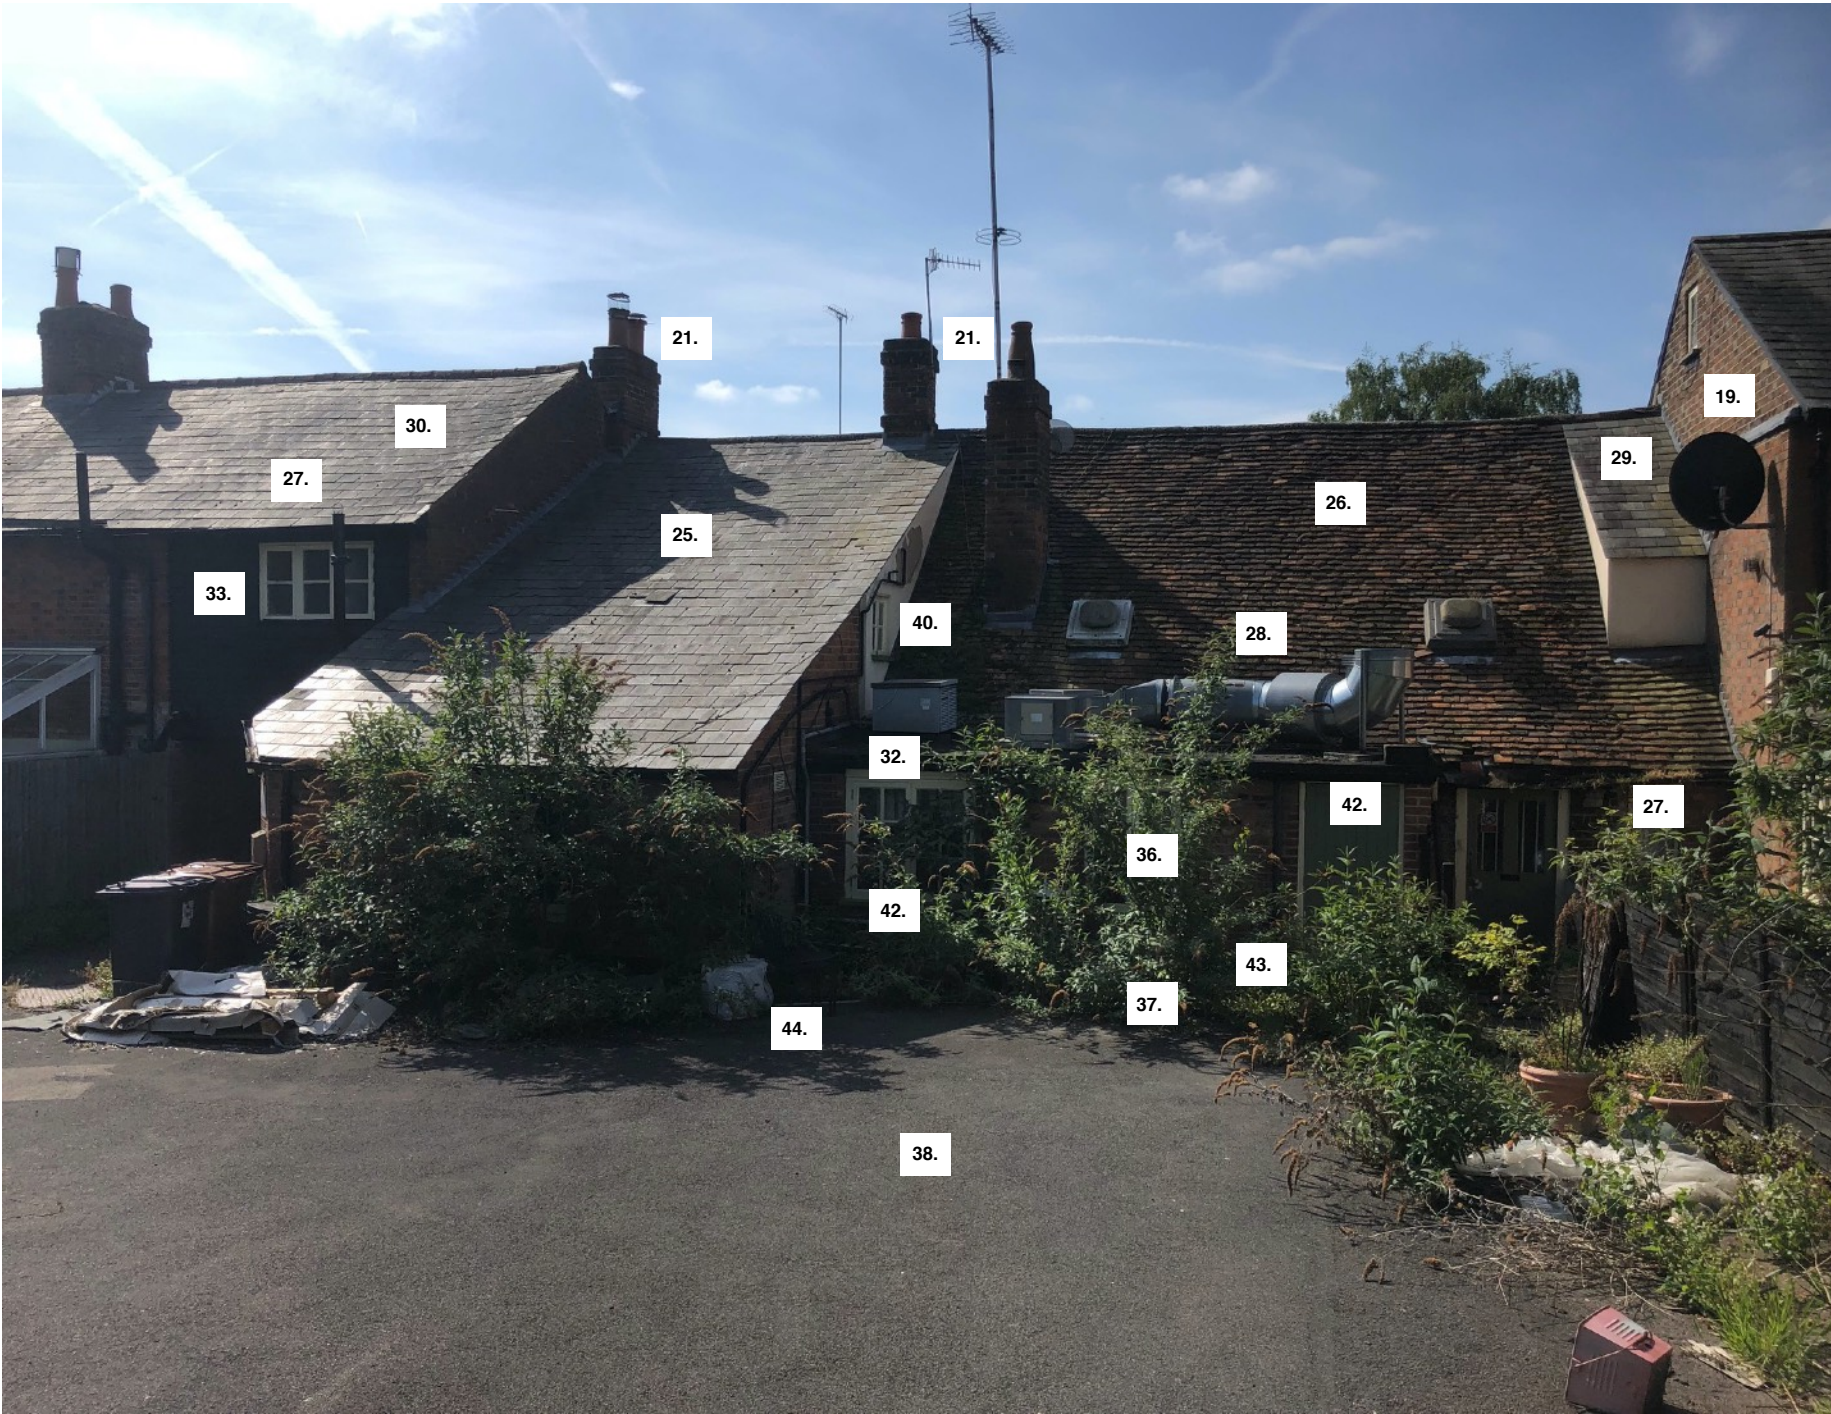
**External: Rear Elevation (North Facing)**

25. Cat slide slate roof with ridge tiles in poor condition with slipped and broken slates.
26. Single lap clay roof tiles on sloping timber rafters with bedded clay ridges displaying evidence of ridge timber deflection. Poor condition with biological growth, some delamination and evidence of sagging to roof timbers. Several broken and slipped tiles observed with evidence of falling tiles to hard standing.

27. Existing cast iron rainwater goods. Very poor condition requiring replacement.
28. Redundant mechanical extraction plant supported on existing, timber roof structure. Poorly flashed - source of water ingress.

29. Natural slate roof shed dormer with rendered walls and lead watertight flashing to clay tile roof. Fair condition.
30. Natural slate pitched roof with bedded clay ridge tiles in fair condition with evidence of sagging to roof timbers.

31. Lead weathering to brick gable. Fair condition.
32. Bituminous felt flat roof. Very poor condition with sagging and ponding observed.
33. Existing timber casement windows in poor condition.

34. Painted sand cement render over existing brickwork. Fair condition.
35. Natural slate mono-pitch roof with bedded clay ridge tiles in fair condition with evidence of sagging to roof timbers.

36. Flush pointed brick with burnt headers in poor condition with delaminated bricks and evidence of poor quality alterations.
37. Existing vegetation to be stripped back

38. Tarmac surfacing in poor condition.
39. Poorly fixed profile sheeting over historic basement stair access. Dangerous condition with evidence of water ingress.

40. Flashed pipework penetration to slate roof. Poor condition with evidence of bitumen repair.
41. Partially sand-cement rendered, stretcher bond brick gable to cat slide slate roof. Poor condition with unsympathetic waste pipe penetrations and small, timber casement window.

42. Timber lintels rotten and subject to structural failure.
43. Sand: cement render band fractured, boast and compromised by water ingress
44. Cellar access hatch corroded and dangerous. Evidence of water ingress from hard-standing.

45. Stained weatherboard on flush pointed brick base. Fair condition with evidence of delimitation to brick base course.

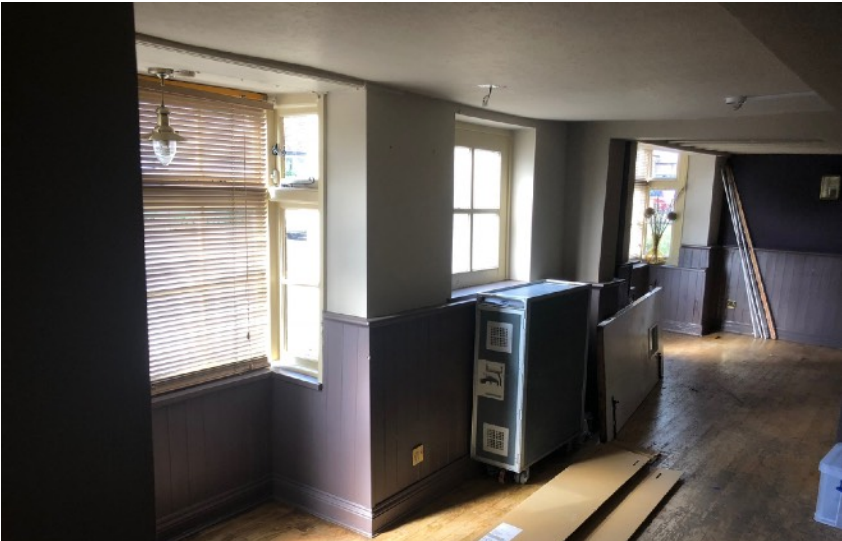
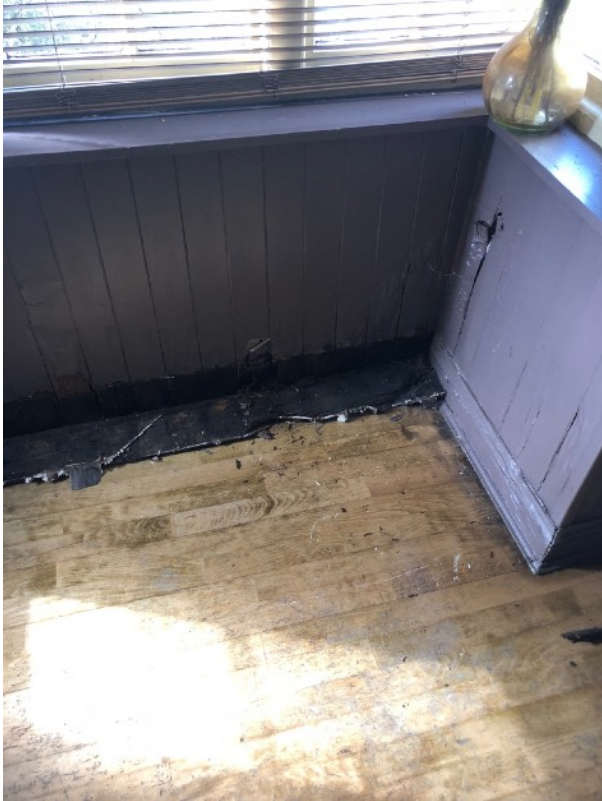
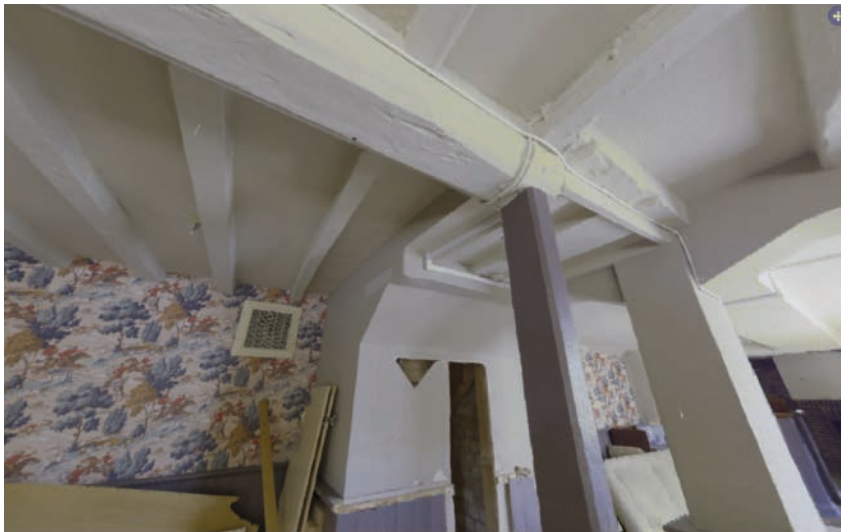
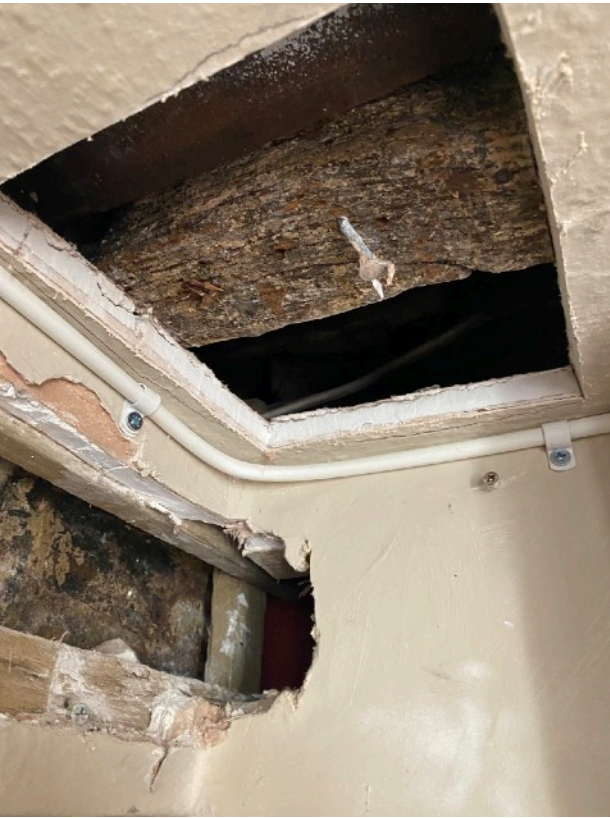
Ground Floor: Front of House Area

- Timber board floor on suspended timbers bearing onto masonry sleeper walls. Opening up work indicates timber joists rest on non-historic masonry sleeper walls with no minimal contact to the outer masonry walls. Poor to Fair condition with isolated sections displaying evidence of rot at wall junctions. Stepped access to basement subject to rot and dangerous.

- Exposed and painted first floor beams timber in fair condition to Western section. Opening up work indicates concealed first floor joists appear to have been affected by historic rot. Eastern section contains modern plasterboard ceiling. Opening up work indicates a central bearing steel beam spanning East to West.

- Walls lined at low level with modern, painted wainscoting. North wall comprised of modern timber stud walling with a historic masonry wall, incorporating fireplace between the Front of House Area and Kitchen. Existing cupboard contains evidence of potential historic inglenook. Evidence of corrosion to modern steelwork as observed through opening up works. Blocking up of external doorway renders condition of fabric unknown.

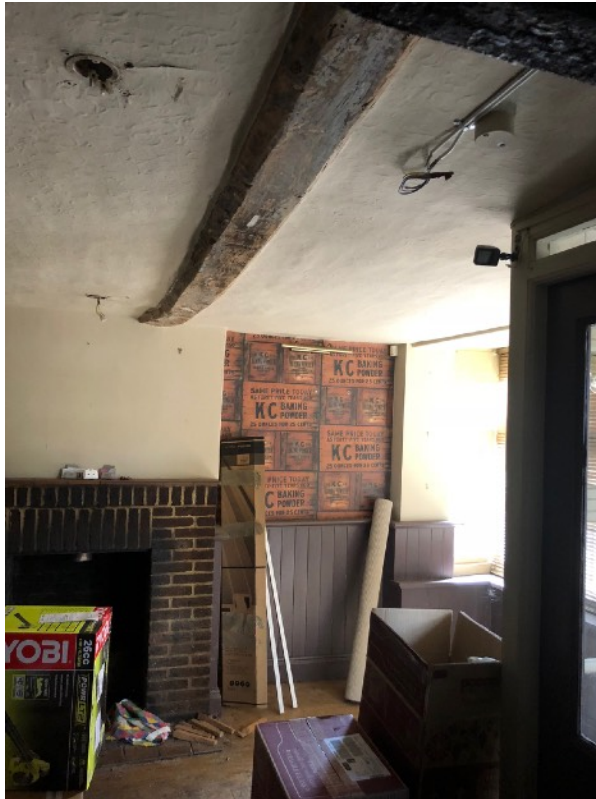
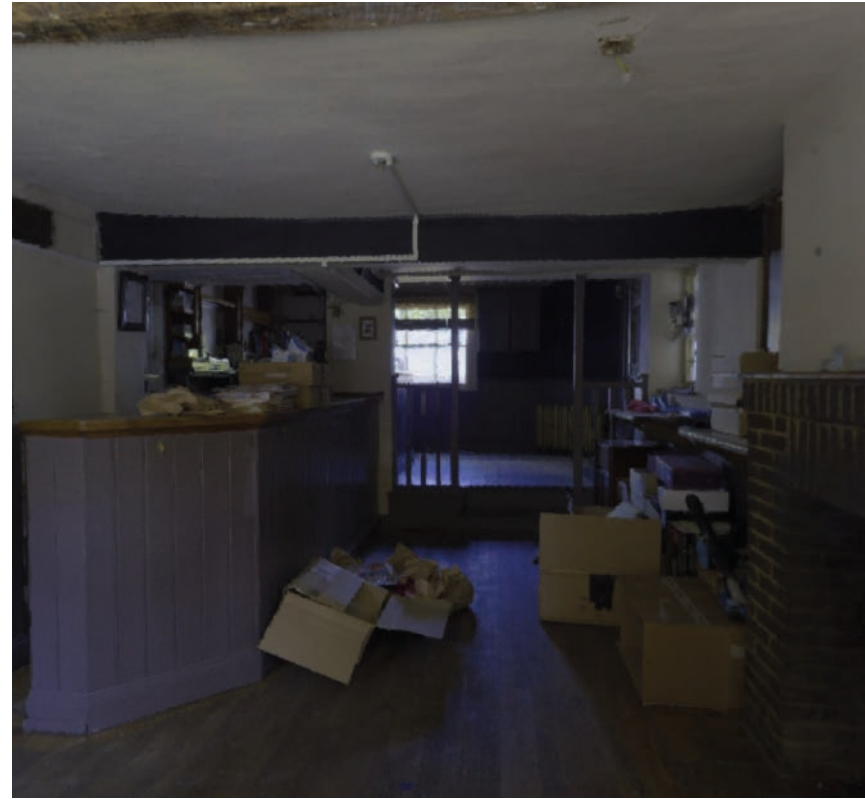
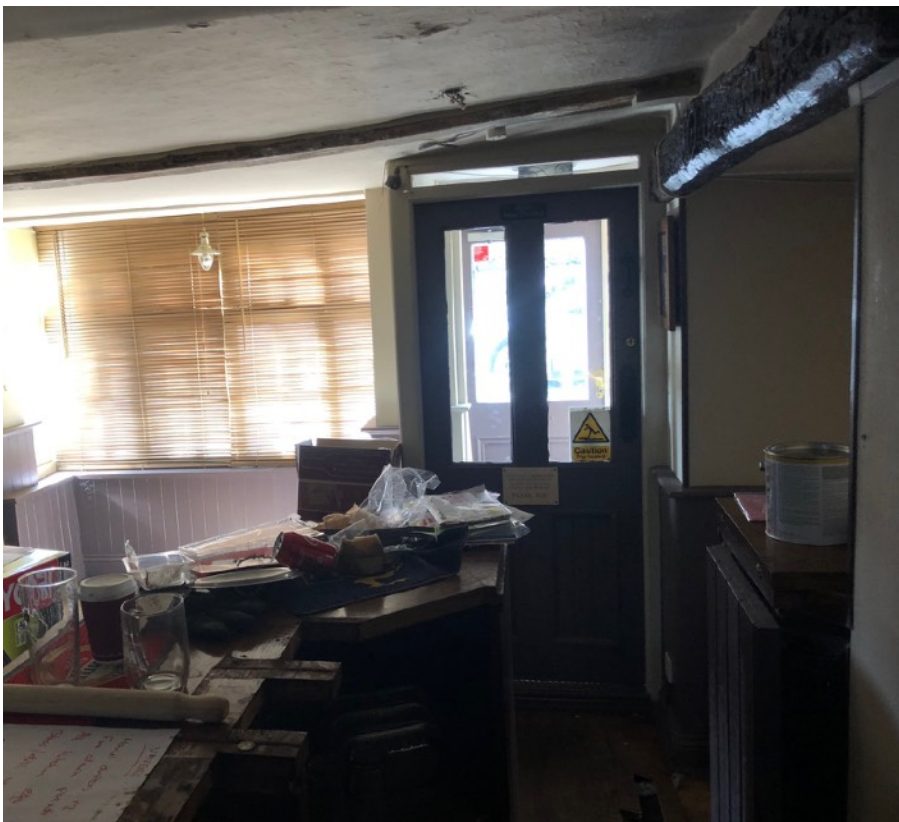
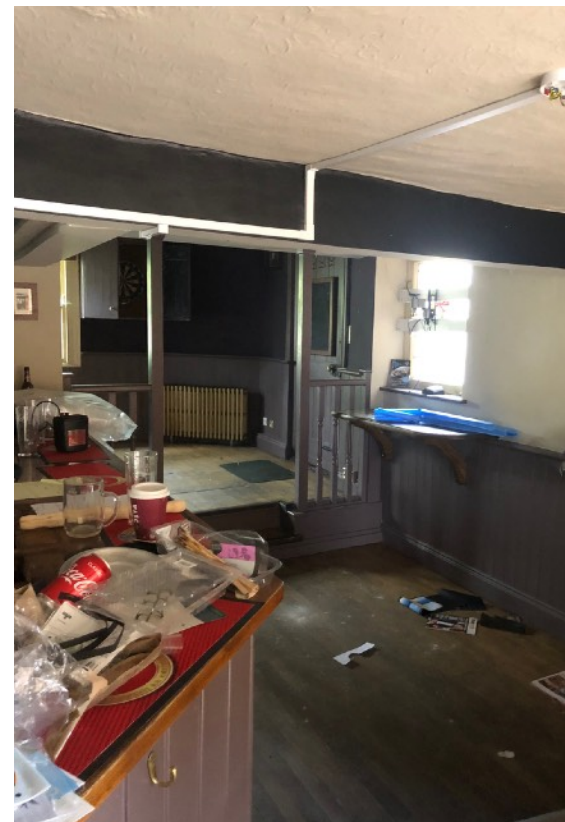
### Ground Floor: Main Bar Area

- Timber board floor on suspended timbers bearing onto masonry sleeper walls. Opening up work indicates timber joists rest on non-historic masonry sleeper walls with no minimal contact to the outer masonry walls. Poor to Fair condition with isolated sections displaying evidence of rot.

- Exposed first floor beams with central bearing timber in fair condition to Southern section. Historic evidence of minor rot. Northern section contains modern plasterboard ceiling with Southern section lath and plaster in fair condition with evidence of minor cracking and some damage by light fittings.

- Walls lined at low level with modern, painted wainscotting. Evidence of damp ingress observed behind wainscotting. Walls a combination of lath and plaster finish and modern plasterboard linings. Fair condition.

- East wall contains a fireplace with modern brickwork surround - further investigation recommended to establish condition of elements i.e hearth, flue, grate etc.

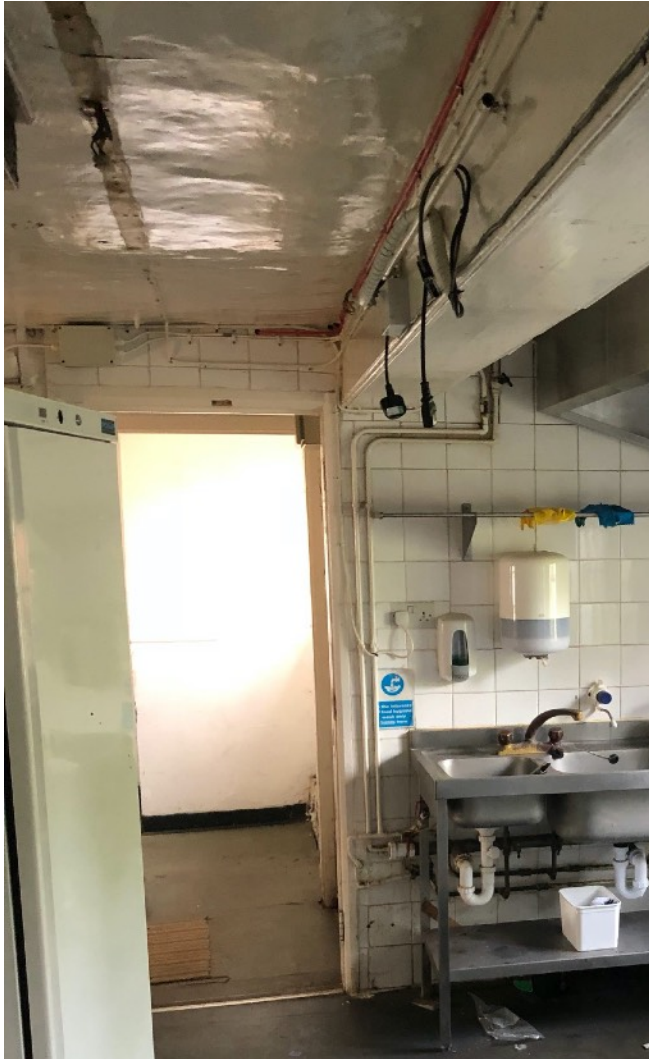
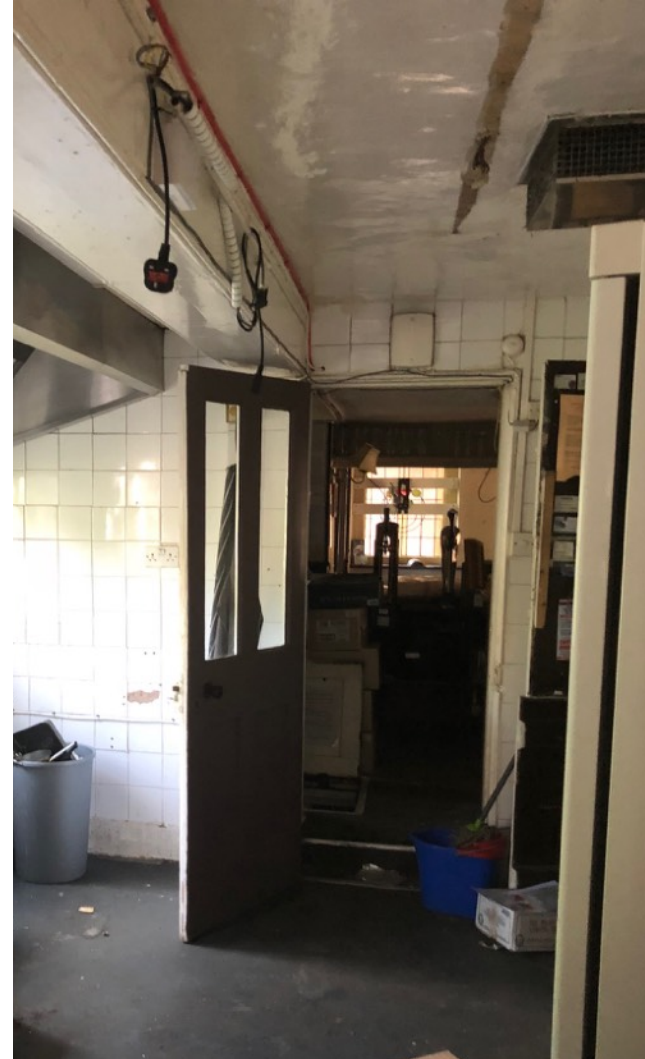
**Ground Floor: Kitchen****Floor**

- Modern solid concrete floor with vinyl finish. Poor condition with evidence of moisture ingress at base course level.

- Lath and plaster ceiling painted in vinyl-based moisture resisting paint with timber cased down stand beams observed on existing wall line. Poor condition with evidence of cracking.

- Walls tiled full height. Historic masonry wall, incorporating a chimney breast present between the Main Bar Area and Kitchen. Poor condition overall. Evidence of moisture ingress and loose tiles observed throughout.

- Stainless steel commercial kitchen fit out and white goods. Poor condition. No evidence of fire doors, fire stopping, fire rated ducting or fire detection observed.
