**The White Horse, Kimpton**  
**Condition Report**  
December 2024

## 1.0 EXECUTIVE SUMMARY

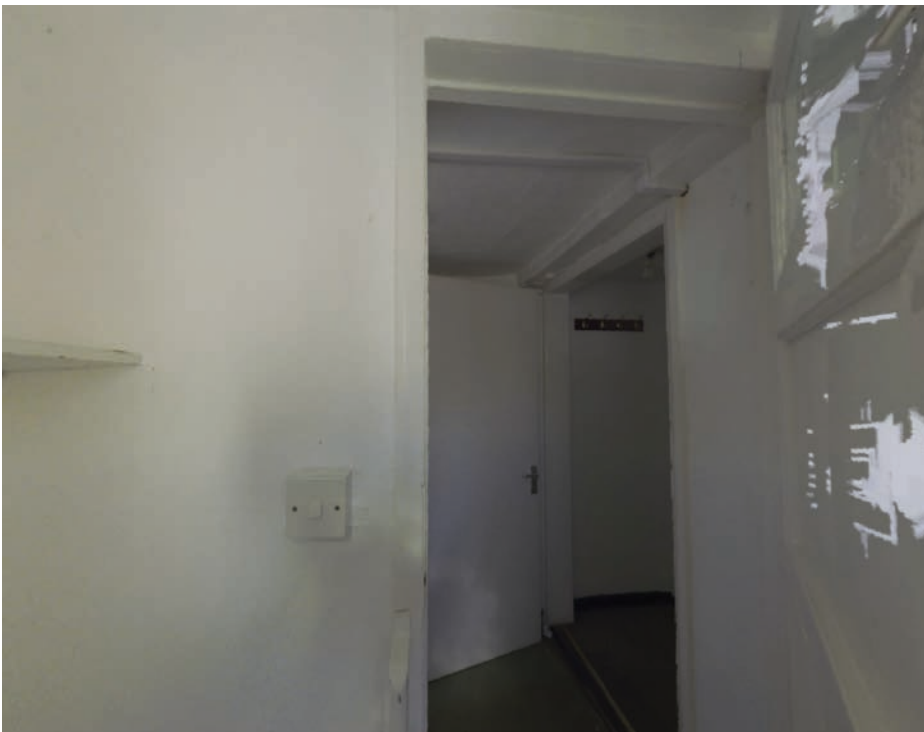
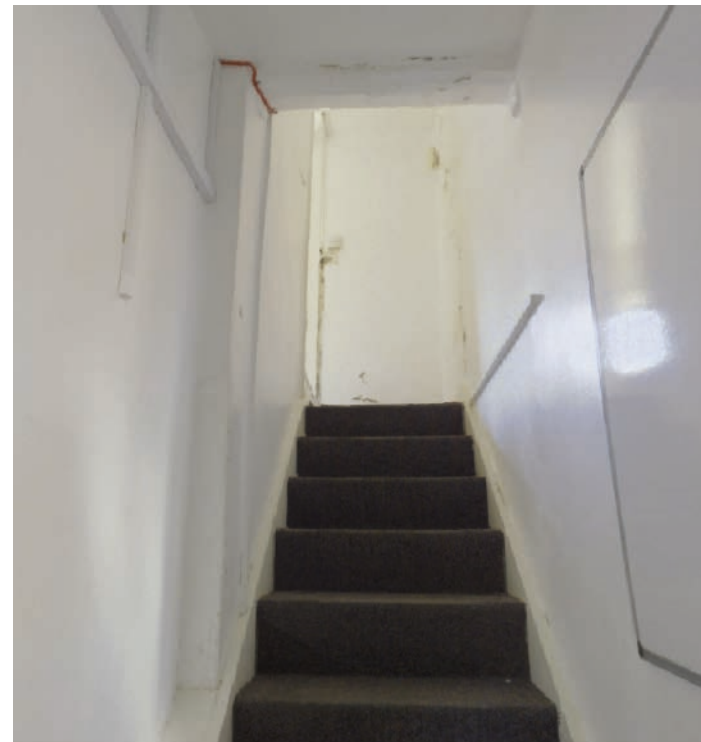
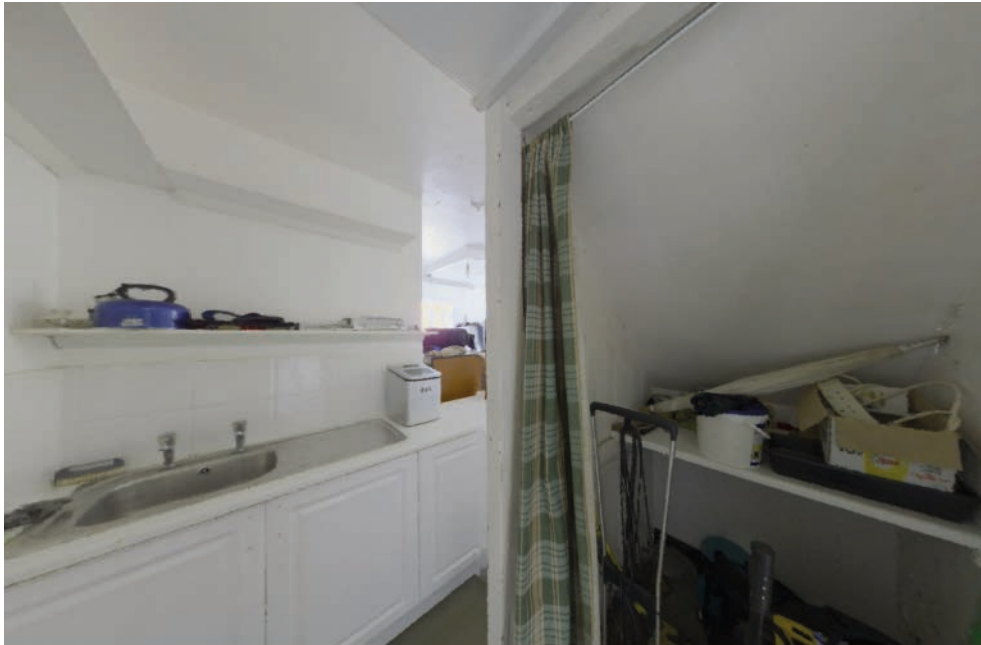
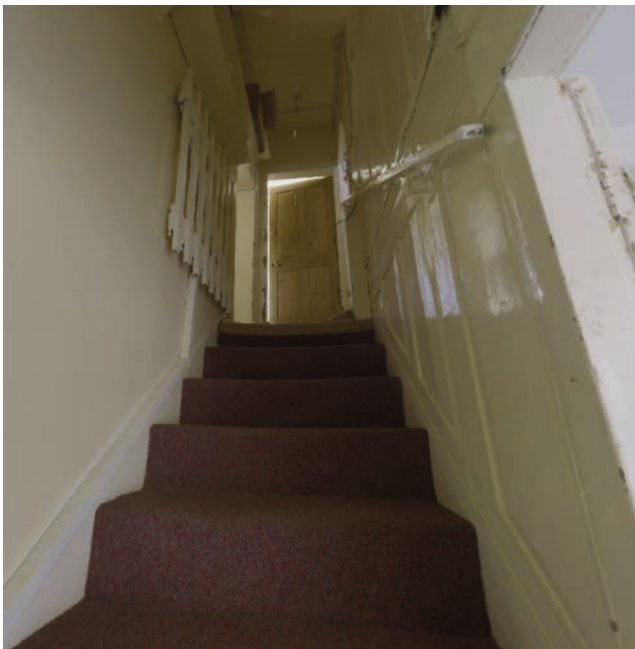
**Ground Floor: Utility Annex and Stair**

- Vinyl covering on timber board floor on historic joists. Refer to basement section for elaboration on condition of floor joists. Access hatch present within corridor. Poor condition.

- Combination of Painted lath and plaster and painted plasterboard. Fair Condition. Boast lath and plaster ceiling above stair.

- Walls painted and plastered with evidence of painted brickwork walls expressed internally to corresponding external walls. Evidence of efflorescence, biological growth and ingress of moisture to base of external walls. Overall Poor condition.

- Timber stair with carpeted finish. Evidence of painted moulded panelling to stair walls with fracturing of plaster to walls at head of stair. Fair to Poor condition. Exposed high level services to head of stair. Existing waste pipe within utility. Condition unknown.

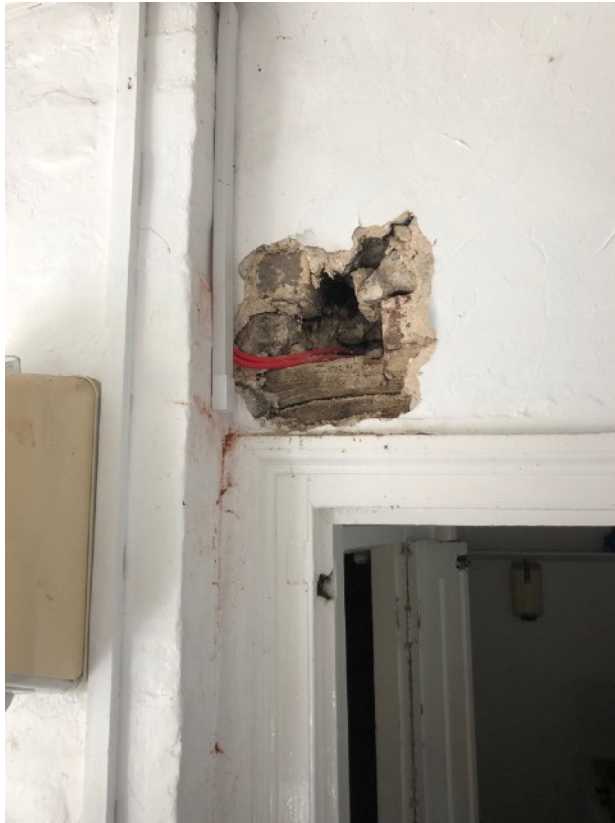
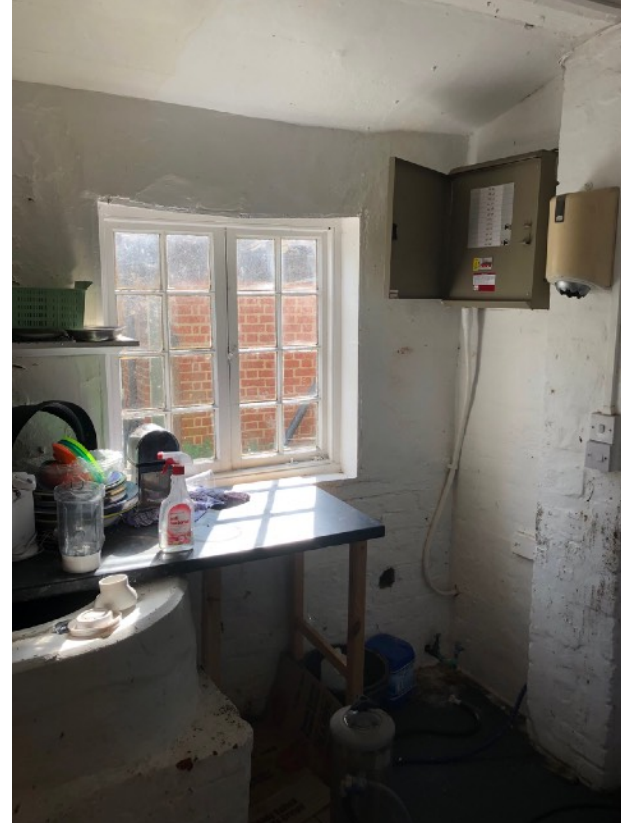
**Ground Floor: Scullery****Floor**

- Vinyl covering on modern screed floor. Substrate unknown. Evidence of damp. Poor condition.

- Painted lath and plaster ceiling throughout with evidence of painted historic floor beams. Minor cracking and damp evident. Poor to fair condition.

- East and South walls painted brickwork expressed internally. Evidence of efflorescence, biological growth and ingress of moisture to all walls. South wall demonstrates evidence of defective tanking membrane to external walls.

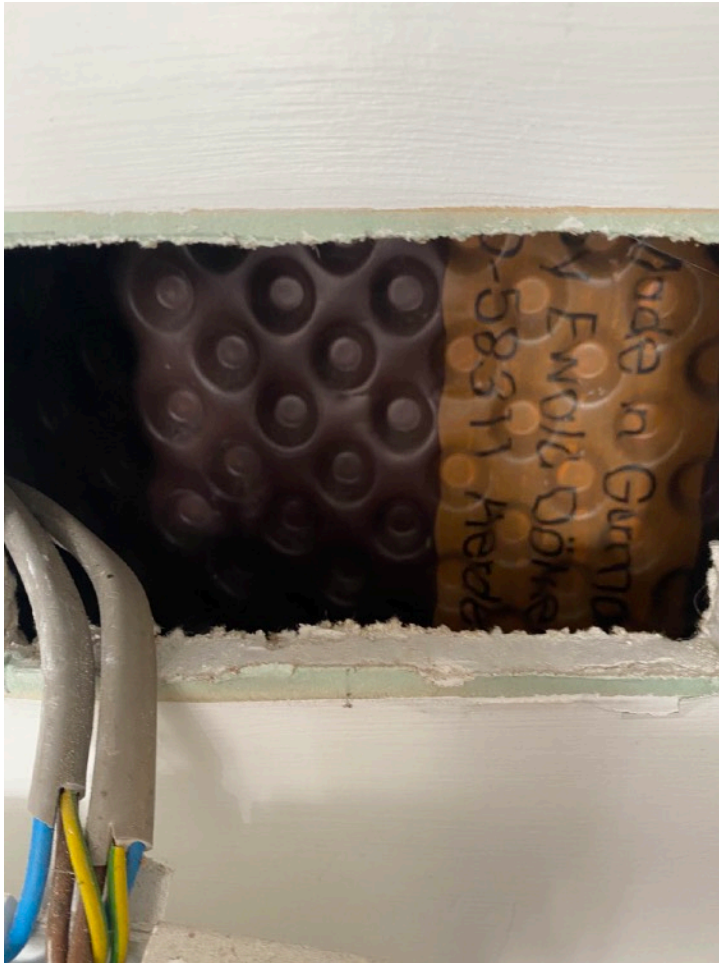
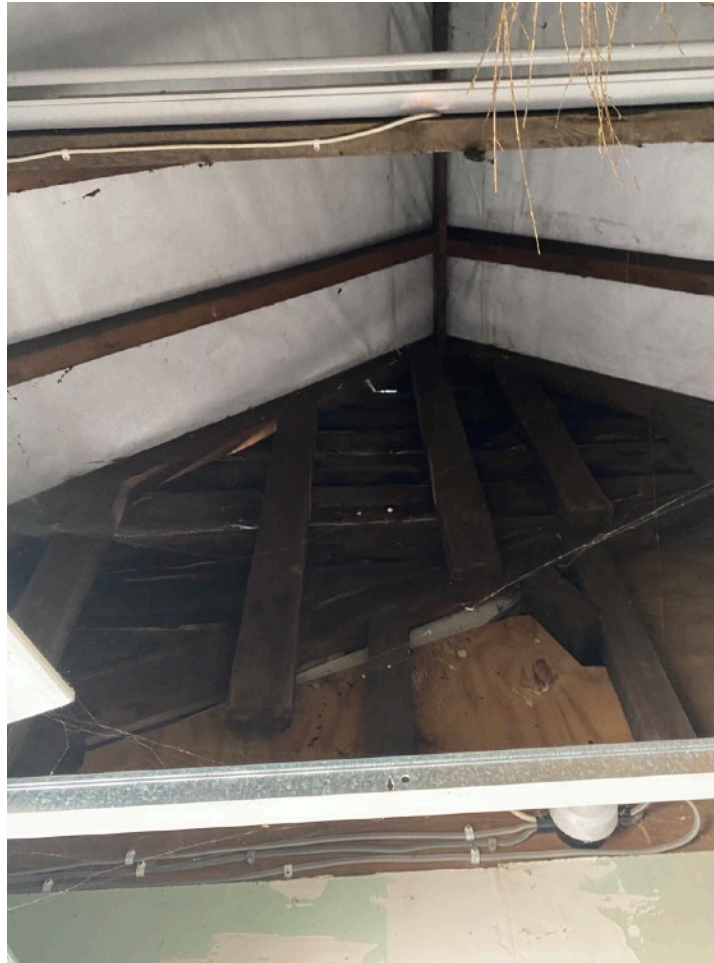
**Ground Floor: Rear Store****Floor**

- Vinyl covering on modern screed floor over historic quarry tile/ brick floor on earth base. Poor Condition.

- Painted and plastered walls lined in plasterboard. Overall Fair condition. Evidence of installation of defective tanking membrane to external walls.

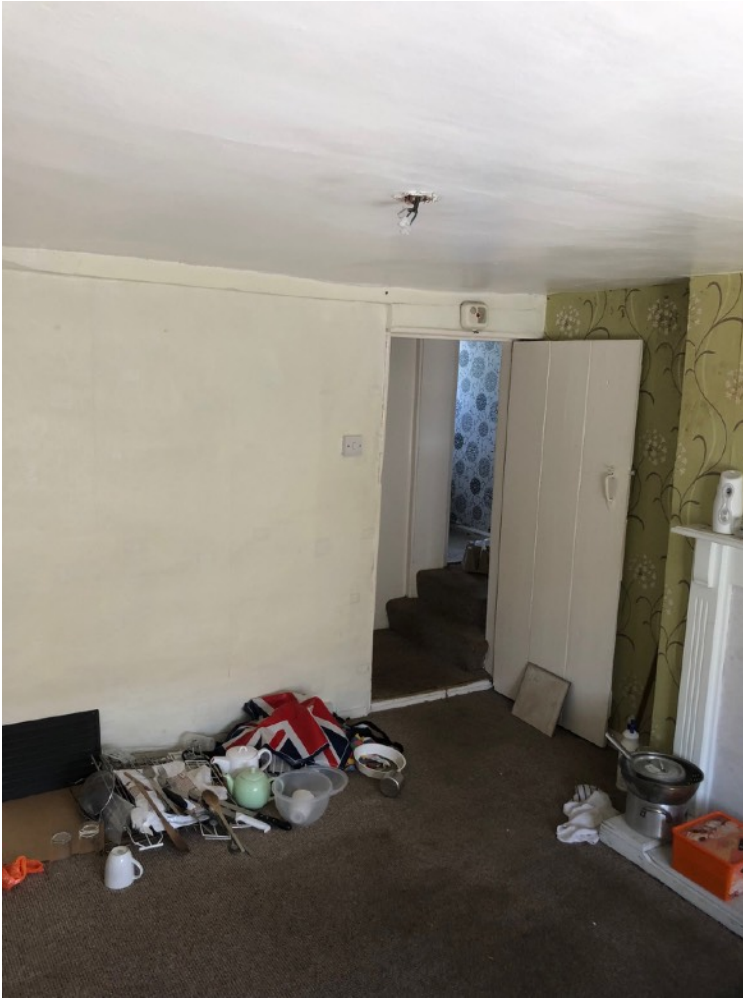
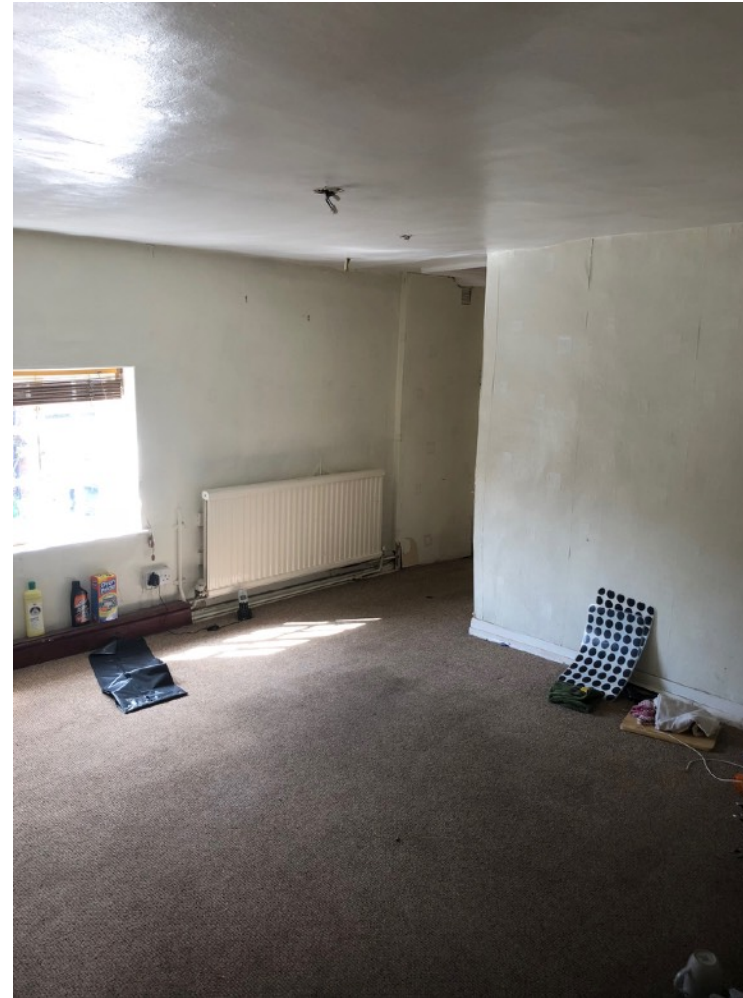
**First Floor Room: Room 1****Floor**

- Carpet finish on original floor boards and joists. Fair condition.

- Lath and plaster ceiling papered and painted. Poor condition with evidence of minor cracking and bowing.

- Painted timber fireplace - further investigation recommended to establish condition of elements i.e hearth, flue, grate etc.

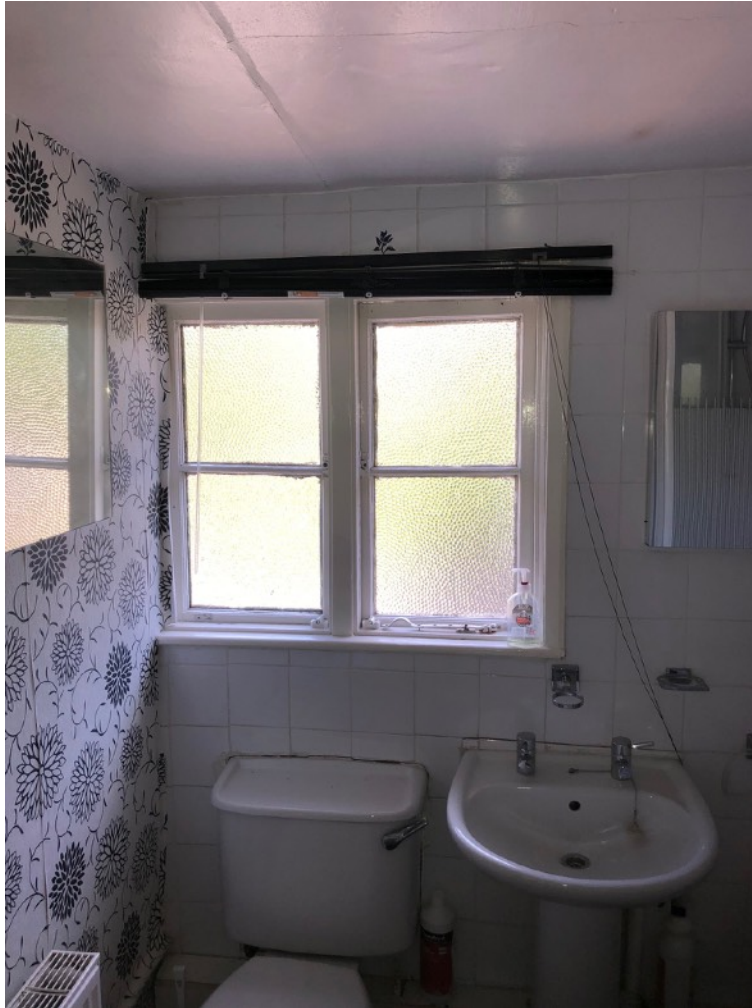
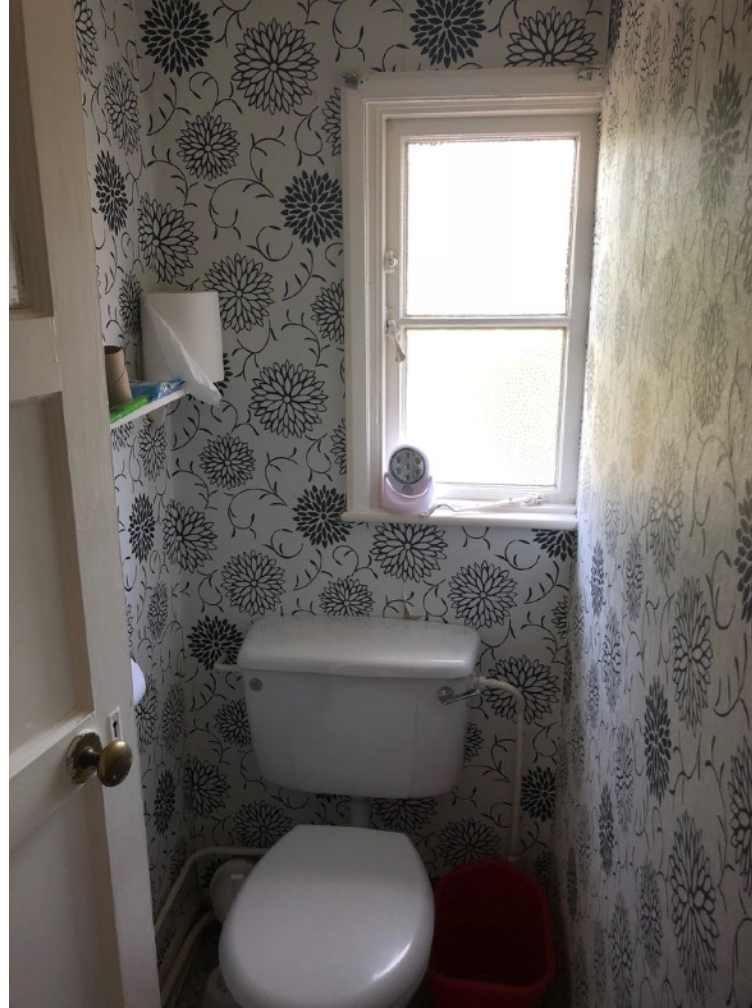
**First Floor Room: Bathroom and WC****Floor**

- Vinyl finish on original floor boards and joists. Note collapsed sections of ceiling to areas below.

- Potentially plasterboard ceiling finished in vinyl-based moisture resistant paint. Poor condition with evidence of minor cracking.

- Combination of papered and tiled finishes. Evidence of tiling debonding from walls due to ingress of moisture. Poor condition.

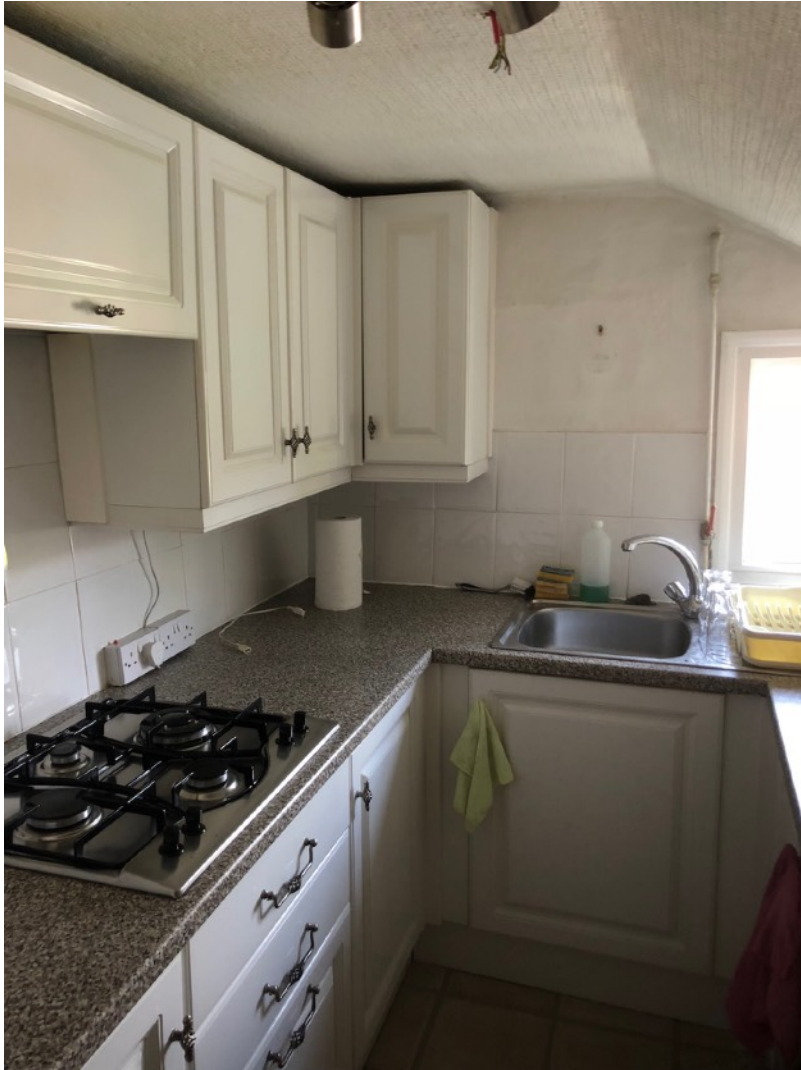
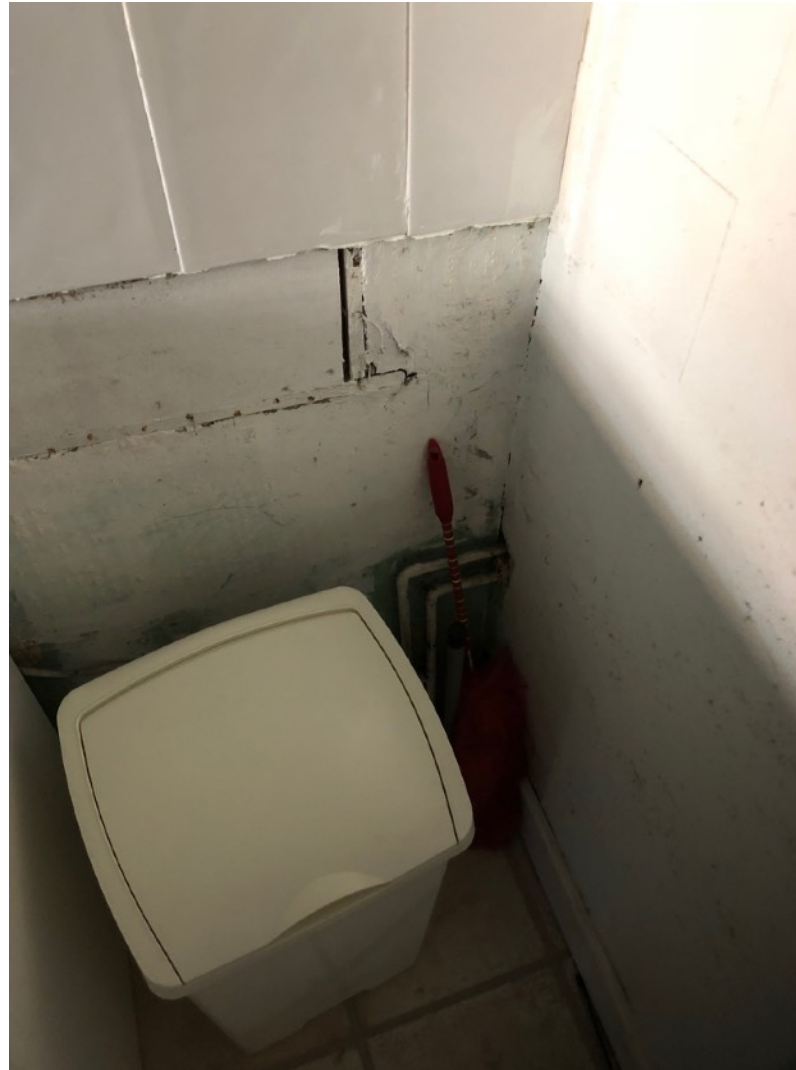
**First Floor Room: Kitchen**

- Combed ceiling with textured finish. Substrate unknown. Fair condition. Presence of artex unknown.

- Combination of painted and plastered and tiled finishes. Poor condition.

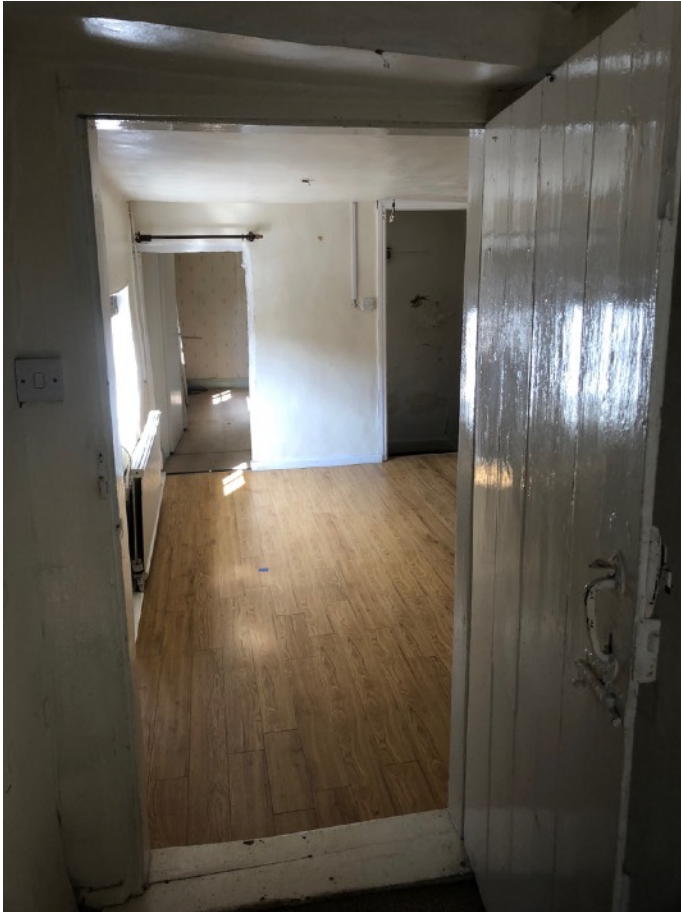
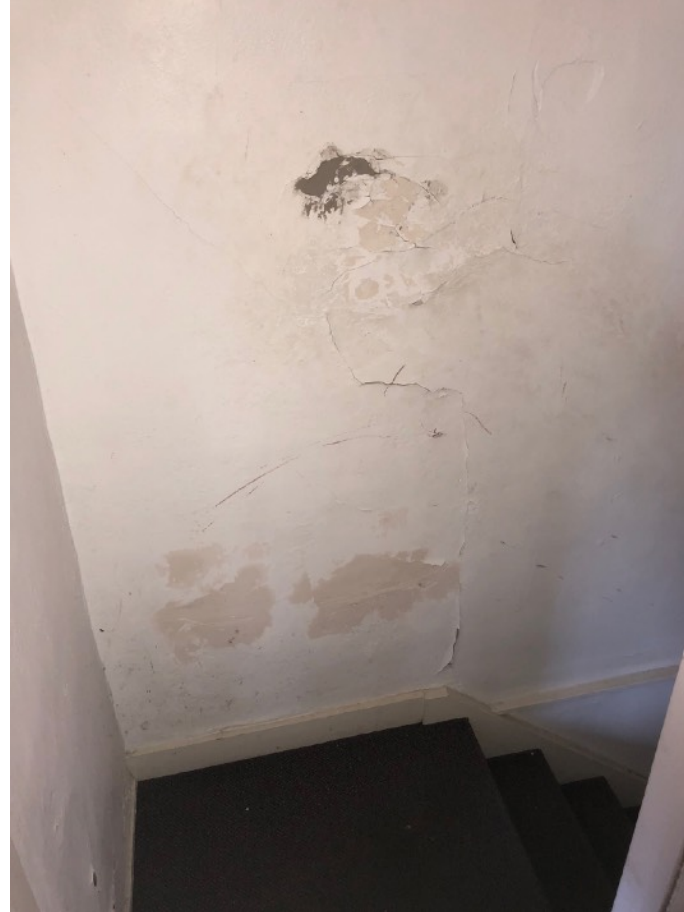
**First Floor Room: Stair Lobby/ Central Bay****Floor**

- Laminate timber floor on unknown substrate. Evidence of historic floorboards at internal door saddles.

- Lath and plaster ceiling papered and painted. Poor condition with evidence of both sagging and cracking. Evidence of damp ingress

- Papered and painted finish on lath and plaster. Historic timber wall to North. Evidence of damp ingress and boast plaster to head of stairs. Fair to Poor condition.

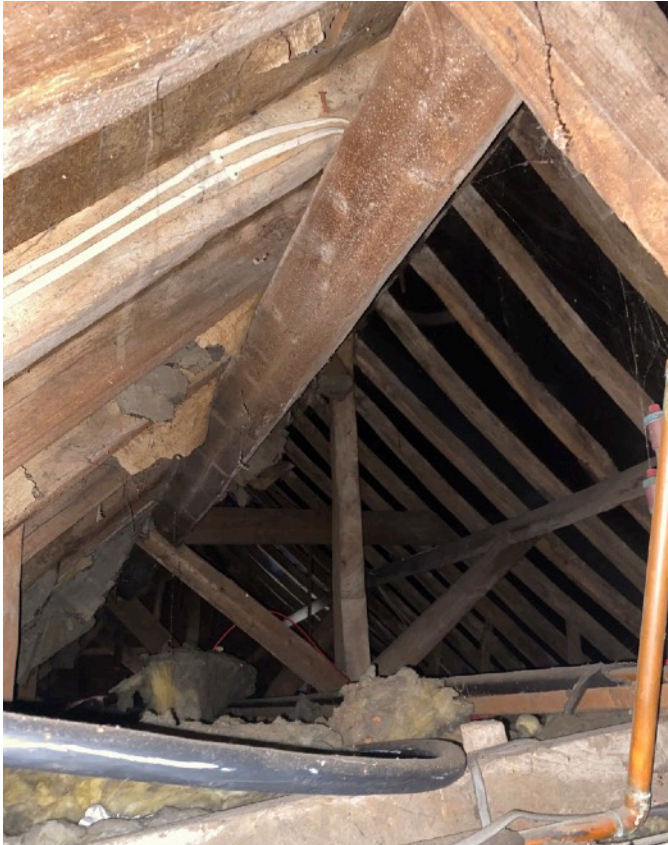
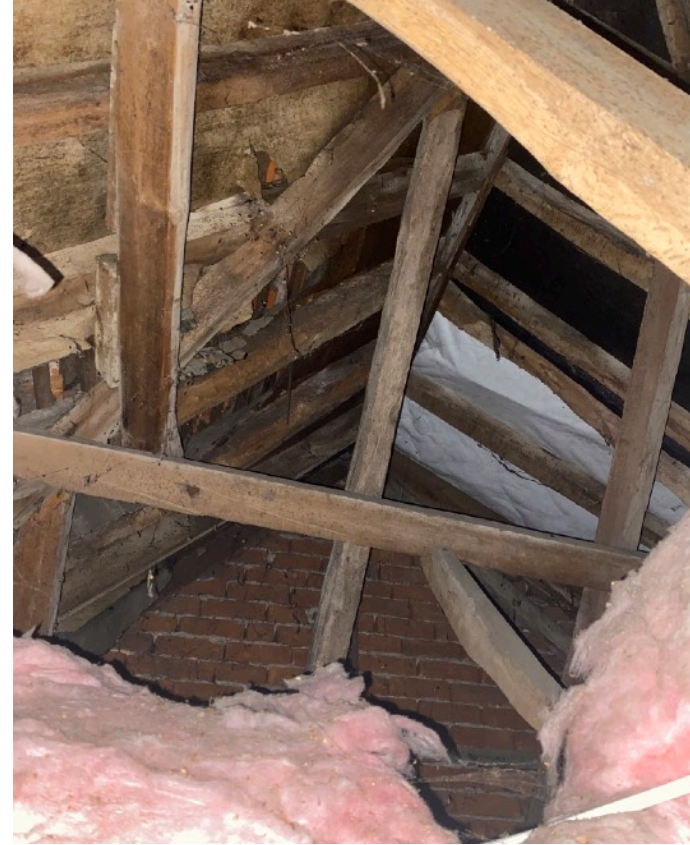
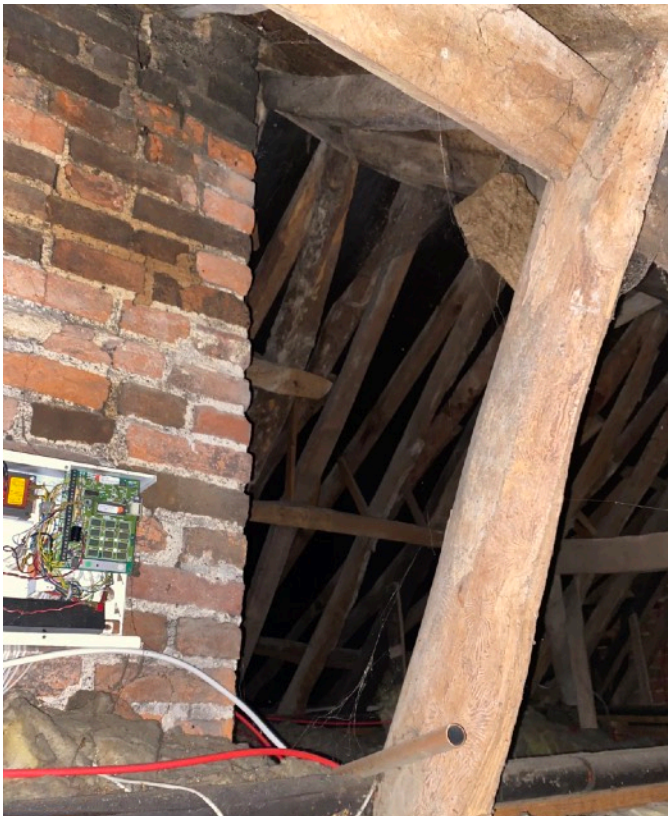
### Roofspace Central Section

- Missing bottom chords to king post trusses.
- No evidence of fire-stopping with exposed electrics and cabling observed.
- Purlins locally bowed. Bearings unable to be inspected.
- Modern underlay to North pitch. Poorly lapped and damaged with evidence of water ingress.
- Poor quality mineral wool insulation sagging.
- Evidence of historic insect attack. Specialist survey required to determine if ongoing.
- Loose tiles and ridge tiles observed.
