Derek LOFTY & Associates

Project: Porters End Barns

## Report on the Existing Barn Structure at

**Porters End House Barns  
Porters End House  
Porters End Lane  
Kimpton  
SG4 8ER**

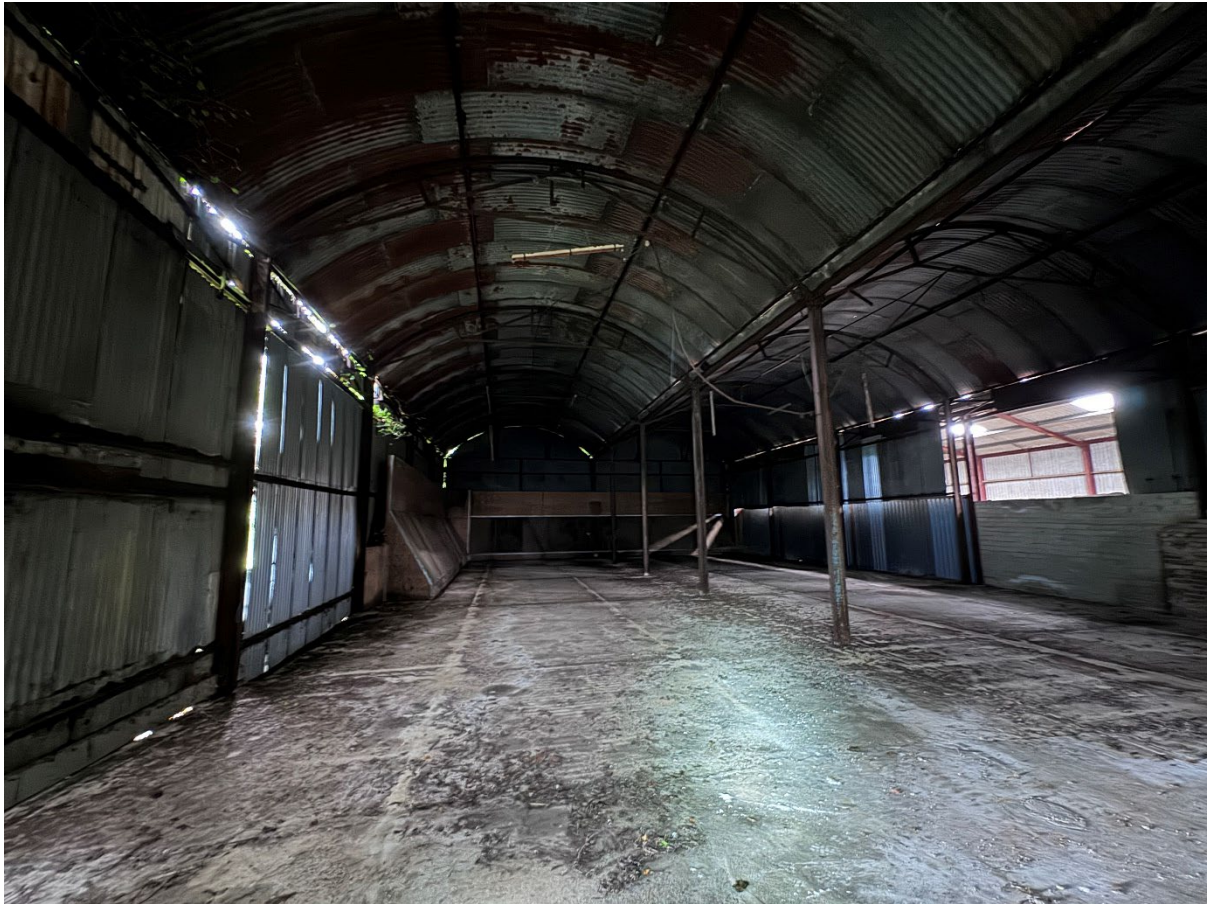
Figure 4 - Internal North Barn

- 3.6 The roof planes of the north barn remain reasonably even and uniform and the walls relatively vertical and true to line. Considering the age and style of building the condition is considered good, with only very localised areas of misalignment visually obvious at the time of our inspection.

- 3.8 The floor slab of the north barn is in good condition, with minor cracks noted, possibly at construction joints. The floor slab remains reasonably level and free from significant structural defect. It is evident the floor slab has been cast around the steel columns after installation.

- 3.9 The purlins supporting the cladding of the north barn appear even and true, with no evidence of structural defect noted during our inspection
- 3.10 The north barn is clad with corrugated metal sheeting. There are visible signs of wear and tear to the sheeting, with daylight penetrating in a number of locations.

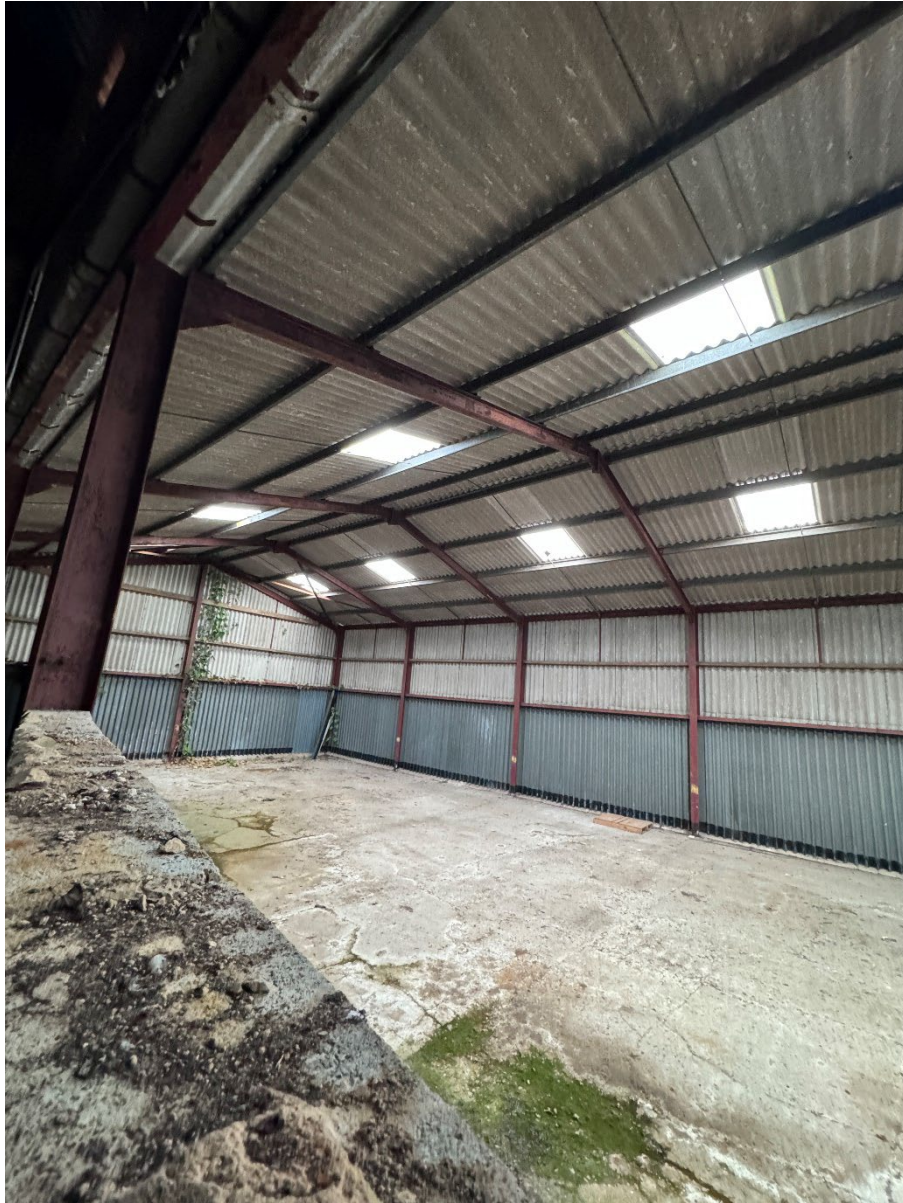
Figure 5 – Internal South Barn

- 3.13 At the time of our inspection the south barn is presented in good structural condition. The ridge line is reasonably level and the roof planes even.

- 3.14 The external walls of the south barn remain reasonably vertical and true to line, with no evidence of structural defect at the time of our inspection.

- 3.15 The concrete floor slab of the south barn is considered substantial, with no evidence of structural defect at the time of our inspection.
- 3.16 The foundations to the portal frames are likely to be mass concrete pads. Whilst these were not exposed as part of this investigation, the superstructure shows no evidence of structural defect and it is fair to assume the foundations are substantial and functioning adequately to support the steel framed building.
