# ARBORICULTURAL ASSESSMENT REPORT

Ivy Cottage, Letchworth Lane, Letchworth Garden City, SG6 3ND

**Survey Date:** 09/05/2023

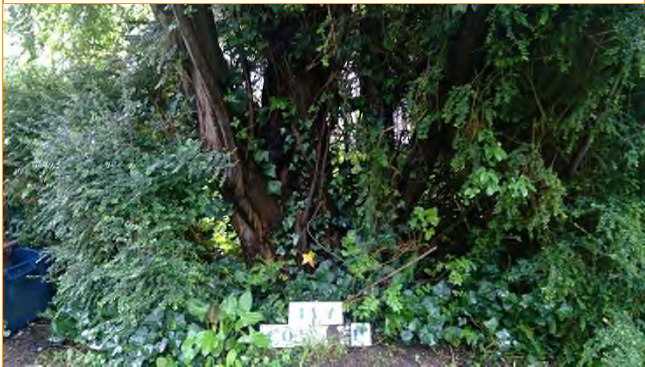
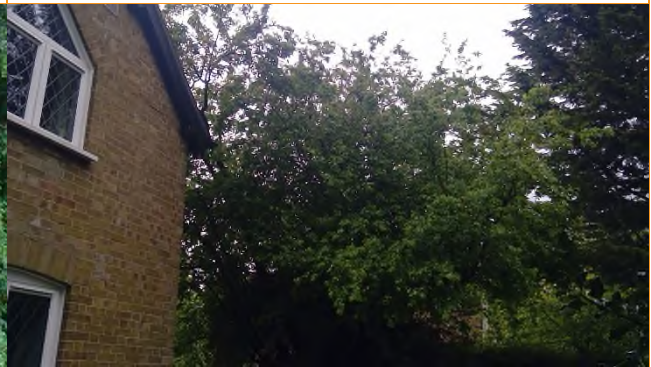
T1 - Plum

| Tree No | Common Name | Age Class | Condition | Height (m) | Crown Spread (m) | Stem diam. (mm) | Dist to bldg. (m) | Roots Implicated | Pruning history | Recommendation | Tree work constraints | Notes | Owner address | Owner |
|---|---|---|---|---|---|---|---|---|---|---|---|---|---|---|
| T1 | Plum | Mature | Fair | 6.8 | 7.0 | 135 | 2.98 | N | Subject to past management. No significant recent management. | Fell and treat stump with eco plugs (broadleaved). | Phone/Power lines through crown. | Implicated due to size and proximity. | Ivy Cottage<br>Letchworth Lane<br>Letchworth<br>Garden City<br>SG6 3ND | PH |

| Tree No: | Species | Works Required | CA | TPO | Ownership |
|---|---|---|---|---|---|
| T1 | Plum | Fell and treat stump with eco plugs (broadleaved) | Yes | No | PH |

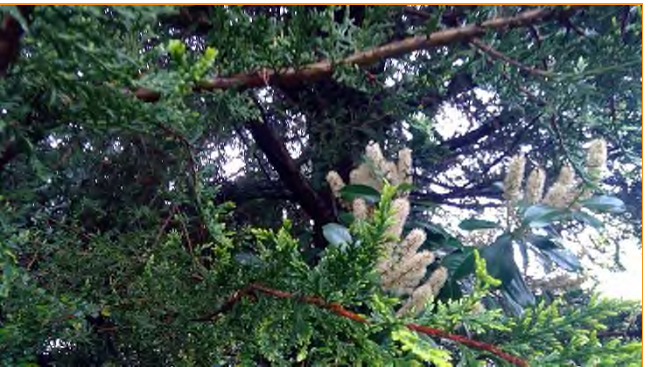
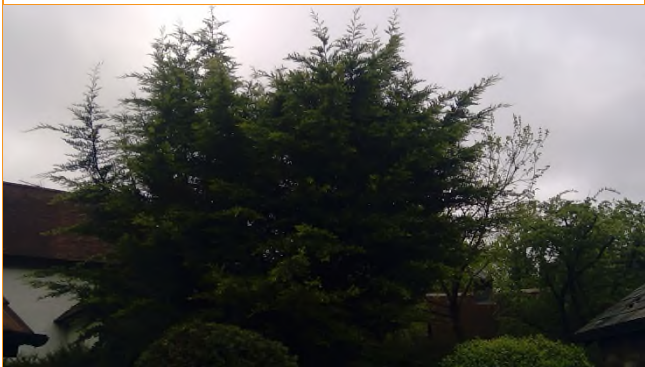
T3 - Cypress

| Tree No | Common Name | Age Class | Condition | Height (m) | Crown Spread (m) | Stem diam. (mm) | Dist to bldg. (m) | Roots Implicated | Pruning history | Recommendation | Tree work constraints | Notes | Owner address | Owner |
|---|---|---|---|---|---|---|---|---|---|---|---|---|---|---|
| T3 | Cypress | Mature | Fair | 6.0 | 6.2 | 280 | 5.51 | N | No significant past tree works. | Fell close to ground level (approx. 50mm) (conifer). | | Implicated due to size and proximity to cracks. | Ivy Cottage<br>Letchworth Lane<br>Letchworth<br>Garden City<br>SG6 3ND | PH |

| Tree No: | Species | Works Required | CA | TPO | Ownership |
|---|---|---|---|---|---|
| T3 | Cypress | Fell close to ground level (approx. 50mm) (conifer) | Yes | No | PH |

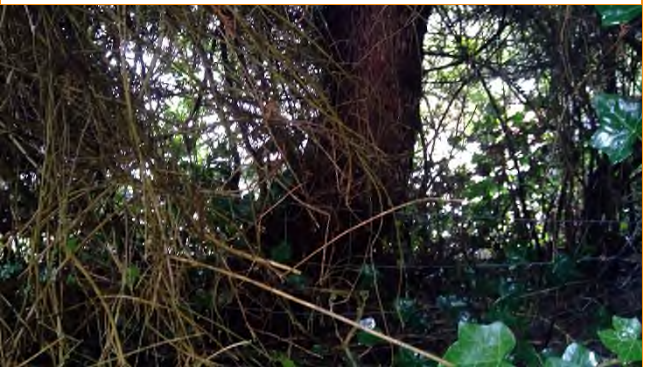
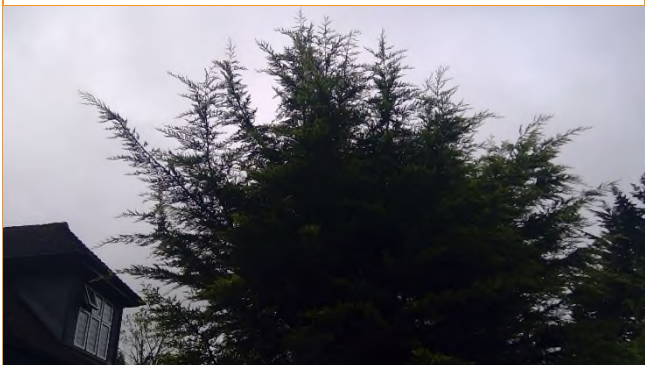
T4 - Cypress

| Tree No | Common Name | Age Class | Condition | Height (m) | Crown Spread (m) | Stem diam. (mm) | Dist to bldg. (m) | Roots Implicated | Pruning history | Recommendation | Tree work constraints | Notes | Owner address | Owner |
|---|---|---|---|---|---|---|---|---|---|---|---|---|---|---|
| T4 | Cypress | Mature | Good | 6.9 | 5.8 | 200* | 6.95 | N | No significant past tree works. | Fell close to ground level (approx. 50mm) (conifer). | | Implicated to size and proximity to cracks. | Ivy Cottage<br>Letchworth Lane<br>Letchworth<br>Garden City<br>SG6 3ND | PH |

| Tree No: | Species | Works Required | CA | TPO | Ownership |
|---|---|---|---|---|---|
| T4 | Cypress | Fell close to ground level (approx. 50mm) (conifer) | Yes | No | PH |
