**R & D for Asbestos containing materials at**

**Storage Sheds  
Temple Dinsley  
School Lane  
Preston, Hitchin  
Hertfordshire, SG4 7RT**

SURVEY DATE; 10th August 2023

REFERENCE; ECB/5347

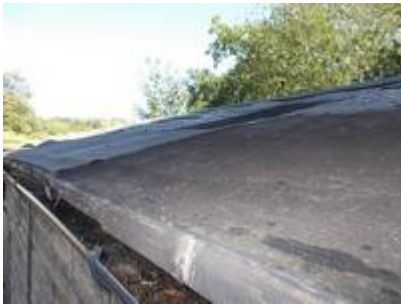
1

Main: Ground floor: External: Roofing felt

Non asbestos bitumastic roofing felts.

No Action Required
