**R & D for Asbestos containing materials at**

**Summerhouse Building  
Temple Dinsley  
School Lane  
Preston, Hitchin  
Hertfordshire, SG4 7RT**

SURVEY DATE; 11th August 2023

REFERENCE; ECB/5345

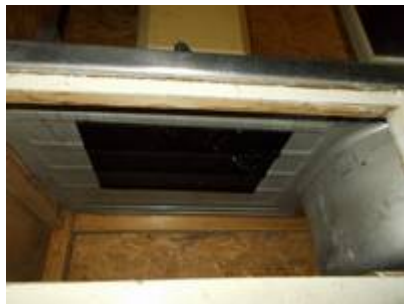
Main: Ground floor: Kitchen: Bitumen pad

Low damage: Scratches or marks

< 1m<sup>2</sup>

Asbestos bitumastic pad under sink.

3

Very Low Risk

4

Remove before refurbishment if affected  
by works
