# **CAMBRIDGE ASBESTOS REMOVAL LTD**

**R & D for Asbestos containing materials at**

**Barn 1 & Barn 2  
Temple Dinsley  
School Lane  
Preston, Hitchin  
Hertfordshire, SG4 7RT**

REFERENCE; ECB/5349

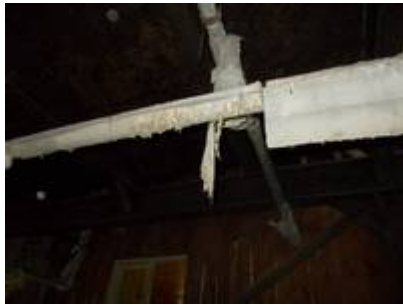
Location Ref: 1

Area/ Floor/ Room/ Product: Barn 2: Ground floor: Room 1 & 2: Pipework insulation

Damage: NADIS

Non asbestos pipework insulation.

No Action Required

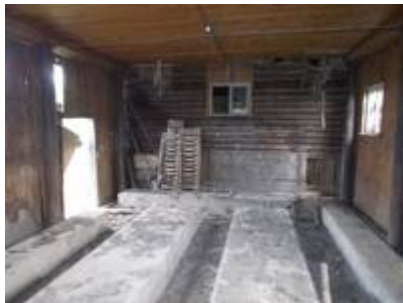
Location Ref: Visual

Area/ Floor/ Room/ Product: Barn 2: Ground floor: Room 2: N/A

No asbestos detected in area but tank above in roof space via a ladder in room 1.

No Action Required
