# **CAMBRIDGE ASBESTOS REMOVAL LTD**

**R & D for Asbestos containing materials at**

**Main House  
Temple Dinsley  
School Lane  
Preston, Hitchin  
Hertfordshire, SG4 7RT**

REFERENCE; ECB/5345

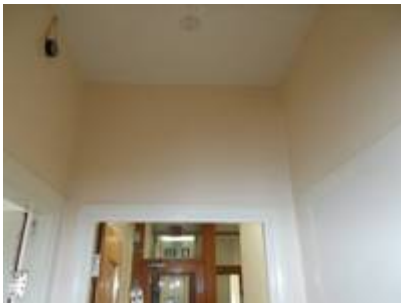
No visible damage

Remove before refurbishment Licenced Contractor

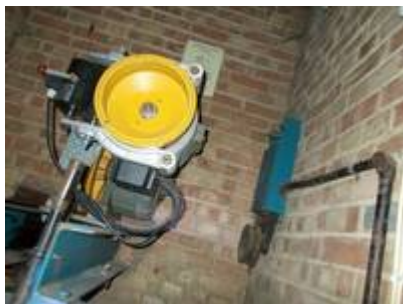
Asbestos cement

No visible damage

Remove before refurbishment

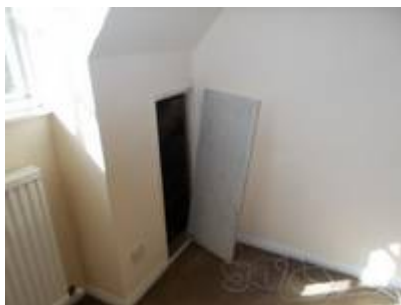
Asbestos Insulating Board

No visible damage

Remove before refurbishment Licenced  
Contractor

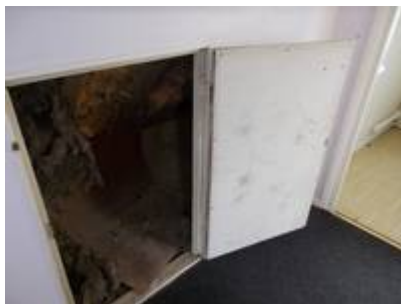
Asbestos Insulating Board

No visible damage

Remove before refurbishment Licenced  
Contractor

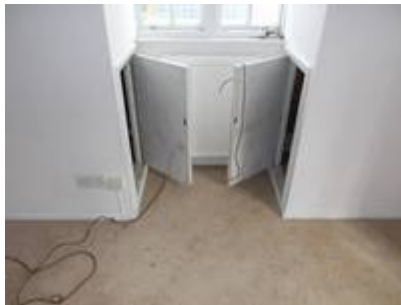
Asbestos Insulating Board

No visible damage

Remove before refurbishment Licenced  
Contractor

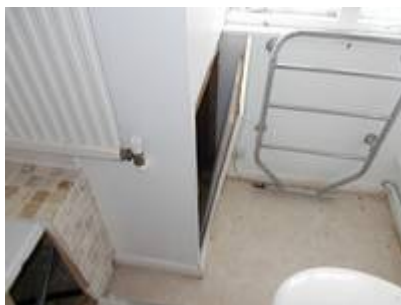
Asbestos Insulating Board

No visible damage

Remove before refurbishment Licenced  
Contractor

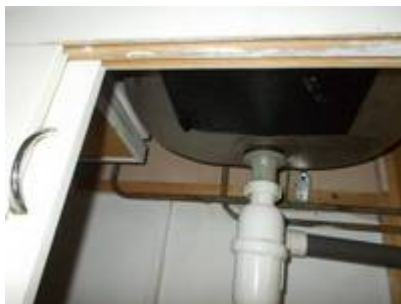
Resins

No visible damage

Remove before refurbishment

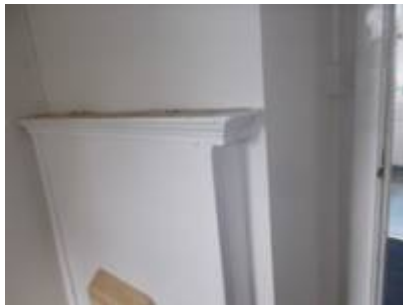
Asbestos cement

No visible damage

Remove before refurbishment

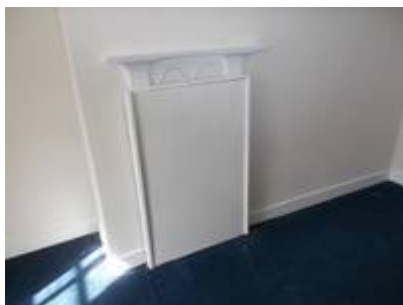
Asbestos cement

No visible damage

Remove before refurbishment

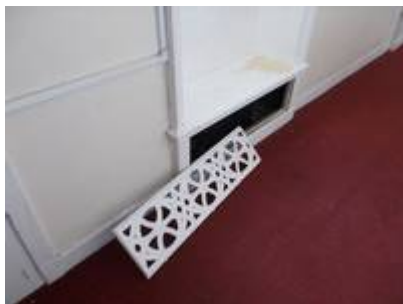
Asbestos Insulating Board

No visible damage

Remove before refurbishment Licenced Contractor

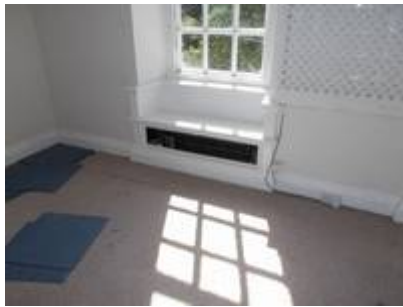
Asbestos Insulating Board

No visible damage

Remove before refurbishment Licenced  
Contractor

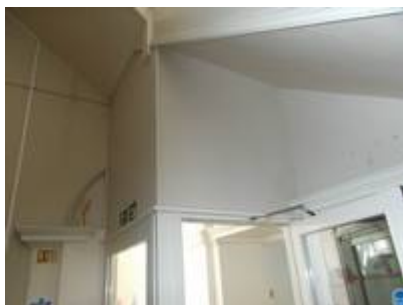
Asbestos Insulating Board

No visible damage

Remove before refurbishment Licenced  
Contractor

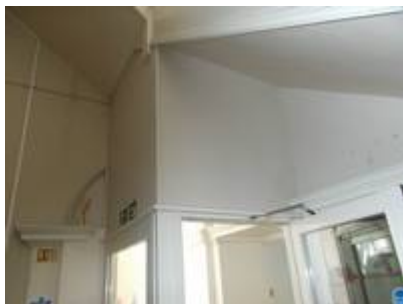
Asbestos Insulating Board

No visible damage

Remove before refurbishment Licenced  
Contractor

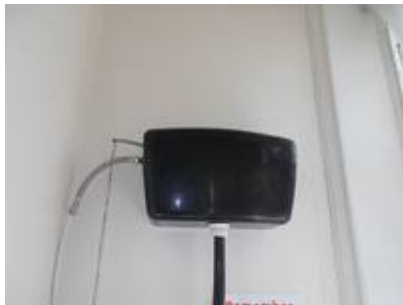
Asbestos Reinforced Composites

No visible damage

Remove before refurbishment

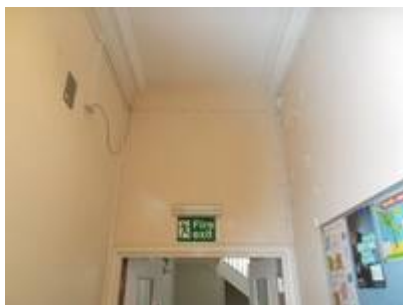
Asbestos Insulating Board

No visible damage

Remove before refurbishment Licenced Contractor

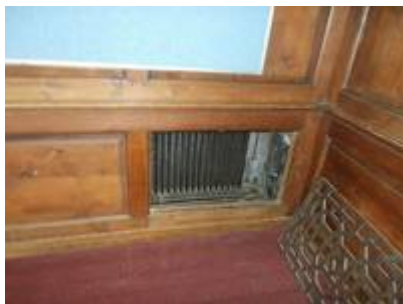
Asbestos Insulating Board

No visible damage

Remove before refurbishment Licenced Contractor

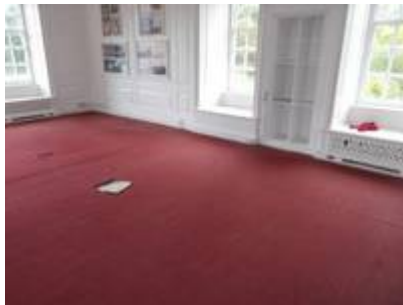
Asbestos Insulating Board

No visible damage

Remove before refurbishment Licenced  
Contractor

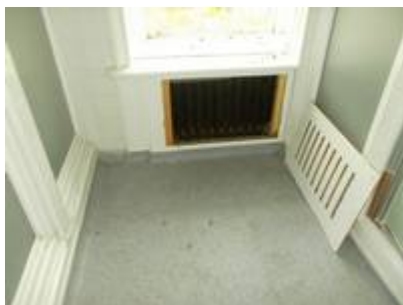
Asbestos Insulating Board

No visible damage

Remove before refurbishment Licenced  
Contractor

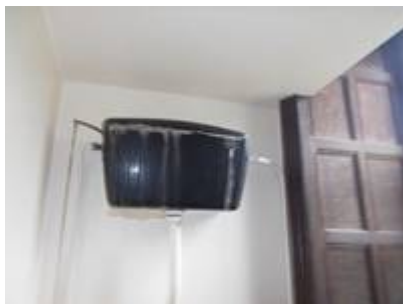
Asbestos Reinforced Composites

No visible damage

Remove before refurbishment

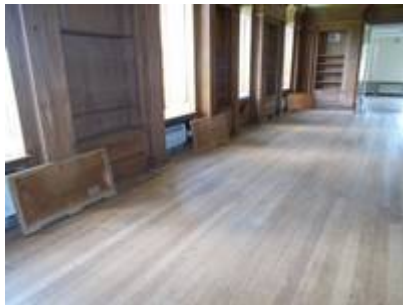
Asbestos Insulating Board

No visible damage

Remove before refurbishment Licenced  
Contractor

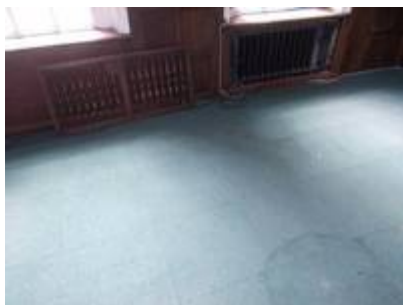
Asbestos Insulating Board

No visible damage

Remove before refurbishment Licenced  
Contractor

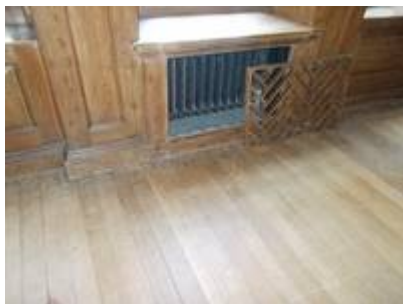
Asbestos Insulating Board

No visible damage

Remove before refurbishment Licenced  
Contractor

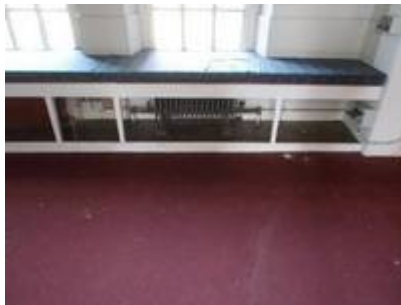
Asbestos Insulating Board

No visible damage

Remove before refurbishment Licenced  
Contractor

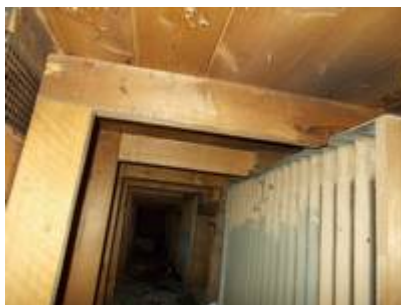
Asbestos cement

No visible damage

Remove before refurbishment

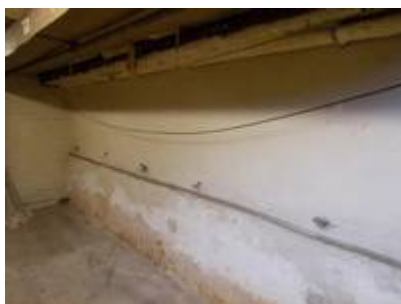
Pipe and boiler lagging

High damage

Environmental clean by Licenced  
Contractor

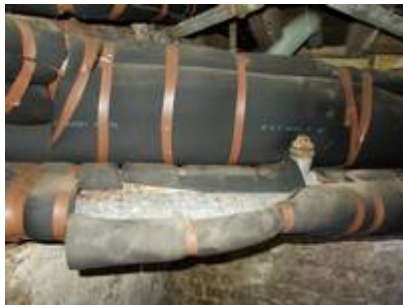
Pipe and boiler lagging

High damage

Environmental clean by Licenced Contractor

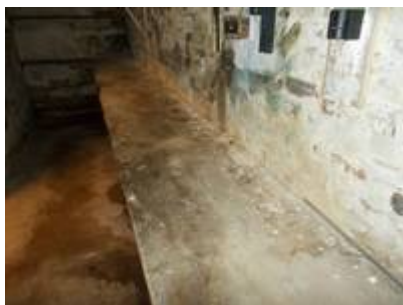
Pipe and boiler lagging

High damage

Environmental clean by Licenced Contractor

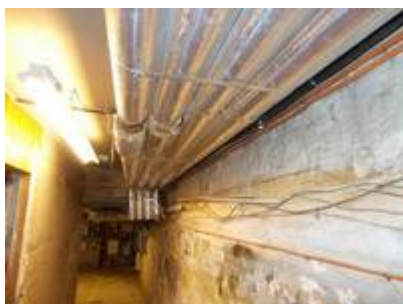
Pipe and boiler lagging

High damage

Environmental clean by Licenced Contractor

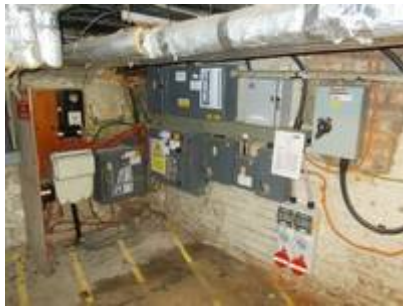
Ropes and woven textiles

No visible damage

Remove before refurbishment

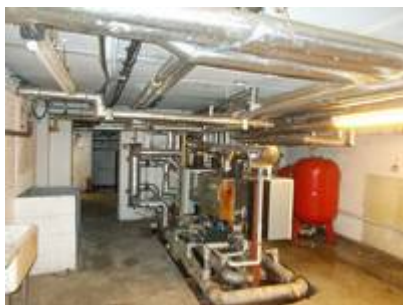
Pipe and boiler lagging

High damage

Environmental clean by Licenced  
Contractor

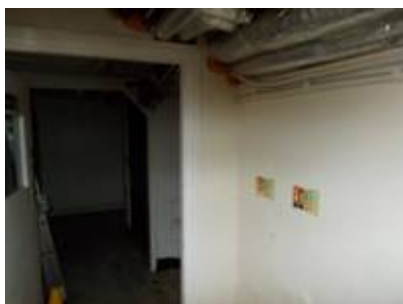
Asbestos Insulating Board

Low damage: Scratches or marks

Remove before refurbishment Licenced  
Contractor

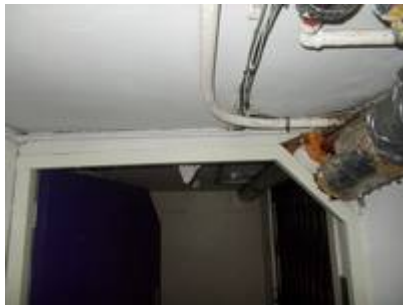
Asbestos cement

Low damage: Scratches or marks

Remove before refurbishment

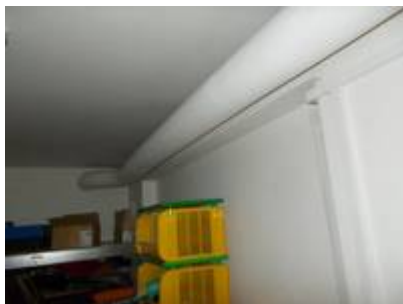
Pipe and boiler lagging

Remove before refurbishment Licenced  
Contractor

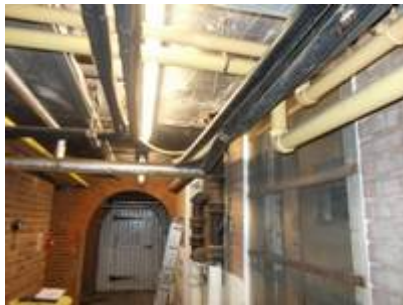
Pipe and boiler lagging

Environmental clean by Licenced  
Contractor

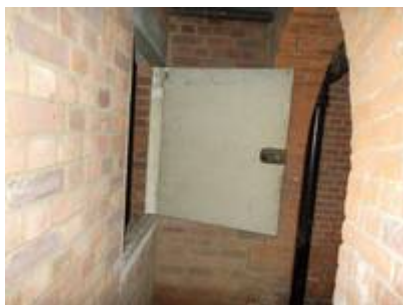
Asbestos cement

Remove before refurbishment

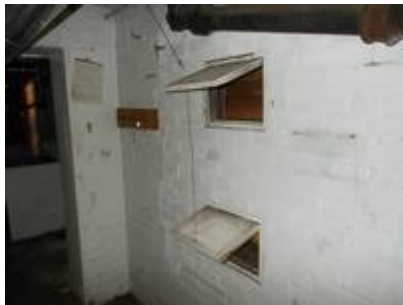
Asbestos cement

Remove before refurbishment

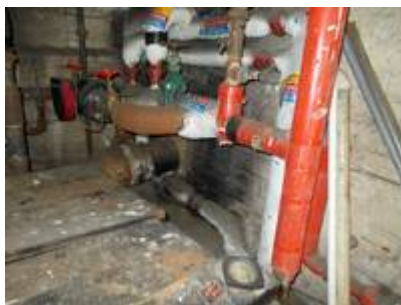
Pipe and boiler lagging

Remove before refurbishment Licenced  
Contractor

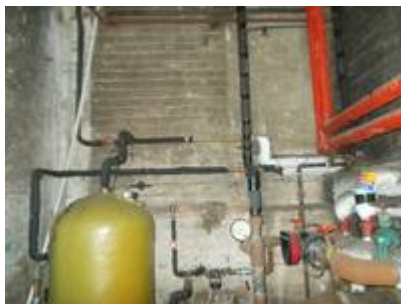
Pipe and boiler lagging

Environmental clean by Licenced  
Contractor

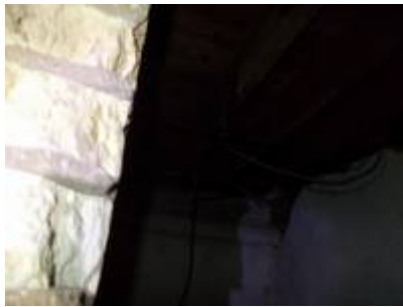
Pipe and boiler lagging

Environmental clean by Licenced  
Contractor

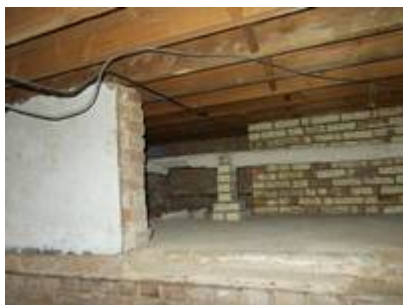
Pipe and boiler lagging

Environmental clean by Licenced  
Contractor
