## Asbestos Inspection Report Management Survey

Princess Helena College  
School Lane  
Preston  
Hitchin  
Hertfordshire  
SG4 7RT

Project No: G-03774  
Report Issue: 1  
Date: Aug 2020

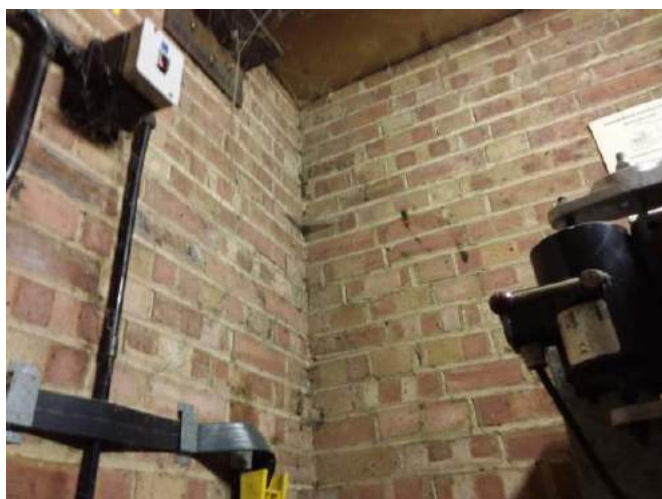
| Floor: | 2nd Floor | Damage: | Low damage 1 |

| Action: | Monitor and manage | | |

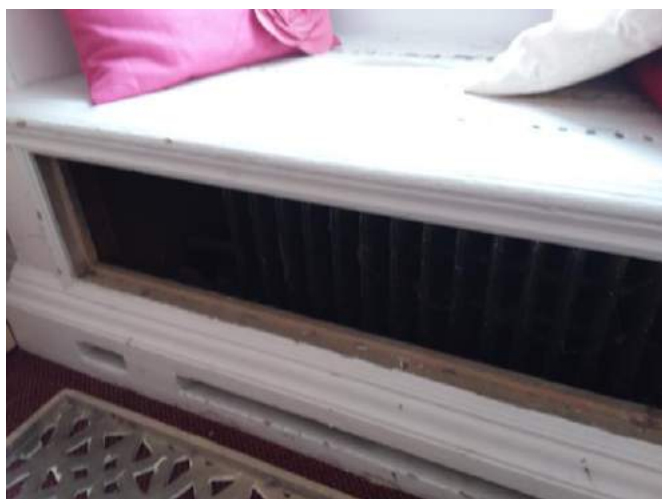
| Floor: | 1st Floor | Damage: | Low damage 1 |

| Action: | Encapsulate, monitor and manage | | |

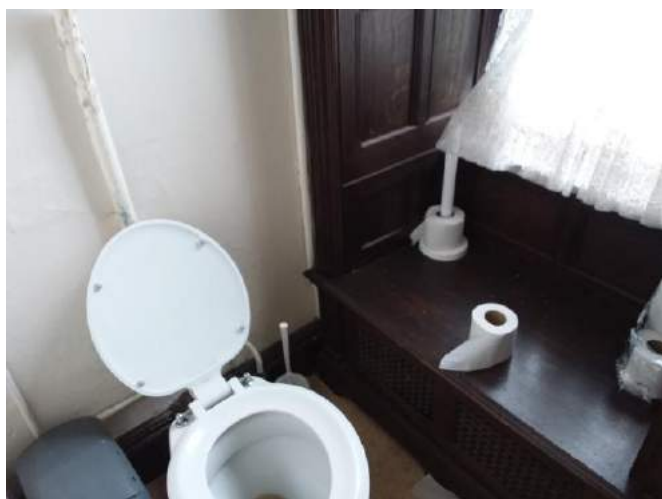
| Floor: | 1st Floor | Damage: | Low damage 1 |

| Action: | Encapsulate, monitor and manage | | |

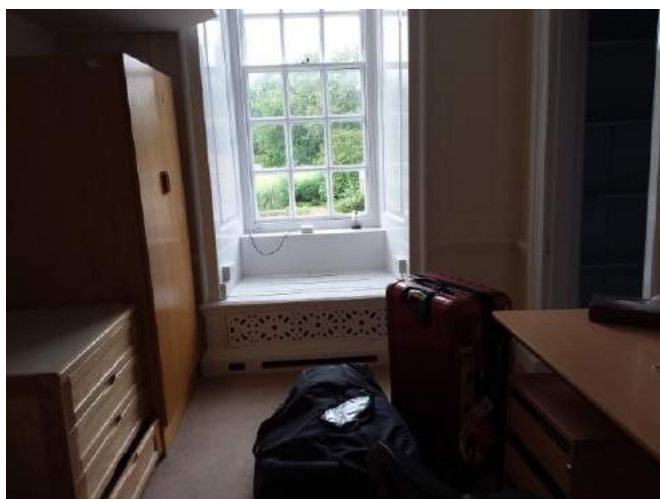
| Floor: | 1st Floor | Damage: | Low damage 1 |

| Action: | Repair, encapsulate, monitor and manage | | |

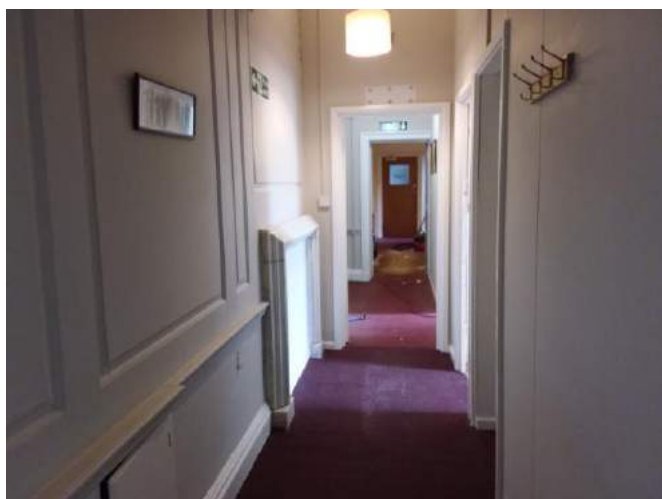
| Floor: | 1st Floor | Damage: | Low damage 1 |

| Action: | Encapsulate, monitor and manage | | |

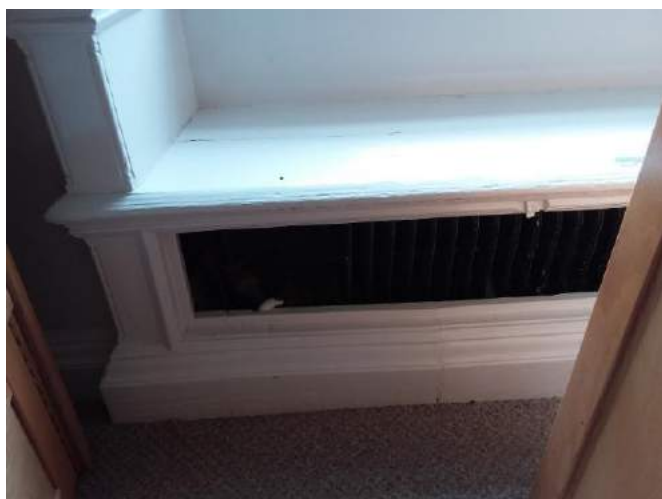
| Floor: | 1st Floor | Damage: | Low damage 1 |

| Action: | Encapsulate, monitor and manage | | |

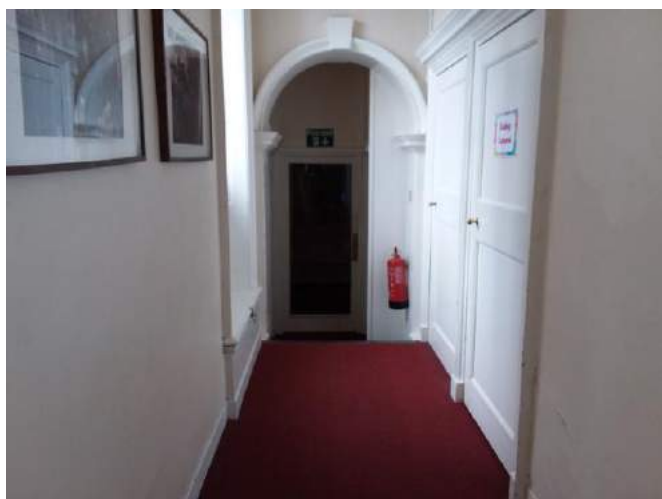
| Floor: | 1st Floor | Damage: | Low damage 1 |

| Action: | Encapsulate, monitor and manage | | |

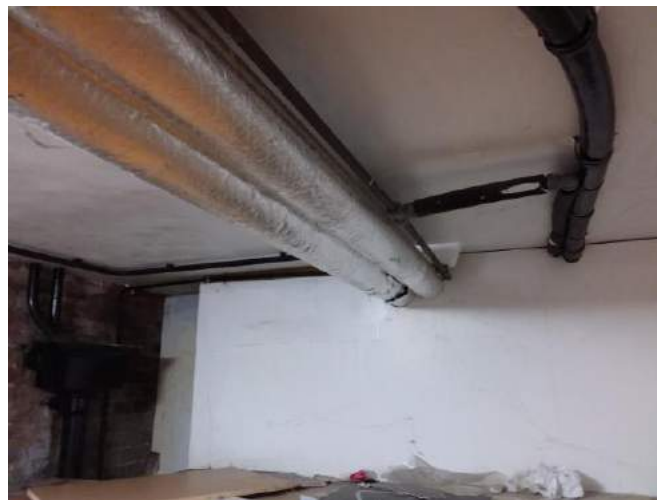
Insulation to pipework - no access beyond MMMF insulation without causing significant damage under management survey

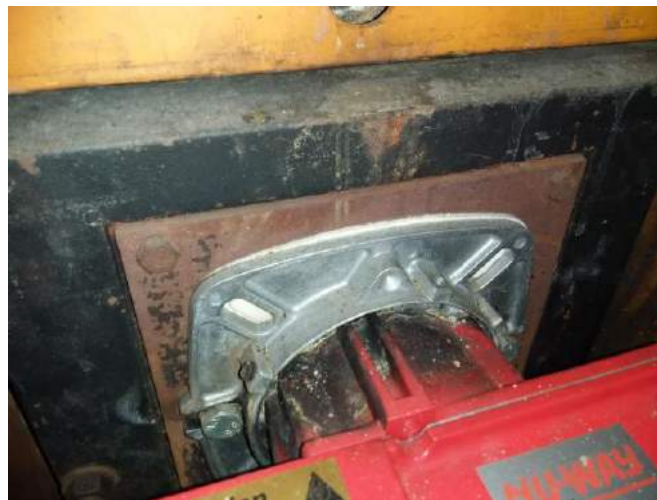
Comments: Gaskets to boiler burner

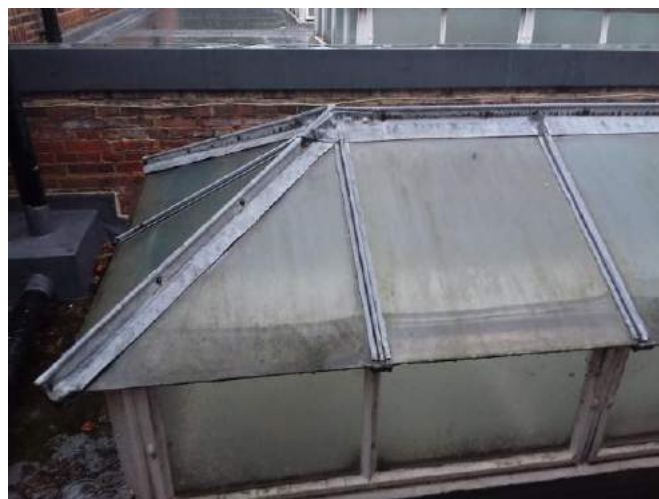
Comments: No access to skylight without causing damage under a Management survey - presumed rope gaskets

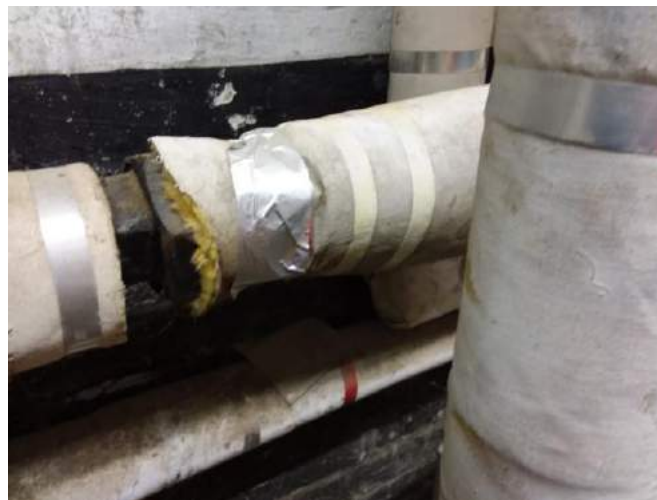
Thermal insulation residue to pipework (small amounts beneath MMMF insulation).  
Limited access beyond MMMF insulation to pipework without causing significant damage under management survey
