Site Address: Princess Helena College, School Lane, Preston, Hitchin, Hertfordshire, SG4 7RT

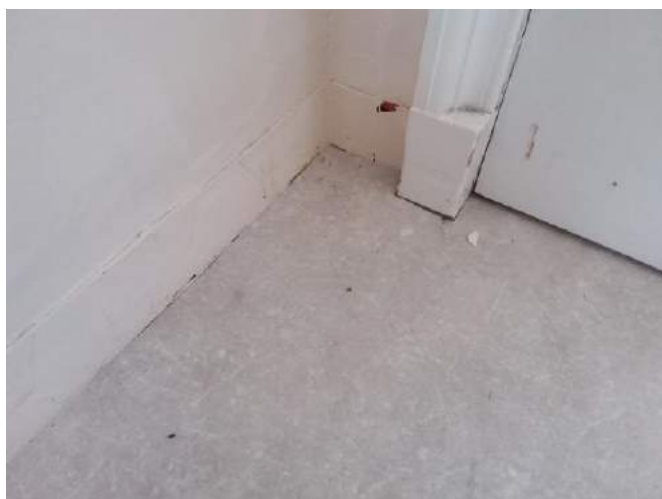
Location Photo

Comments: No access beneath modern vinyl floor covering without causing damage under management survey

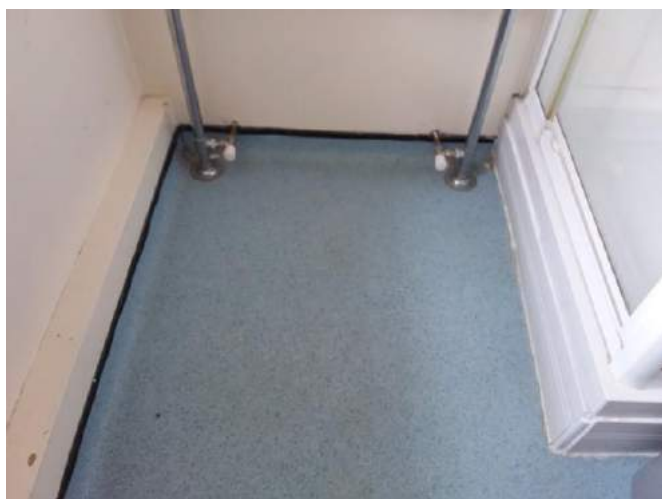
Location Photo

Comments: No access beneath modern vinyl floor covering without causing damage under management survey

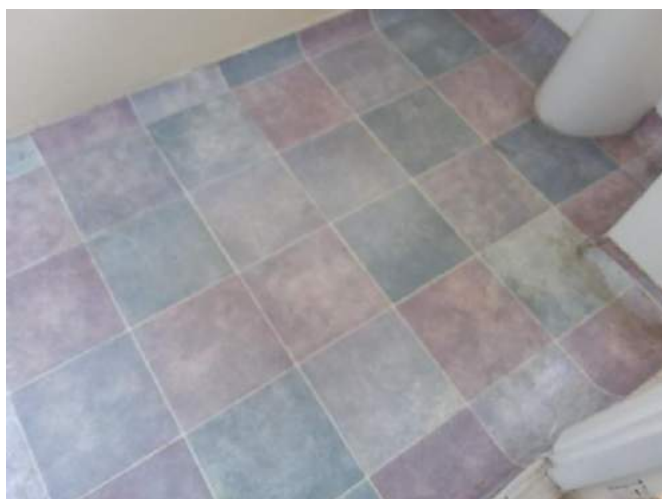
Location Photo

Comments: No access beneath modern vinyl floor covering without causing damage under management survey

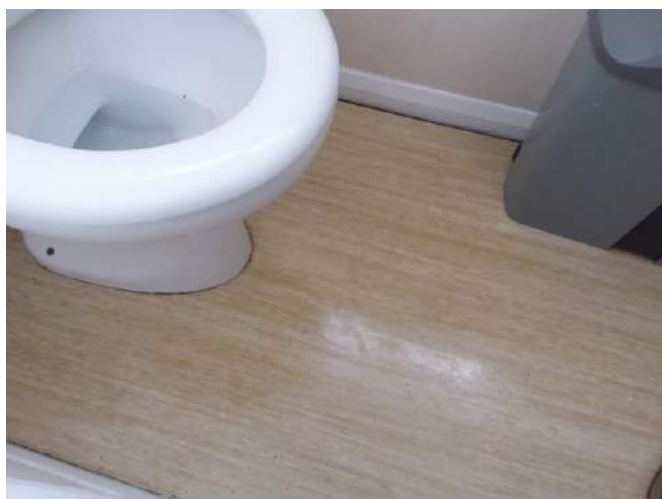
Location Photo

Comments: No access beneath modern vinyl floor covering without causing damage under management survey

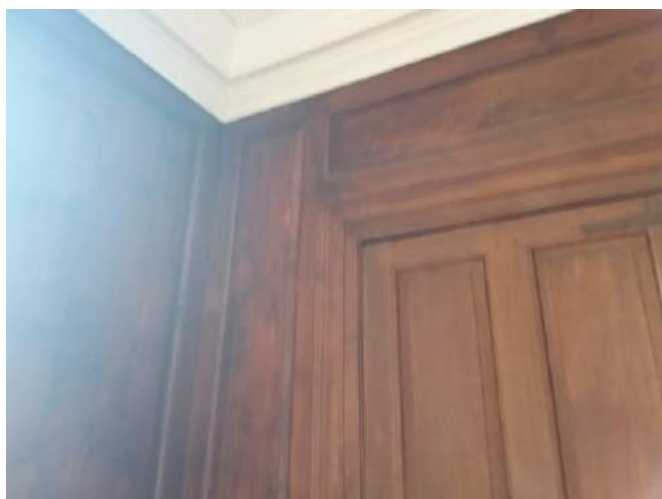
Product Photo

Comments: View of ornate timber panelling to walls (no asbestos detected)

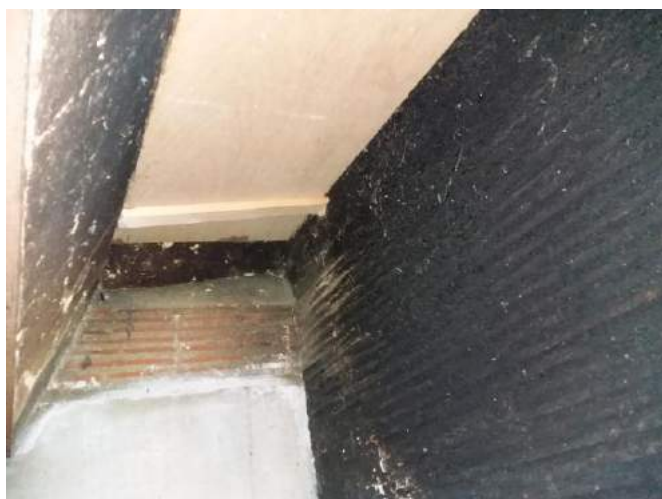
Product Photo

Comments: View of timber panel over fireplace (no asbestos detected)

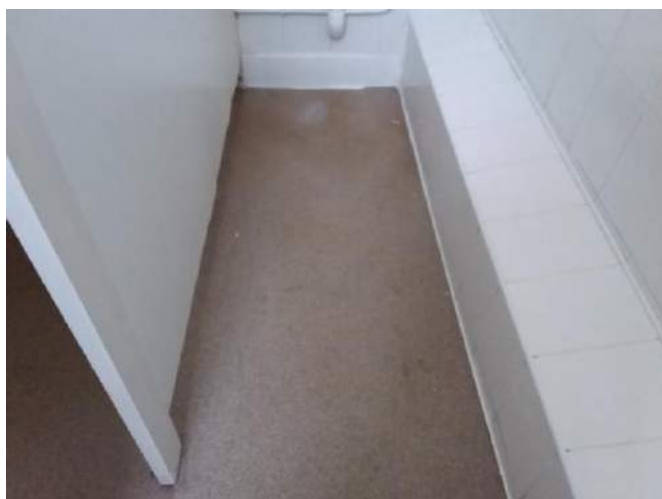
Location Photo

Comments: No access beneath modern vinyl floor covering without causing damage under management survey

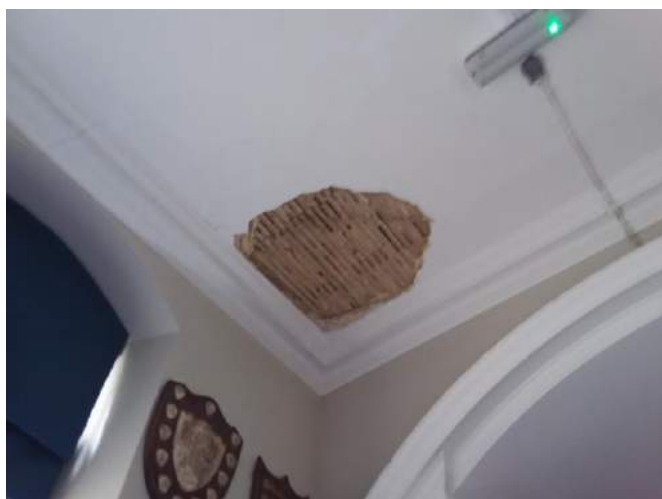
Location Photo

Comments: View of damaged lath and plaster ceiling (no asbestos detected)

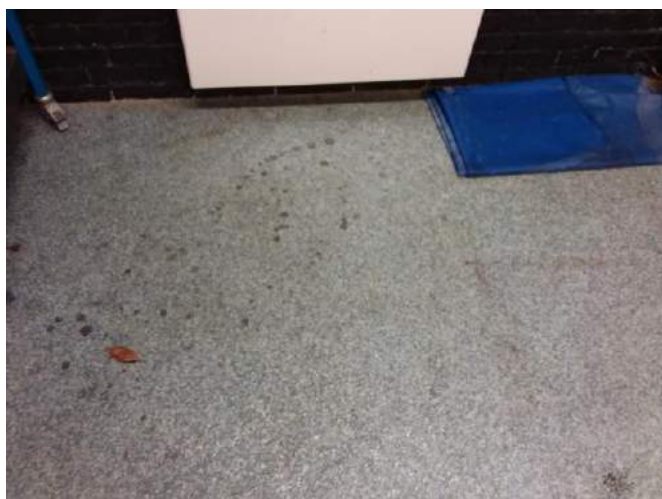
Location Photo

Comments: No access beneath modern vinyl floor covering without causing damage under management survey
