**21/00434/HYA**

ARBORICULTURAL IMPACT ASSESSMENT AND METHOD STATEMENT REPORT

Land North Pound farm, London Road, St Ippolyts, Herts, SG4 7NE

**OUR REF: SHA 1874**

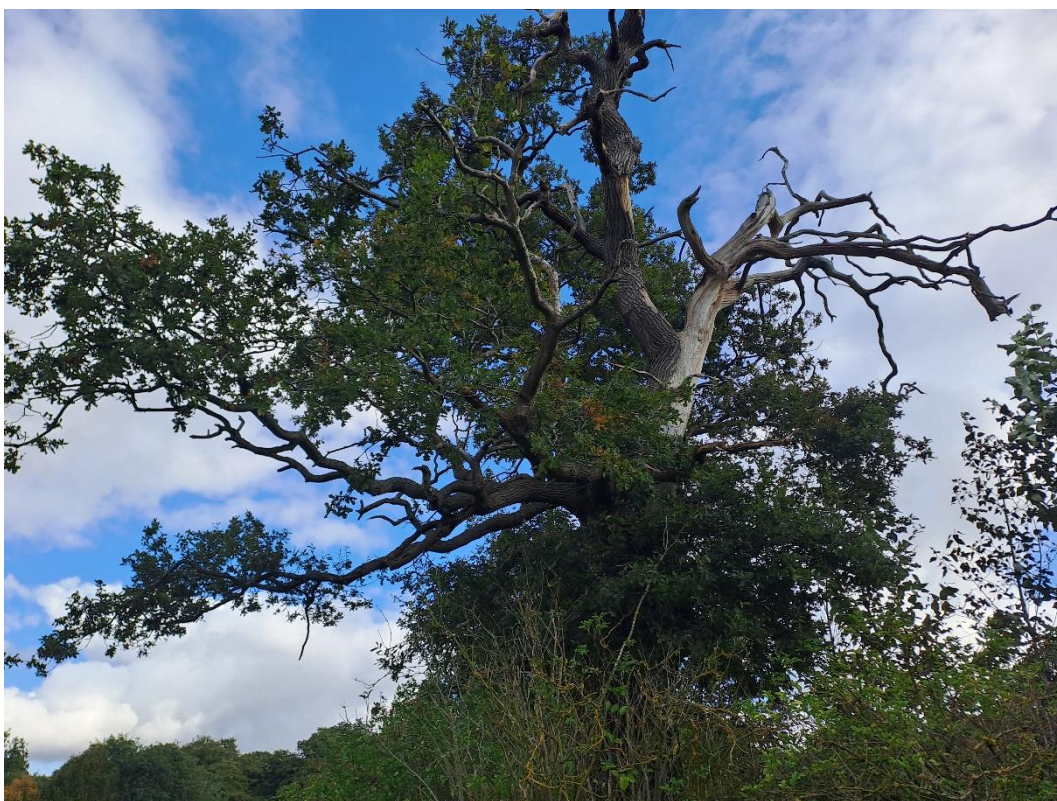
*Photo 5 of T41 viewed from the site side.*

- 8.12. That the landowner is made aware of the condition of the oak T41 and ash T47.

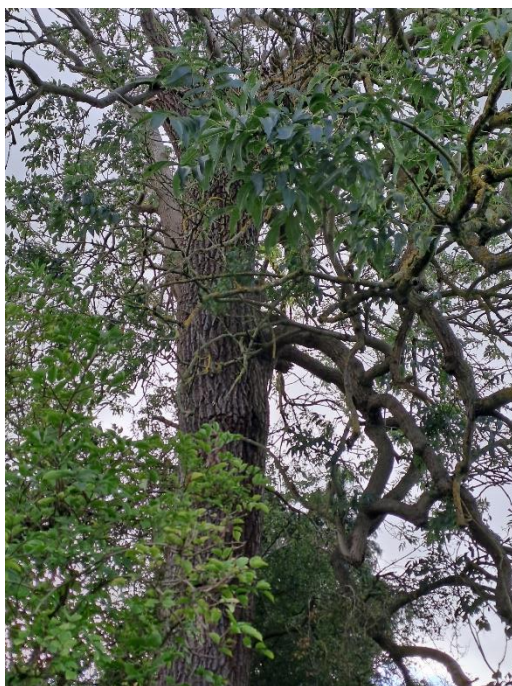
*Photo 6 of T47 ash close up*

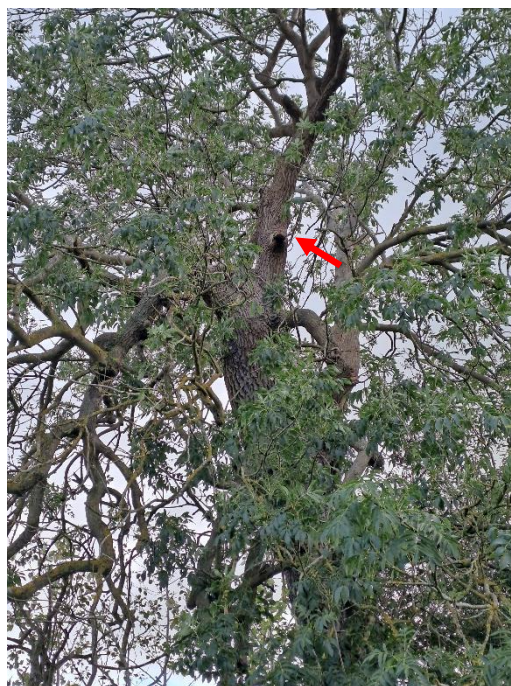
*Photo 7 of T47 ash close up showing fungi*

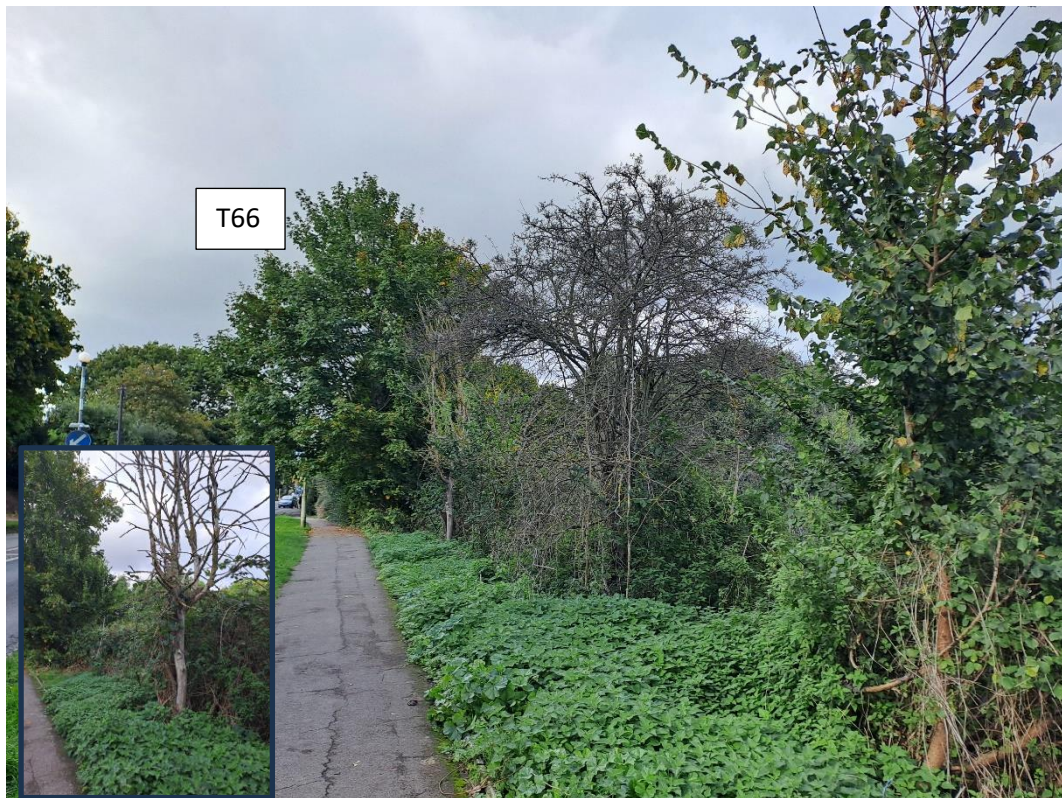
The vegetation on the roadside is very patchy, with the prominent tree being T68 Norway maple. A group of dense early mature hollies (G67) is on the south-western corner. There are a few dead and dying elms (S64) which pose a risk to the road.

*Photo 10 of the roadside looking north. Dead elm in S64 in inset*

- 6.3. *Tree removals* – in accordance with approved consent, T59 oak (Anna French reference T16) and T4 Norway maple (Anna French reference T59) will be removed. This report recommends the removal of dead and dying elms S64 next to London Road for safety reasons. Trees to be removed are shown by red circles on the plan SHA 1874 TPP at appendix 3 and detailed in the tree surgery schedule at appendix 4. Areas of scrub will also be removed.

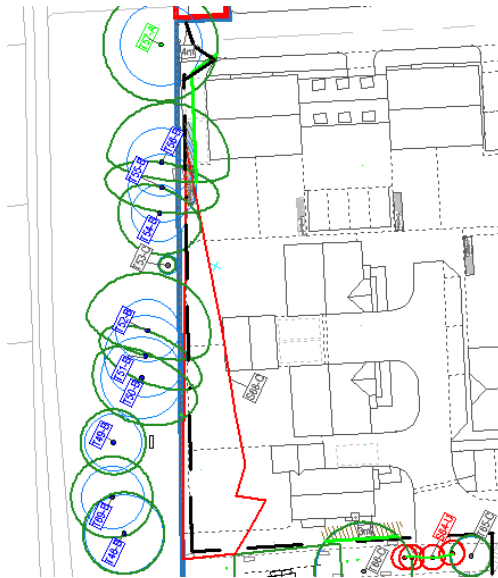
Overhanging branches of offsite trees next to the northern boundary T55, T56 and part of T57 and the eastern part of the crown of the roadside tree T66 will be pruned back in accordance with the tree surgery schedule at appendix 4. This is shown pictorially on the tree protection plan SHA 1874 TPP (extract below).

Plan 3 – extract from SHA 1874 TPP. Green thick line shows pruning outline  
 Red shapes/circles – to be removed  
 Black dashed lines – tree protection fencing  
 Pruning is required to provide safe clearance for scaffolding and to ensure a reasonable relationship between the tree and buildings. The trees will need to be pruned back every few years to the newly pruned points and is permissible under common law.

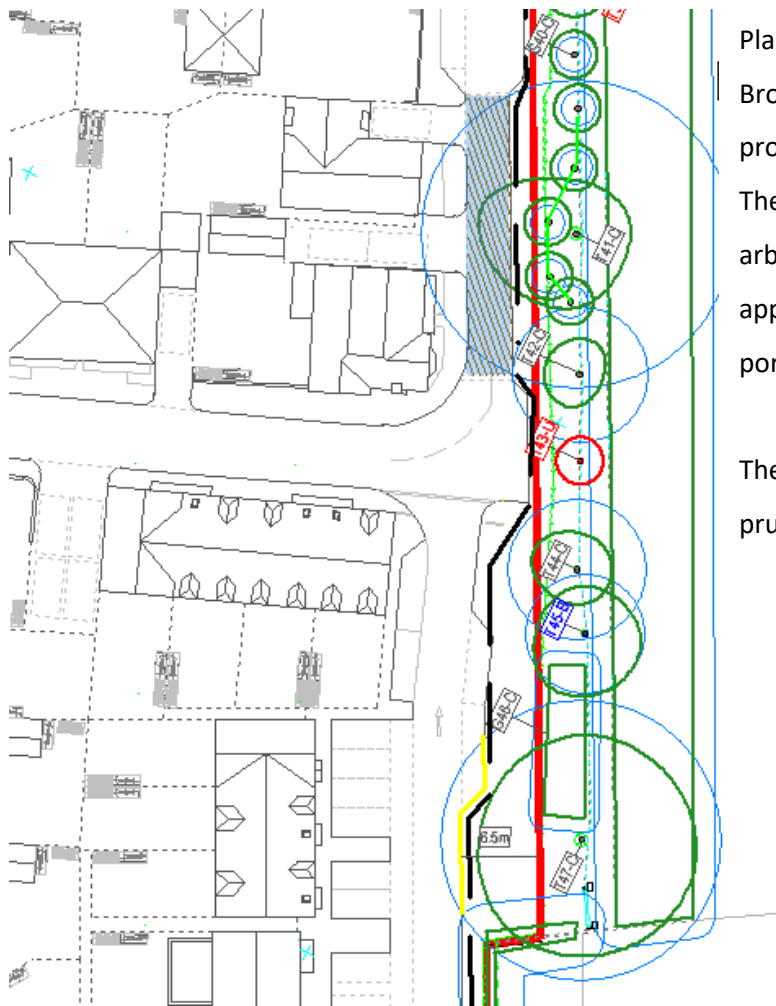
Where the fencing is set back to provide clearance for scaffolding, the ground will be protected during works. New hard surfacing is required near the oak T41 within the root protection area. To ensure the retention and function of the roots, the road will be a minimal dig and porous construction and will be installed under arboricultural supervision. At the same visit, any roots on the edge of the RPA of the ash T47 will be pruned neatly and the road can be constructed in the normal way. The edge of the pruned roots will be protected with hessian (to prevent desiccation) and plastic (to prevent the alkalinity of concrete kerb haunching scorching roots). The drainage route has been re-routed to avoid the root protection areas of T41 and T47.

Plan 4 – extract from SHA 1874 TPP.
