## **Arboricultural Impact Assessment**

Redwings Lodge, Baldock, North Herefordshire

Report Reference: BG25.250

**REV1 – February 2026**

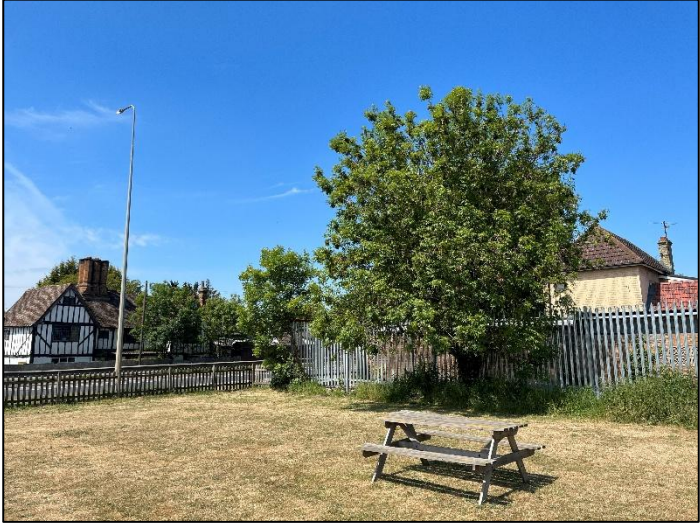
| Image | Description |
|---|---|
| | <p>T1 and T2 to the north-east of the site.</p> |

- 4.9.1 A 0.5m southwestern reduction is recommended to T2 to facilitate CEZ fencing installation.
- 4.9.2 A 2m crown reduction is required to the eastern aspect of G2, and a crown reduction of 1.5m is recommended for the southeast aspect of G5.
- 4.9.3 Any appointed contractor must carry out tree works according to BS 3998:2010 'Recommendations for Tree Work'.

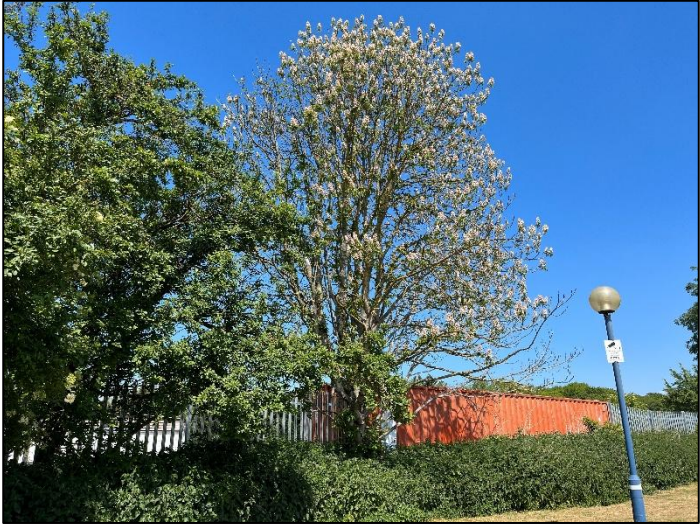
| Tree ID | Common Name | Maturity | Height (m) | No. of Stems | Calculated Stem Diameter (mm) | Radius of Nominal Circle (m) | RPA <sup>(m2)</sup> | Crown Spread (m) | | | | Crown Height (m) | | | | Crown | Stem | Basal Area | BS 5837 Category | Life Expectancy | Phys Condition | Comment |
|---|---|---|---|---|---|---|---|---|---|---|---|---|---|---|---|---|---|---|---|---|---|---|
| T3# | Common Horse Chestnut | Young | 12 | 3 | 532 | 6.4 | 128.0 | 3.5 | 5 | 4 | 4 | 2.5 | 3.5 | 3 | 5 | Poor | Poor | Poor | C1 | 10 to 20 yrs | Decline | Not directly accessible due to dense nettle - estimated. Lower branches not included in height measurements - dead. Tree shows signs of physiological decline - branch and twig death, bark delamination, cracking and stress epicormic to lower structure. No bleeding spots (no evidence of bleeding canker). |

| Group ID | Species | BS 5837 Category | Description |
|---|---|---|---|
| G2 | Common Elder, Common Plum | C1 | Low-quality, small, scrubby group comprising of elder and plum, with young and semi-mature trees. Average stem 175mm. In grass verge next to car park. One tree experienced significant structural failure of one stem. Height to 8m. Unremarkable. |

| Image | Description |
|---|---|
| | <p>Eastern section of G2 (left) and T3 (right).</p> |

- 4.5.1 The following trees and groups are recommended for removal to facilitate the development: T3, G3, G4, G8, and H2.
- 4.5.2 Tree, group and hedgerow removal is required to facilitate construction of the new building extension and associated hardstanding paths and expanded car park. Tree removal predominantly impacts Category C, low-quality trees and groups. Individual details on trees proposed for removal can be found in the survey schedule in Appendix 1.
- 4.5.3 T7, a dead elder, is recommended for removal irrespective of development.

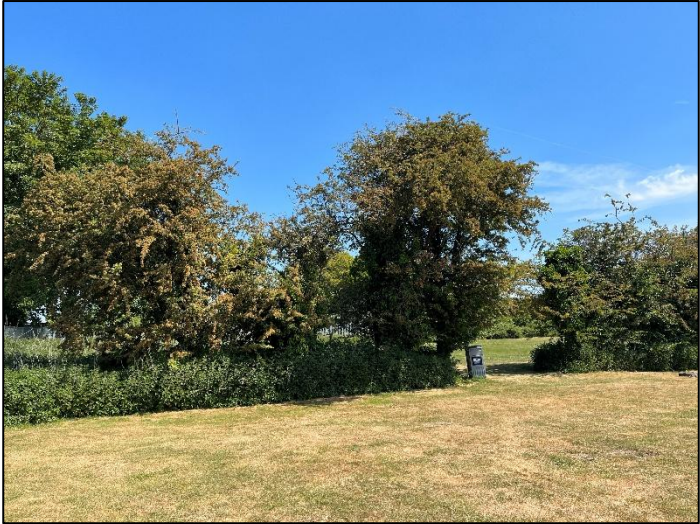
| Image | Description |
|---|---|
| | <p>G3, running north-south across the site.</p> |

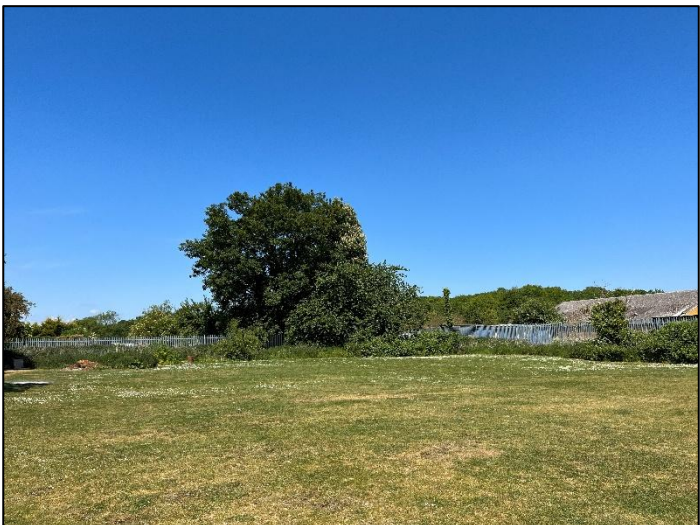
| Image | Description |
|---|---|
| | <p>T4-T6, offsite trees, with G4 to the forefront.</p> |

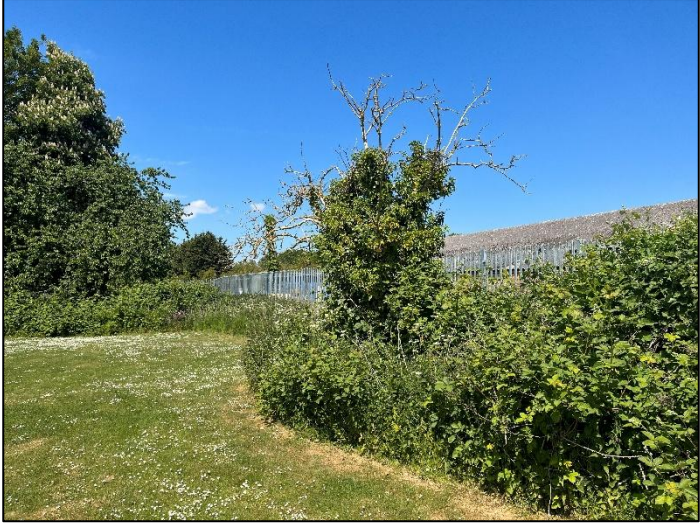
| Image | Description |
|---|---|
| | <p>T7, dead tree colonised by ivy.</p> |

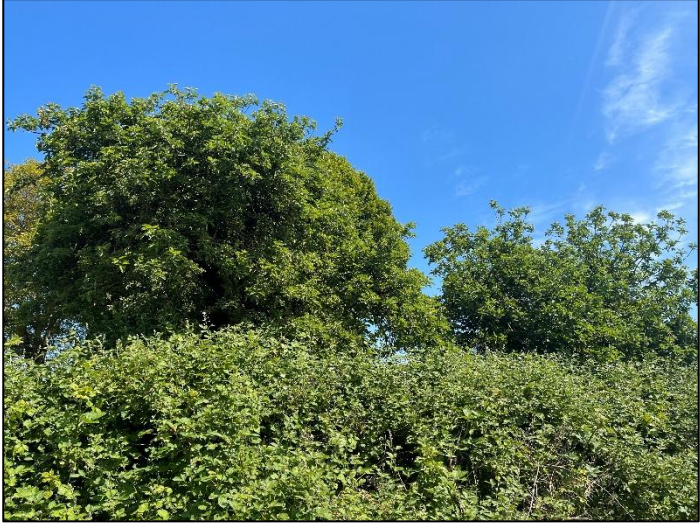
| Image | Description |
|---|---|
| | <p>G5, by the eastern boundary.</p> |

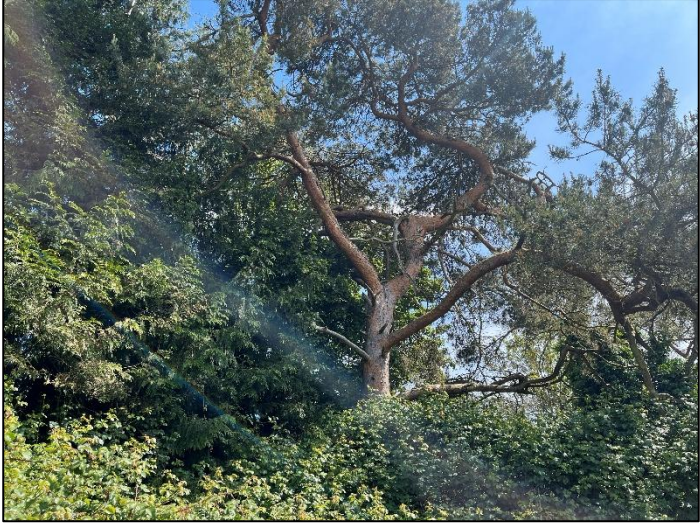
| Image | Description |
|---|---|
| | <p>T8, with G6 to the left.</p> |

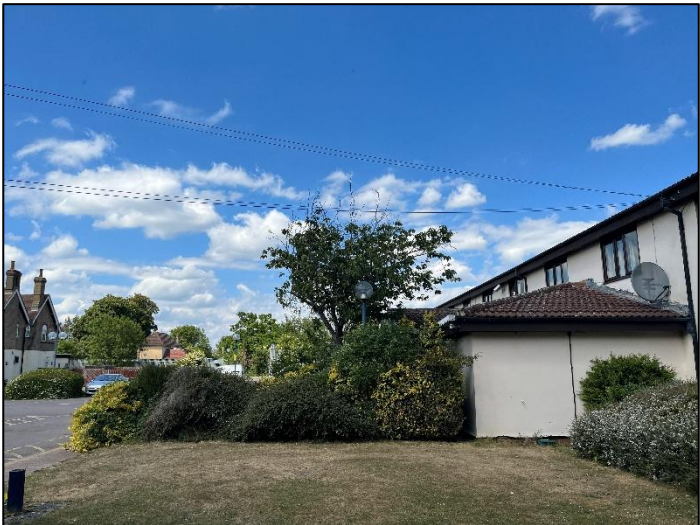
- 4.3.3 No CEZ fencing is recommended for T9 to allow continued use of the hotel entrance, or for T10-T14 and G7, due to the absence of proposed works in this area,

| Image | Description |
|---|---|
| | <p>T9 by the entrance to the hotel.</p> |

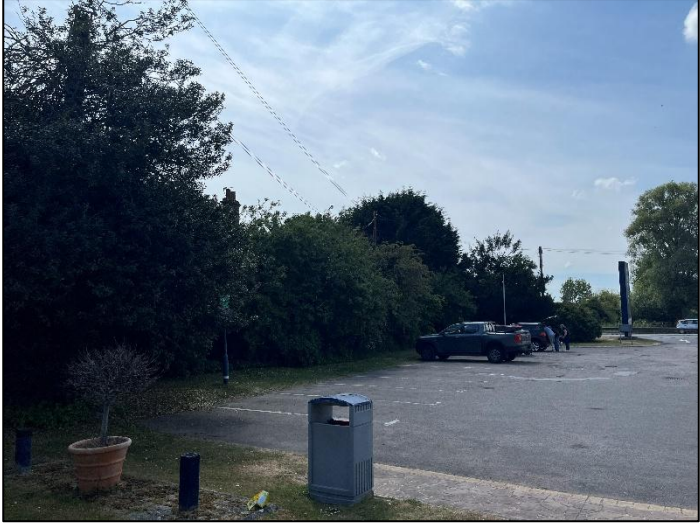
| Image | Description |
|---|---|
| | <p>T11, left, and G7 to the rear.</p> |

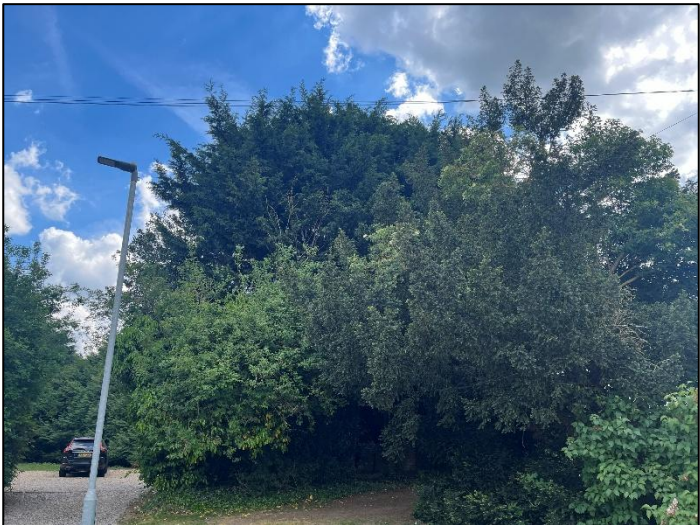
| Image | Description |
|---|---|
| | <p>T15, T16 and G8 to the rear.</p> |
