## Second Floor – Proposed Apartment 19 – Plan of Significance

**641-KS-06-MB-SH-A-90019 – P02**
**Temple Dinsley Level 2, GA – Apartment 19 - Helena**

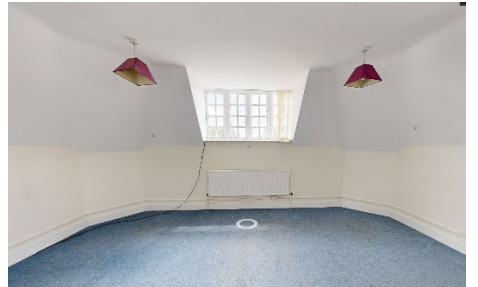
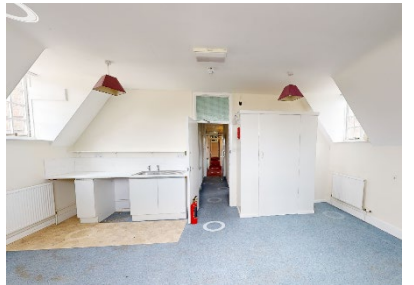
| Reference | Proposal | Significance of affected fabric | Impact | Reasoning and mitigation |
|---|---|---|---|---|
| A-Walls<br>19A. D1 | Removal of MC20 plaster finish including timber skirtings to all external masonry walls to all areas. | Low | Neutral Benefit | <p>South Room - looking south</p> <p>South Room – looking north</p> |

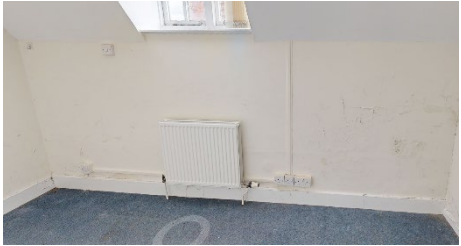
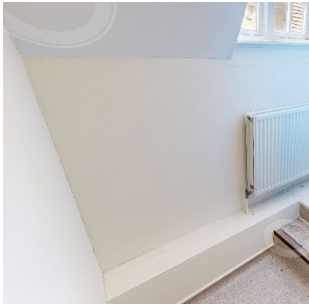
| Reference | Proposal | Significance of affected fabric | Impact | Reasoning and mitigation |
|---|---|---|---|---|
| | | | | <p>Evidence of damp ingress to east wall</p> <p>West wall to bathroom</p> <p>The low wall constructed in 1935 to raise the level of the Lutyens hipped roof is masonry construction. There is of damp penetration in some areas to the east side (existing bedroom) and the west side (existing bathroom) Investigation of external flashings and roof coverings to the east side will be necessary to prevent further ingress of damp. All areas of plaster and timber skirtings will be removed to allow the masonry to fully dry out where there is damp penetration. Removal of damp plaster and repair of external copper and leadwork will prevent further deterioration of the masonry wall and is considered a benefit.</p> |

| Reference | Proposal | Significance of affected fabric | Impact | Reasoning and mitigation |
|---|---|---|---|---|
| A-Walls 19A.R1 | Repairs to upstand wall, hung tiles, copper gutter and lead flashings | Low 1935 alterations | Low Impact Benefit | The construction of the upstand wall and associated copper gutter, lead flashings and hung tiles are to be investigated where evidence of damp ingress is apparent. Proposals for repairs will be submitted for approval. |

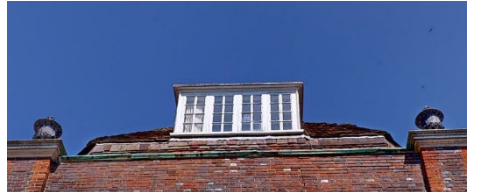
| Reference | Proposal | Significance of affected fabric | Impact | Reasoning and mitigation |
|---|---|---|---|---|
| A-Walls 19A.P3 | Alteration to C20 upstand wall to allow installation of new window. | Low 1935 alterations | Low Impact Enhance | MC20 masonry upstand wall and associated hung tile cladding and flashings to be adjusted to suit increased depth of proposed replacement window. Existing sill level to be reduced by approx 540mm. Refer to E-Windows 19E.D3<br><br><br>South dormer window – existing sill level to be reduced |

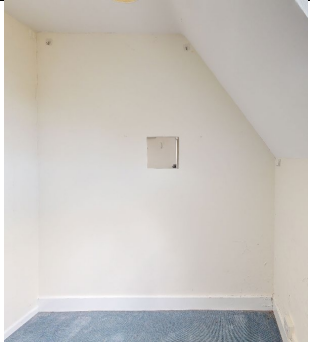
| Reference | Proposal | Significance of affected fabric | Impact | Reasoning and mitigation |
|---|---|---|---|---|
| A-Walls 19A.P4 | Upgrading of existing partition between stairwell/corridor and Helena Apartment 19 | Low C20 partition | Low Impact | <br>Partition to stairwell<br><br>Construction of existing wall is to be investigated and upgraded to form a fire rated compartment and sound separation to the stairwell to comply with Building Regulations requirements.<br><br>Other side |

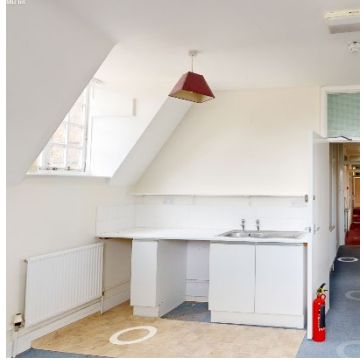
| Reference | Proposal | Significance of affected fabric | Impact | Reasoning and mitigation |
|---|---|---|---|---|
| A-Walls 19A.P5 | Retention of section of existing partition between proposed bedroom and living area. Acoustic upgrading to existing construction to be confirmed. | Low C20 partition | Low impact | <p>Retain partition</p> |

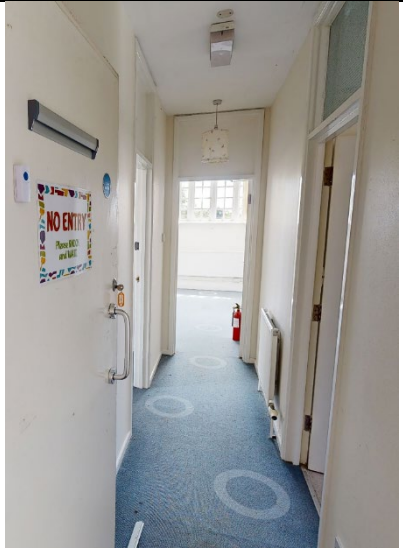
| Reference | Proposal | Significance of affected fabric | Impact | Reasoning and mitigation |
|---|---|---|---|---|
| A-Walls 19A.D3 | Removal of C20 internal timber stud partitions forming living accommodation. | Low C20 fabric. | Low Impact | <p>Removal all existing partitions forming corridor</p> |

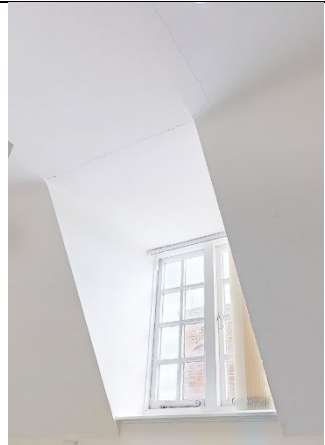
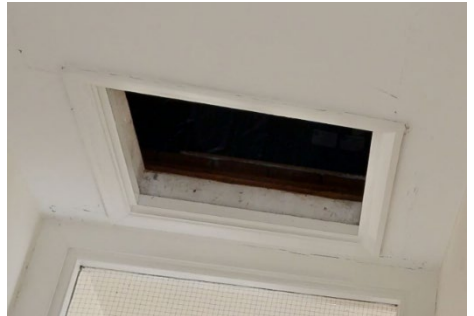
| Reference | Proposal | Significance of affected fabric | Impact | Reasoning and mitigation |
|---|---|---|---|---|
| C-Ceilings<br>19C. D1 | Removal of existing plasterboard to ceilings throughout 2 <sup>nd</sup> floor accommodation including. | Roof structure<br>High<br>Early C20<br>1909 Lutyens with<br><br>Plasterboard linings<br>Neutral/Negative<br>MC20 (1935<br>conversion works) | Low-<br>Moderate<br>Impact | <p>Bedroom window (east side)<br/>Cracks in the plasterboard joints are visible.</p> <p>Roof access hatch located in corridor to be removed along with plasterboard ceiling linings.</p> <p>Linings will be removed to allow the roof structure to be assessed/recorded/condition investigated and the roof void insulated. This is considered a positive impact which will benefit the building fabric and the internal environment.</p> <p>Coved/rolled plaster junction between ceiling and sloping section of walls to be reinstated.</p> |

| Reference | Proposal | Significance of affected fabric | Impact | Reasoning and mitigation |
|---|---|---|---|---|
| C-Ceilings<br>19C. P1 | Carry out all necessary repairs/strengthening works to structural members. Fix new timber between/below existing rafters & ceiling joists as necessary for head fixing for new partitions. | Roof structure<br>High<br><br>Early C20<br>1909 Lutyens | Low<br>Impact<br><br>Benefit | Installation of new timber noggins and battens is reversible. |
| C-Ceilings<br>19C. P2 | Installation of compartment separation between apartments and common areas and thermal insulation between/below existing rafters & ceiling joists | Roof structure<br>High<br>Early C20<br>1909 Lutyens | Low-<br>Moderate<br>Impact | Compartment separation is a Building Regulations requirement. Thermal insulation of the ceilings is considered to be a positive impact which will benefit the building fabric and the internal environment. |

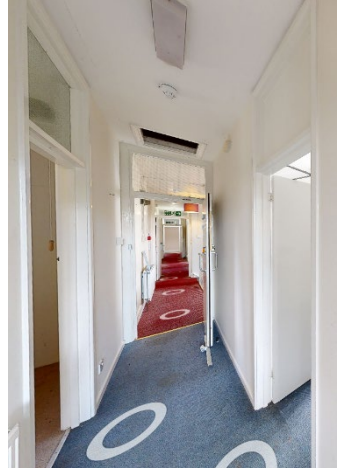
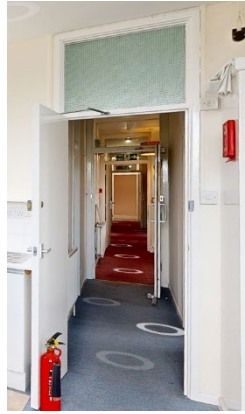
| Reference | Proposal | Significance of affected fabric | Impact | Reasoning and mitigation |
|---|---|---|---|---|
| D-Doors 19D.D1 | Painted flush panel C20 doors/fire rated doors and ironmongery to all accommodation to be removed. | Neutral<br>Late C20 alterations | Low<br>Impact | <p>Entrance door, bathroom &amp; bedroom doors along corridor</p> <p>Door to living area</p> <p>All modern C20 doors/fire doors/frames and glass panels over to rooms and corridor/stairwell to be removed along with partitions.</p> |

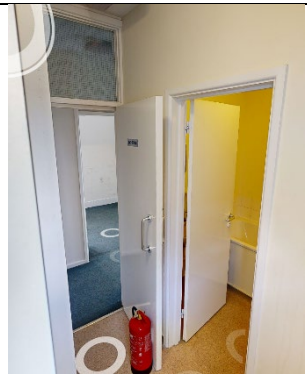
| Reference | Proposal | Significance of affected fabric | Impact | Reasoning and mitigation |
|---|---|---|---|---|
| D-Doors 19D.D2 | Painted flush panel C20 wc cubicle doors and ironmongery to be removed. | Neutral<br>Late C20 alterations | Low<br>Impact | <p>C20 wc cubicle doors/frame/partitions</p> |

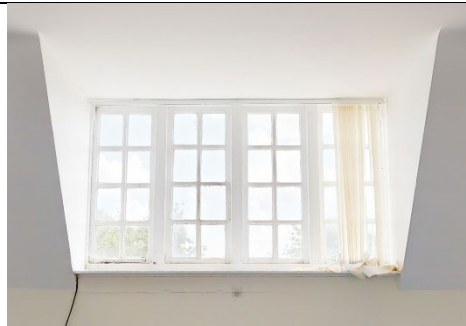
| Reference | Proposal | Significance of affected fabric | Impact | Reasoning and mitigation |
|---|---|---|---|---|
| E-Windows<br>19E.D1 | Removal of C20 timber dormer window | Low C20 (1935) alterations | Low Impact<br><br>Benefit & Enhance | <p>South dormer window – existing sill level to be reduced</p> <p>Window is to be removed and replaced with a new window with a reduced sill height to be confirmed.<br/>Refer to note A-Walls 19A.P3</p> |

| Reference | Proposal | Significance of affected fabric | Impact | Reasoning and mitigation |
|---|---|---|---|---|
| E-windows<br>19E.P1 | Install new replacement window in adjusted opening. | Low C20 (1935) alterations | Low Impact<br><br>Benefit & Enhance | New window to match existing in adjusted opening with increased sill depth. The reduced sill level will enhance aspect/views out of the room. Slim-line double glazing will improve the comfort of the internal environment and the viability of the historic building for future use. |

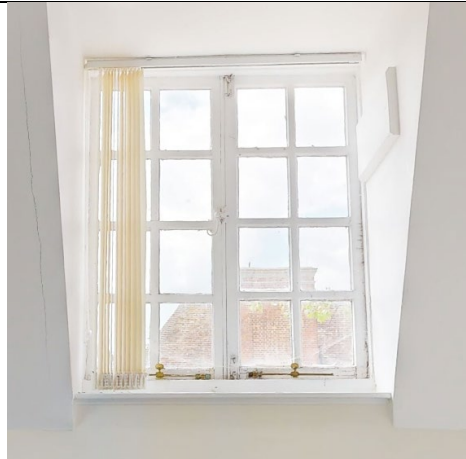
| Reference | Proposal | Significance of affected fabric | Impact | Reasoning and mitigation |
|---|---|---|---|---|
| E-Windows<br>19E.R1 | Renovation of C20 timber casement dormer windows to bathroom, bedroom & living area (4no) | Low C20 alterations | Low Impact<br><br>Benefit & Enhance | <p>Existing dormer window (Living area west side)</p> |

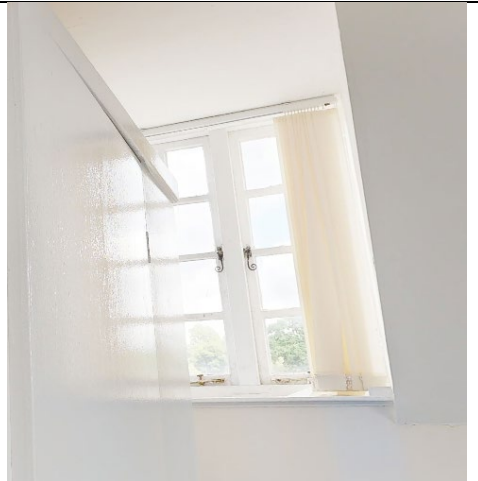
| Reference | Proposal | Significance of affected fabric | Impact | Reasoning and mitigation |
|---|---|---|---|---|
| | | | | <p>Existing dormer window (Living area east side)</p> <p>The existing timber multi-pane windows (4no) will be repaired/renovated/redecorated and upgraded with slim-line double glazing which improve the comfort of the internal environment and the viability of the historic building for future use. Splice repairs to be carried out where required. Resin for more localised repair. Perished putty replacement. Easing of window as required. Original 'monkey tail' casement latches to be retained for reuse. New ironmongery/locking is to comply with building regulations where required. The repairs will improve the appearance and longevity of the window.</p> |

| Reference | Proposal | Significance of affected fabric | Impact | Reasoning and mitigation |
|---|---|---|---|---|
| E-Windows 19E.R2 | Renovation of dormer windows (leadwork to roof and cheeks) | Low C20 (1935) alterations by school | Low Impact<br><br>Benefit & Enhance | C20 dormer windows with lead flat roofs and lead clad cheeks. All leadwork and will be inspected and repairs/replacement carried out as necessary. Construction void to dormer roof and cheeks to be upgraded with high performance insulation. |

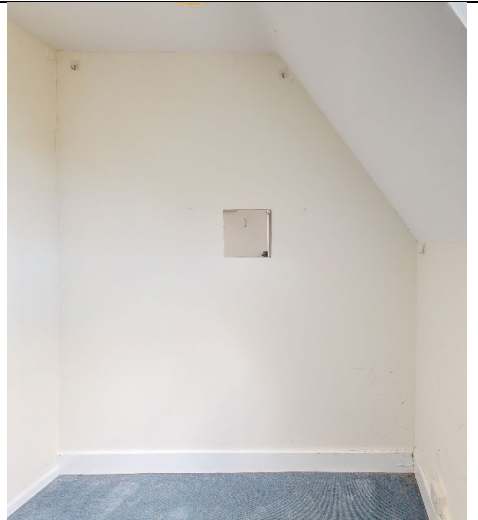
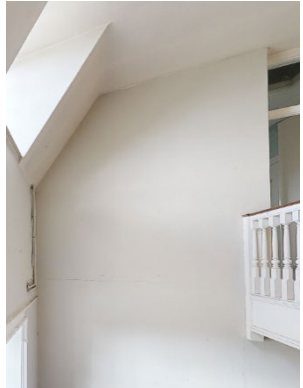
| Reference | Proposal | Significance of affected fabric | Impact | Reasoning and mitigation |
|---|---|---|---|---|
| F-New openings<br>19F.D1 | Form opening in masonry partition between stairwell and Helena Apartment 20 | Low<br>C20 (1935)<br>alterations by school | Low<br>Impact | <p>Remove section of wall to form new door opening (to RHS)</p> <p>Wall from stairwell side (Left of balustrade)</p> |

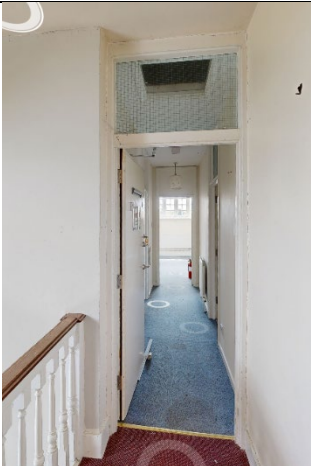
| Reference | Proposal | Significance of affected fabric | Impact | Reasoning and mitigation |
|---|---|---|---|---|
| G-New partitions<br>19G.P2 | Infill existing door opening | Low<br>C20 alterations | Low impact | <p>Existing entrance opening to south dormitory accommodation<br/>Infill existing door opening with new timber stud partition to comply with Building Regulations requirements for sound separation and fire protection.<br/>Intervention is reversible.</p> <p>Refer to 19R.P1</p> |

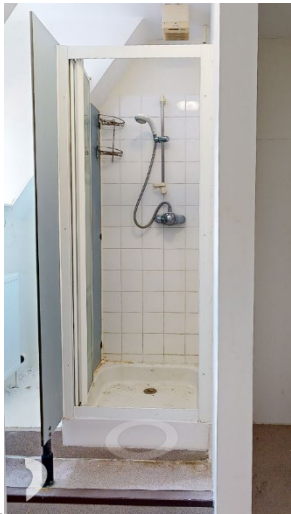
| Reference | Proposal | Significance of affected fabric | Impact | Reasoning and mitigation |
|---|---|---|---|---|
| J-Internal fixtures and fittings<br>19J.D1 | Removal of modern C20/C21 sanitaryware and associated fittings. | Neutral<br>Late C20 / C21 school insertions | Neutral Impact | <p>Shower enclosure</p> <p>Shower and enclosure, 1no wc and cistern, basin and associated plumbing and pipework, tile splashback &amp; bath surround and fittings and fixtures to be removed. All installations are C20/21.</p> |

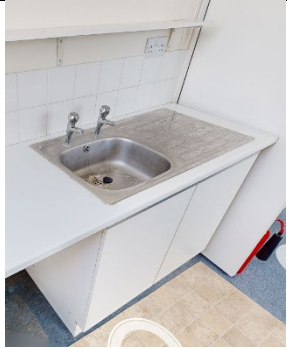
| Reference | Proposal | Significance of affected fabric | Impact | Reasoning and mitigation |
|---|---|---|---|---|
| | | | | <p>Kitchen sink in living area including associated pipework and drainage to be removed</p> |

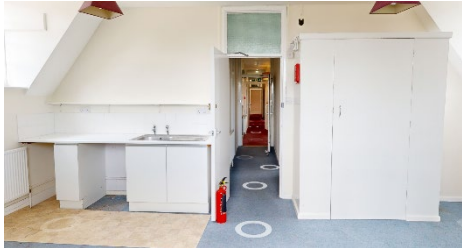
| Reference | Proposal | Significance of affected fabric | Impact | Reasoning and mitigation |
|---|---|---|---|---|
| J-Internal fixtures and fittings 19J.D3 | Removal of all C20/21 fittings and fixtures | Low MC20 school insertions | Low Impact | <p>Existing kitchen units, fitted cupboard, wall mounted pin boards, fixed shelving and blinds to be removed.</p> |
