# HITCHIN SWIMMING CENTRE

## Tree Survey Report and Arboricultural Impact Assessment

5268\_772  
Tree Survey Report and  
Arboricultural Impact  
Assessment  
E  
02 April 2025

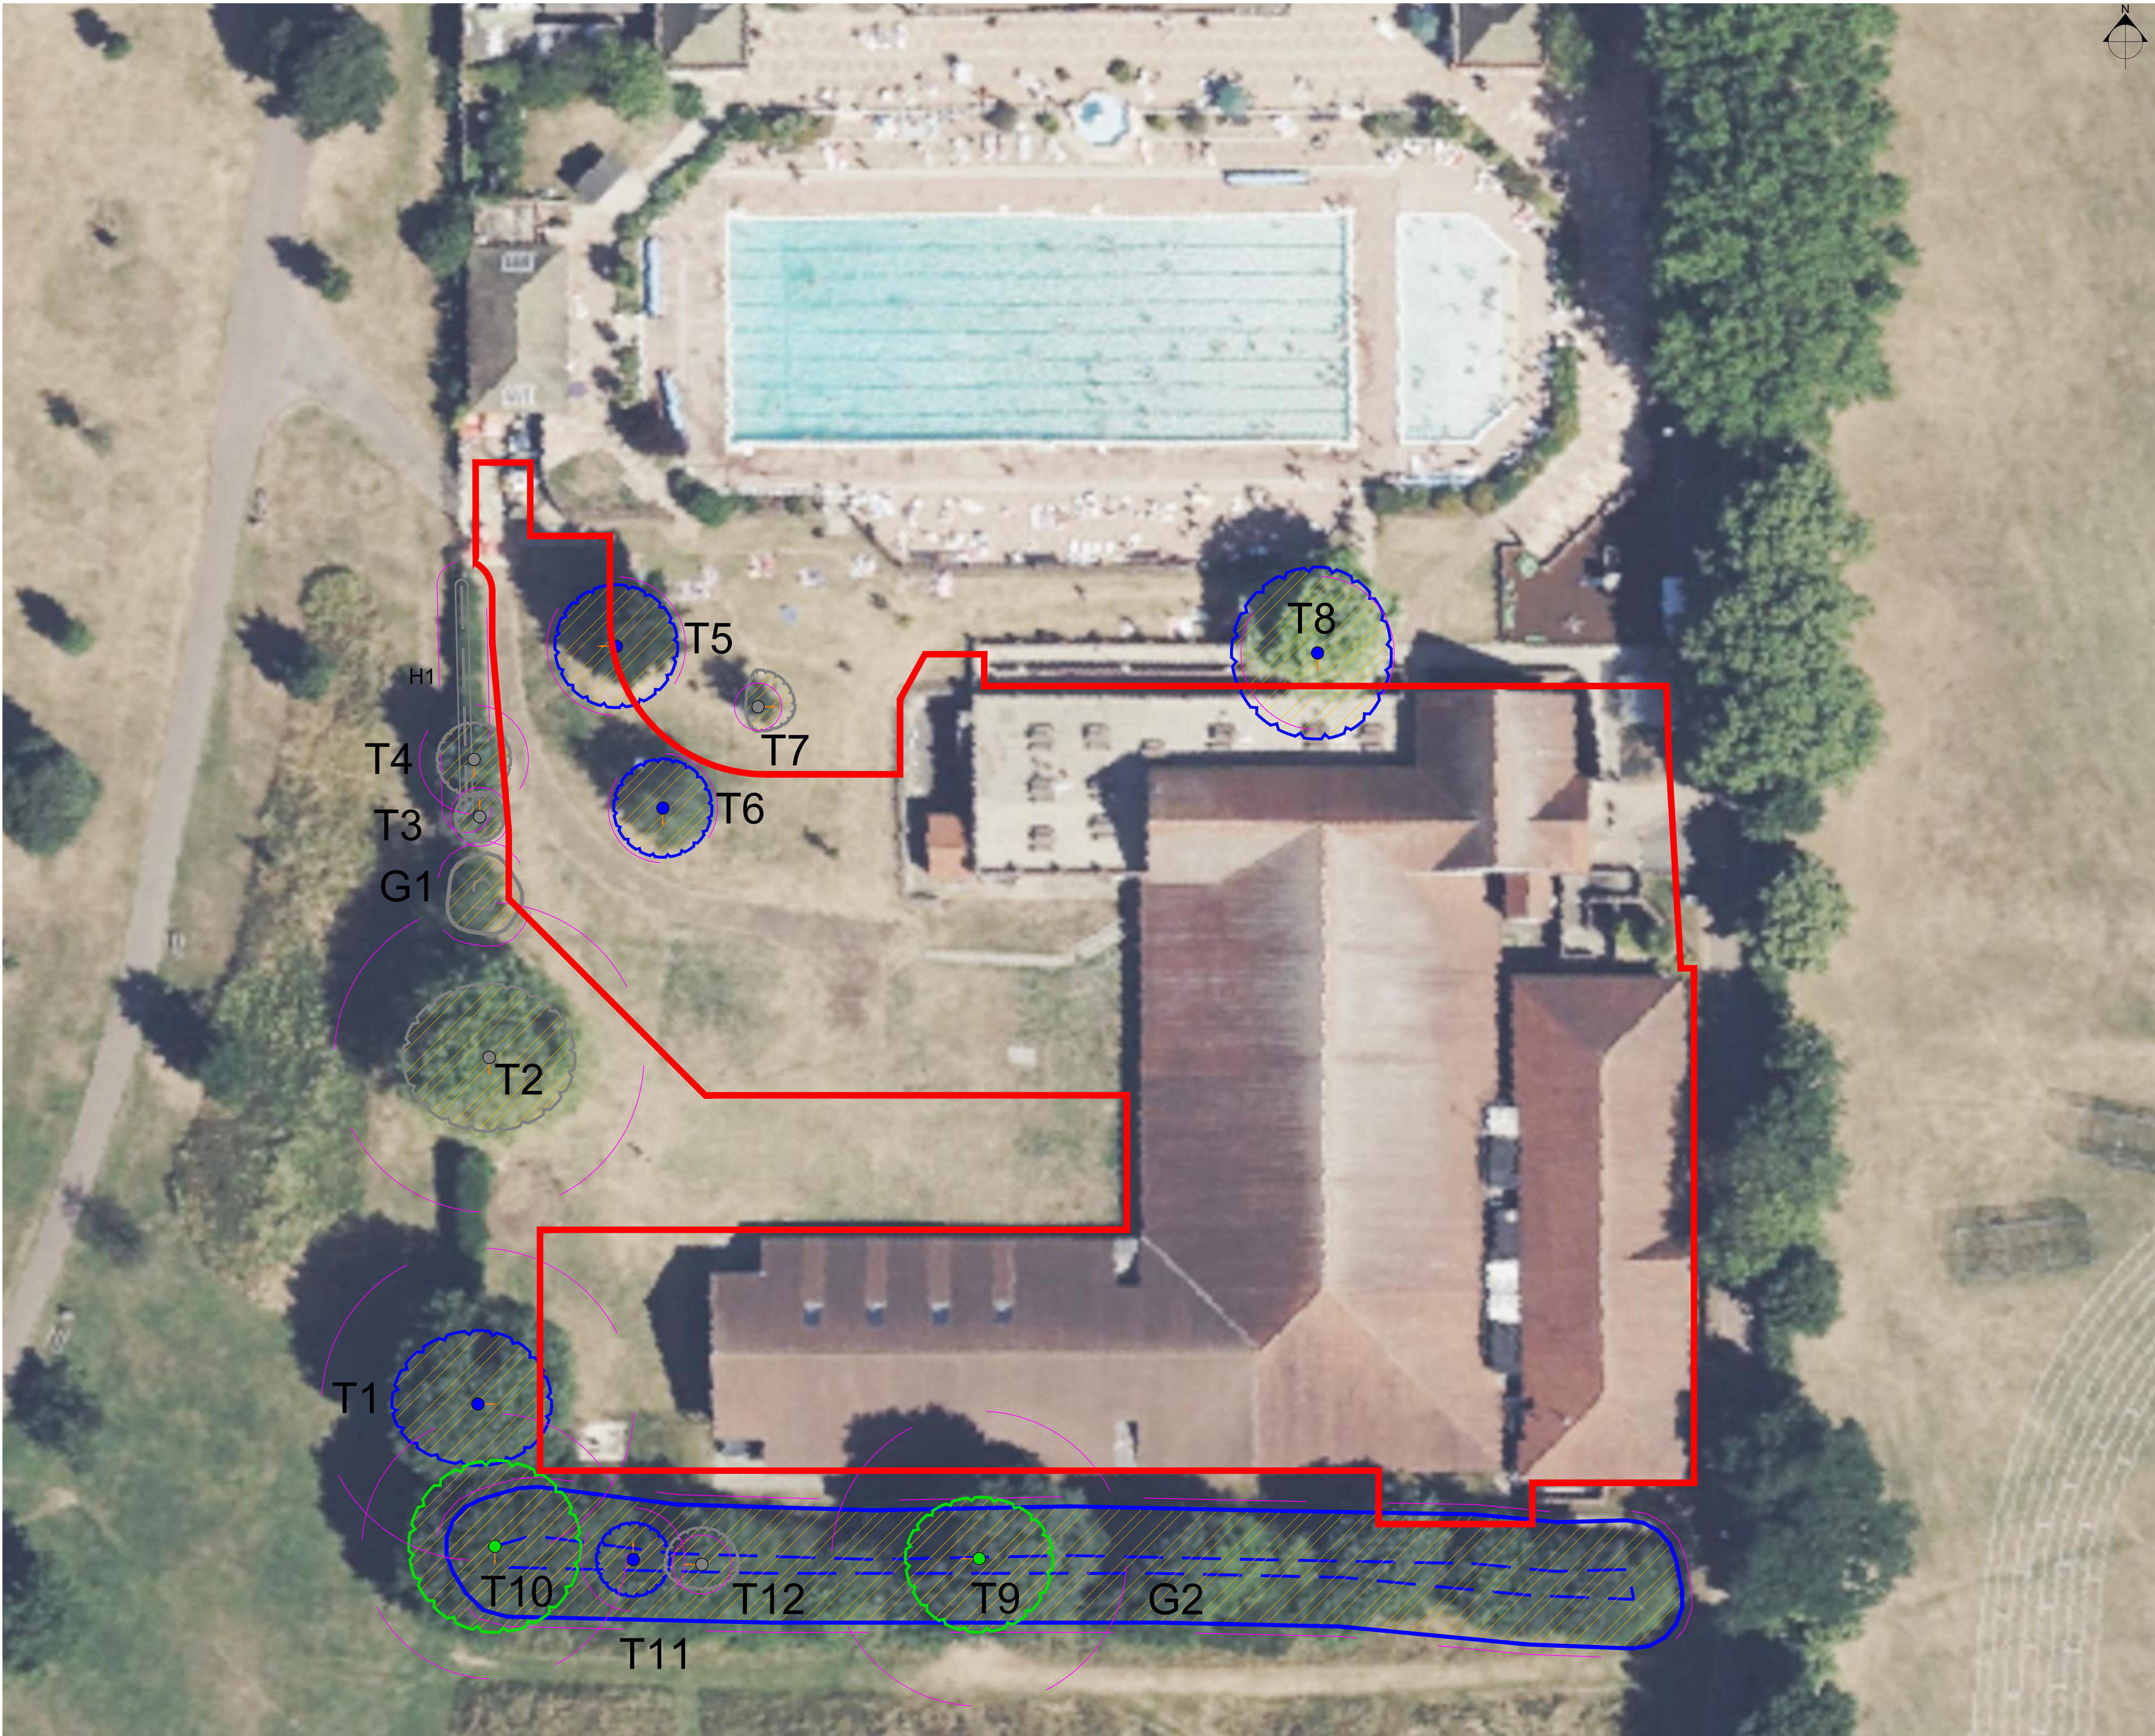
### Tree Constraints Plan

| Ref. no | Species | Height (m) | Canopy Spread (m) | | | | Crown Area (m <sup>2</sup> ) | Stem dia. (mm) | Stem no. at 1.5m | Height of crown clearance (m) | FSB Height (Direction) | Age class | Condition | General Observations<br>Management Recommendations | Estimated remaining contribution (yrs) | Tree Quality Category (BS5837) |
|---|---|---|---|---|---|---|---|---|---|---|---|---|---|---|---|---|
| T1 | Fraxinus excelsior (Ash) | 16 | 6 | 6 | 5 | 7 | 0 | 1060 | 1 | 2 | 3.5 (E) | M | Fair | Significant bark tear wound to lower eastern stem leaving heartwood exposed. Remnant fungal fruiting body within wound. Another significant tear wound above this with bark stains beneath. Twin stemmed from 2m. Previously reduced to c.10m. Good vigour. | 20+ | B1 |
| T2 | Fraxinus excelsior (Ash) | 14 | 6 | 7 | 6 | 7 | 0 | 1050 | 1 | 2 | 2 (S) | M | Fair | Multi stemmed from 2m. Previously reduced to c.10m. Good vigour. Large bark wounds at previous cut points. Central leader coved with Daldinia cintrica fungi suggesting internal decay. Limited future potential. | 10+ | C1 |
| T8 | Catalpa bignonioides (Indian Bean Tree) | 9 | 7 | 6 | 7 | 7 | 0 | 520 | 1 | 2 | 3 (S) | EM | Good | Hard standing in RPA to east and south. Exposed surface roots. Flush pruning wounds noted. Good form and vigour. | 20+ | B1 |

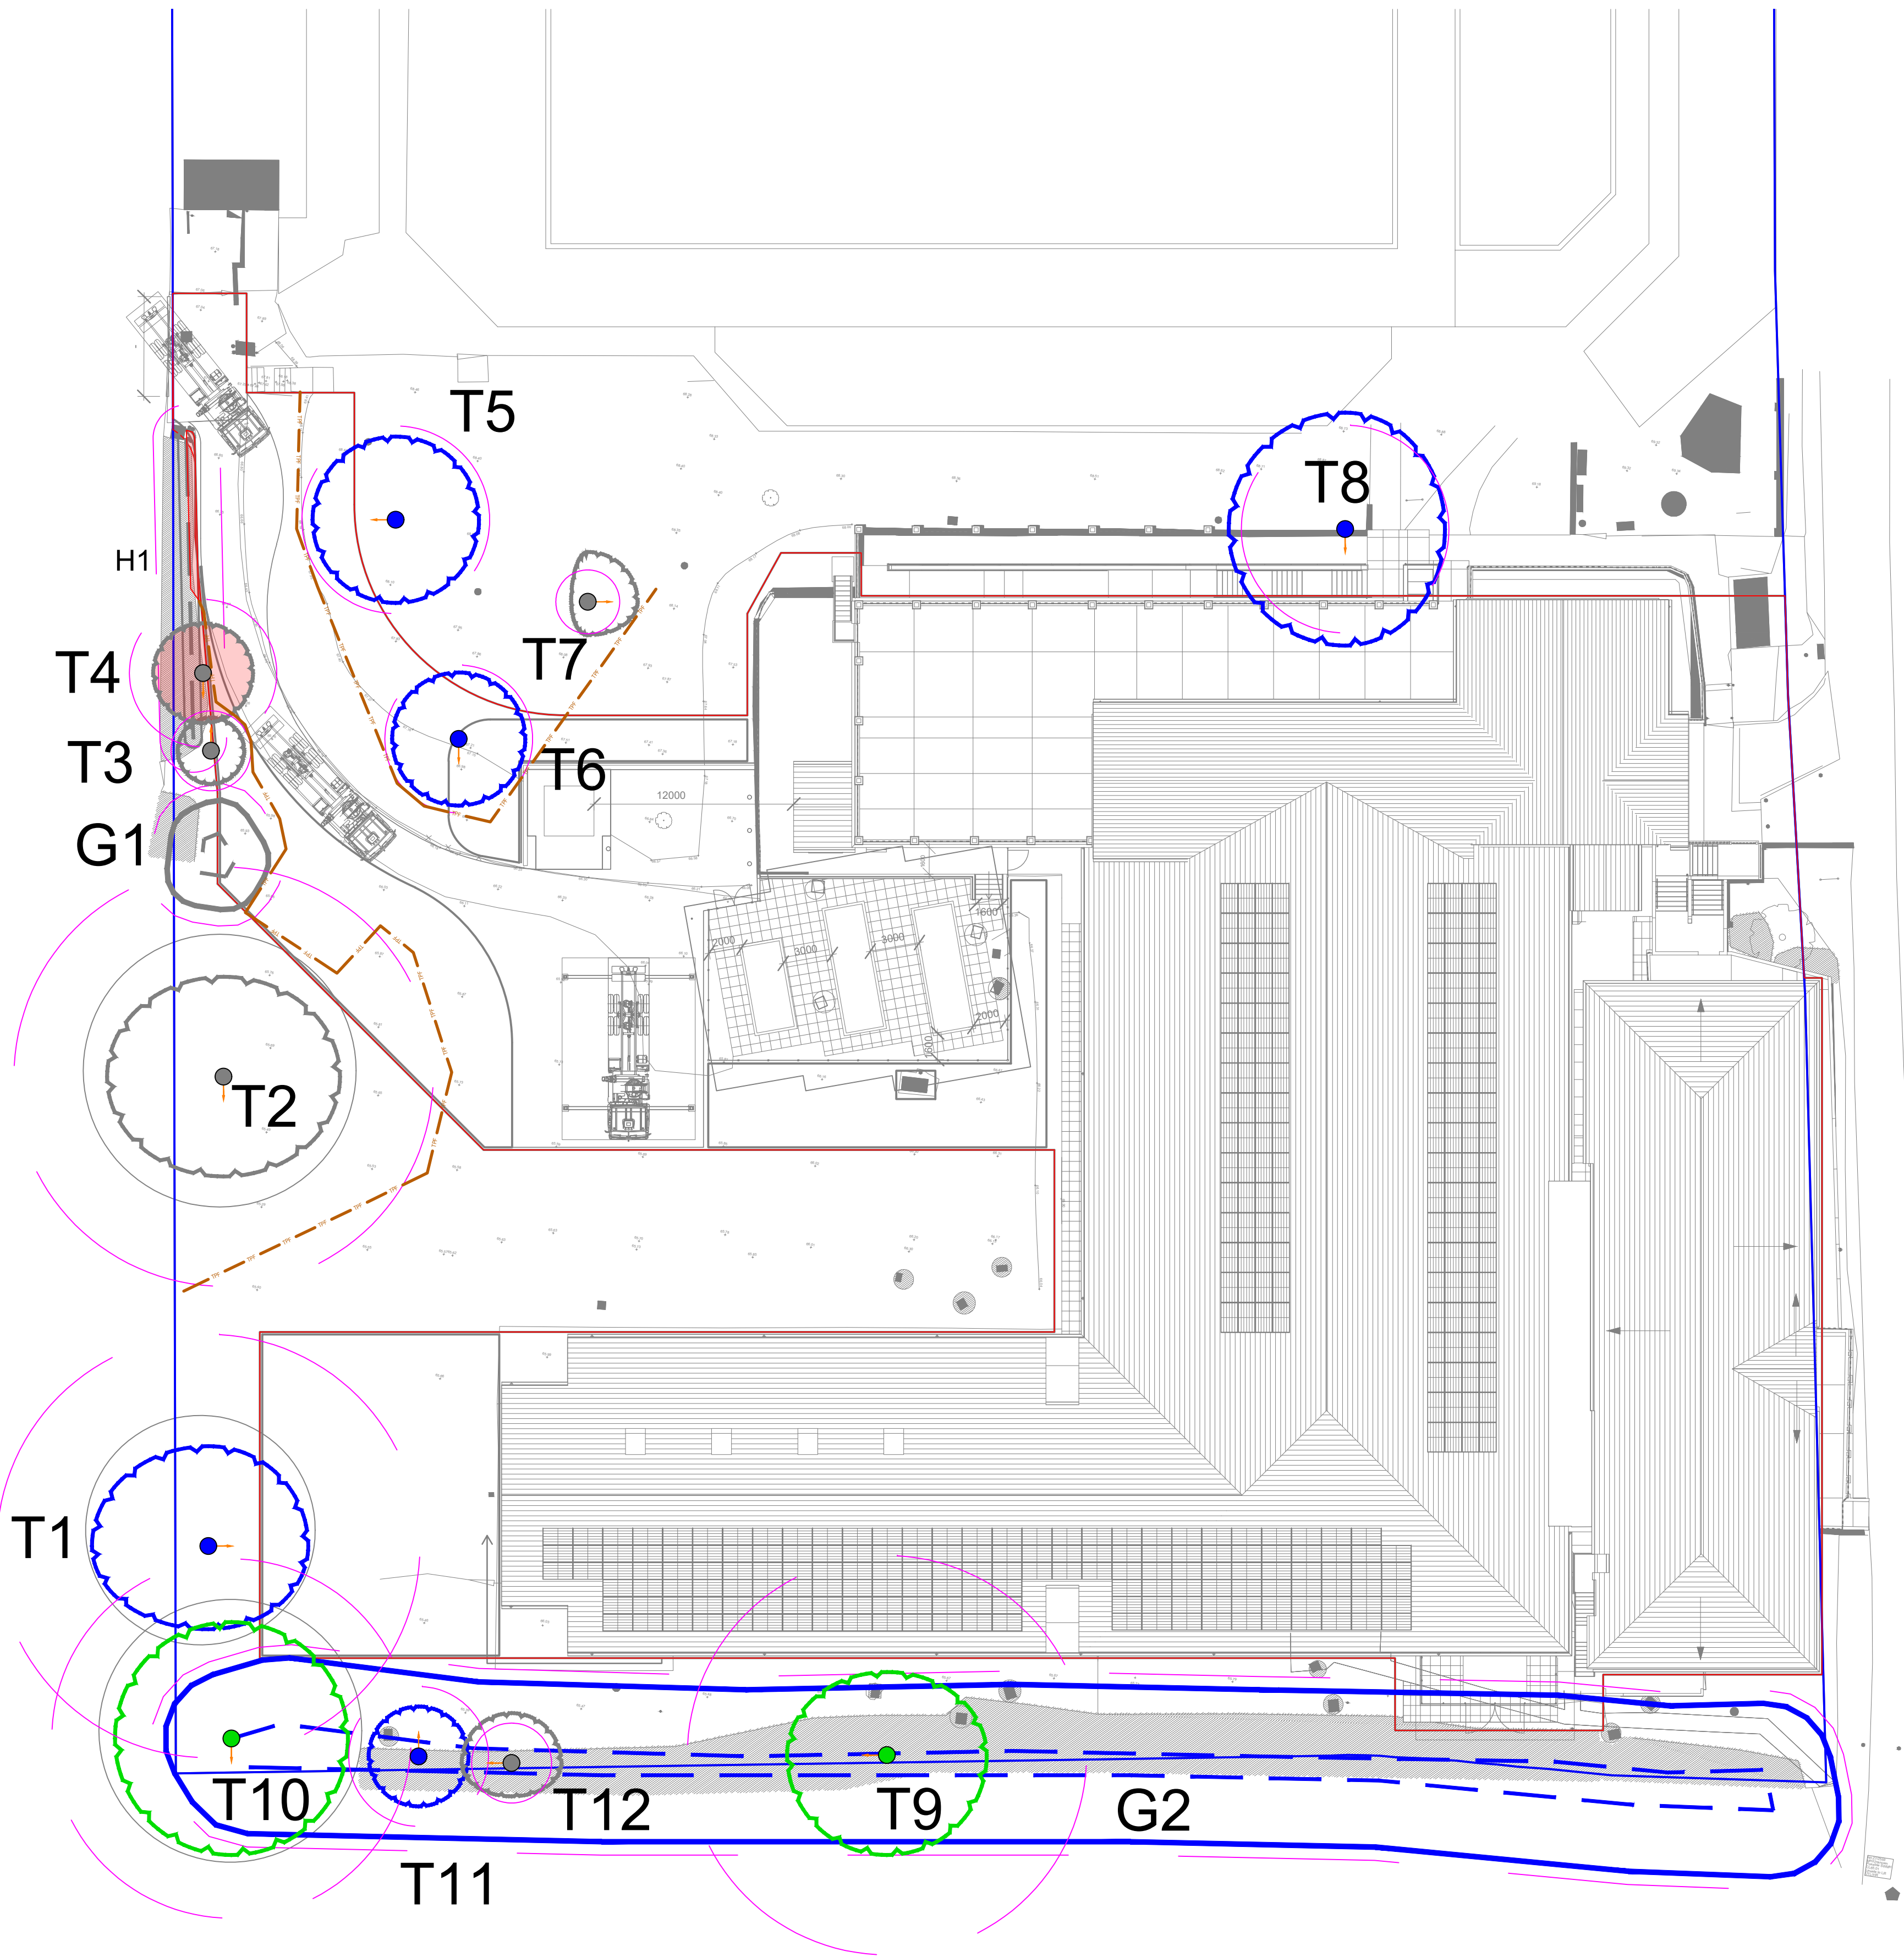
### Tree Removal & Protection Plan

- 5.12 Most of the individual trees on site are to be retained, with 90% of the individual trees surveyed on site being retained.
- 5.13 Overall, the impact of this proposed tree removal work, can be seen as minimal and deemed acceptable to facilitate construction. Given the small proportions of T4 at present, its removal from the site will have minimal impact to the arboricultural quality of the site and surrounding conservation area and it can be readily replaced in the short term with replacement planting.

- 7.11 Copies of the Tree Removal & Protection Plan shall be placed in the site office for reference by all site staff.
- 7.12 Signs detailing the purpose of the protective barrier shall be attached to the barriers at 10m intervals. Such signs should be weatherproof and shall be substantially in the form of the specimen provided in Appendix D. Signs must be replaced as necessary should they be removed or become illegible.
