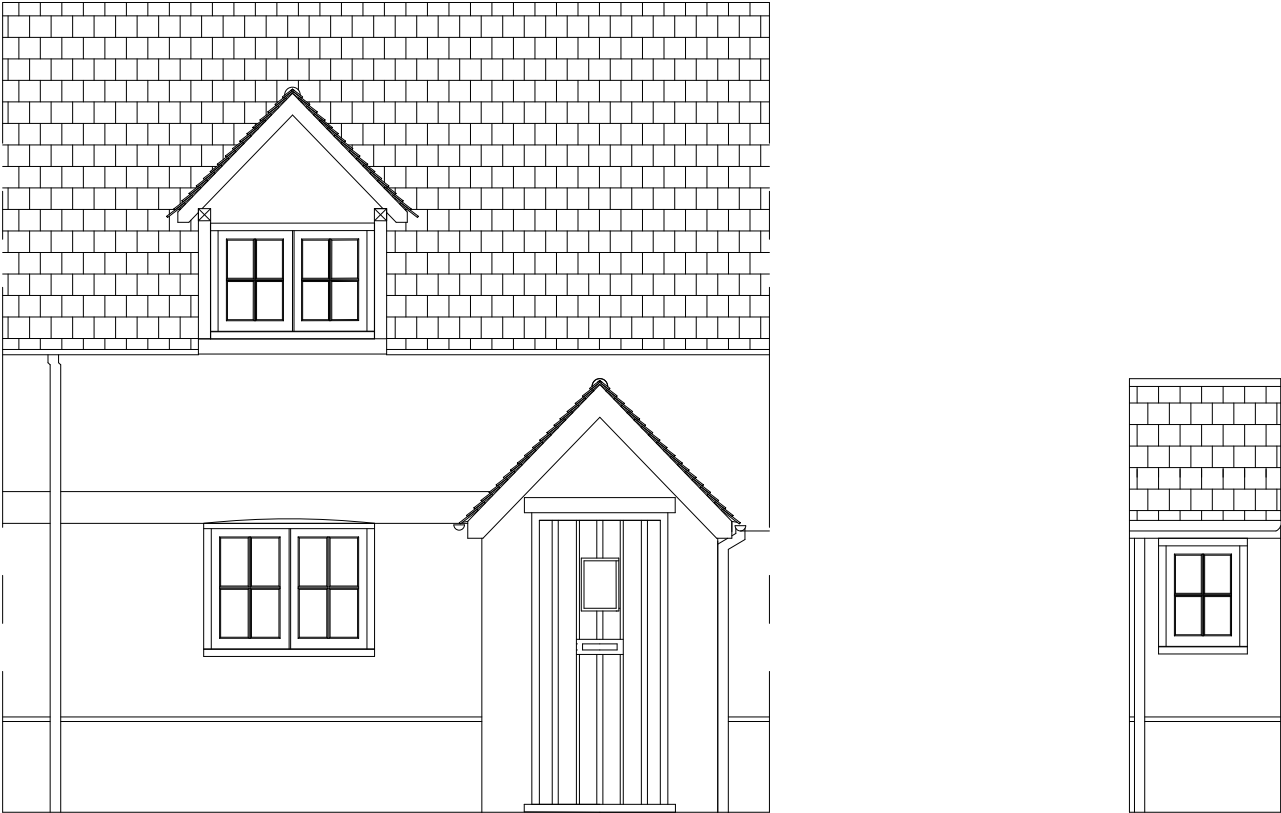
- Existing front elevation
- The mismatched window styles between the ground floor and 1st floor in front elevation nor keeping with heritage conservation.
  - Existing windows are rotten and beyond economical repair
  - Windows let water in the property and cause damp problems
  - Property very cold in winter and doesnt keep heat in
