# **BS 5837:2012**

## **Arboricultural Impact Assessment**

### **Extra Baldock Service Station, A1(M)**

**GRIDSERVE Sustainable Energy Ltd**

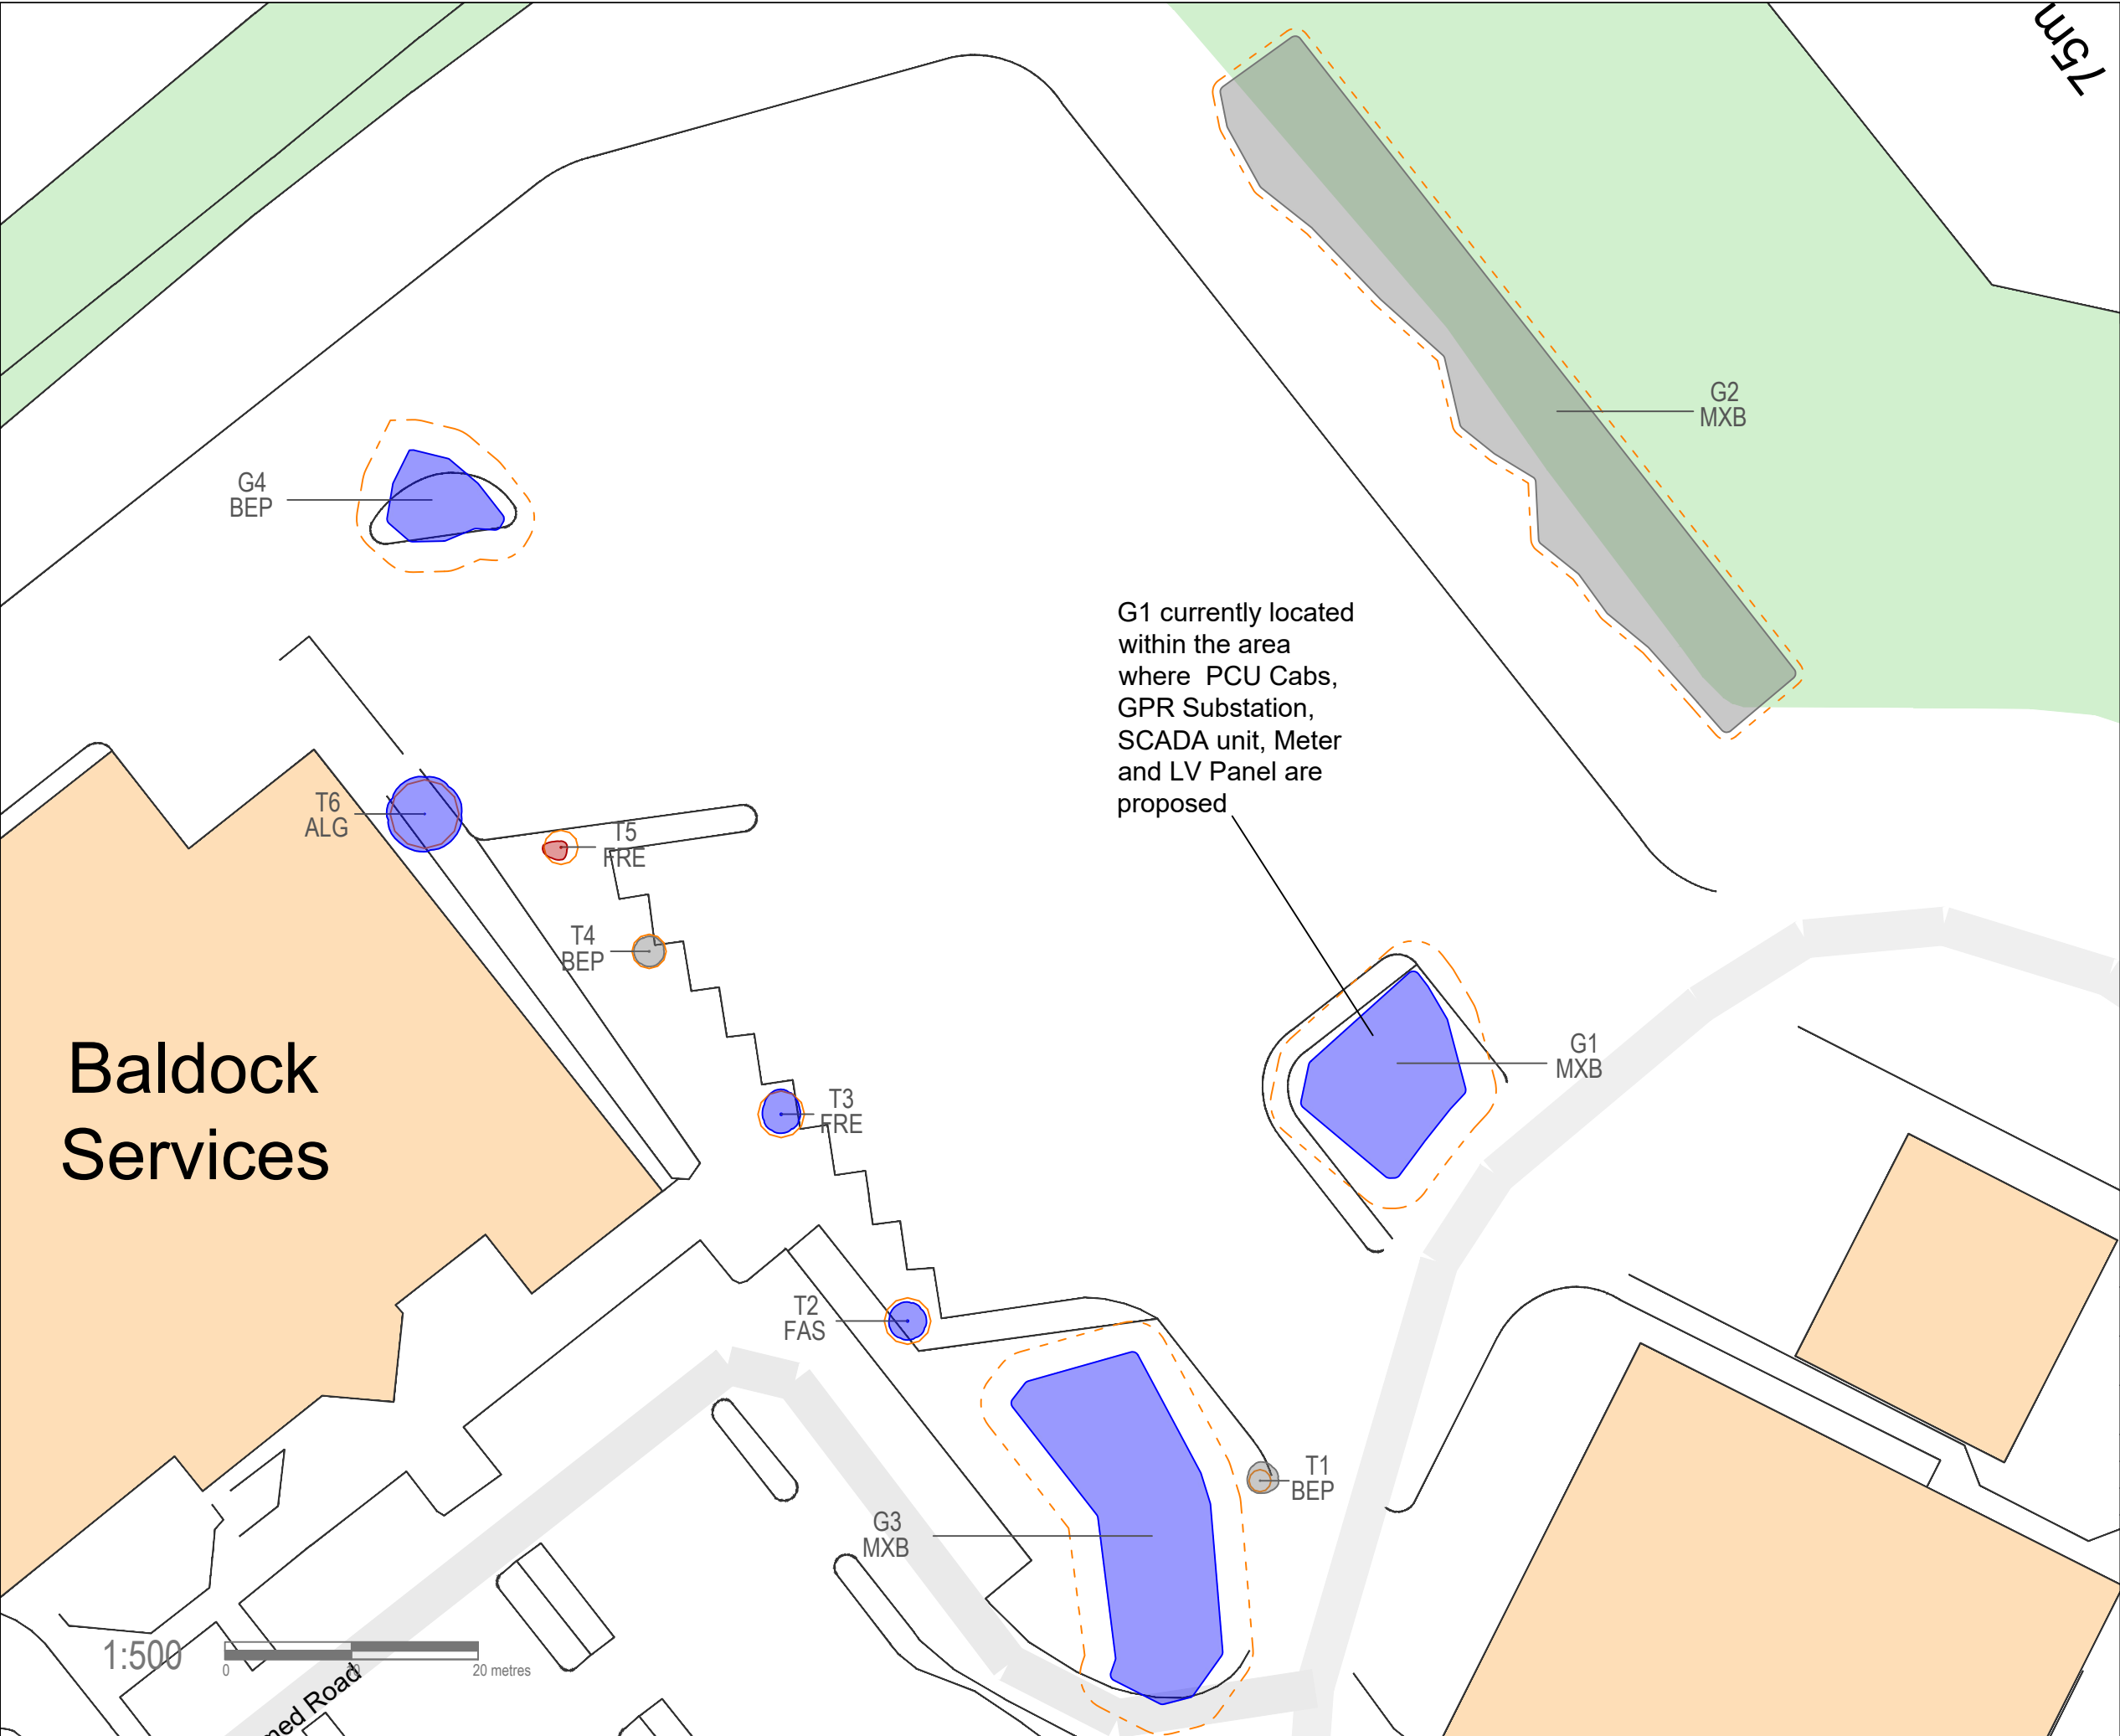
The current plan (**8914-BOW-A0-00-DR-A-0105**) shows that **G1** a **category B** group, which comprises of **four semi-mature beech**, **one semi-mature goat willow**, **one semi-mature grey willow**, and **one standing dead grey willow**, and also includes an ornamental shrub group consisting of Portuguese laurel (*Prunus lusitanica*), box honeysuckle (*Lonicera nitida*) and cherry laurel (*Prunus lauroceracus*), will all require removal to facilitate this project.

G1 currently located within the area where PCU Cabs, GPR Substation, SCADA unit, Meter and LV Panel are proposed

Due to the removal of six category B semi-mature trees, mitigation is required in the form of new planting on-site. Due to the location of this group, its removal will mean a loss of amenity value and the loss of its screening effect between the HGV parking area and the petrol station. Mitigation should be achieved by on-site planting of fifteen standard native or futureproof trees of good quality nursery stock.

**Remove G1 to ground level and remove stumps.**
