**PLANNING REFERENCE 17/01955/1 Conditions 6 and 7**

ARBORICULTURAL IMPACT ASSESSMENT AND METHOD STATEMENT REPORT

Ickleford Mill, Arlesey Road, Ickleford

**OUR REF: SHA 1948**

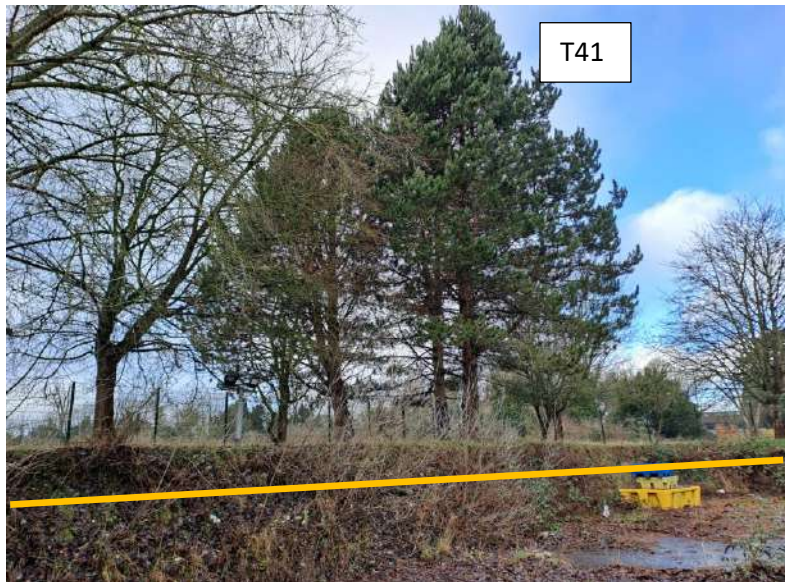
8.1 The trees on the northern and the western boundary (northern section) are on a raised bank. The bank is steep with a level change of 2m in some parts, and at the base the land is mostly laid to hard surface. Given the change in level, the facts that trees root generally in the top 600mm, raising the soil level up to the bank to reduce the steepness will not cause root asphyxiation or loss of physiological function. The tree protection fencing will be erected on the top of the bank to enable soil grading on, and up to, the bank. The raised areas will be planted with a native whip mix. The following photos and plans illustrate the proposed change.

*Photo 10 of north-western corner showing step bank and level change – annotated for proposed levels*

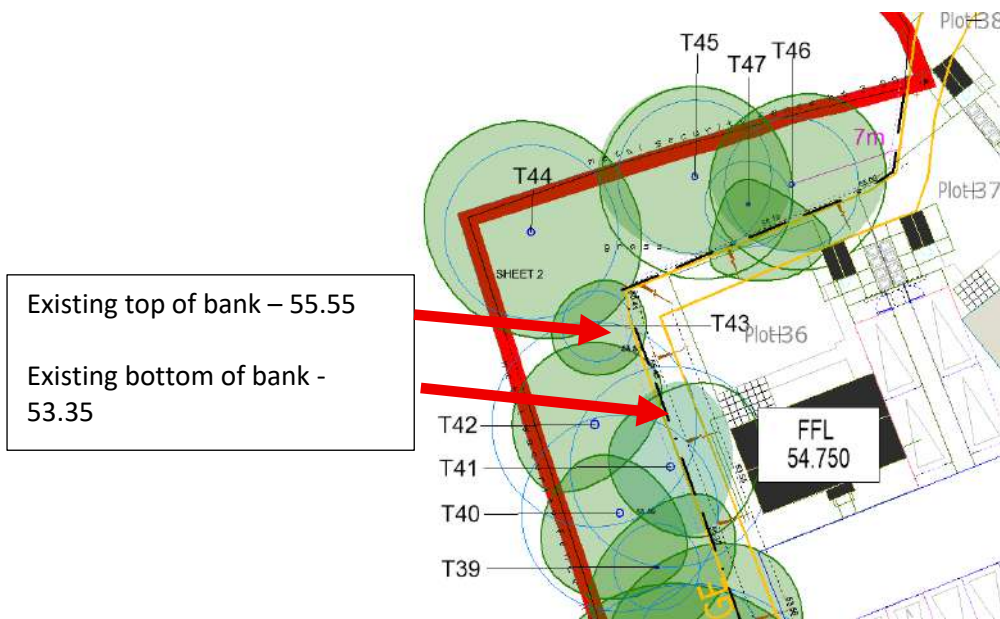
*Plan 6 – extract from SHA 1948 TPP2 – annotated.*

*Soil raising here will result in a bank of c.700mm height.*

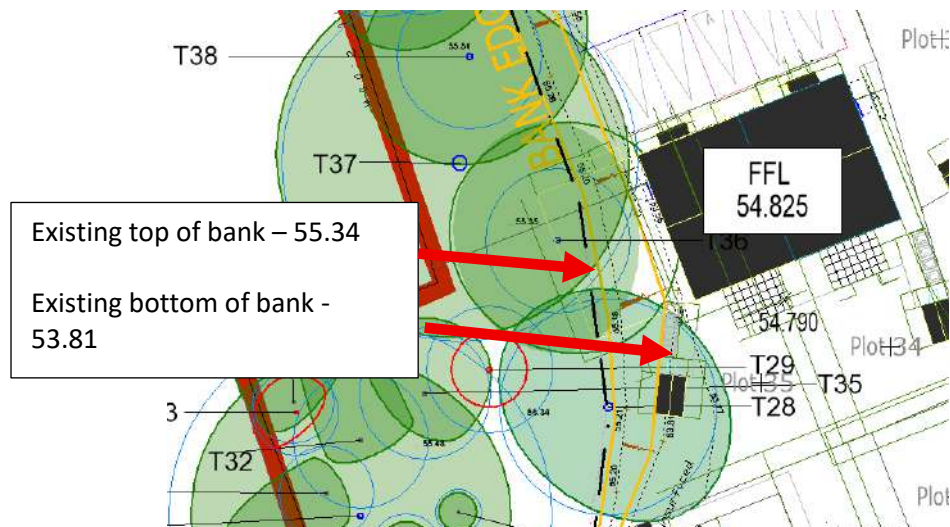
*Plan 7 – extract from SHA 1948 TPP2 – annotated. Soil raising here will result in a bank of c.500mm height.*

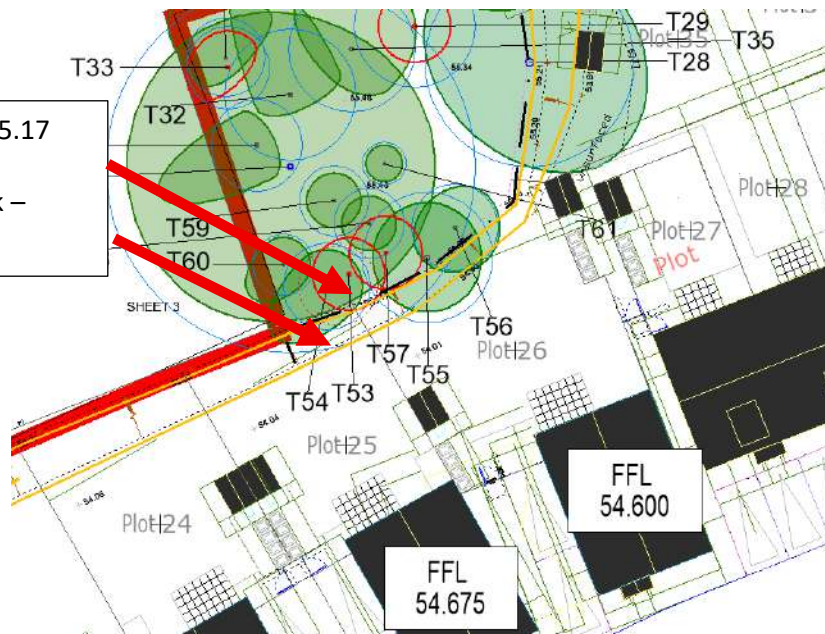
Plan 8 – extract from SHA 1948 TPP2 – annotated. Soil raising here will result in a bank of c.500mm height.

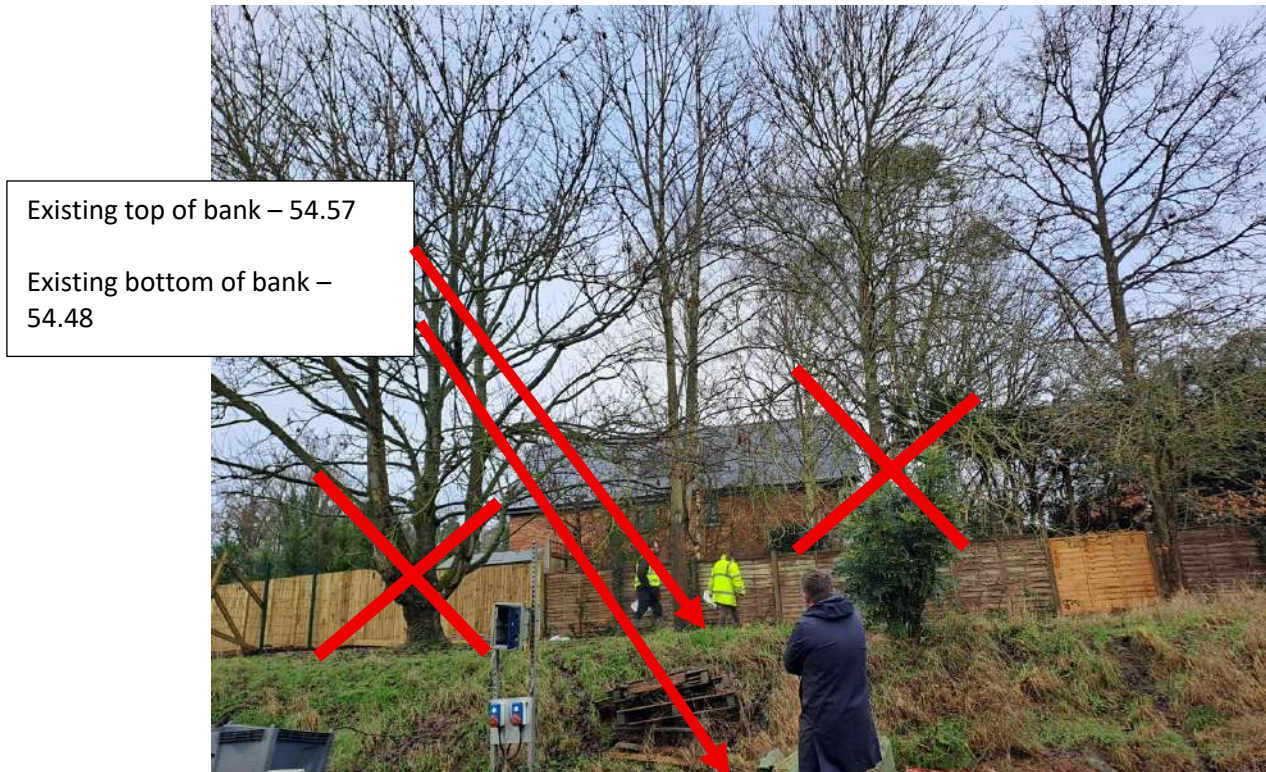
*Photo 13 of T49 and T51 looking north at the north-western part of the boundary.*

*Note trees with red X to be removed.*

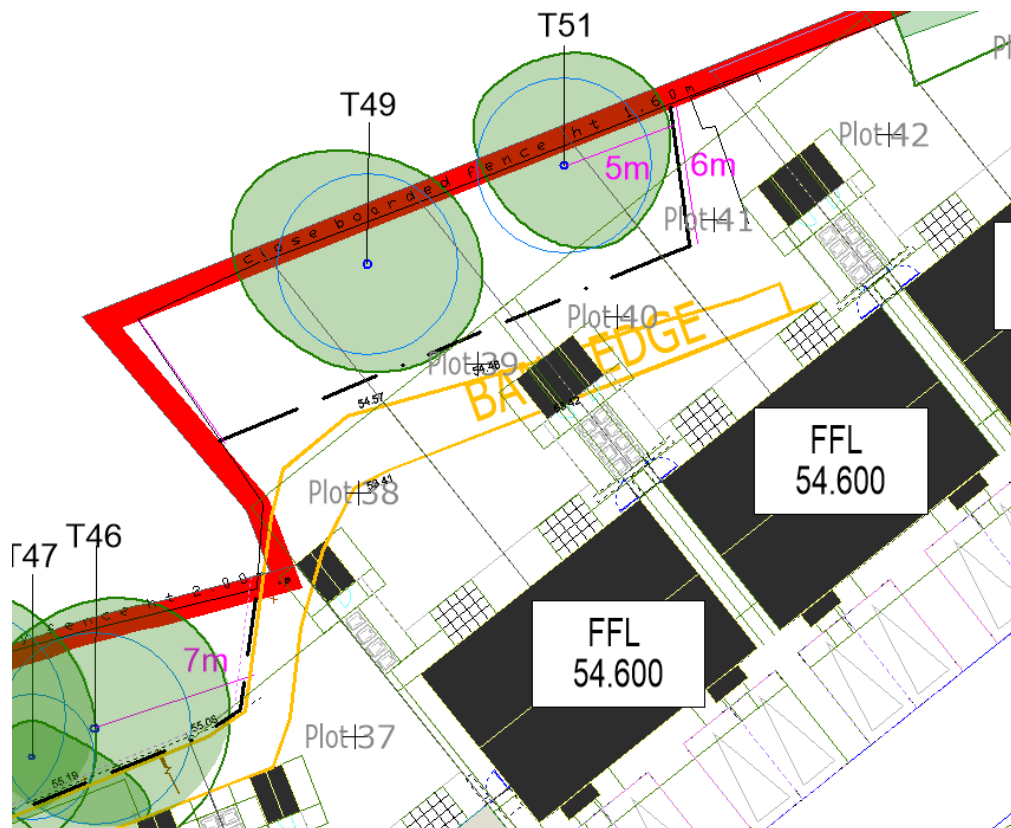
*Plan 9 – extract from SHA 1948 TPP2 – annotated. Soil raising here will result in raising of 112mm, which given the trees being removed are on the edge occupying root space near the change in level, has no arboricultural impact.*

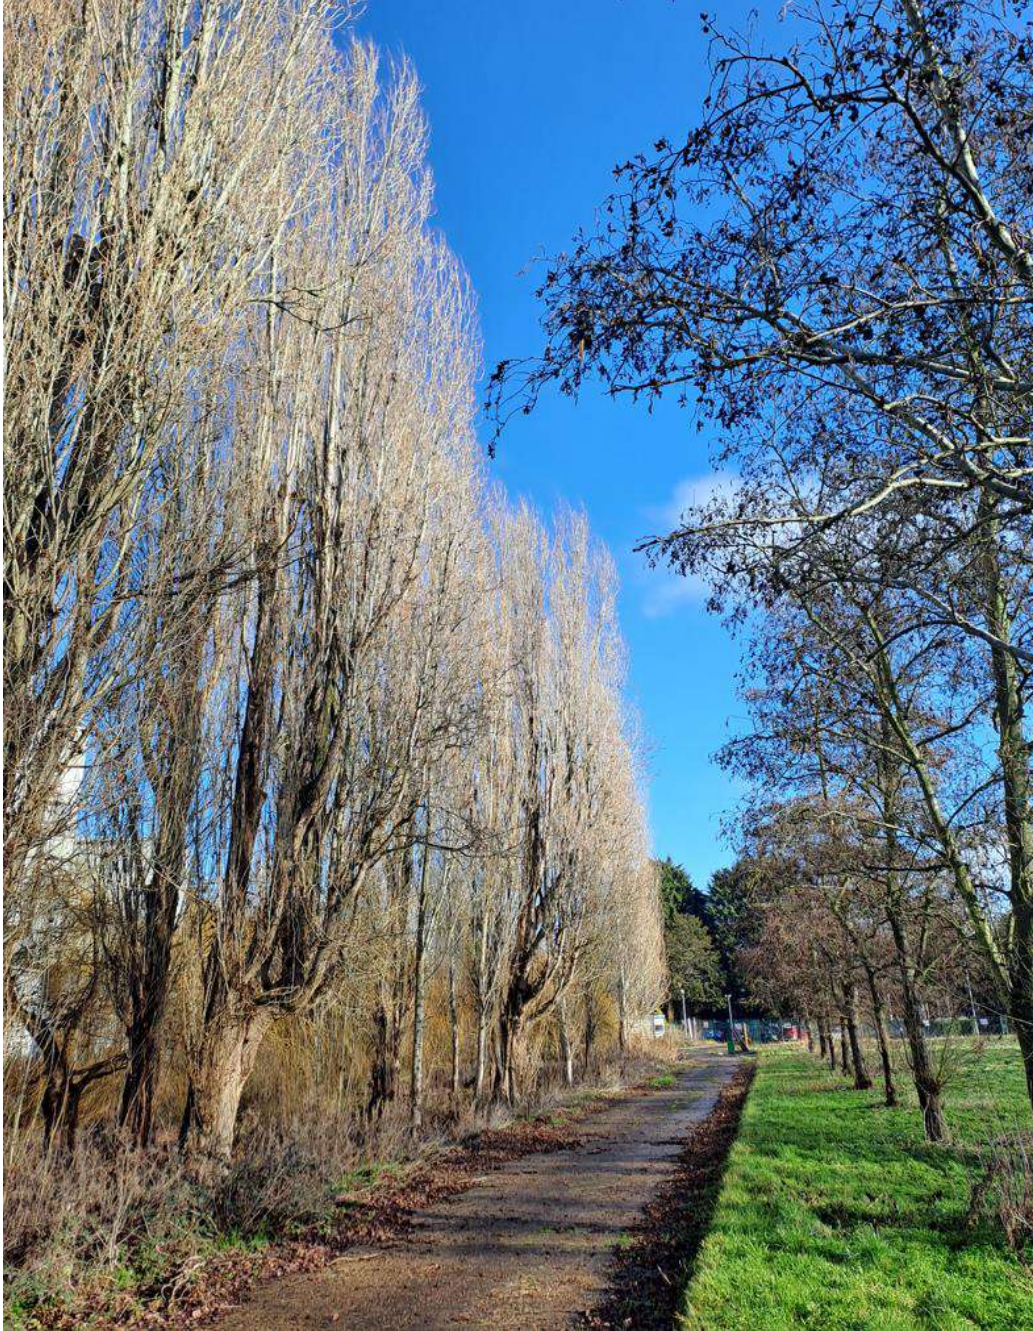
*Photo 14 of the poplars on the northern part of the existing path and alders on the southern side.*

*Looking east. Note that the removal of the path and replacement path with hoggins is beneficial as this surface is flexible and adjusts to tree root growth without causing cracking.*
