# ROYSTON LEISURE CENTRE

## Tree Survey Report and Arboricultural Impact Assessment

5268\_770  
Tree Survey Report and  
Arboricultural Impact  
Assessment  
E  
02 April 2025

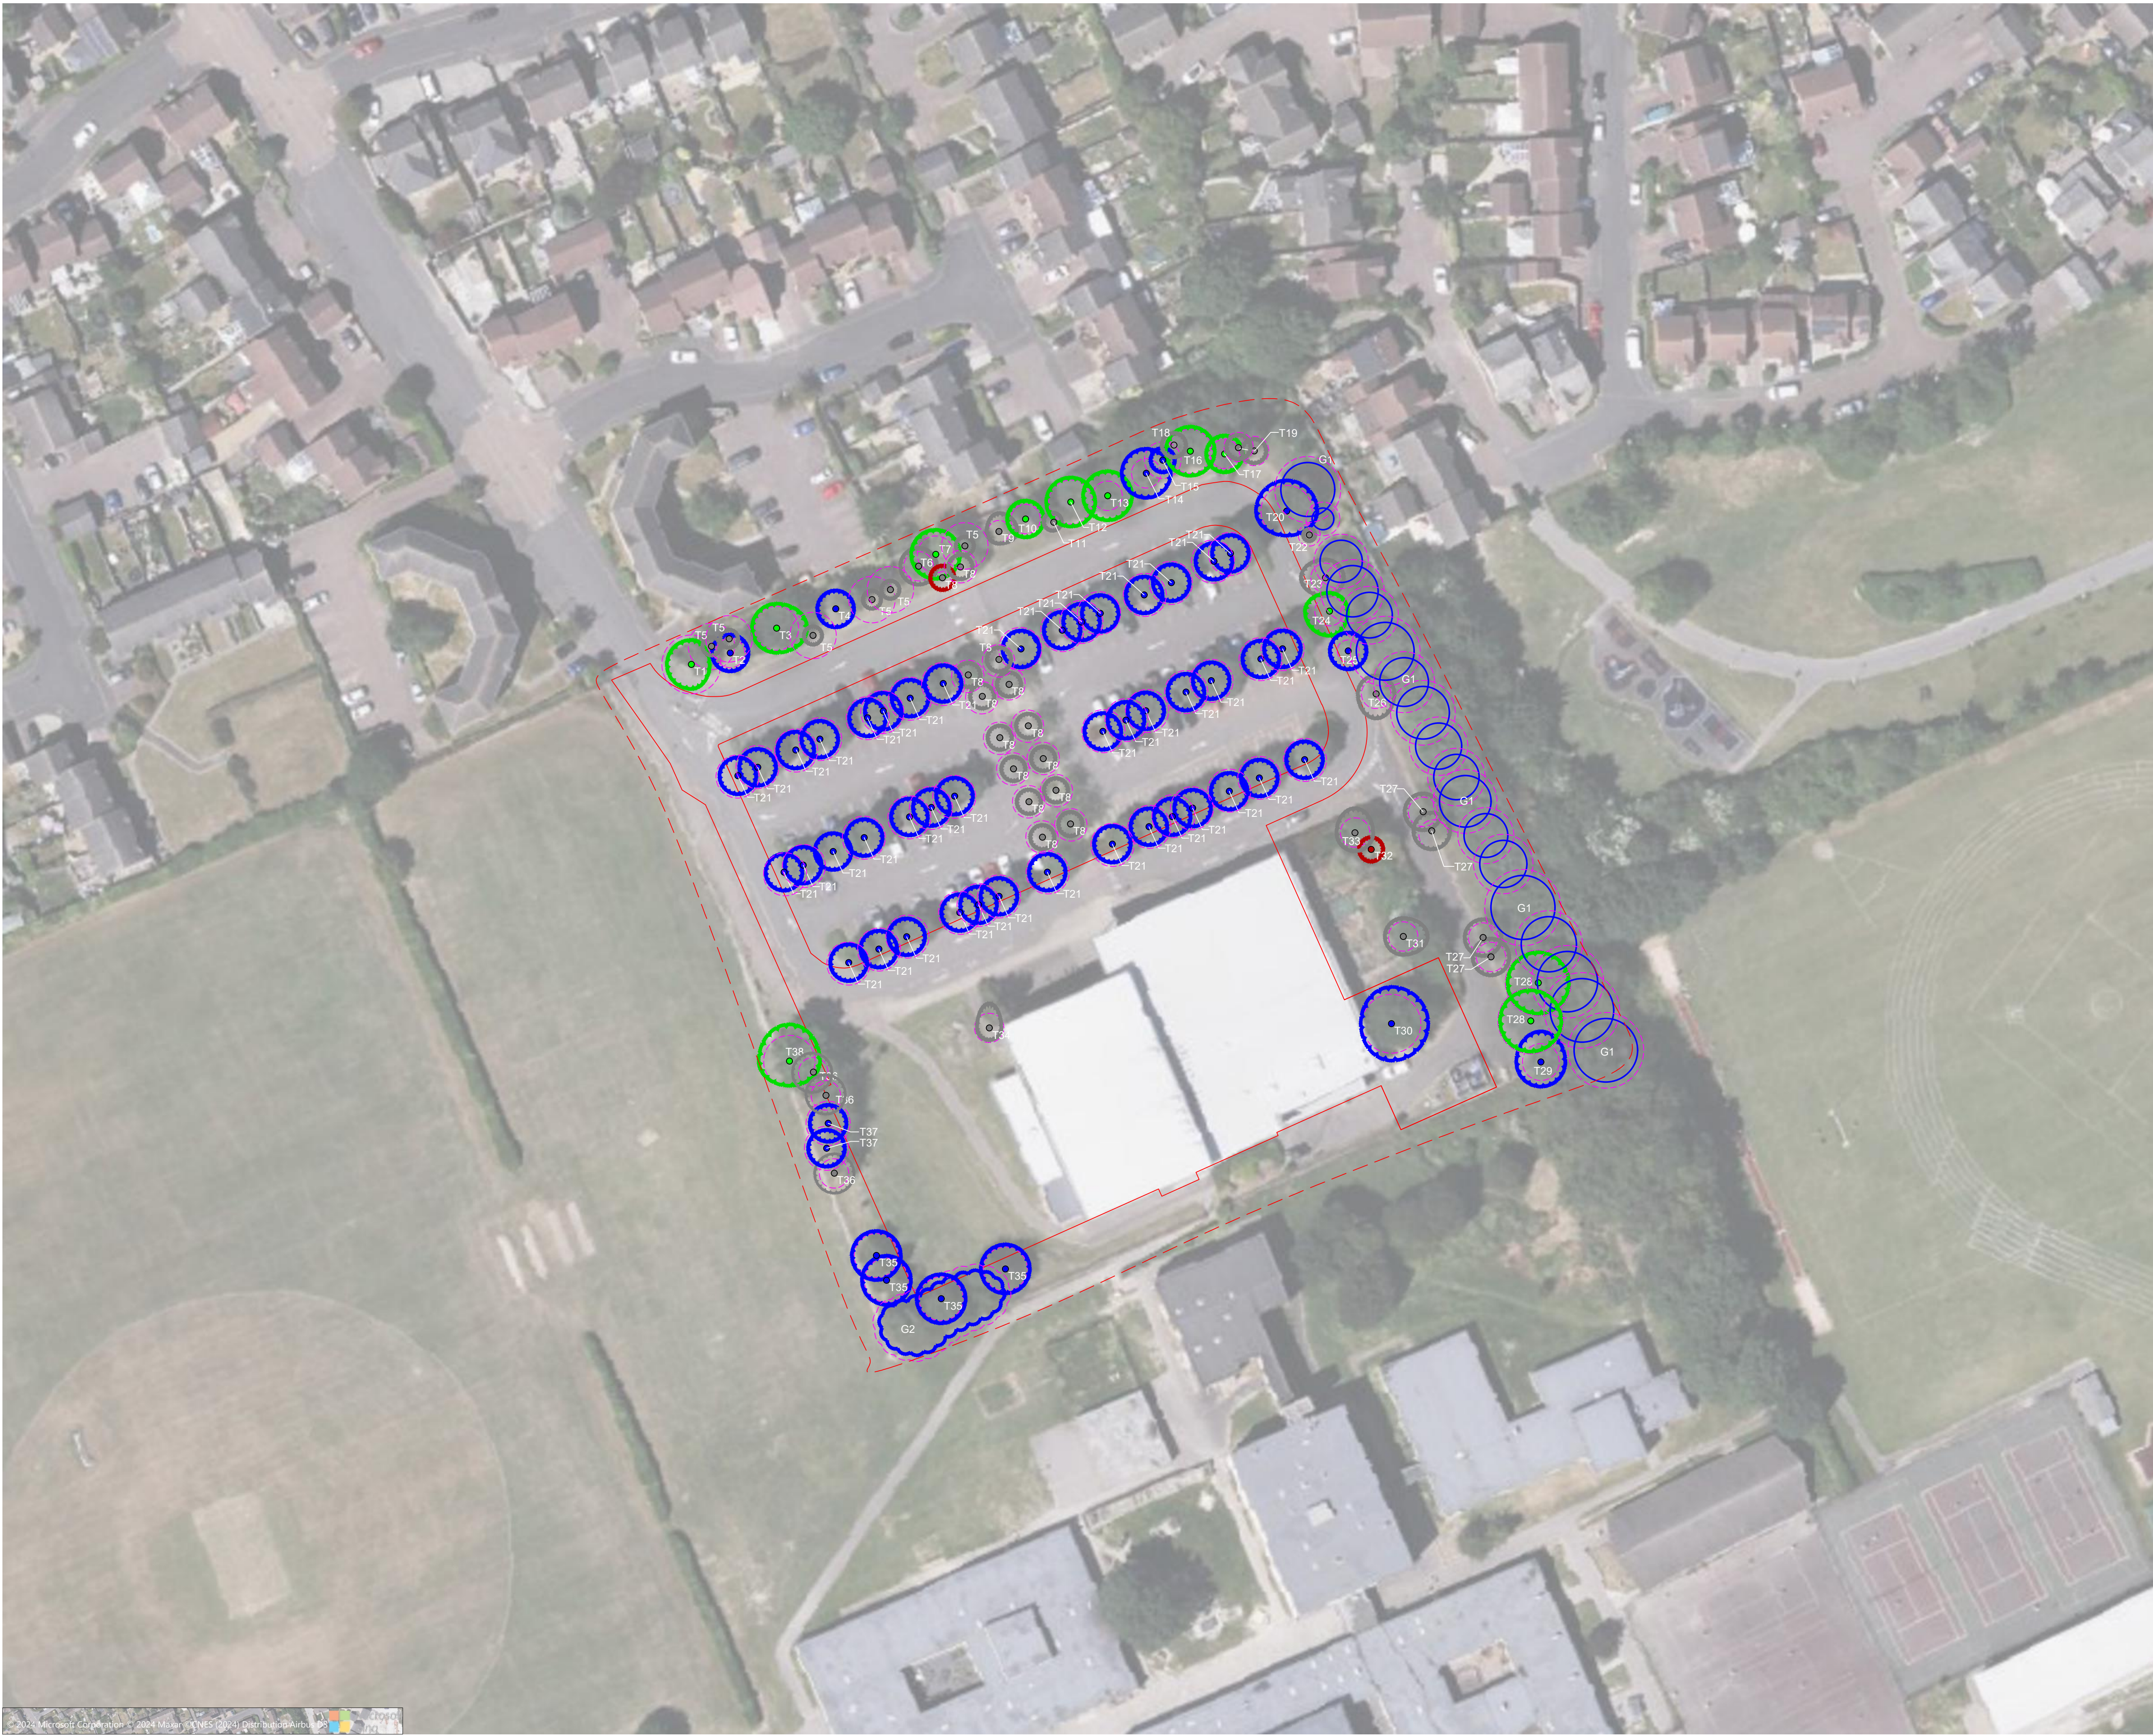
### Tree Constraints Plan

- 4.1 During the survey 60 trees were surveyed. The survey also recorded 2 Groups.
- 4.2 These trees were mostly located around the peripheries of the site and within the site's car park.
- 4.3 The BS5837 quality of the surveyed trees is broken down in the table below:

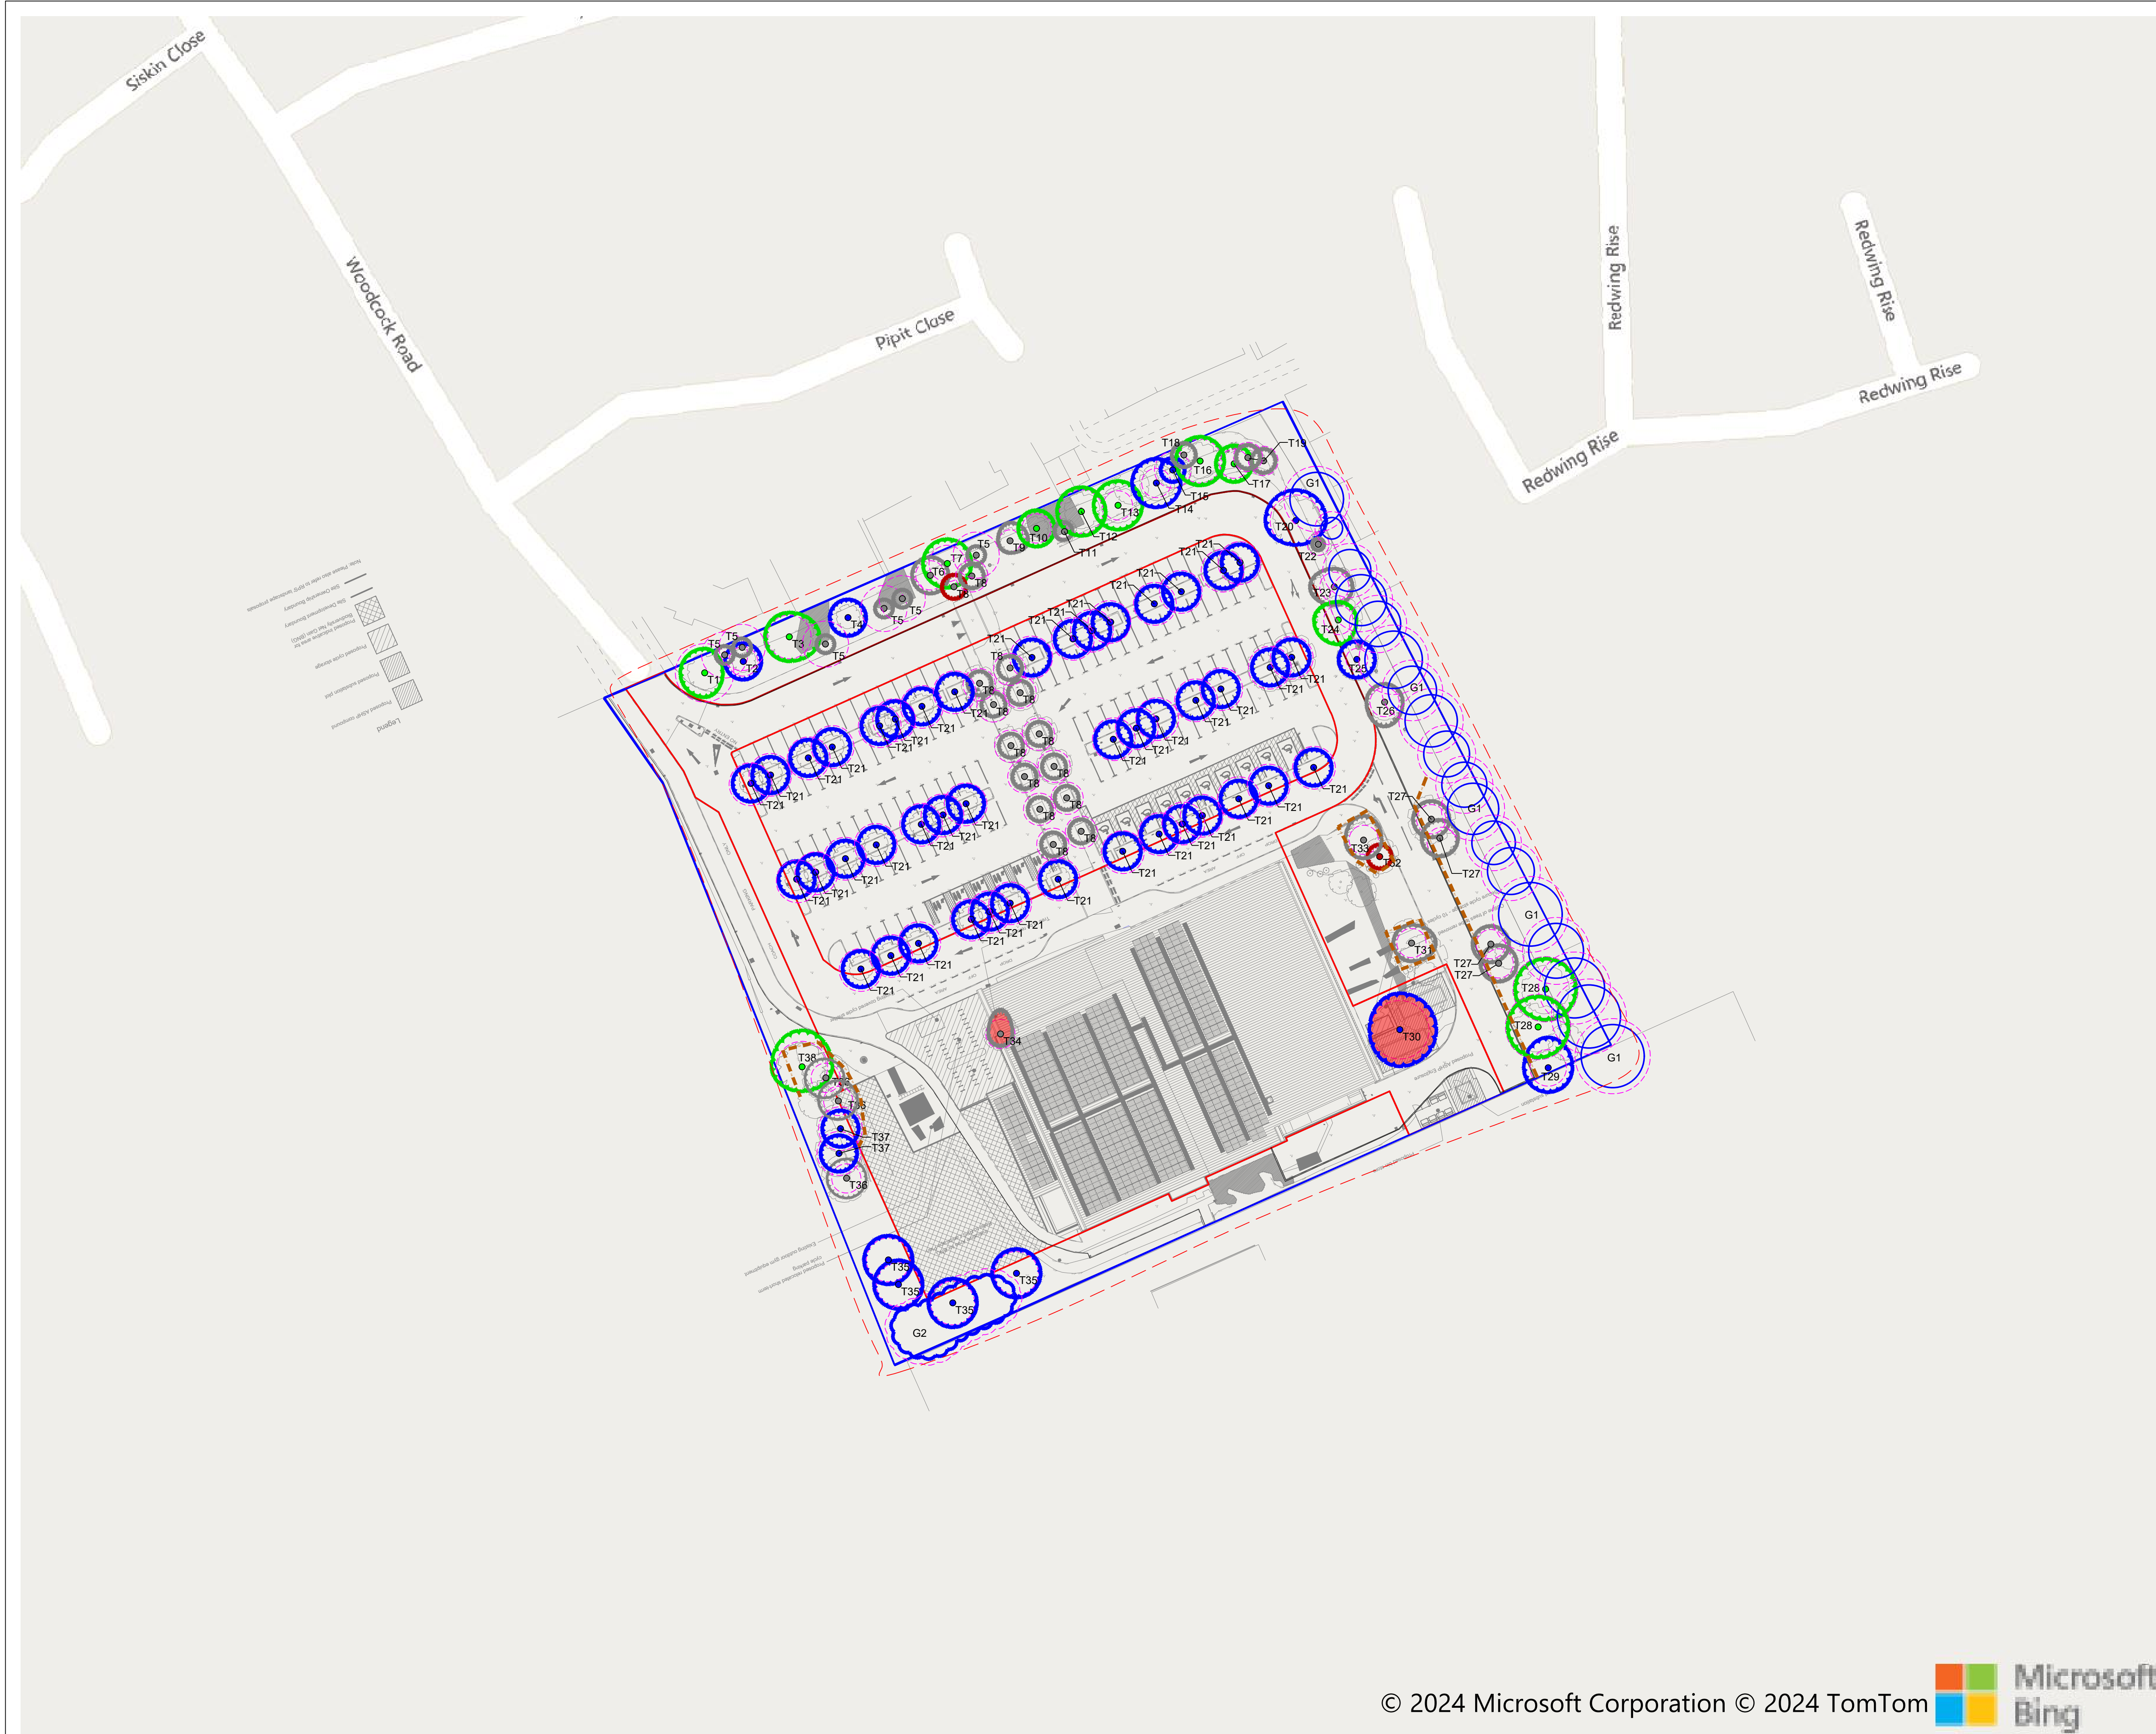
### Tree Removal & Protection Plan

- 1.5 The Tree Protection and Removal Plan included in Appendix B identifies the following:
- Trees to be retained
  - Trees to be removed
  - Alignment and design of protective fencing
