## **Arboricultural Report**

For 35 Gray's Lane, Hitchin, Hertfordshire

on 10 December 2025

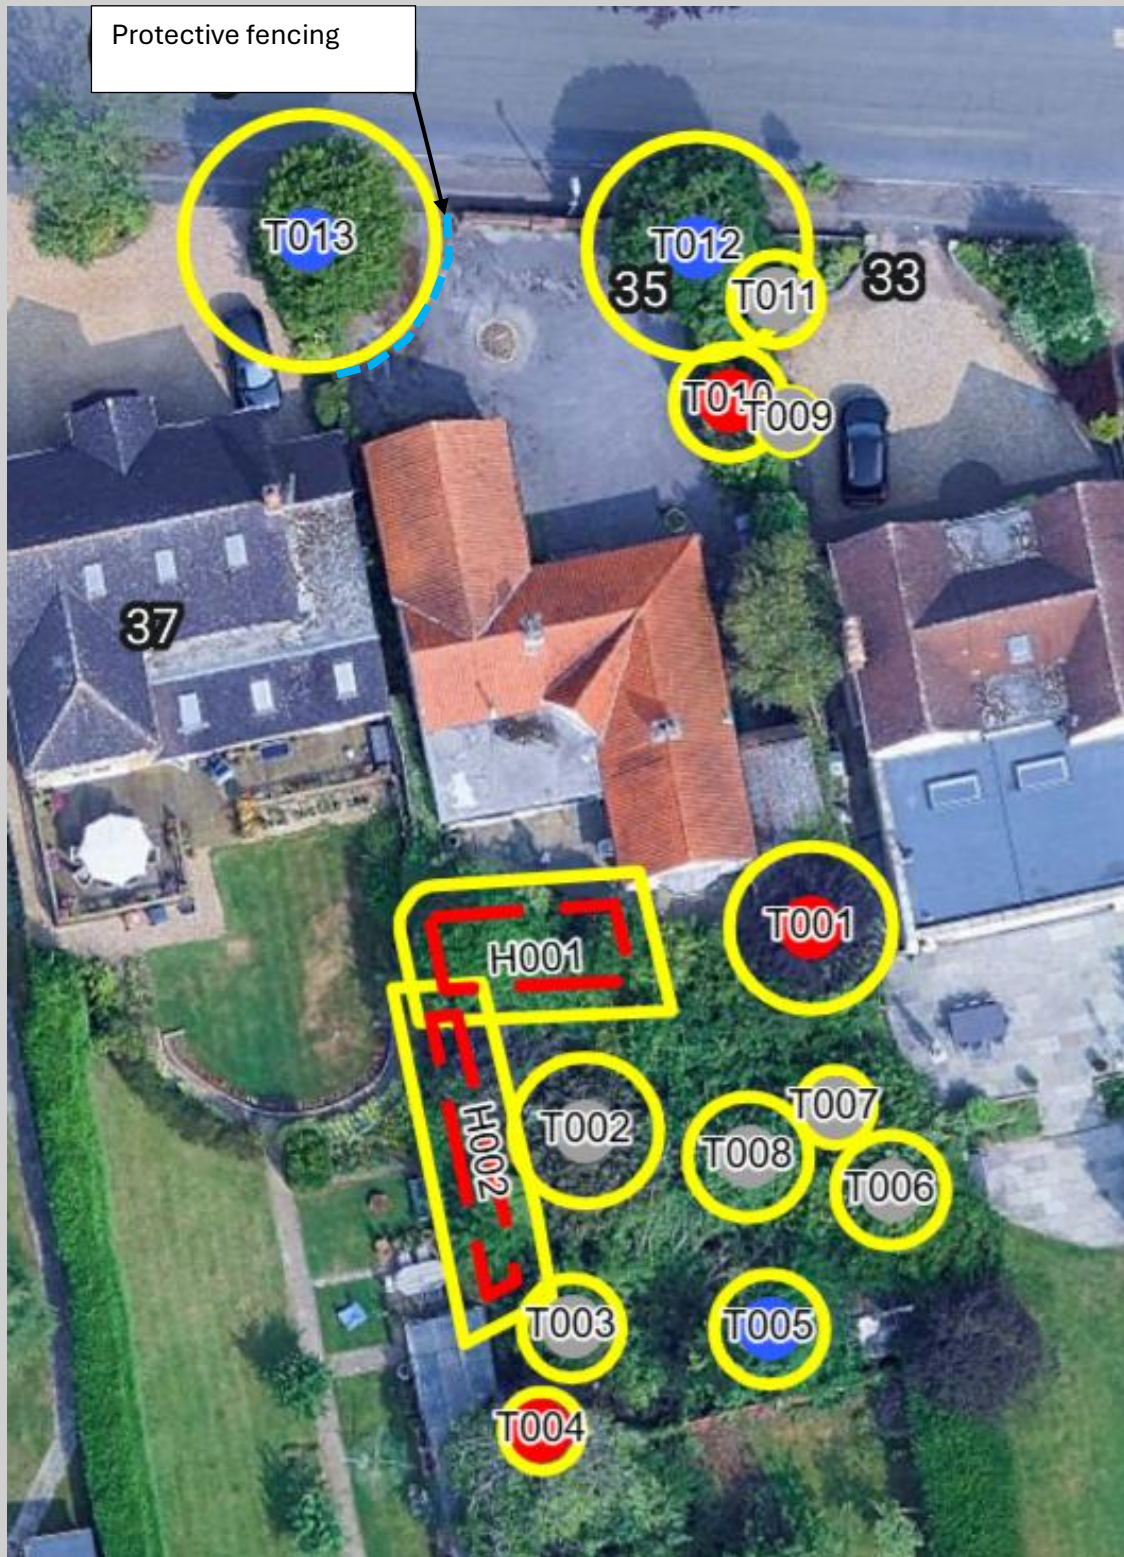
## Tree Protection Plan

The Tree Protection Plan above shows the only tree proposed to be retained, T013, with a protective barrier, to be installed in line with its Root Protection Area (RPA). This ensures that no excavations will affect roots within, thus eliminating the risk of damaging this tree.

RPA will be a minimum of 2 metres clear of the existing/proposed property line. Therefore all excavations for the foundation could be carried out comfortably without encroaching into tree T013's RPA.

In terms of the impact of the retained Yew tree T013 onto the proposed development, this will be minimal and no different to any impact this tree might have caused for a number of decades, located within the same position with respect to the existing house and driveway.

2. Protection fencing as per *Tree Protection Plan* shall be erected prior to any operations on site.
3. The fencing shall not be removed or breached during operations without prior consultation with an Arboricultural specialist and the approval of the Local Authority.
