## **ARBORICULTURAL REPORT:**

**ARBORICULTURAL  
IMPACT ASSESSMENT**

**ARBORICULTURAL METHOD  
STATEMENT**

**The Node Court, Drivers End Lane,  
Codicote, Hertfordshire, SG4 8TR.**

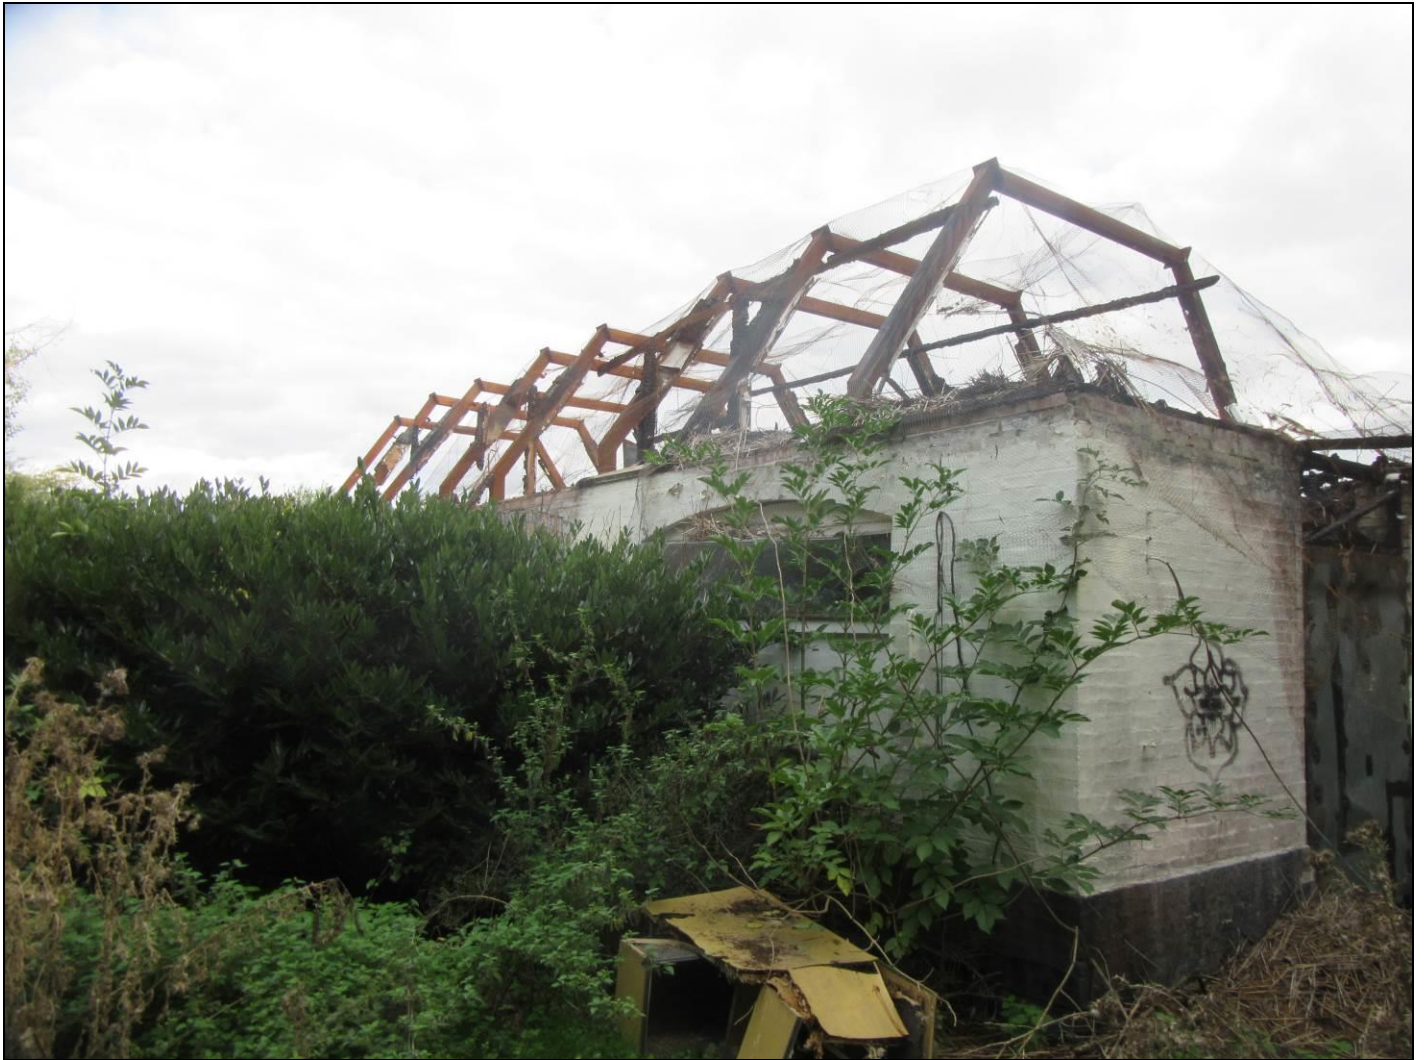
Photograph B – Showing the derelict building to the rear site boundary.

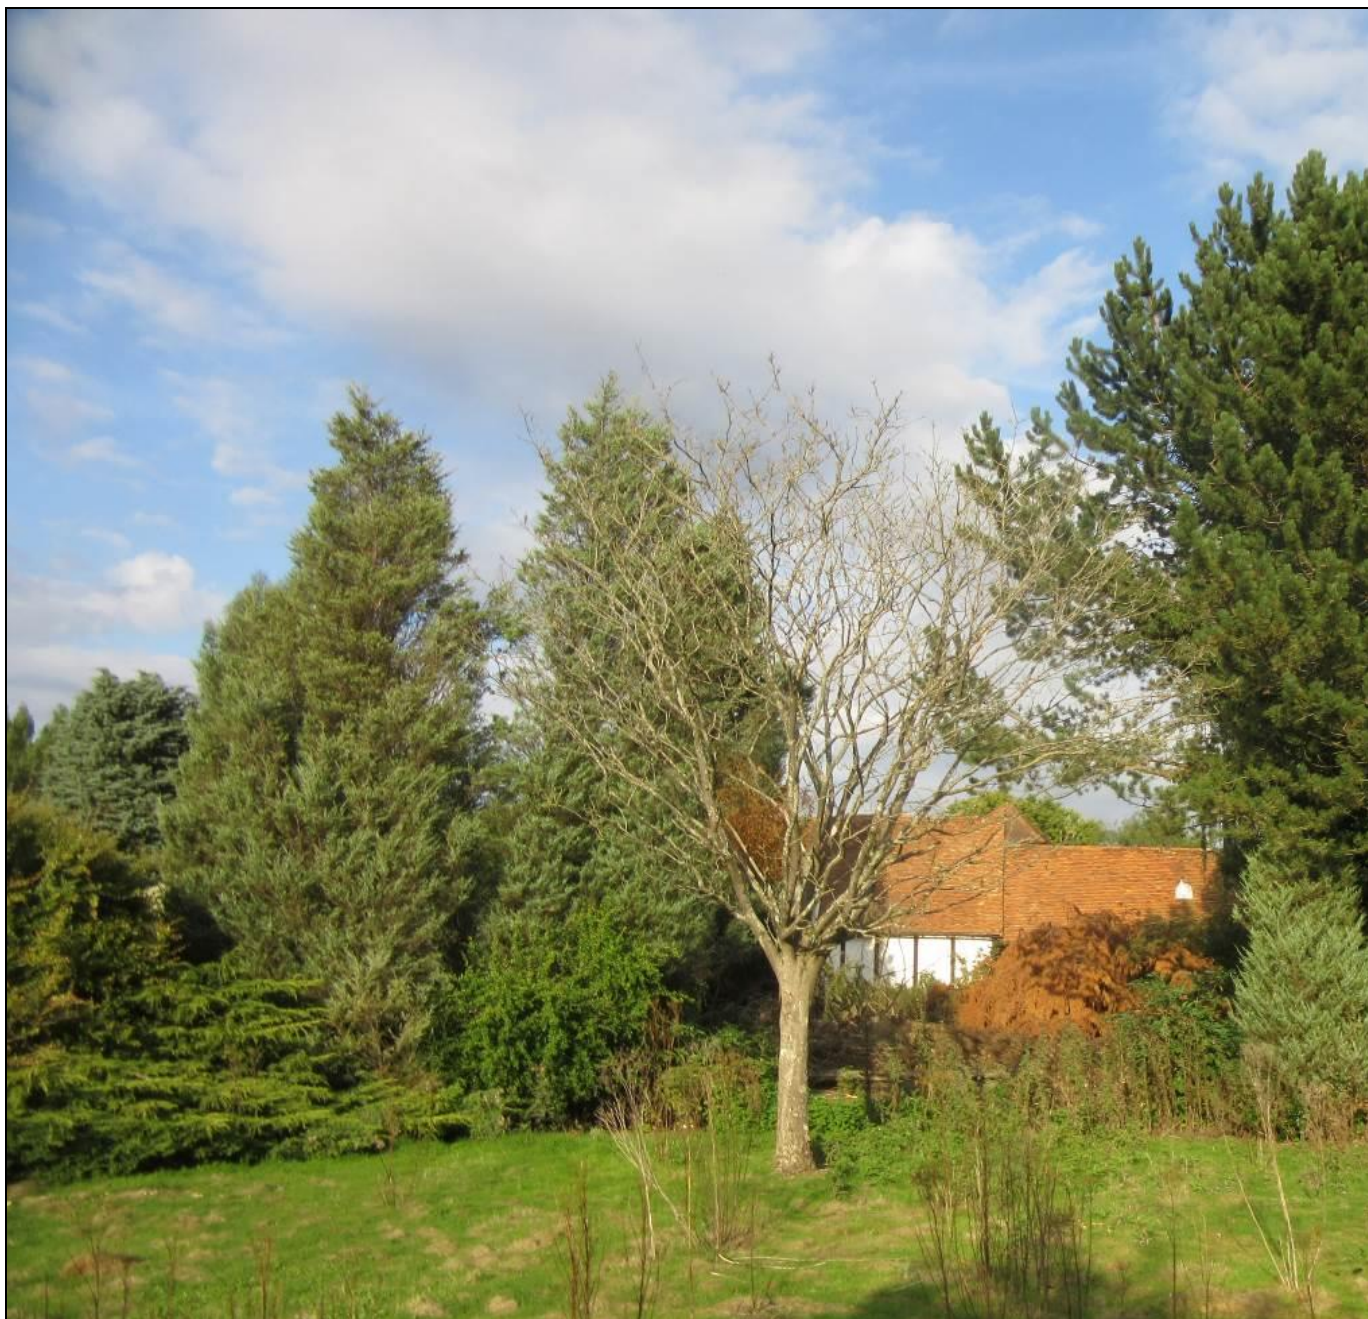
| <u>Tree No.</u> | <u>Species</u><br>(Common Name) | <u>BS</u><br><u>Category</u> | <u>Reason for recommended removal</u> |
|---|---|---|---|
| T1 | Sorbus | U | Predominately dead. |

Photograph E – Looking towards Sorbus (T1).

Of the trees within this report 1 no. individual tree (T1) is recommended for removal irrespective of this Planning Application. This tree has limited life expectancy. The fire to the rear of the site has damaged trees within G5 which are growing closely together. These trees should be assessed and monitored to confirm which trees can be retained within the ongoing use of the site. Some trees may need to be removed if they are exposed to 'wind throw' by the removal of adjacent trees. At this stage it is assessed that up to 12 no. trees will be removed. Trees may be retained as a standing deadwood resource if there is no risk to users of the site. Alternatively, trees could be felled and cut up to form log piles which can be stacked on site to be utilised by wildlife.

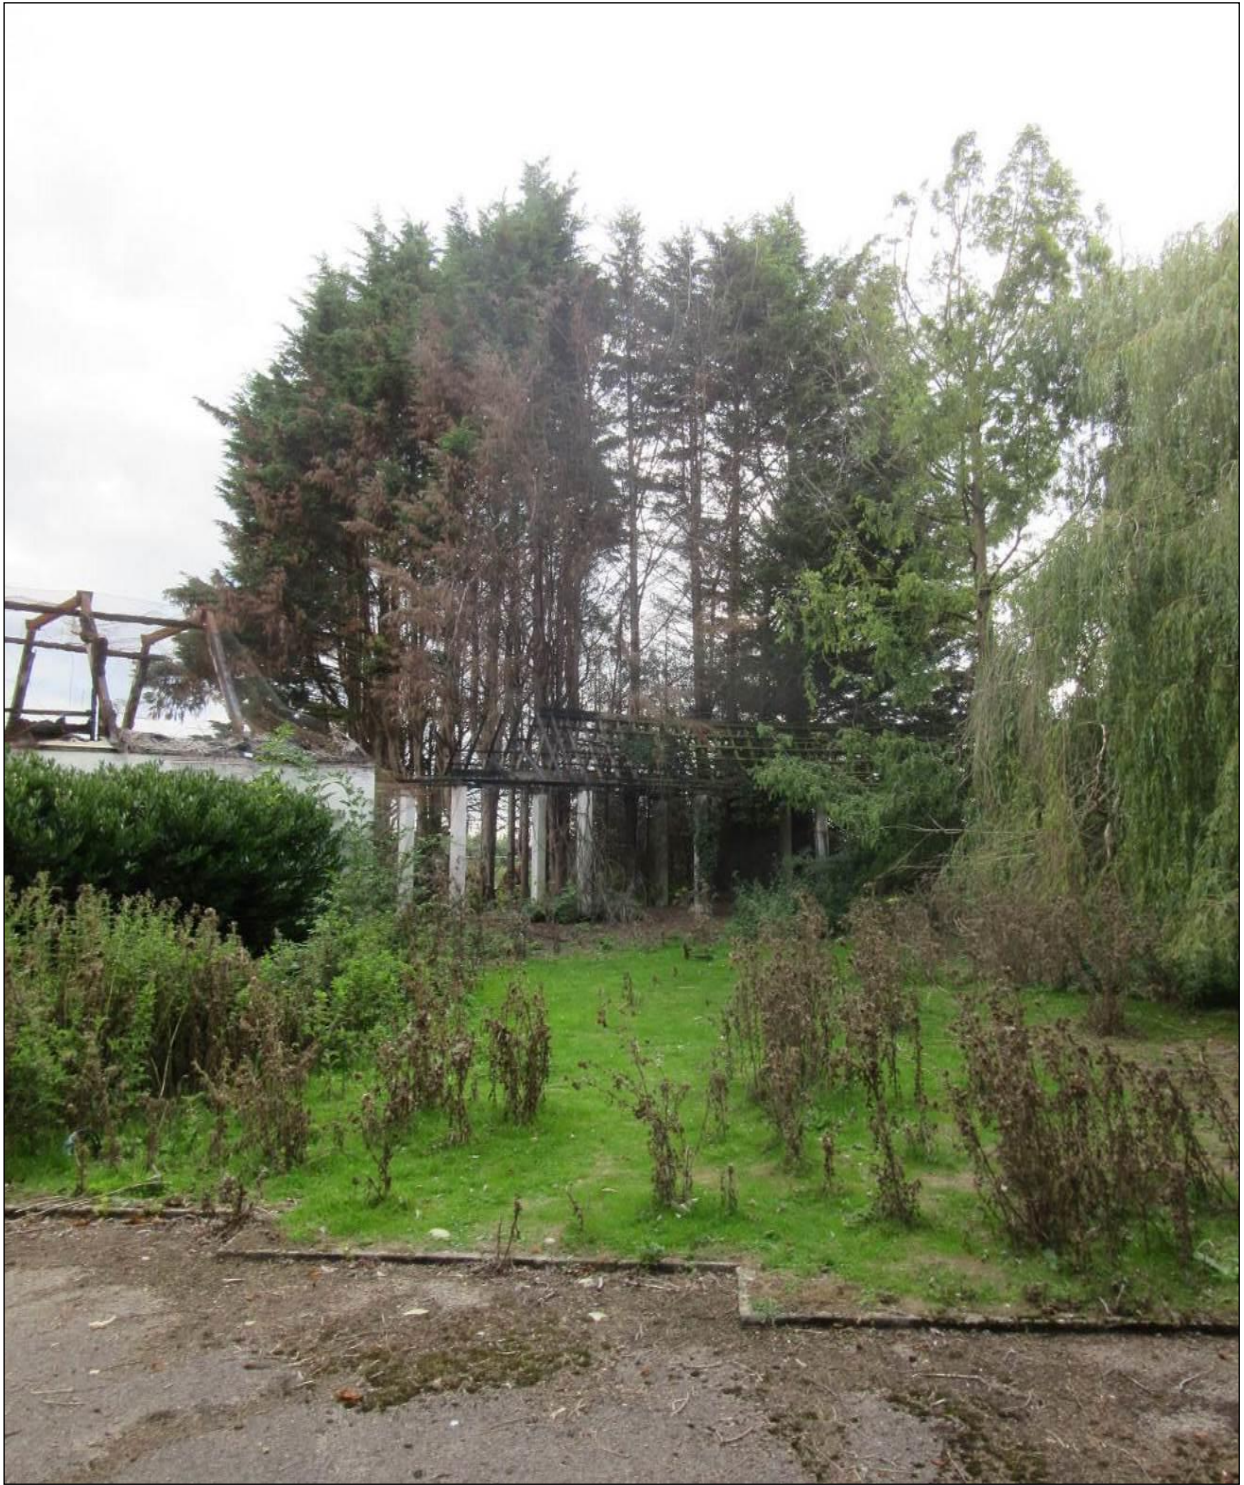
| <u>Tree No.</u> | <u>Species</u><br>(Common Name) | <u>BS</u><br><u>Category</u> | <u>Reason for recommended removal</u> |
|---|---|---|---|
| G5 | Several Cypress and Thuja | U/C2 | Monitor trees and confirm which trees will need to be removed. |

Photograph F – Showing fire damage to G1.

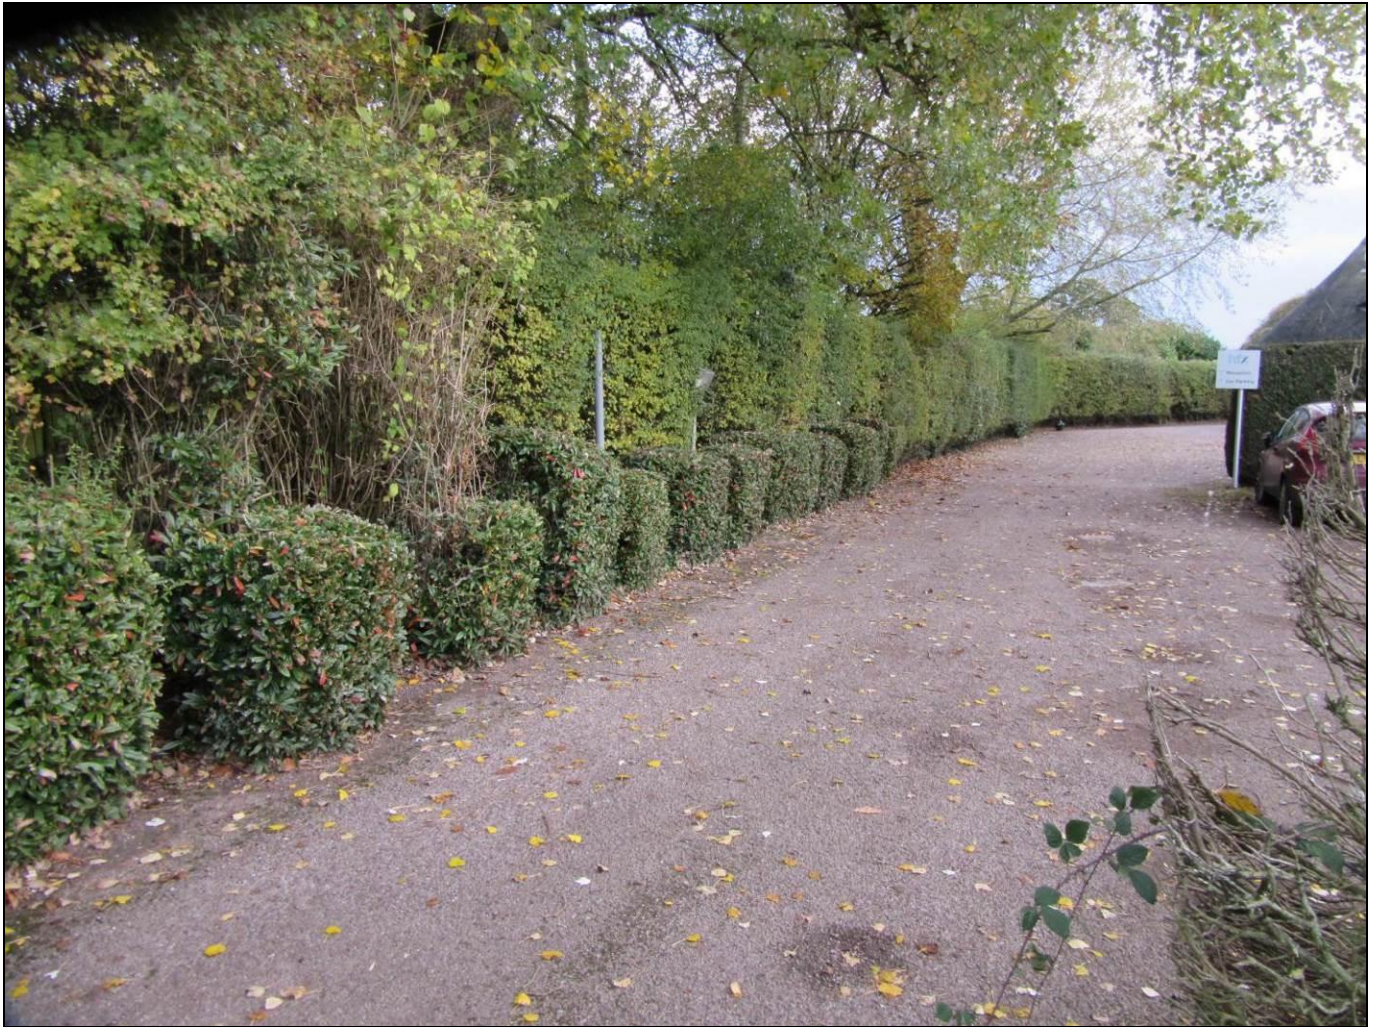
Photograph G – Showing existing access driveway adjacent to eastern boundary and trees T11-T13 and G6 (2018).

The refurbishment of the main building will take place outside the RPAs of trees. The enabling development will take place within 12% of the RPA of Aspen (T13). This is within the area of the existing hardstanding and approximately 9.0 m from the tree. As set out above the presence and construction of the hardstanding will have had an effect on the rooting activity from this tree. Additionally at this distance from the tree it is anticipated that there will be few (if any) roots from T13 over 20 mm diameter here (Biddle 'Tree Root Damage to Buildings' Volume 1). Fibrous roots may be present. The potential incursion is mitigated by the removal of the existing access driveway within 30% of the RPA and the formation of this area into the landscape area of the site. It is noted that – as discussed in BS 5837:2012 – there are soil volumes contiguous with the RPA of this tree which it can exploit. The 12% incursion could therefore be considered as insignificant to the long term viability of this tree.

- 6.31 However this is a prominent (offsite) tree within this part of the site and its retention is seen as an important element within the site development. To achieve this it is recommended that further site investigations (in the form of exploratory trial trenches) are undertaken to determine root activity. This would guide the foundation design of the adjacent buildings. If

relevant the final design of the foundations would ensure that as much rooting material as possible from this tree is retained and gaseous exchange and water percolation to roots can still occur. A methodology for the site investigations and the design of the foundations is set out in the Arboricultural Method Statement.

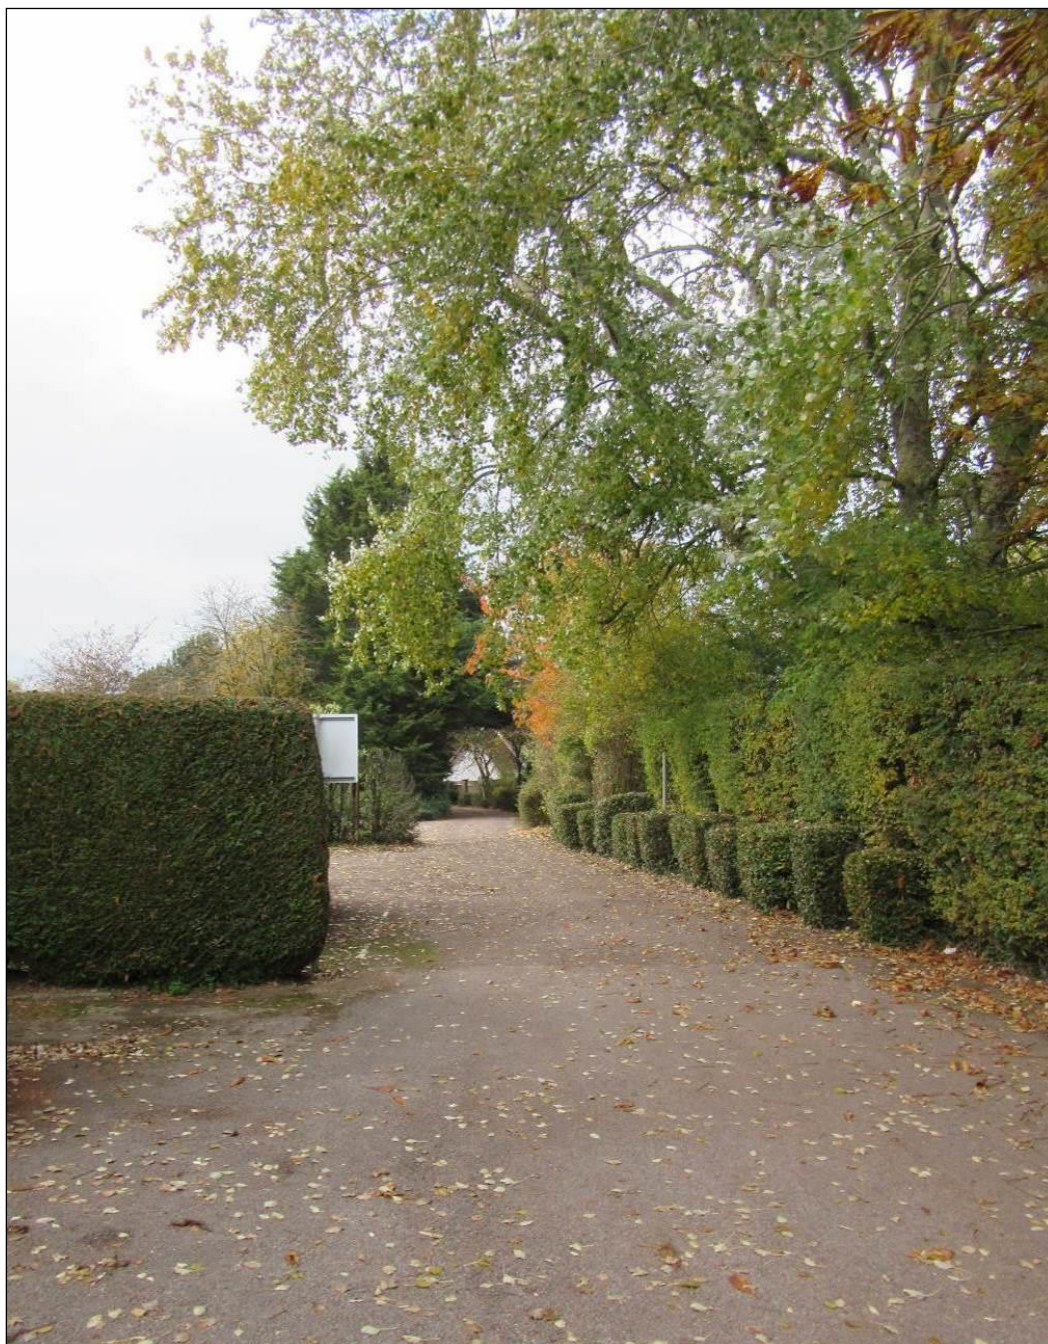
Photograph H – Showing the canopies of trees along the eastern boundary (2018).

- 6.35 The canopies of Aspens (T11 and T13) – see Photograph E - are over the garden areas of the enabling development. It is proposed to prune these canopies back to create a harmonious relationship between the trees and the garden area. The trees would be selectively pruned by approximately 4.0 m to the western aspect leaving a branch spread of 5.0-6.0 m to this aspect. The canopies of the trees would be shaped to create a flowing and natural form. These works are considered to be minor and insignificant within the current structure and condition of the trees. These works will not affect the long term viability and amenity value of these trees.

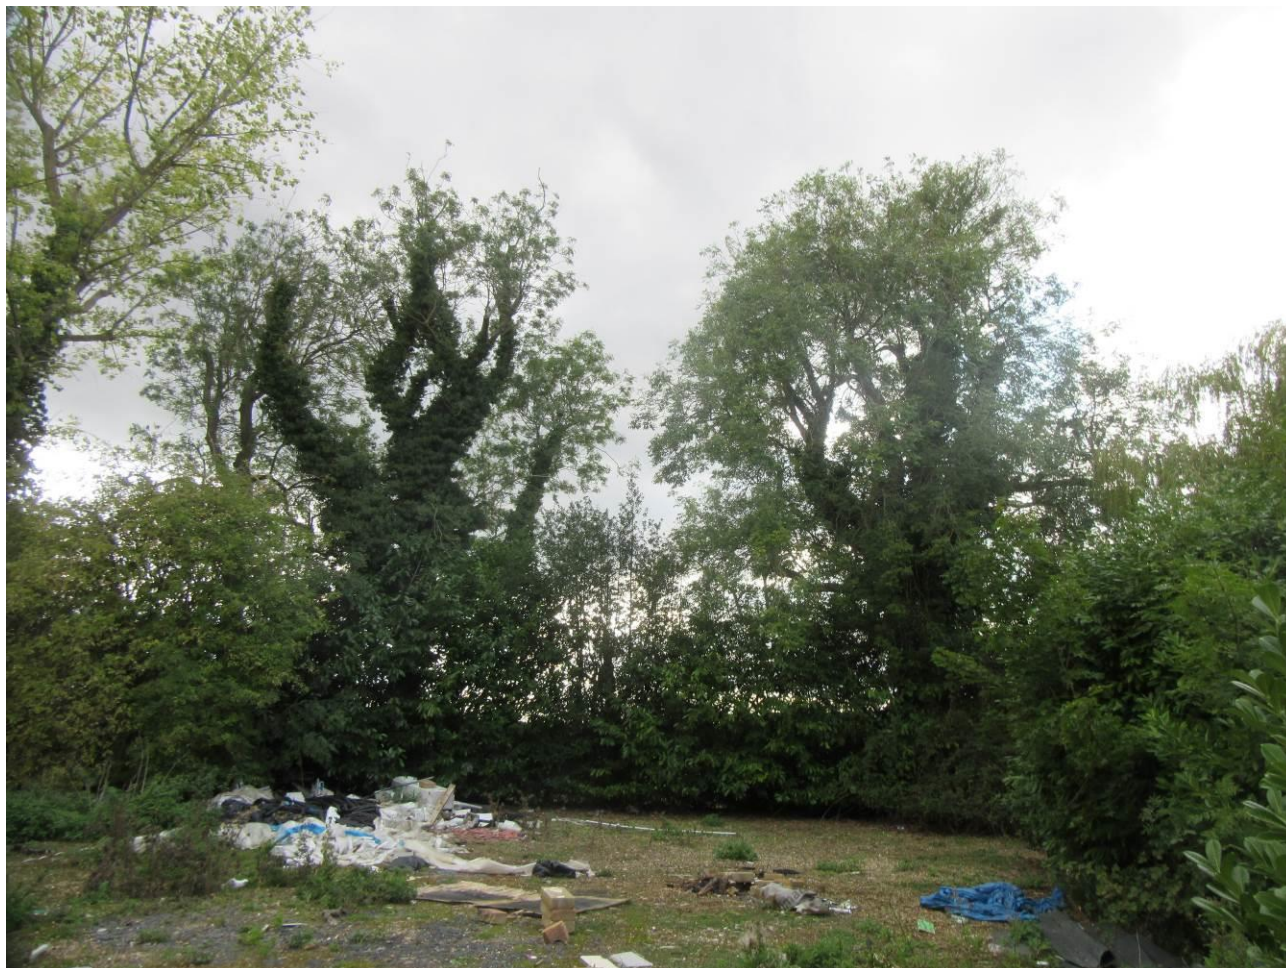
Photograph I – Looking west towards Ash (T5) and G3). Some of the fly tipping within the site is visible.

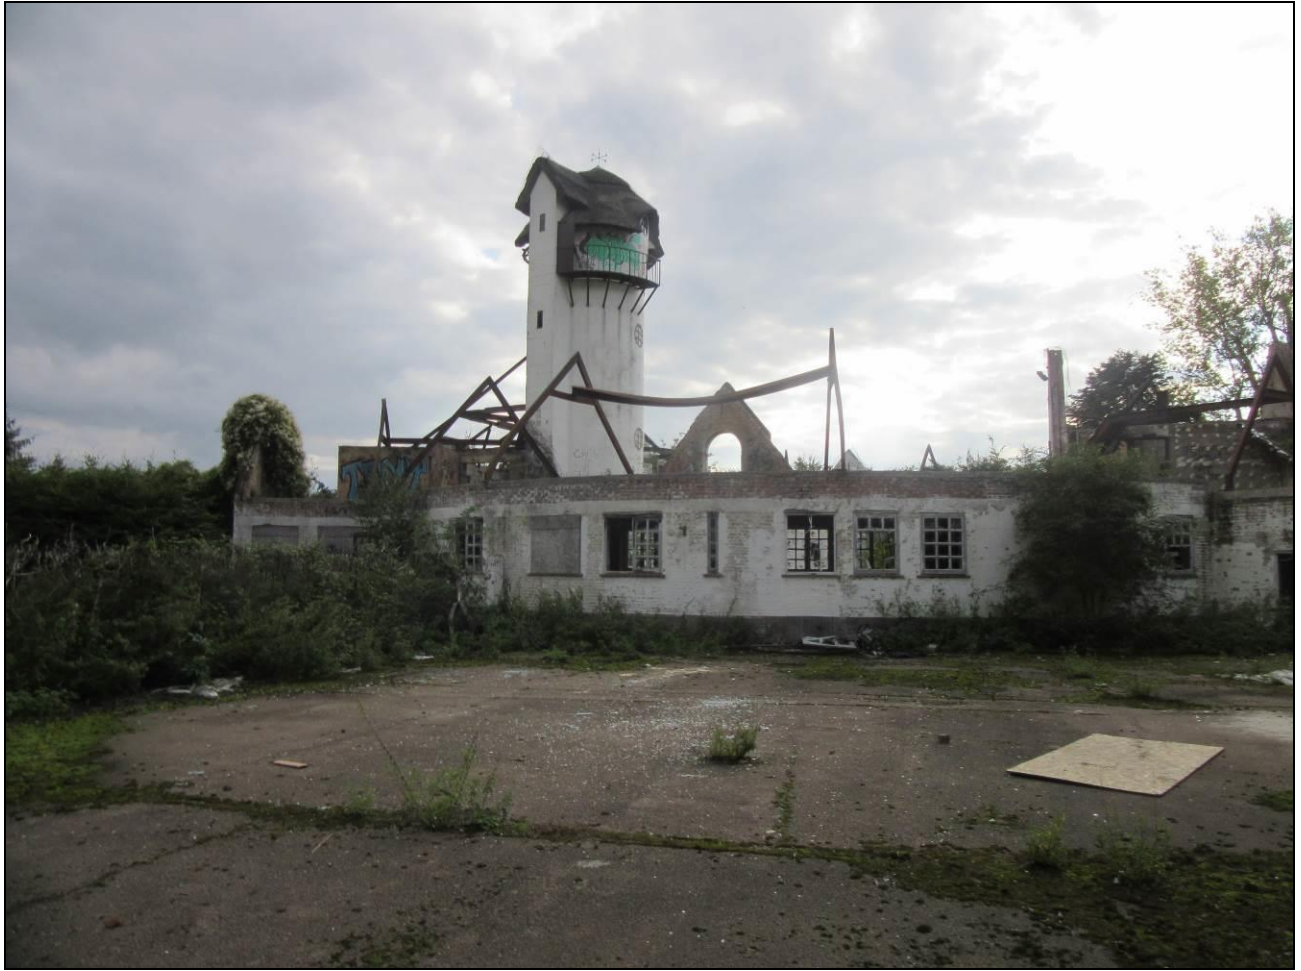
Photograph K – Showing the condition of the Listed Building.
