# Arboricultural Impact Assessment and Method Statement

**Client:** 1418 Development & Consulting Ltd

**Site:** 38 Heathfield  
Royston  
Hertfordshire  
SG8 5BN

**Reference:** TCTC-19171

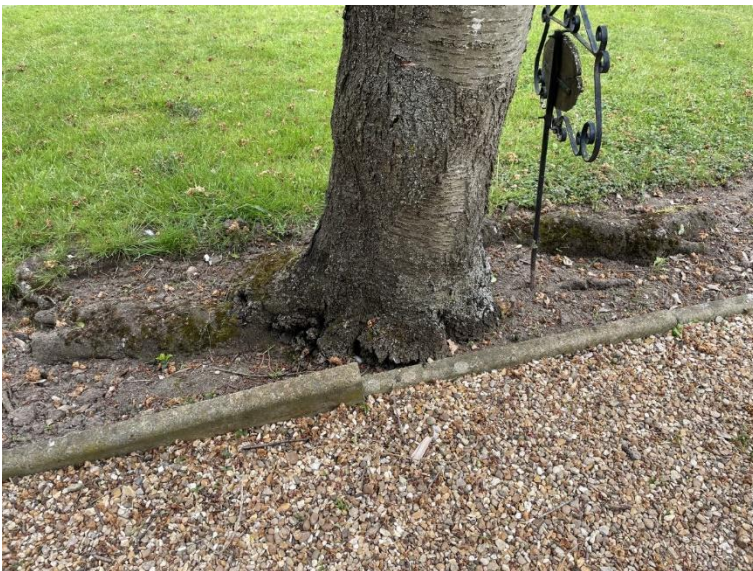
TC3 (13.05.24) Structural roots of T43 to be retained and protected with design

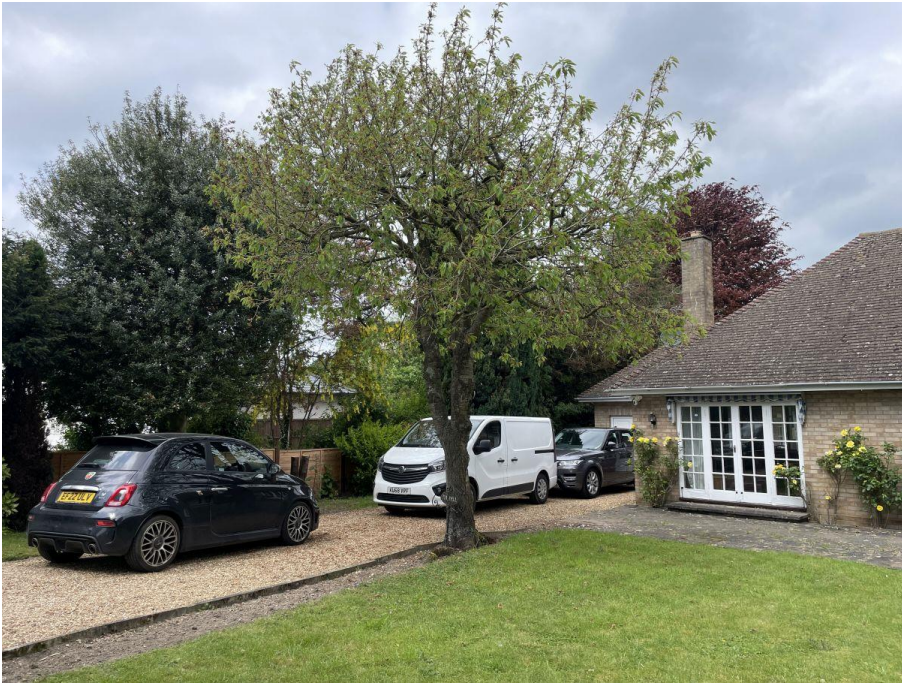
TC4 (13.05.24) View looking northwest, T43 in the foreground

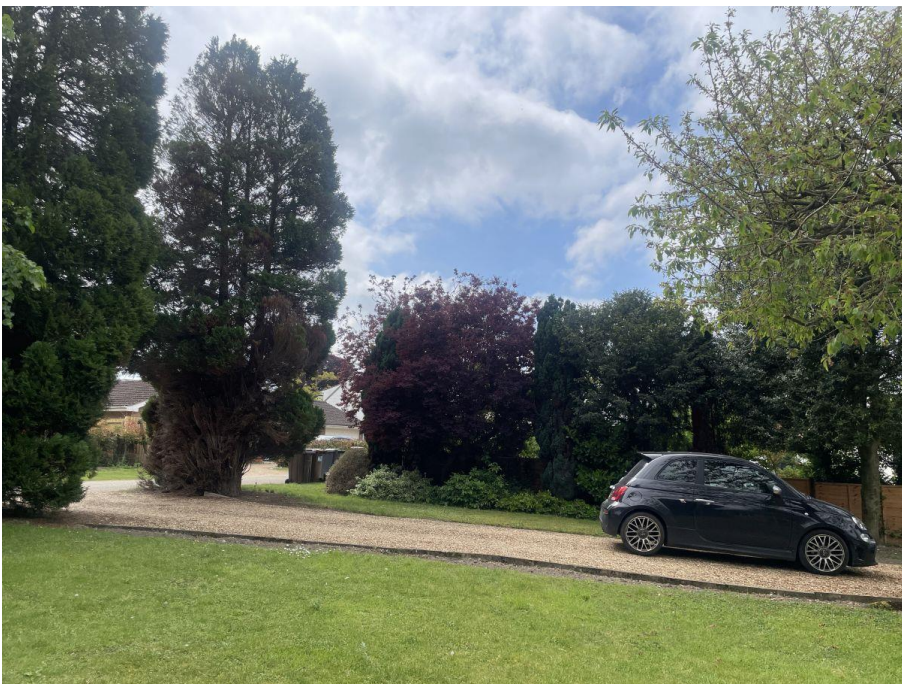
TC5 (13.05.24) View looking west, existing drive alignment and boundary vegetation retained
