**PLANNING REFERENCE 17/01955/1 Conditions 6 and 7**

ARBORICULTURAL IMPACT ASSESSMENT AND METHOD STATEMENT REPORT

Ickleford Mill, Arlesey Road, Ickleford

**OUR REF: SHA 1948 Rev A**

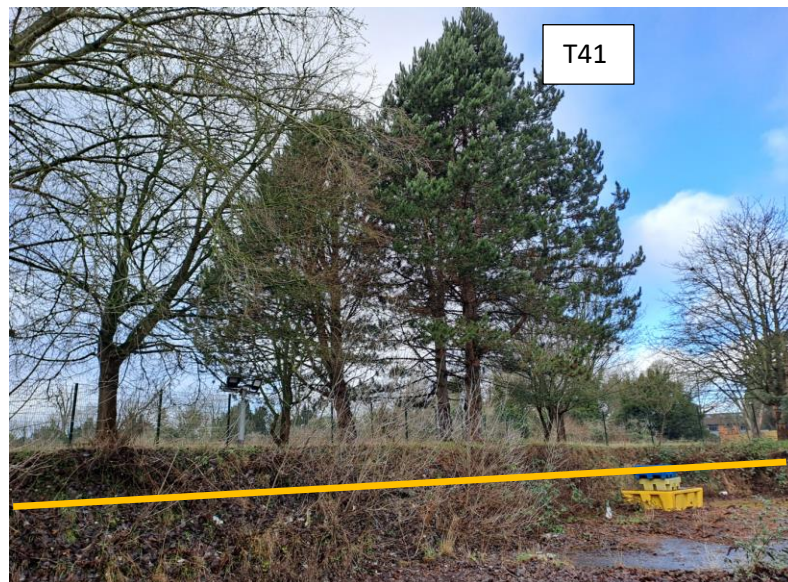
*Photo 10 of north-western corner showing step bank and level change – annotated for proposed levels*

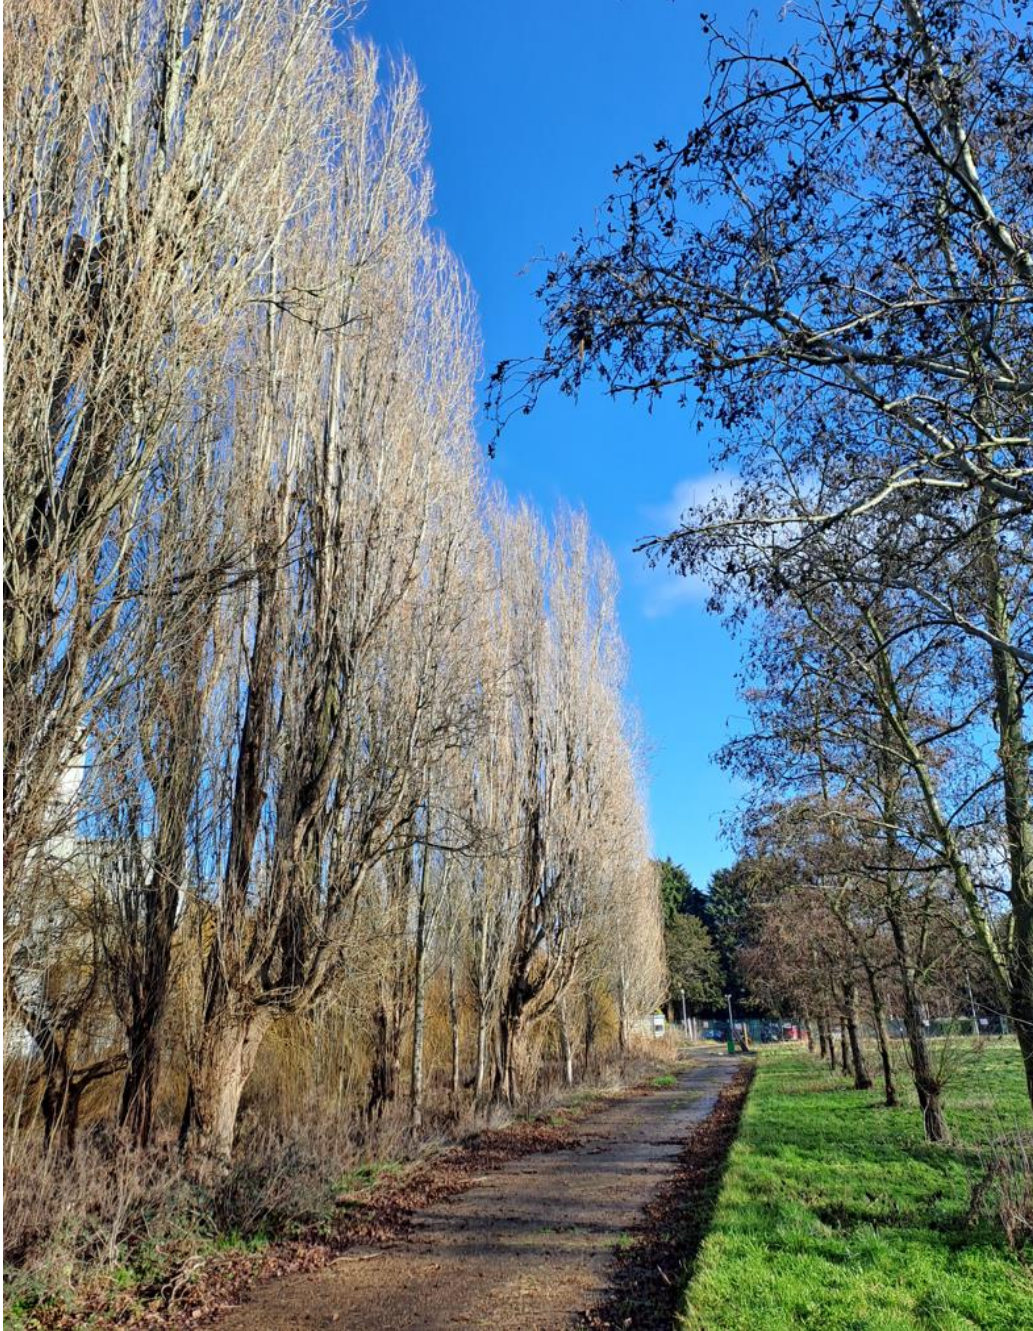
*Photo 14 of the poplars on the northern part of the existing path and alders on the southern side.*

*Looking east. Note that the removal of the path and replacement path with hoggin is beneficial as this surface is flexible and adjusts to tree root growth without causing cracking.*

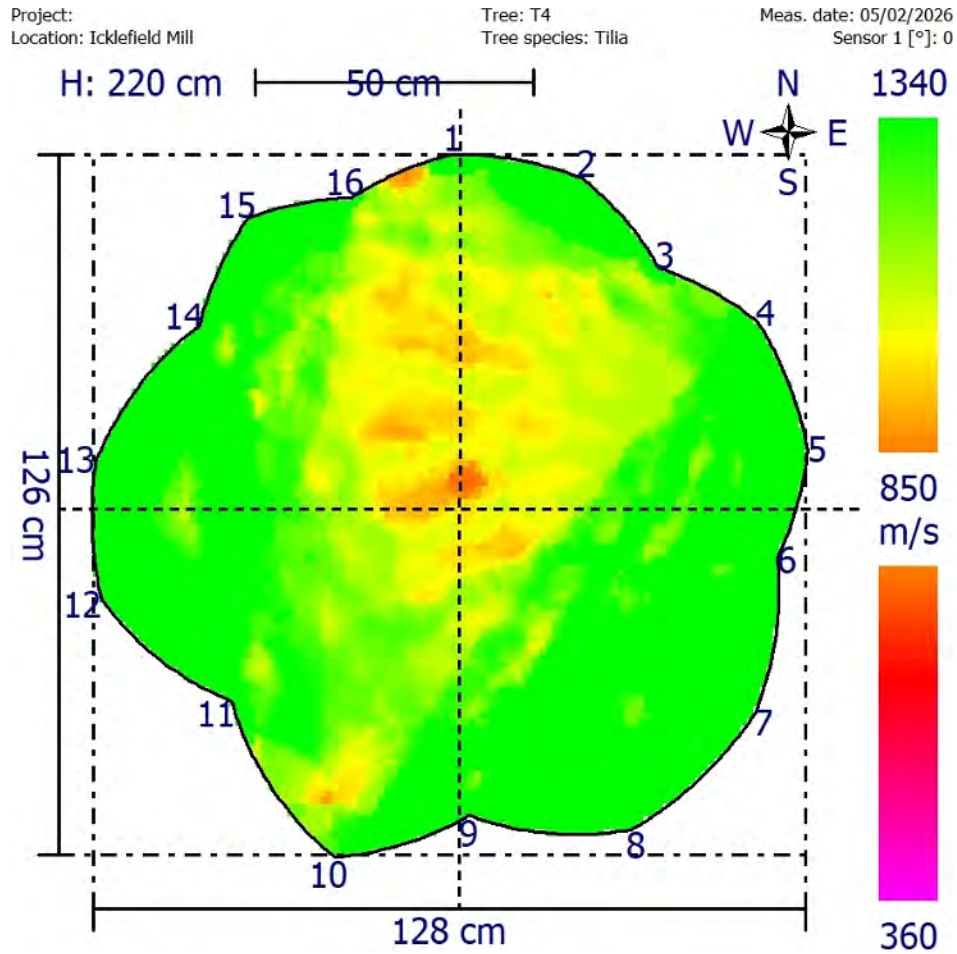
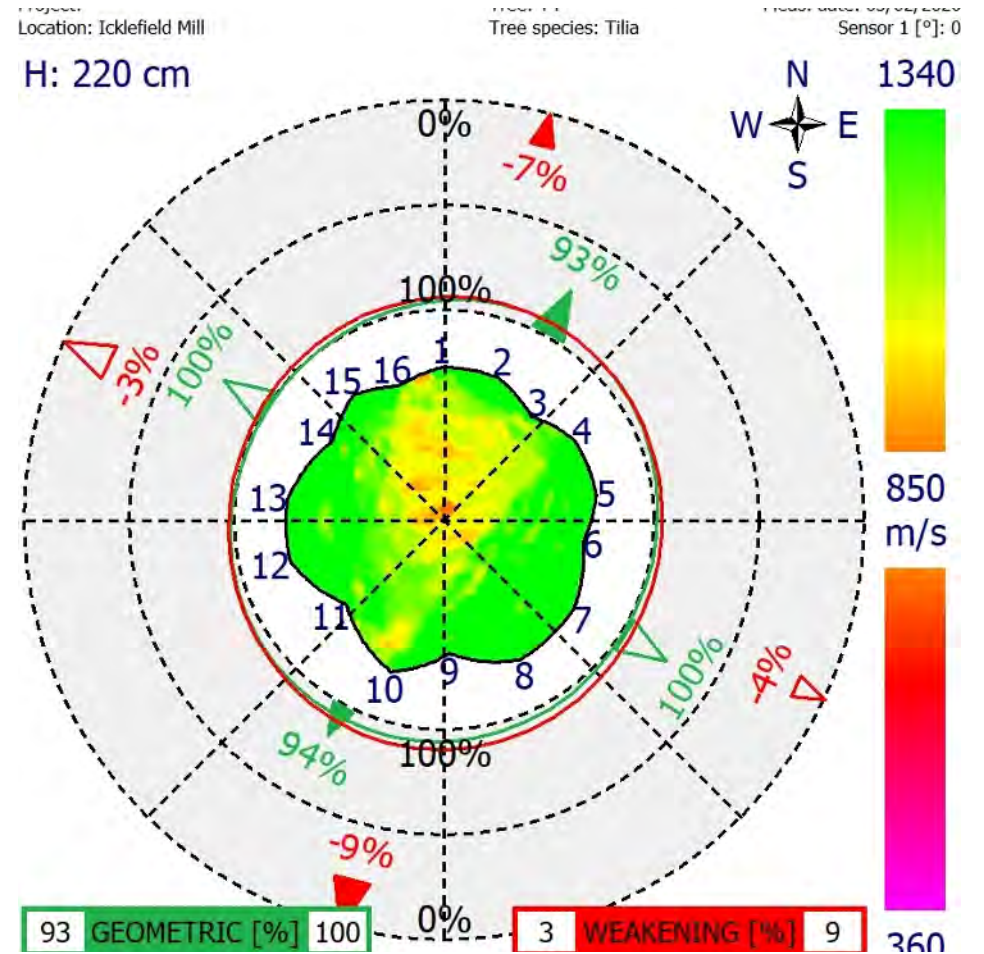
# Tomography - T4 at 220cm

Decay at 220cm above ground level is moderate. Impact on mechanical strength is low to moderate at 9%.
