ARBORICULTURAL IMPACT ASSESSMENT REPORT

Temple Dinsley, School Lane, Preston, Hertfordshire, SG4 7RT

The Door PHC Ltd

**DATE: July 2024**

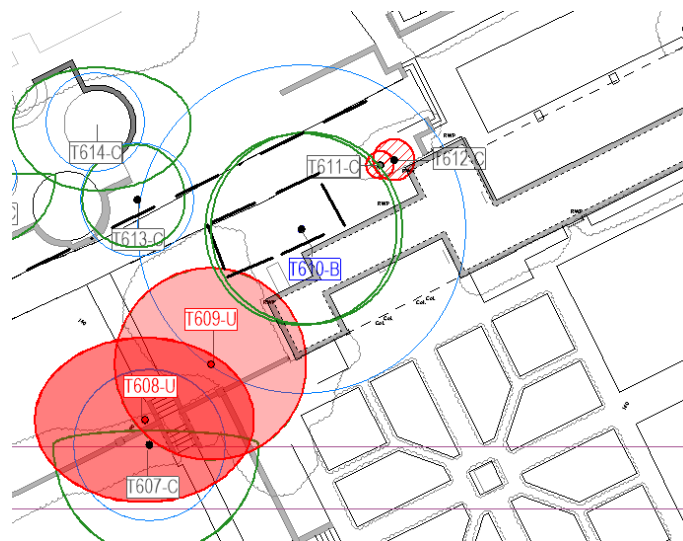
*Plan 3 – extract from SHA 1676 TPP – do not scale, north is vertical. Note this is very much a draft, but the tree T610 will be retained and protected.*

6.4.1 **The Pavilion:** 2 C category trees. Two nearby U category trees are recommended for removal due to poor condition, and not in connection with the proposal

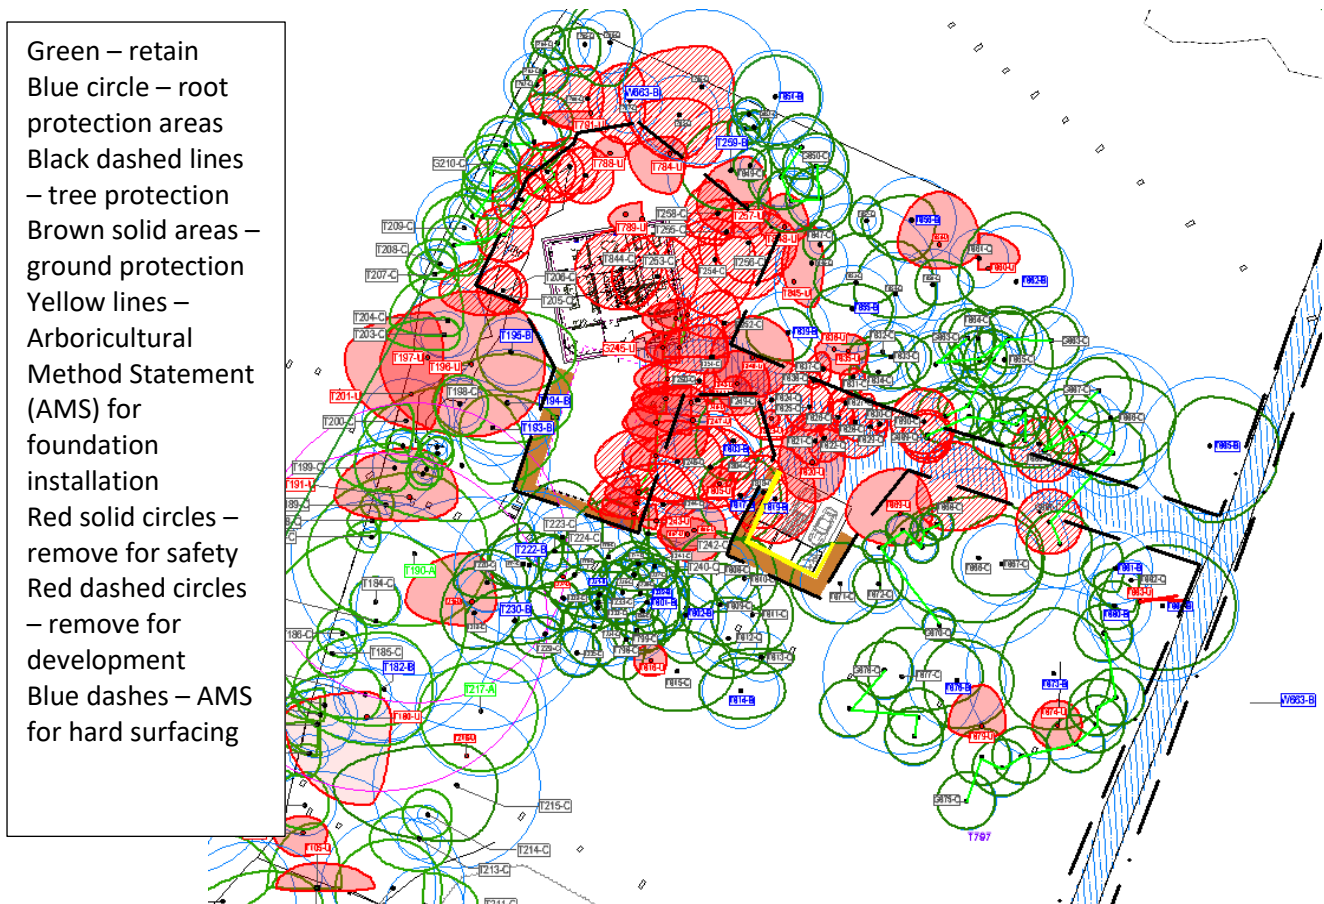
Plan 5 – extract from SHA 1676 TPP – do not scale, north is vertical.

#### 6.4.2 Summer House: 2 B, 43 C and 45 U category trees

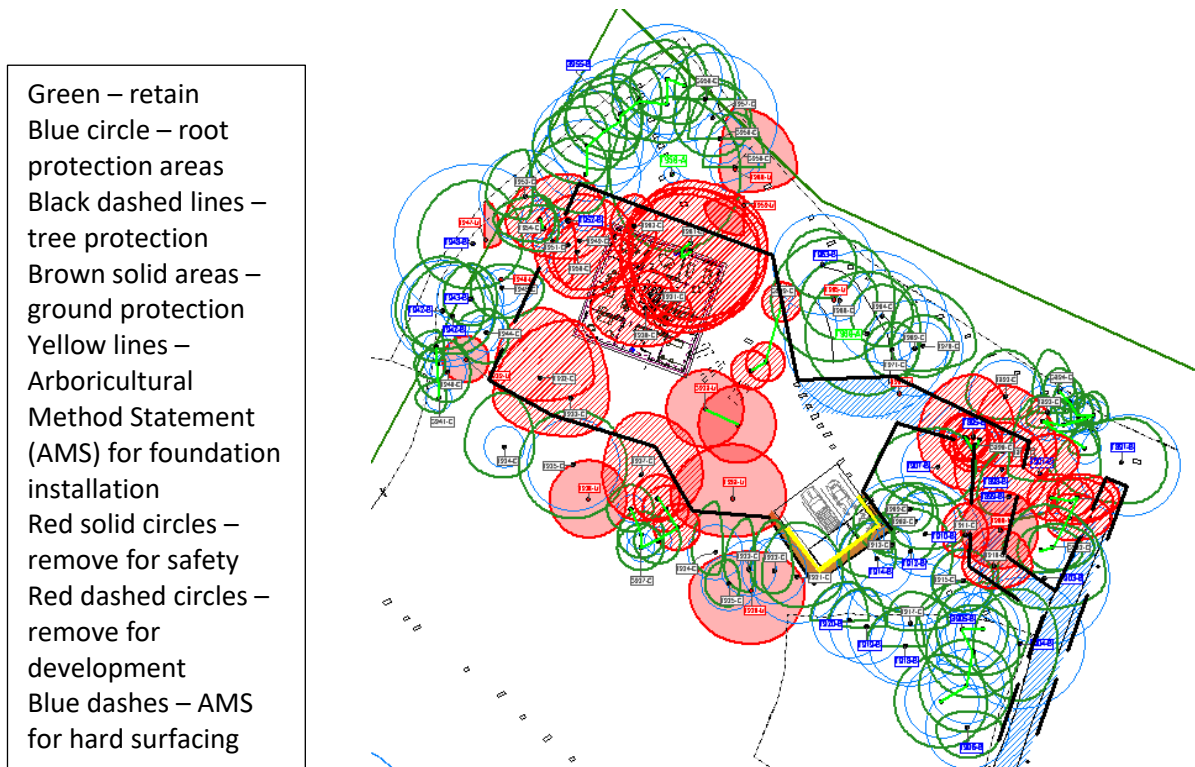
Plan 6 – extract from SHA 1676 TPP – do not scale, north is vertical.

#### 6.4.3 Harwood House: 4 B, 25 C and 16 U category trees

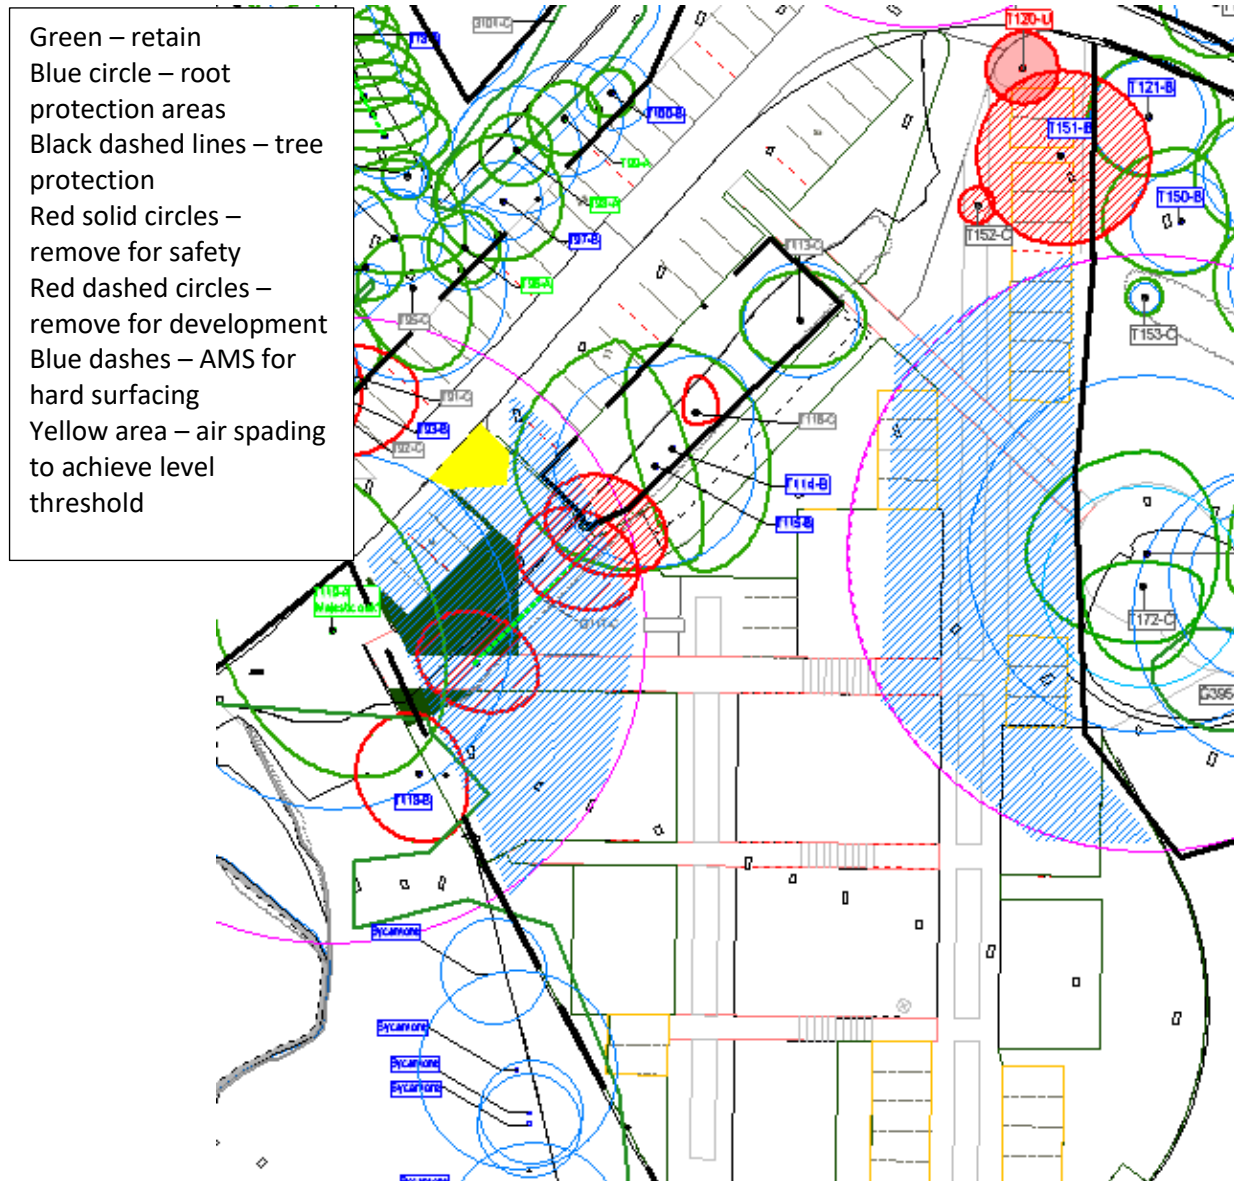
Plan 7 – extract from SHA 1676 TPP – do not scale, north is vertical.

#### 6.4.4 East park: 1 B, 5 C and 1 U category trees

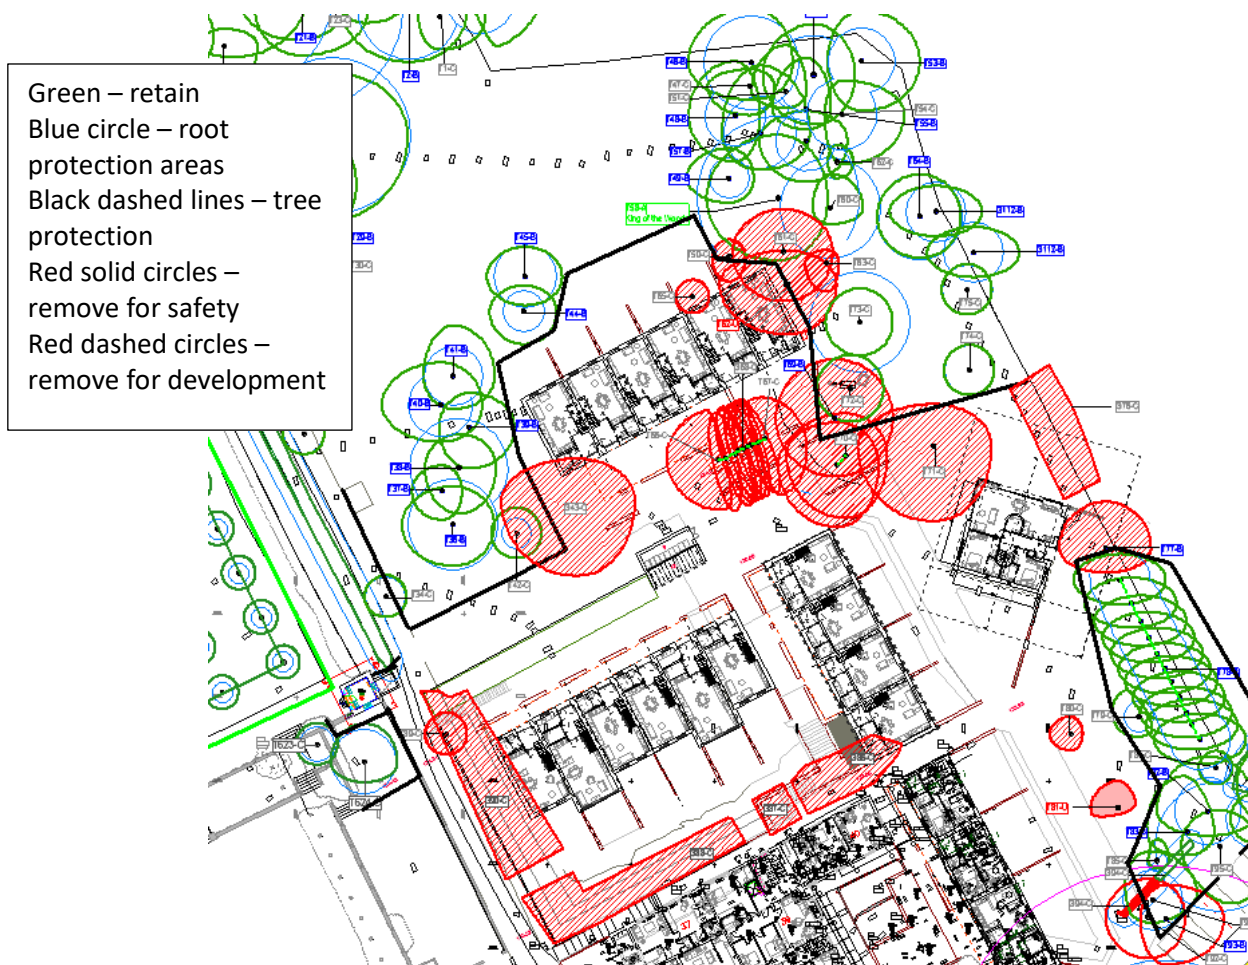
Plan 8 – extract from SHA 1676 TPP – do not scale, north is vertical.

#### 6.4.5 Sports Hall locale Housing: 3 B, 14 C and 2 U category trees
