**641-KS-06-MB-SH-A-90090 – P04**

**Temple Dinsley Level 0, GA – Apartment 9 - Pavilion**

**Pavilion – Proposed Apartment 9 – Plan of Significance – Refer to 641-KS-03-MB-DR-A-02010**

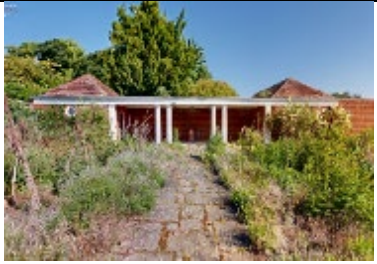
| Reference | Proposal | Significance of affected fabric | Impact | Reasoning and mitigation |
|---|---|---|---|---|
| A-Walls<br>9A.P1 | Conversion and extension to Lutyens' Pavilion Building. Demolition of Late C20 and Early C21 additions. | High<br>Remnants of Pre 1884 Outbuilding<br>Early C20<br>1909 Lutyens | Moderate | <p>The Pavilion is a great opportunity to make use of a forgotten part of the site that was an integral part of Lutyens' 1909 West wing proposals.</p> <p>To minimise the impact of the conversion of the Pavilion the visible alterations are proposed to the North Elevation. Removing the unsympathetic late C20 and early C21 additions and inserting a new link extension with minimal alteration to the historic fabric, incorporates the garden wall within the design whilst limiting any visible change to the significant South Elevation. The proposed link will adopt a different materiality (vertical boarding has been shown) to differentiate between the new and old. The roof line has been kept shallow pitched behind a parapet and is lower than the 1909 garden wall so it remains concealed on the South Elevation. The layout of the design gives access to the dwelling to the North. Views to the West and East also.</p> <p>As the South terrace was designed to be used by visitors to the Rose Garden there is a intention to keep this a communal space.</p> <p>The 1909 panelled doors to the covered terrace are to be visually retained but closed off – providing no access. This allows for clear separation between communal areas (the terrace) and the pavilion (dwelling). The arrangement of the gardens and terrace will remain unchanged and its context within the setting is preserved.</p> |

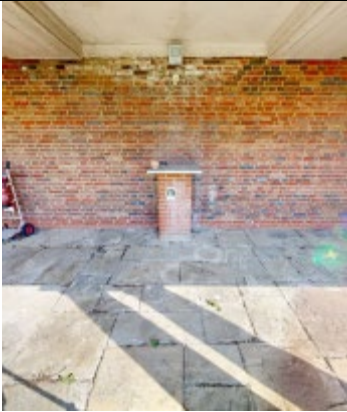
| Reference | Proposal | Significance of affected fabric | Impact | Reasoning and mitigation |
|---|---|---|---|---|
| A-Walls<br>9A.R1 | Repair to existing South Terrace of Rose Graden Pavilion. | High<br>Early C20<br>1909 Lutyens | Low<br>Impact<br>Benefit | |

| Reference | Proposal | Significance of affected fabric | Impact | Reasoning and mitigation |
|---|---|---|---|---|
| | | | | <p>This terrace was used as a covered access by the school Art Department. The roof / ceiling build up, cornice detailing and pillars will require some repair. The sheltered brickwork will require a small amount of lime repointing. Repair work will have a positive impact and revive the structure visually and address any damp.</p> |

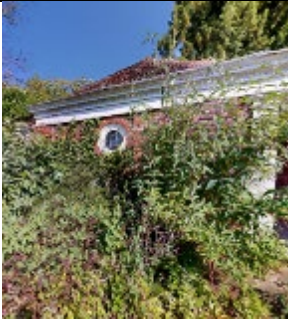
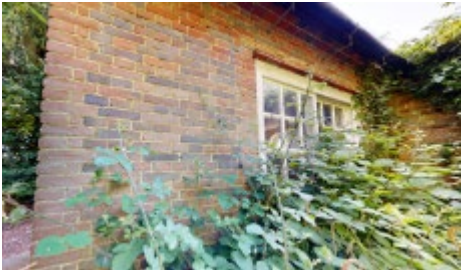
| Reference | Proposal | Significance of affected fabric | Impact | Reasoning and mitigation |
|---|---|---|---|---|
| A-Walls<br>9A.R2 | Repair to West Building of Pavilion. | High<br>Early C20<br>1909 Lutyens | Low<br>Impact<br>Benefit | <p>Overgrown planting shall be removed and the wall repointed where required. Cornice detail to be repaired and replacement of any lead flashings and blown clay tiles to the hipped roof. Positive impact and visual improvement.</p> |

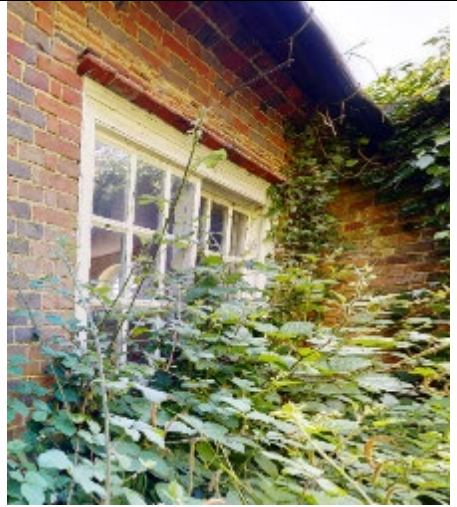
| Reference | Proposal | Significance of affected fabric | Impact | Reasoning and mitigation |
|---|---|---|---|---|
| | | | | <p>The West Pavilion Building has some special architectural features such as a brick soffit, creasing tile lintel and metal rise and fall brackets with half round gutters. All the existing elements shall be retained and repaired.</p> |

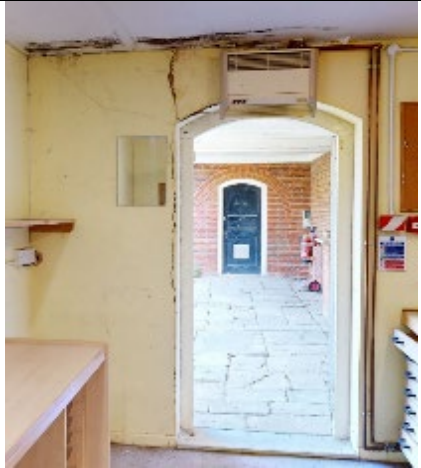
| Reference | Proposal | Significance of affected fabric | Impact | Reasoning and mitigation |
|---|---|---|---|---|
| A-Walls<br>30A.R4 | Repair wall to East Pavilion Building that has visible signs of damp (leaking roof/flashing detail) and structural movement. | High<br>Early C20<br>1909 Lutyens | Low<br>Impact<br>Benefit | <p>The roof shall be repaired with repair/replacement of any structural timbers as required. Once the cause of the movement has been established, allow for helibars to be used locally to tie the wall together. These walls have been plastered with a cement based plaster. Prior to lining the walls any cement based plasters shall be removed.</p> |

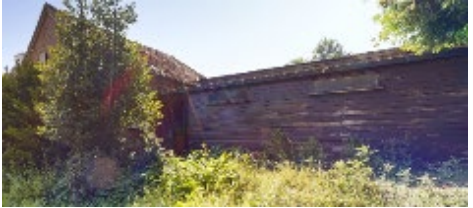
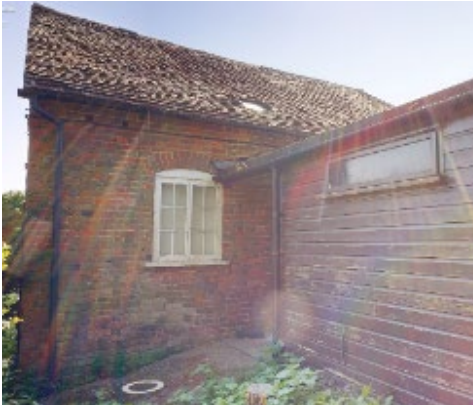
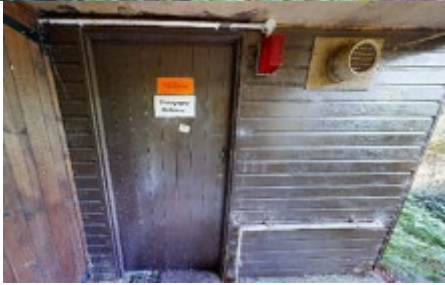
| Reference | Proposal | Significance of affected fabric | Impact | Reasoning and mitigation |
|---|---|---|---|---|
| A-Walls<br>9A.D1 | Demolition of shed style buildings. | Low-Negative<br>Late C20<br>Early C21<br>School additions. | Low<br>Impact<br>Benefit<br>Enhance | |

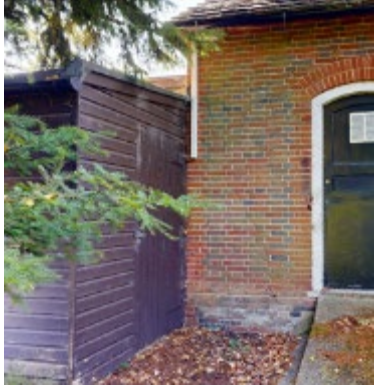
| Reference | Proposal | Significance of affected fabric | Impact | Reasoning and mitigation |
|---|---|---|---|---|
| | | | | <p>The sheds are of poor construction and basic arrangement. The junctions with Lutyens' pavilions are awkward and unsympathetic. The materiality is low specification. The proximity to the existing yew tree has not been managed. The removal of these sheds will be a massive benefit to the heritage asset and will enhance the setting.</p> |

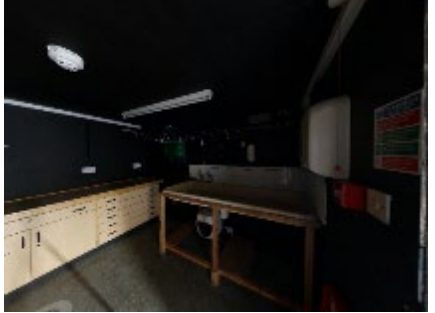
| Reference | Proposal | Significance of affected fabric | Impact | Reasoning and mitigation |
|---|---|---|---|---|
| A-Walls<br>9A.D2 | Demolition of shed style buildings (cont). | Low-Negative<br>Late C20 and Early C21. | Low<br>Impact<br>Benefit<br>Enhance | <p>These sheds are a C20/C21 school addition and have been added with little alteration to the historic fabric. There are unsympathetic junctions where the sheds meet the historic architectural features of the pavilion. The design is basic and has a negative impact on the setting visually, particularly to the north.</p> |

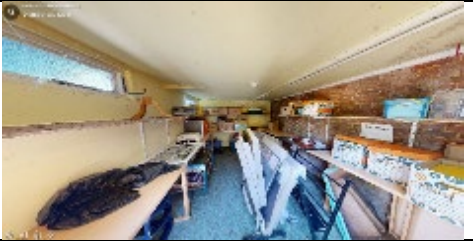
| Reference | Proposal | Significance of affected fabric | Impact | Reasoning and mitigation |
|---|---|---|---|---|
| A-Walls<br>9A.D3 | Demolition of shed style buildings (cont). | Low-Negative<br>Late C20 and Early C21. | Low<br>Impact<br>Benefit<br>Enhance | |

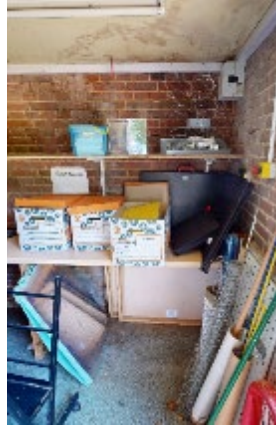
| Reference | Proposal | Significance of affected fabric | Impact | Reasoning and mitigation |
|---|---|---|---|---|
| | | | | <p>These sheds are a C20/C21 school addition and have been added with little alteration to the historic fabric. There are unsympathetic junctions where the sheds meet the historic architectural features of the pavilion. The design is basic and has a negative impact on the setting, particularly to the north. Visible damp due to a failed flashing. Positive impact of removal.</p> |

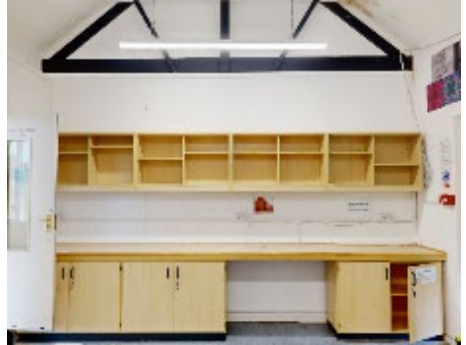
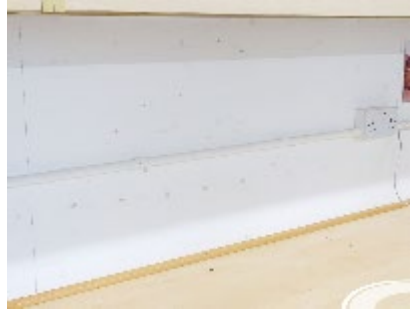
| Reference | Proposal | Significance of affected fabric | Impact | Reasoning and mitigation |
|---|---|---|---|---|
| 9A.D4 | Removal of C20 modern partition. | Low-Negative<br>Late C20 and Early C21. | Low<br>Impact<br>Benefit | <p>The internal partition is a modern addition that has been built on the line of the Lutyens' 1909 roof truss. The lines of the plasterboard are visible.</p> |

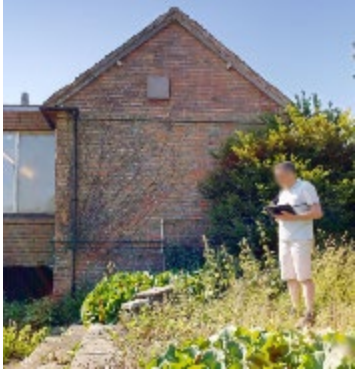
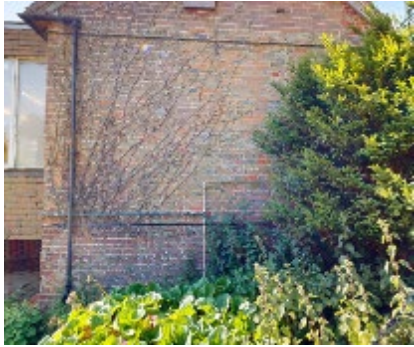
| Reference | Proposal | Significance of affected fabric | Impact | Reasoning and mitigation |
|---|---|---|---|---|
| A-Walls<br>9A.P2 | Removal of redundant services to North Elevation of East Pavilion Building. Reinstall door opening as a window (refer to 9E-WG05). | High<br>Early C20<br>1909 Lutyens<br>Remnants of Pre 1884 Outbuilding<br><br>Negative<br>Window infill | Tidying services<br>Low<br>Impact<br>Benefit<br><br><br>Window<br>High<br>impact<br>Benefit | <p>Three panels of brickwork visible on this elevation show the evolution of the outbuilding. The lower section of the wall is part of the C19 brick outbuildings that were ancillary to Temple Dinsley. At the wall plate height of the gable we can see the additional section, which is part of the 1909 Lutyens' phase. The roof plan shows to achieve the visual symmetry of the pavilion buildings on the South Elevation, the garden wall height to the South conceals the lower eaves on the East Pavilion. The East Pavilion building is wider than the West Pavilion building. This is visible on the North Elevation but not the South.</p> <p>Three panels of brickwork visible. There is a blocked up doorway positioned centrally on the gable. The varied brickwork and perp joint arrangement confirm this. The doorway is likely to have been blocked up as part of the 1909 Lutyens' design..</p> |

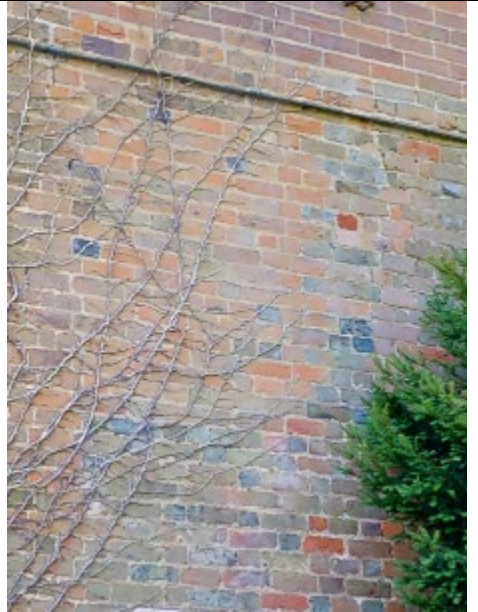
| Reference | Proposal | Significance of affected fabric | Impact | Reasoning and mitigation |
|---|---|---|---|---|
| | | | | <p>Three types of brickwork form the north gable of the East Pavilion. The Queen Closers that would have framed the door opening are clearly visible in the above image and will guide the width of the opening to be reinstated. Reinstating the door opening will have a positive impact on the appearance of the Pavilion to the North and will allow views and connection, from the Pavilion to the North, that were originally intended.</p> |

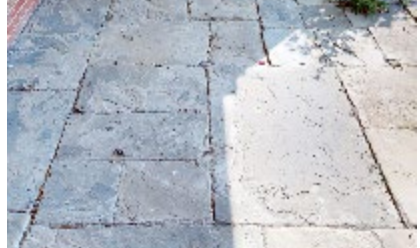
| Reference | Proposal | Significance of affected fabric | Impact | Reasoning and mitigation |
|---|---|---|---|---|
| B-Floors<br>9B.R1 | Pavilion South Terrace<br>riven York stone floor<br>repair. | High<br>Early C20<br>1909 Lutyens | Low<br>Impact<br>Benefit | <p>Riven York stone floor to be retained. Bedding joints to be repointed using lime mortar as required. Minimal repairs to this floor are required. The proposals will improve the appearance and integrity of the terrace.</p> |

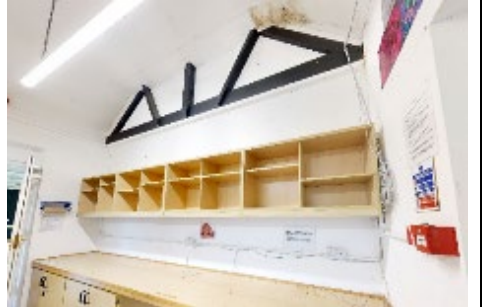
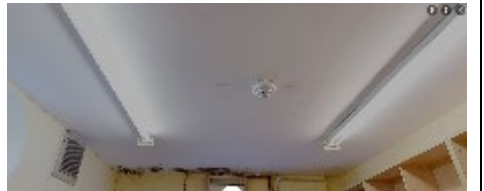
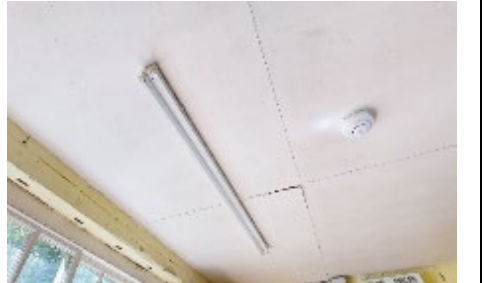
| Reference | Proposal | Significance of affected fabric | Impact | Reasoning and mitigation |
|---|---|---|---|---|
| C-Ceilings<br>9C.D1 | Ceiling – Remove all modern linings that have been applied to underdraw the existing rafters in both pavilion buildings. | Truss / Structure<br>High<br>Early C20<br>1911 Lutyens with<br><br>Linings<br>Neutral/Negative<br>Late C20/C21<br>alterations | Low<br>Impact<br>Benefit | <p>Both pavilions have been lined with modern boards. These shall be removed which is considered a positive impact and will allow the condition of the roof structure to be assessed and recorded.</p> |

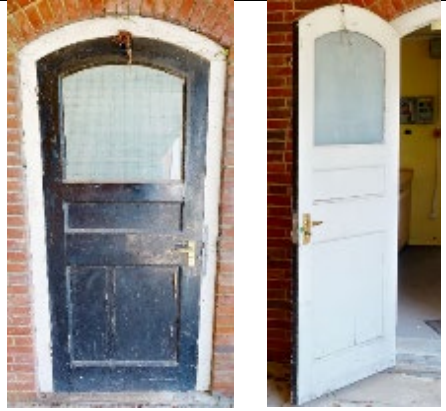
| Reference | Proposal | Significance of affected fabric | Impact | Reasoning and mitigation |
|---|---|---|---|---|
| D-Doors<br>9D-DG01 | Repair door, reinstate upper solid panel and close off door lining internal side. Remove modern C20 ironmongery. | High<br>Early C20<br>1909 Lutyens<br><br>Neutral/Negative<br>Late C20/C21<br>alterations | Moderate<br>Impact<br>Benefit | <p>Positive impact on the fabric of the door and setting of the terrace and pavilion reinstating its former appearance. Impact of closing off the door for access has been reduced by retaining the original door and frame appearance. Visual impact mitigated by design. Refer to 9R.P2 also.</p> |

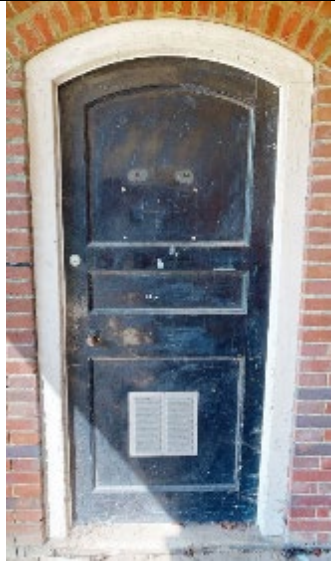
| Reference | Proposal | Significance of affected fabric | Impact | Reasoning and mitigation |
|---|---|---|---|---|
| D-Doors<br>9D-DG02 | Repair door and remove modern grille and repair lower panel. Close off door lining internal side. Remove modern C20 ironmongery and decorate. | High<br>Early C20<br>1909 Lutyens<br><br>Neutral/Negative<br>Late C20/C21<br>alterations | Moderate<br>Impact<br>Benefit | <p>Positive impact on the fabric of the door and setting of the terrace and pavilion reinstating its former appearance. Impact of closing off the door for access has been</p> |

| Reference | Proposal | Significance of affected fabric | Impact | Reasoning and mitigation |
|---|---|---|---|---|
| | | | | reduced by retaining the original door and frame appearance. Visual impact mitigated by design. Refer to 9R.P2 also. |

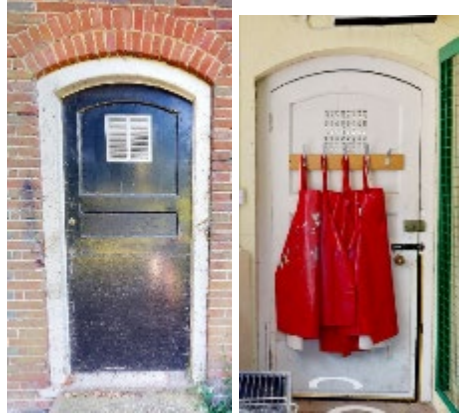
| Reference | Proposal | Significance of affected fabric | Impact | Reasoning and mitigation |
|---|---|---|---|---|
| D-Doors<br>9D-DG03 | Repair door and remove modern grille repairing upper panel. Insert glazing to upper panel subject to investigation. Remove modern C20 ironmongery, retaining historic ironmongery and decorate. | High<br>Early C20<br>1909 Lutyens<br><br>Neutral/Negative<br>Late C20/C21<br>alterations | Low<br>impact<br>Benefit. | <p>Repairing the door is a positive impact and visually will enhance the appearance of the north elevation of the Pavilion. The replacement of the damaged upper panel with clear glass will improve the appearance and provide natural light to the interior.</p> |

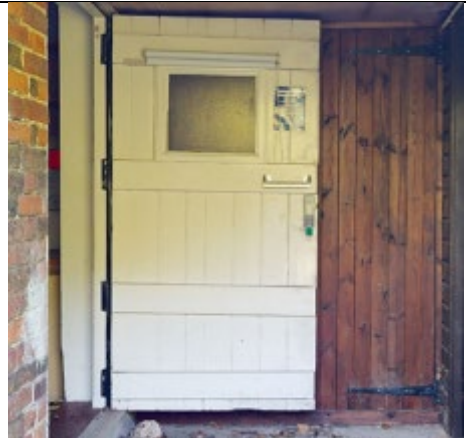
| Reference | Proposal | Significance of affected fabric | Impact | Reasoning and mitigation |
|---|---|---|---|---|
| D-Doors<br>9D-DG04 | Repair door and remove modern ironmongery and vision panel. | High<br>Early C20<br>1909 Lutyens<br>Remnants of Pre<br>1884 Outbuilding<br><br>Neutral/Negative<br>Late C20/C21<br>alterations | Low<br>Impact<br>Benefit | <p>Positive impact on the fabric of the door. Keeping the door in this location is important to the historic arrangement of the Pavilion buildings and reinforces the contrasting characteristics of the historic pavilion and new link.</p> |

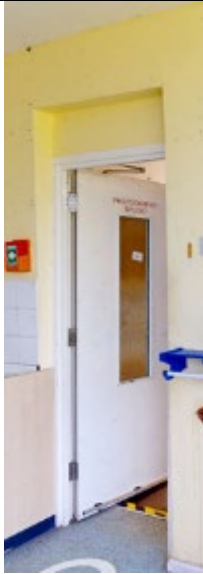
| Reference | Proposal | Significance of affected fabric | Impact | Reasoning and mitigation |
|---|---|---|---|---|
| D-Doors<br>9D-DG05 | Modern C20 fire door. | Neutral/Negative<br>Late C20 school alterations | Low<br>Impact | <p>Modern C20 fire door to be removed. The opening, which was higher prior to the Modern C20 alterations to form the school art block, would have been a window or door opening. This wall opening shall be closed off as this wall shall form part of a compartment wall however, there is enough depth for the reveal to be expressed on the East side of the wall (in Apartment 8). As the opening has already been altered the impact is low and will not affect the significance of the heritage asset.</p> |

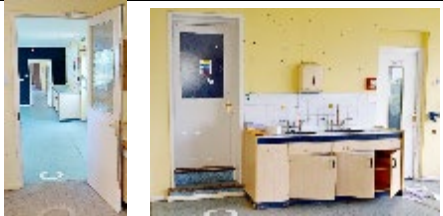
| Reference | Proposal | Significance of affected fabric | Impact | Reasoning and mitigation |
|---|---|---|---|---|
| D-Doors<br>9D-DG06 | Modern C20 fire door. | Neutral/Negative<br>Late C20 school alterations | Low<br>Impact | <p>Modern C20 fire door to be removed. The head of this opening lines through with DG05. This opening shall be closed off as this wall shall form part of a compartment wall however, there is enough depth for the reveal to be expressed on the East side of the wall (in Apartment 8). As the opening has already been altered the impact is low and will not affect the significance of the heritage asset.</p> |

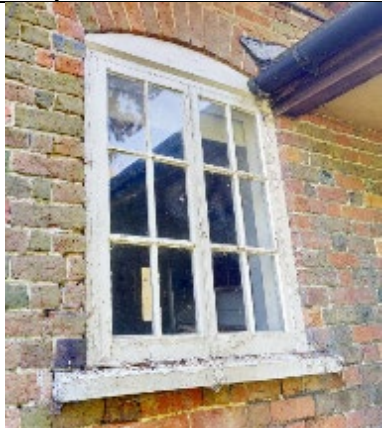
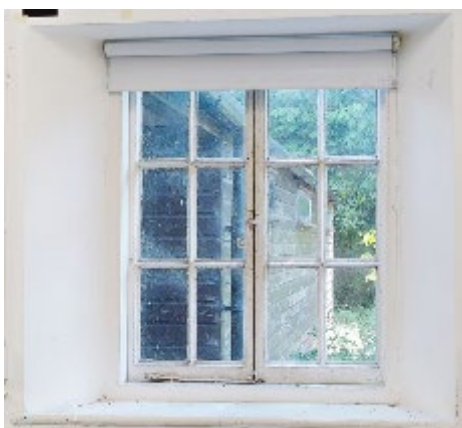
| Reference | Proposal | Significance of affected fabric | Impact | Reasoning and mitigation |
|---|---|---|---|---|
| E-Windows<br>9E-WG04 | 1909 Lutyens' casement to be retained and repaired. | High Early C20 1909 Lutyens | Low Impact Benefit | <p>Splice repairs carried put where required. Resin repairs for more localised repair. Replacement lights for any broken panes. Perished putty replacement. Easing of window as required. Original ironmongery retained. New ironmongery shall be required to comply with building regulations. Window locks. The repairs will improve the appearance and longevity of the window.</p> |

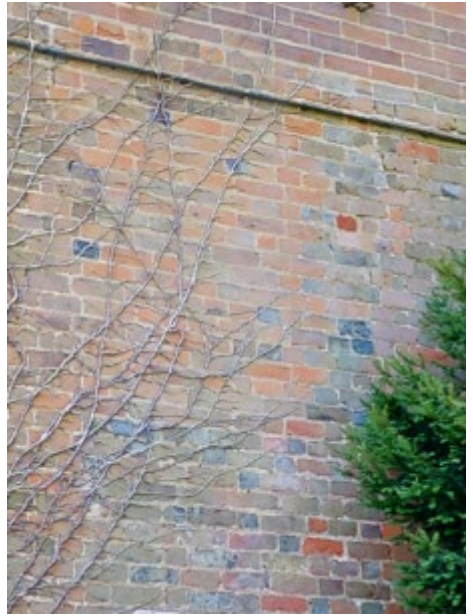
| Reference | Proposal | Significance of affected fabric | Impact | Reasoning and mitigation |
|---|---|---|---|---|
| 9E-WG05<br>Refer to detailed notes within 9A.P2 | New Window within reinstated opening to match 9E-WG04. | High<br>Early C20<br>1909 Lutyens<br>Remnants of Pre 1884 Outbuilding | Low<br>Impact<br>Benefit | <p>As discussed previously the window is to be reinstated. The brick height of WG04 matches that of the visible panel so the design of the new window shall be a casement to match WG04 with narrow double glazing and integral glazing bars.</p> <p>WG05 window position with queen closers retained and the size and proportions of proposed window are designed to suit the evidence and better reveal the historic design of this building.</p> |

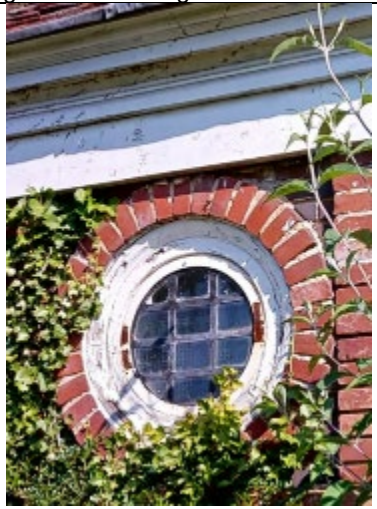
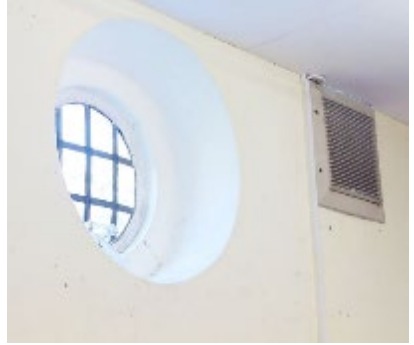
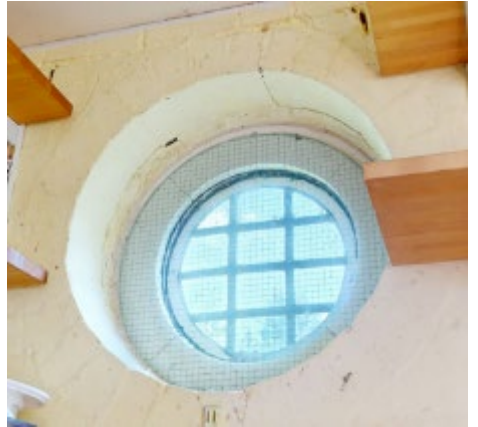
| Reference | Proposal | Significance of affected fabric | Impact | Reasoning and mitigation |
|---|---|---|---|---|
| E-Windows<br>9E-WG06 & WG07 | 1909 Lutyens' circular casements to be retained and repaired. | High<br>Early C20<br>1909 Lutyens | Low<br>Impact<br>Benefit | |

| Reference | Proposal | Significance of affected fabric | Impact | Reasoning and mitigation |
|---|---|---|---|---|
| | | | | <p>Both circular windows are part of the original 'Lutyens' design. The glazing was made up of smaller panes and lead cames.</p> <p>Both windows will need to be repaired with splice repairs or resin repairs for more localised areas. Replacement lights for any broken panes. Easing of windows and as required. Original ironmongery retained. New ironmongery shall be required to comply with building regulations.</p> <p>The glazing panes to WG06 (West Pavilion) as none of the original glazing remains. An additional internal frame has also been fixed to the original frames with wired safety glass as a quick repair in the early C21 which shall be removed. The retention of the existing windows and their repair is considered a positive impact as it improves the appearance and longevity.</p> |

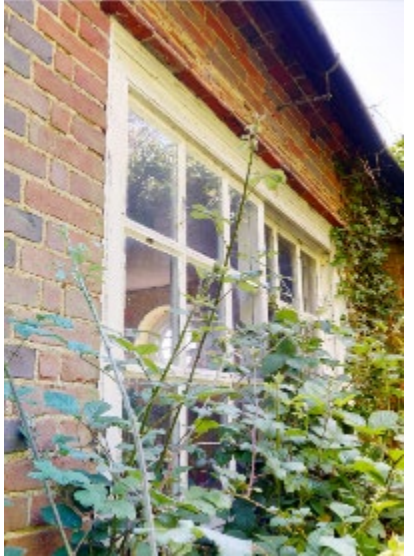
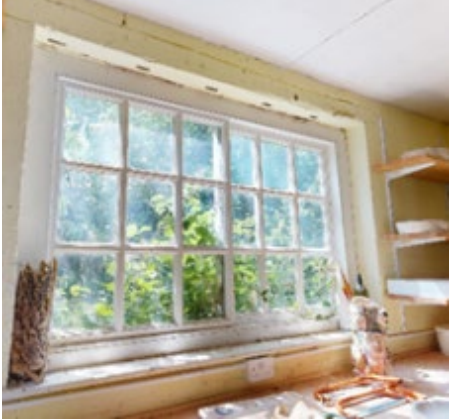
| Reference | Proposal | Significance of affected fabric | Impact | Reasoning and mitigation |
|---|---|---|---|---|
| E-Windows<br>9E-WG08 | 1909 Lutyens' sliding casement to be retained and repaired. | High<br>Early C20<br>1909 Lutyens | Low<br>Impact<br>Benefit | <p>Original sliding casement which looks to be in a good condition. Splice repairs carried put where required. Resin repairs for more localised repair. Replacement lights for any broken panes. Perished putty replacement. Easing of window as required. Original ironmongery retained. New ironmongery shall be required to comply with building regulations. The repairs will improve the appearance and longevity of the window.</p> |

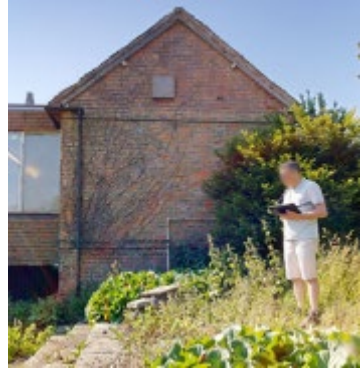
| Reference | Proposal | Significance of affected fabric | Impact | Reasoning and mitigation |
|---|---|---|---|---|
| F-New Opening 9F.P1 | Reinstate window opening 9E-WG05 | High<br>Early C20<br>1909 Lutyens<br>Remnants of Pre 1884 Outbuilding<br><br>Neutral-Negative<br>Late C20 infill | Low<br>Impact<br>Benefit | <p>See note 9A.P2 and 9E.WG05 above which refers to the phases of brickwork. The proposals is to reinstate a opening. Window 9-WG05 shall match 9-WG04. The window appearance is inkeeping with the heirarchy of the windows to the pavilion and across the estate. This gable has undergone historic alteration and the reinstatement of a opening in this position will have a low impact on the historic fabric and setting of the site. Positive impact on the interior space within the pavilion.</p> |

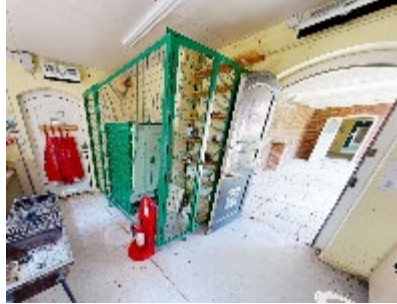
| Reference | Proposal | Significance of affected fabric | Impact | Reasoning and mitigation |
|---|---|---|---|---|
| F-New Opening 9F.P2 | Form opening between new link extension and West Pavilion Building to provide access. | High<br>Early C20<br>1909 Lutyens | Low | <p>Opening formed in corner of East wall of the West pavilion (where wall of pavilion steps) to give access from link extension to the West pavilion building (proposed bedroom). The wall is one brick length thick and is the original wall of the 1909 Lutyens' pavilion. The opening will be minimal in size and the width and height of a doorway. Although the opening will involve the removal of some historic fabric, the step in the wall and the arrangement of the pavilion are not affected. The change in materiality of the spaces and window treatment will allow you to distinguish between the old and new, passing through the historic wall. Formation of the opening will not have a negative impact on the setting and will not detract from the playful arrangement of the pavilion.</p> |

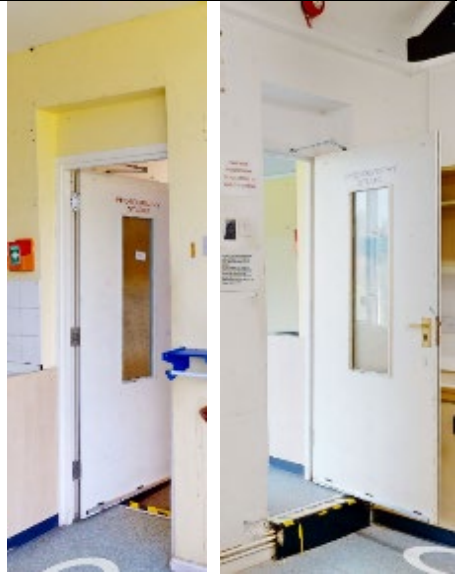
| Reference | Proposal | Significance of affected fabric | Impact | Reasoning and mitigation |
|---|---|---|---|---|
| G-New Internal Partitions 9G.P1 | New solid infill treatment with fireproofing and soundproofing treatment to Apartment 9 side, West side of wall. | High<br>Early C20<br>1909 Lutyens' Remnants of Pre 1884 Outbuilding<br><br>Neutral<br>Infill late C20 / C21 door and surround | Neutral Impact | <p>Refer to note for 9D-DG05.<br/>This wall opening shall be closed off as this wall shall form part of a compartment wall however, there is enough depth for the reveal to be expressed on the East side of the wall (in Apartment 8). As the opening is C20 in character the impact is neutral and will not affect the significance of the heritage asset.</p> |

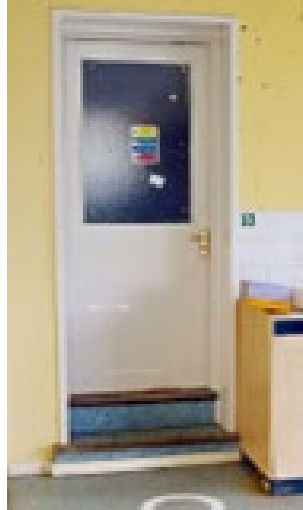
| Reference | Proposal | Significance of affected fabric | Impact | Reasoning and mitigation |
|---|---|---|---|---|
| G-New Internal Partitions 9G.P2 | New solid infill treatment with fireproofing and soundproofing treatment to Apartment 9 side. | High<br>Early C20<br>1909 Lutyens Remnants of Pre 1884 Outbuilding<br><br>Neutral<br>Infill late C20 / C21 door and surround | Neutral Impact | <p>Refer to note for 9D-DG06.<br/>This wall opening shall be closed off as this wall shall form part of a compartment wall however, there is enough depth for the reveal to be expressed on the East side of the wall (in Apartment 8). As the opening is C20 in character the impact is neutral and will not affect the significance of the heritage asset.</p> |
