## Second Floor – Proposed Apartment 5 – Plan of Significance

**641-KS-06-MB-SH-A-90050 – P01****Temple Dinsley Level 2, GA – Apartment 5 - Lander**

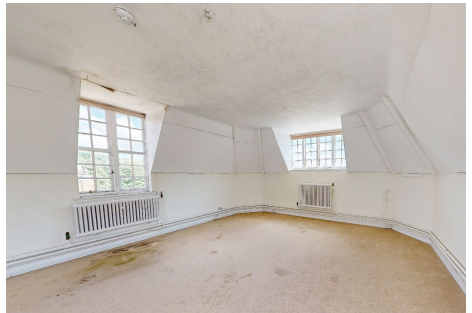
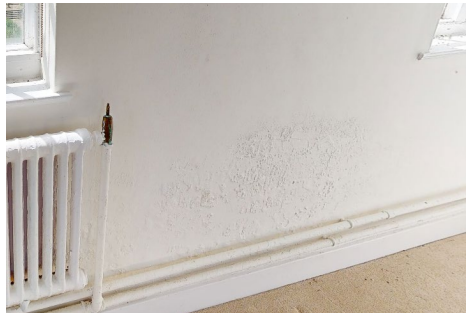
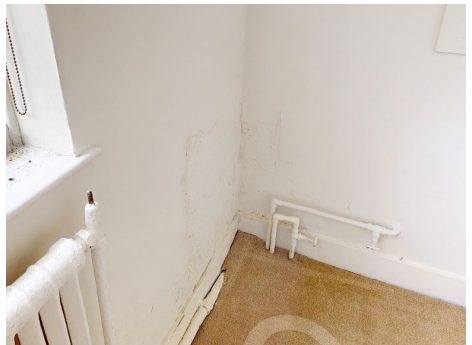
| Reference | Proposal | Significance of affected fabric | Impact | Reasoning and mitigation |
|---|---|---|---|---|
| A-Walls<br>5A. D1 | Removal of MC20 plaster finish and timber skirtings to all external masonry walls to all areas. | Low | Neutral Impact<br><br>Benefit | <p>South Room</p> <p>Damp penetration south room west wall</p> <p>Damp penetration Room 16 west wall<br/>The low wall constructed in 1935 to raise the level of the Lutyens hipped roof is masonry construction. There is evidence at low level of damp penetration in several areas to the east side of the south room</p> |

| Reference | Proposal | Significance of affected fabric | Impact | Reasoning and mitigation |
|---|---|---|---|---|
| | | | | <p>and Room 16. It is expected that water ingress is occurring due to failure of the copper parapet capping and/or the lead flashing at the junction of the capping with the wall. Investigation and repair of the external copper/leadwork will be necessary to prevent further ingress of damp. All areas of plaster and timber skirtings will be removed to allow the masonry to fully dry out</p> <p>Removal of damp plaster and repair of external copper and leadwork will prevent further deterioration of the masonry wall and is considered a benefit.</p> |

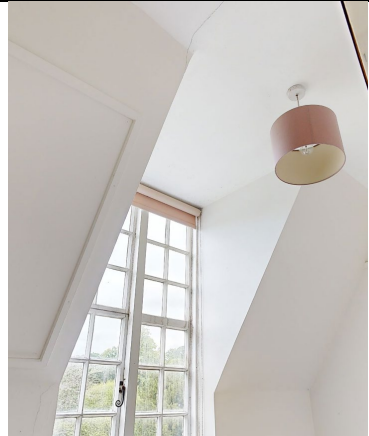
| Reference | Proposal | Significance of affected fabric | Impact | Reasoning and mitigation |
|---|---|---|---|---|
| A-Walls 5A.D2 | Removal of MC20 plasterboard linings to all sloping sections of walls. | Low 1935 alterations | Low Impact Benefit | <p>Room 16</p> <p>Plasterboard linings to sloping sections of walls are to be removed to allow the roof structure to be assessed/recorded/condition investigated, the roof void insulated and an insulated timber lining to be installed below the existing rafters. This is considered to be a positive impact which will benefit the building fabric, the internal environment and the viability of the building for future use.</p> <p>The coved/rolled plaster junction between the flat and sloping ceiling will be reinstated.</p> |

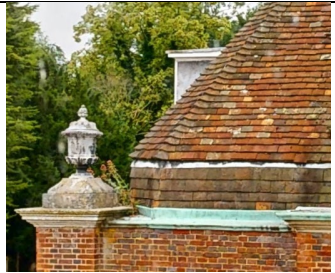
| Reference | Proposal | Significance of affected fabric | Impact | Reasoning and mitigation |
|---|---|---|---|---|
| A-Walls 5A.R1 | Repairs to upstand wall, hung tiles, copper gutter and lead flashings | Low 1935 alterations | Low Impact<br>Benefit | <p>The construction of the upstand wall and associated copper gutter, lead flashings and hung tiles are to be investigated where evidence of damp ingress is apparent. Proposals for repairs will be submitted for approval.</p> |

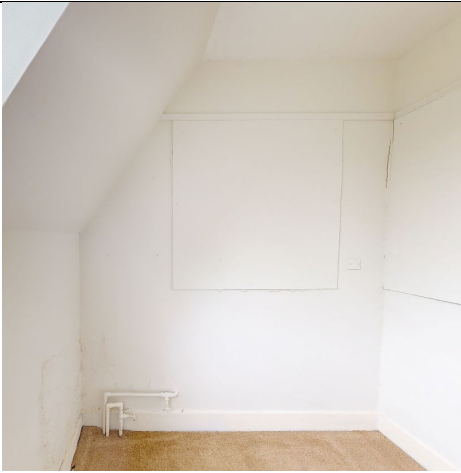
| Reference | Proposal | Significance of affected fabric | Impact | Reasoning and mitigation |
|---|---|---|---|---|
| A-Walls 5A.P4 | Upgrading of existing partition between stairwell and Lander Apartment 4 | Low MC20 alterations | Low Impact | <p>Room 16<br/>Construction of existing partition is to be investigated and upgraded to form a fire rated compartment and sound separation to the stairwell to comply with Building Regulations requirements.</p> |

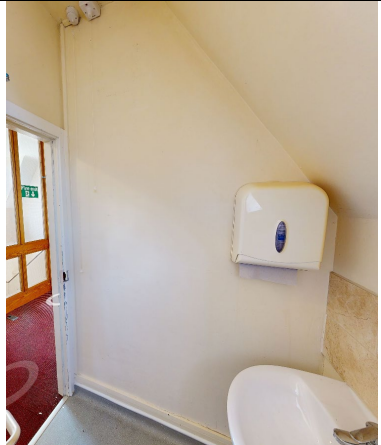
| Reference | Proposal | Significance of affected fabric | Impact | Reasoning and mitigation |
|---|---|---|---|---|
| A-Walls<br>5A.D3 | Partial removal of MC20 masonry partition. | Low<br>MC20 fabric | Low<br>Impact | <p>Partial removal of partition to provide headroom for new entrance door to Apartment 5 Lander</p> |

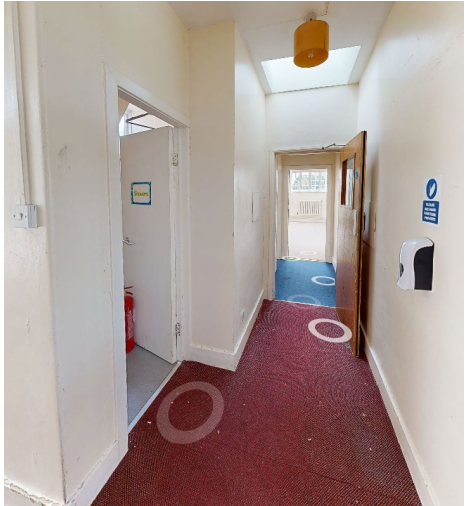
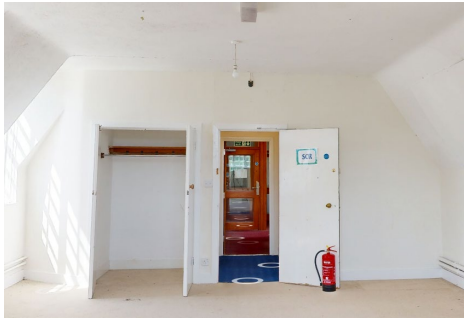
| Reference | Proposal | Significance of affected fabric | Impact | Reasoning and mitigation |
|---|---|---|---|---|
| A-Walls<br>5A.D4 | Removal of MC20 internal partitions forming shower room, wc, bedroom & living area to the south. | Low<br>MC20 fabric | Low<br>Impact | <p>Existing corridor<br/>C20 plasterboard lined timber partitions forming Room 16, 2no cupboards, WC and shower room.</p> <p>Removal of C20 partition and cupboards will eliminate awkward junction with dormer window.</p> |

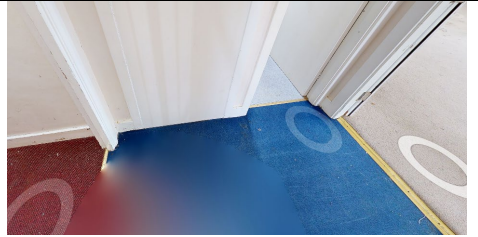
| Reference | Proposal | Significance of affected fabric | Impact | Reasoning and mitigation |
|---|---|---|---|---|
| | existing floor construction. | | | <p>C20 carpet and vinyl floor finishes to dormitory accommodation. Investigation will be necessary to confirm what intervention/strengthening works may have been carried out in 1935 to convert the 2<sup>nd</sup> floor to dormitories. Floorboarding may have been installed as part of the 1909 Lutyens construction to provide an accessible attic space and this original fabric may remain in place.</p> <p>The existing floor construction will need to be insulated for fire and sound protection to the 1st floor accommodation below to comply with Building Regulations. This work will need to be carried out from above to protect existing lath and plaster ceilings at 1<sup>st</sup> floor.</p> <p>Any 1909 floorboards found to remain will be carefully removed and replaced following upgrading of the floor construction.</p> <p>Details of upgrading works/necessary repairs to the floor will be submitted following investigation.</p> |

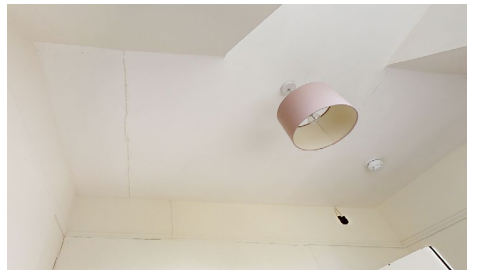
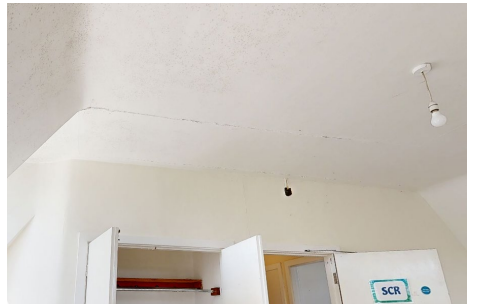
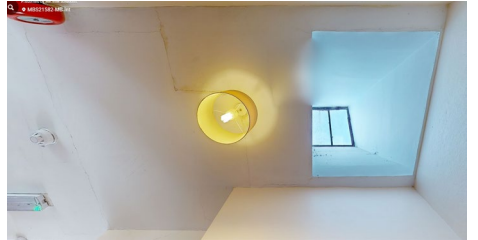
| Reference | Proposal | Significance of affected fabric | Impact | Reasoning and mitigation |
|---|---|---|---|---|
| C-Ceilings<br>5C. D1 | Removal of existing plasterboard ceilings throughout 2 <sup>nd</sup> floor accommodation including linings around rooflight. | <p>Roof structure<br/>High<br/>Early C20<br/>1909 Lutyens with</p> <p>Low<br/>Plasterboard linings<br/>Neutral/Negative<br/>MC20 alterations</p> | Low-Moderate Impact | <p>Room 16</p> <p>South Room</p> <p>Partial views of existng ceilings to the west wing Room 16 and the south room. Cracks in the plasterboard joints are visible. These linings will be removed to allow the roof structure to be assessed/recorded/</p> |

| Reference | Proposal | Significance of affected fabric | Impact | Reasoning and mitigation |
|---|---|---|---|---|
| | | | | <p>condition investigated and the roof void insulated. This is considered a positive impact which will benefit the building fabric and the internal environment.</p> <p>Rooflight in existing hallway to be removed along with C20 ceiling linings.</p> |

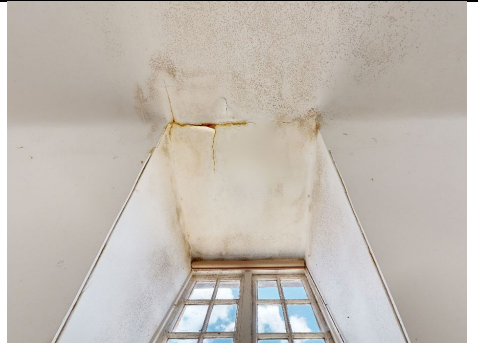
| Reference | Proposal | Significance of affected fabric | Impact | Reasoning and mitigation |
|---|---|---|---|---|
| C-Ceilings 5C.R1 | South room. Removal of existing plasterboard linings to dormer roof and cheeks and to flat ceiling area where damp ingress is apparent. Repairs to joists/boards as necessary. | <p>Roof structure (joists) High Early C20 1909 Lutyens with</p> <p>Plasterboard linings and carcassing to dormer Neutral/Negative MC20 (1935)</p> | | <p>East dormer to south room<br/>Removal of the plasterboard linings is necessary to allow access to the roof timbers to investigate the cause of the damp penetration and to carry out all necessary repairs.</p> |

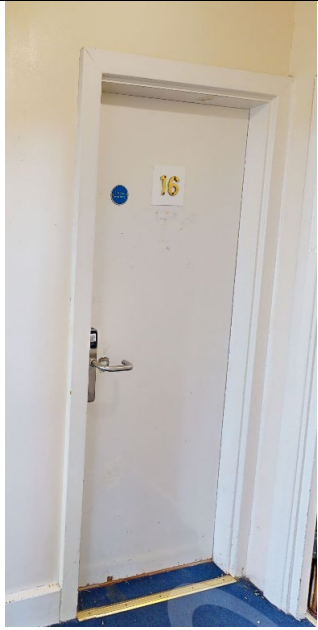
| Reference | Proposal | Significance of affected fabric | Impact | Reasoning and mitigation |
|---|---|---|---|---|
| | | | | <p>Fire rated door to dormitory Room 16</p> <p>All modern C20 doors/fire doors to be removed along with partitions.</p> |

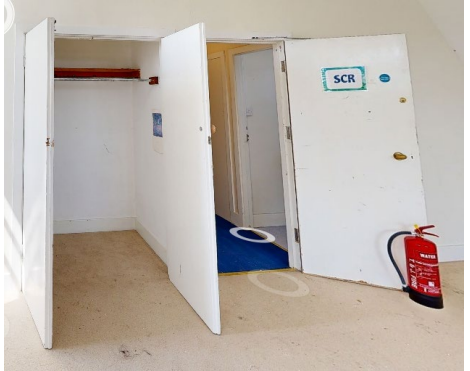
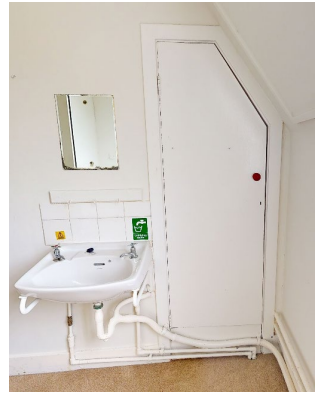
| Reference | Proposal | Significance of affected fabric | Impact | Reasoning and mitigation |
|---|---|---|---|---|
| D-Doors<br>5D.D2 | Painted flush panel C20 cupboard doors to Room 16 and south room (3no total) | Neutral/Negative<br>Late C20 alterations | Low<br>Impact | <p>Cupboard doors and fire rated to south room to be removed</p> <p>Cupboard door in Rm 16 to be removed</p> |

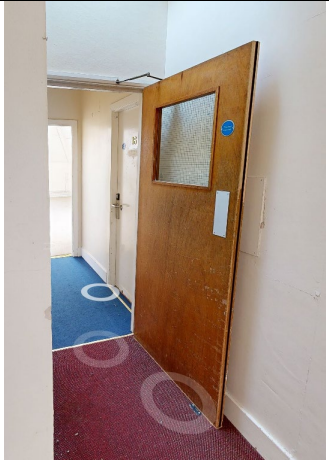
| Reference | Proposal | Significance of affected fabric | Impact | Reasoning and mitigation |
|---|---|---|---|---|
| D-Doors<br>5D.D3 | Timber top glazed C20 fire rated door forming compartment to west wing south accommodation. | Neutral/Negative<br>Late C20 alterations | Low<br>Impact | <br>Part glazed C20 compartment door to west wing south accommodation to be removed |

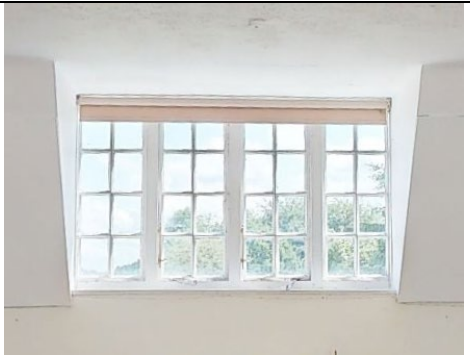
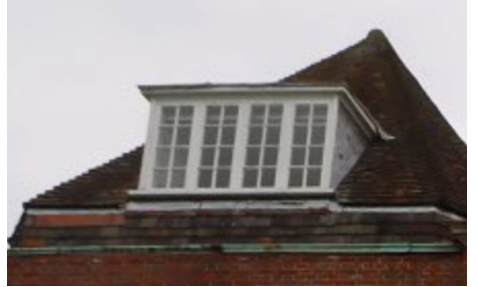
| Reference | Proposal | Significance of affected fabric | Impact | Reasoning and mitigation |
|---|---|---|---|---|
| E-Windows<br>5E.D1 | Removal and replacement of C20 timber dormer window | Neutral | Low<br>Impact<br><br>Benefit &<br>Enhance | <br>South dormer |

| Reference | Proposal | Significance of affected fabric | Impact | Reasoning and mitigation |
|---|---|---|---|---|
| | | | | <p>South dormer – external view</p> <p>The existing window has a sill height that is significantly higher than the adjacent existing windows. Window is to be removed and replaced with a new window to match the sill height of the windows to the east and west elevations. The reduced sill level will enhance aspect/views out of the room. Slim-line double glazing will improve the comfort of the internal environment and the viability of the historic building for future use. Refer to note A-Walls 5A.P2</p> |

| Reference | Proposal | Significance of affected fabric | Impact | Reasoning and mitigation |
|---|---|---|---|---|
| E-Windows 5E.P1 | Install new replacement window in adjusted opening. | Low C20 (1935) alterations | Low Impact<br><br>Benefit & Enhance | New timber window to amctch existing in adjusted opening. |

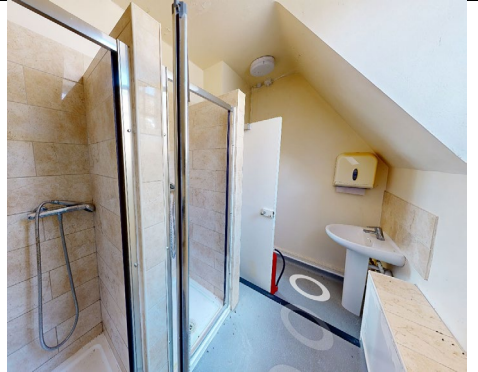
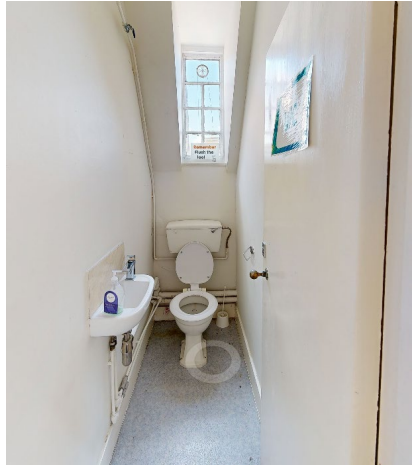
| Reference | Proposal | Significance of affected fabric | Impact | Reasoning and mitigation |
|---|---|---|---|---|
| J-Internal fixtures and fittings 5J.D1 | Removal of modern C20/C21 sanitaryware and associated fittings. | Neutral<br>Late C20 / C21 school insertions | Neutral Impact | <p>2no existing shower cubicles and 1no basin to be removed</p> <p>1no WC and cistern, 1no basin to be removed.<br/>All associated plumbing and pipework, tile splashbacks, fittings and fixtures to be removed to both rooms. All installations are C20/21.</p> |

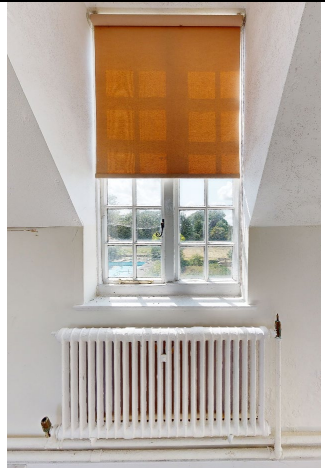
| Reference | Proposal | Significance of affected fabric | Impact | Reasoning and mitigation |
|---|---|---|---|---|
| J-Internal fixtures and fittings 5J.P1 (?) | Renovation / redecoration of MC20 cast iron wall mounted radiators (?) | Neutral<br>Retention of MC20 / C21 school insertions | Neutral impact | <p>All cast iron radiators to be removed and restored/redecorated and relocated within new layout as required.</p> |

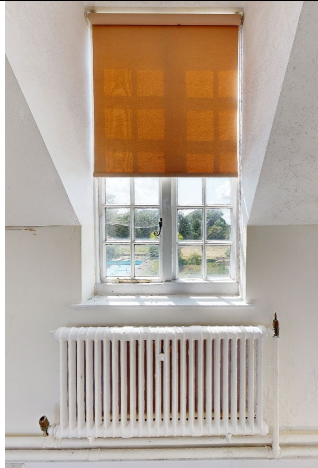
| Reference | Proposal | Significance of affected fabric | Impact | Reasoning and mitigation |
|---|---|---|---|---|
| J-Internal fixtures and fittings 5J.D2 (?) | Removal of MC20 cast iron wall mounted radiators and pipework(?) | Low MC20 school insertio5J.P2ns | Low Impact | <p>Existing heating system was installed as part of conversion of attic space to dormitories. All cast iron MC20 radiators and associated pipework to be removed.</p> |
