## Second Floor – Proposed Apartment 4 – Plan of Significance

**641-KS-06-MB-SH-A-90040 – P01****Temple Dinsley Level 2, GA – Apartment 4 - Felix**

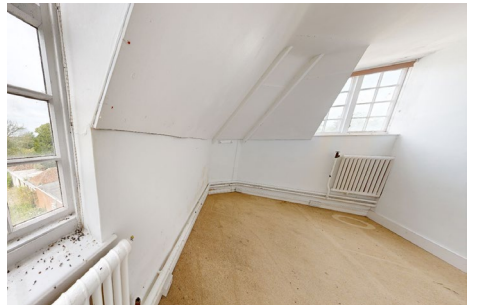
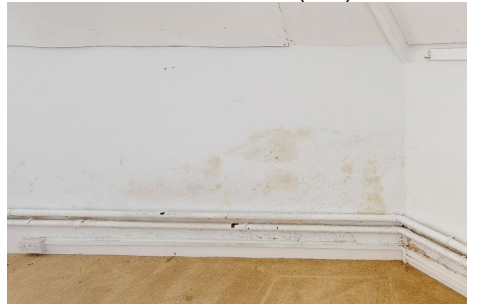
| Reference | Proposal | Significance of affected fabric | Impact | Reasoning and mitigation |
|---|---|---|---|---|
| A-Walls<br>4A. D1 | Removal of MC20 plaster finish including timber skirtings to all external masonry walls to all areas. | Low | Low Impact<br>Benefit | <p>LHS north room (12a)</p> <p>Damp penetration at low level (12a)</p> |

| Reference | Proposal | Significance of affected fabric | Impact | Reasoning and mitigation |
|---|---|---|---|---|
| | | | | <p>the wall. Investigation and repair of the external copper/leadwork will be necessary to prevent further ingress of damp. All areas of plaster and timber skirtings will be removed to allow the masonry to fully dry out.</p> <p>Removal of damp plaster and repair of external copper and leadwork will prevent further deterioration of the masonry wall and is considered a benefit.</p> |

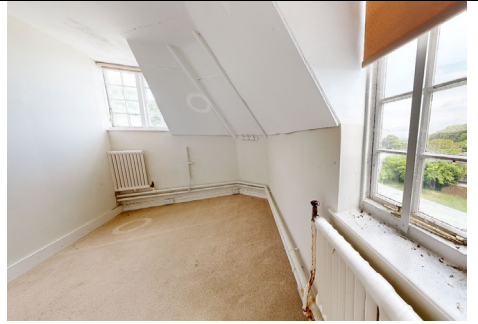
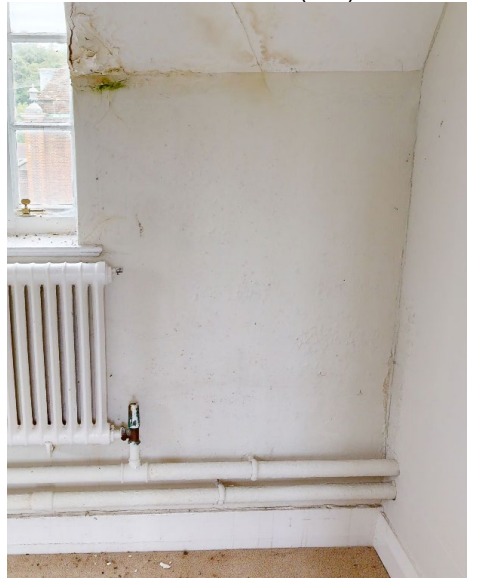
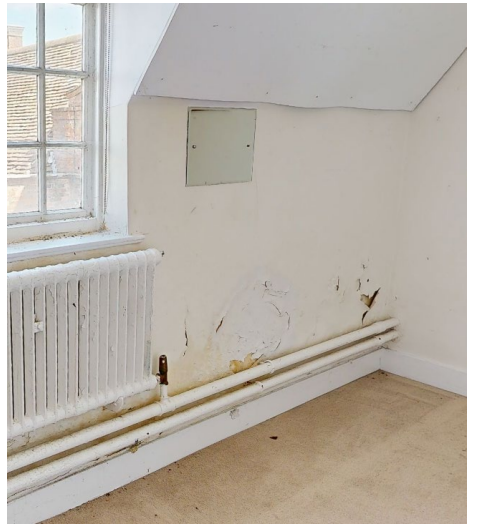
| Reference | Proposal | Significance of affected fabric | Impact | Reasoning and mitigation |
|---|---|---|---|---|
| | | | | <p>RHS north room (12b)</p> <p>Damp penetration to full height of wall</p> <p>Room 14</p> <p>The low wall constructed in 1935 to raise the level of the Lutyens hipped roof is masonry construction. There is evidence at low level of damp penetration in several areas to the east and west sides of Rooms 12 a &amp; b, Room 14 and to the WCs and washroom. It is expected that water ingress is occurring due to failure of the copper parapet capping and/or the lead flashing at the junction of the capping with</p> |

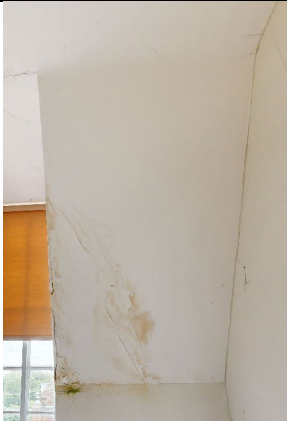
| Reference | Proposal | Significance of affected fabric | Impact | Reasoning and mitigation |
|---|---|---|---|---|
| A-Walls<br>4A.R1 | Room 12a<br>Removal of existing plasterboard lining to sloping section of wall where damp ingress is apparent to allow repairs to rafters/sarking boards/wallplate to be carried out as necessary. | Roof structure<br>High<br>Early C20<br>1909 Lutyens with<br><br>Plasterboard linings<br>Neutral/Negative<br>MC20 (1935 alterations | Low-<br>Moderate<br>Impact | <p>Room 12a<br/>Removal of the plasterboard lining is necessary to allow access to the rafters to investigate the cause of the damp penetration and to carry out any repairs required to the rafters/sarking boards/wallplate.</p> |

| Reference | Proposal | Significance of affected fabric | Impact | Reasoning and mitigation |
|---|---|---|---|---|
| A-Walls<br>4A.R2 | Repairs to upstand wall, hung tiles, copper gutter and lead flashings | Low<br>1935 alterations | Low<br>Impact<br><br>Benefit | The construction of the upstand wall and associated copper gutter, lead flashings and hung tiles are to be investigated where evidence of damp ingress is apparent. Proposals for repairs will be submitted for approval. |

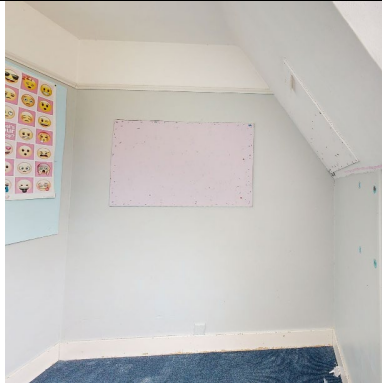
| Reference | Proposal | Significance of affected fabric | Impact | Reasoning and mitigation |
|---|---|---|---|---|
| | | | | <p>Partition to stairwell existing Room 15</p> <p>Construction of existing partition is to be investigated and upgraded to form a fire rated compartment and sound separation to the stairwell to comply with Building Regulations requirements.</p> |

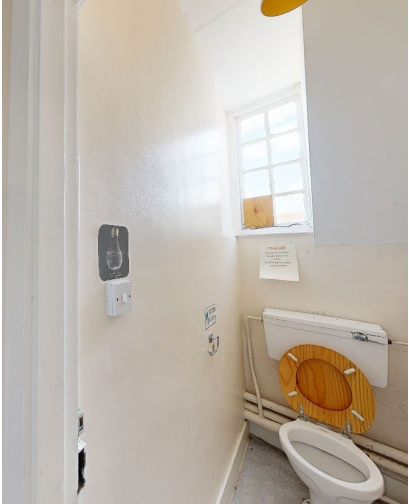
| Reference | Proposal | Significance of affected fabric | Impact | Reasoning and mitigation |
|---|---|---|---|---|
| A-Walls<br>4A.D3 | Removal of C20 masonry partition. | Low<br>MC20 partition | Low<br>Impact | <p>Masonry partition to east side (separating wc cubicles) to be removed. It is expected that the masonry wall was constructed as part of the 1936 works to brace the new external upstand wall.</p> |

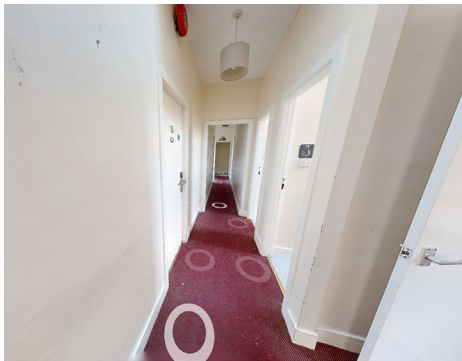
| Reference | Proposal | Significance of affected fabric | Impact | Reasoning and mitigation |
|---|---|---|---|---|
| A-Walls<br>4A.D4 | Removal of C20 internal partitions dividing north room, forming stairwell, corridor and 3no rooms to east and west, WCs and washroom. | Low<br>C20 fabric formed following raising of roof in 1935. | Low<br>Impact | <p>Existing corridor</p> <p>Plasterboard lined timber partitions forming C20 dormitory accommodation.</p> |

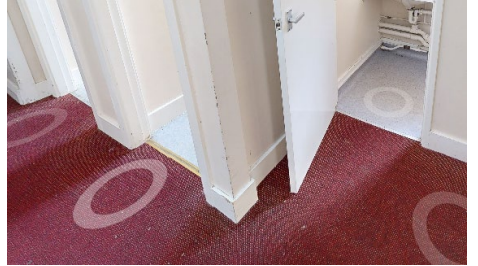
| Reference | Proposal | Significance of affected fabric | Impact | Reasoning and mitigation |
|---|---|---|---|---|
| | of existing C20 floor finishes. Upgrading of existing floor construction. | | | <p>C20 carpet and vinyl floor finishes to dormitory accommodation. Investigation will be necessary to confirm what intervention/strengthening works may have been carried out in 1935 to convert the 2<sup>nd</sup> floor to dormitories. Floorboarding may have been installed as part of the 1909 Lutyens construction to provide an accessible attic space and this original fabric may remain in place.</p> <p>The existing floor construction will need to be insulated for fire and sound protection to the 1st floor accommodation below to comply with Building Regulations. This work will need to be carried out from above to protect existing lath and plaster ceilings at 1<sup>st</sup> floor.</p> <p>Any 1909 floorboards found to remain will be carefully removed and replaced following upgrading of the floor construction.</p> <p>Details of upgrading works/necessary repairs to the floor will be submitted following investigation.</p> |

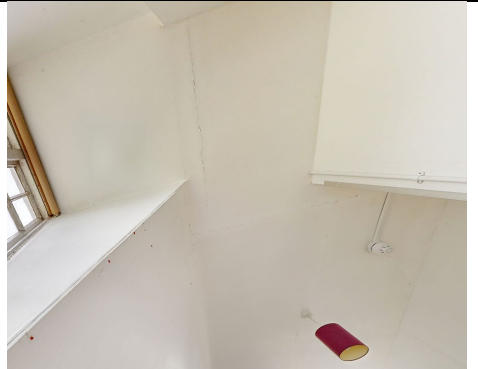
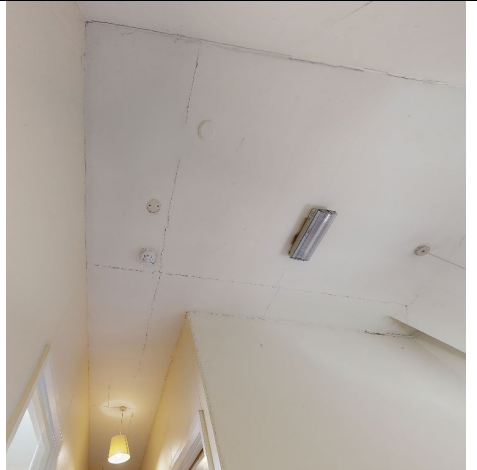
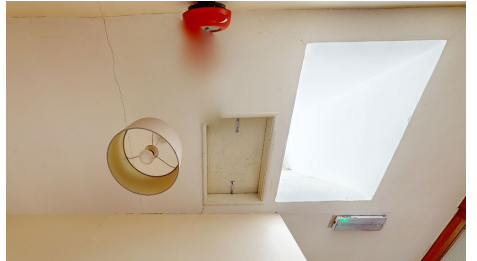
| Reference | Proposal | Significance of affected fabric | Impact | Reasoning and mitigation |
|---|---|---|---|---|
| C-Ceilings<br>4C. D1 | Removal of existing plasterboard to ceilings throughout 2 <sup>nd</sup> floor accommodation including linings around rooflight and roof void access hatch in corridor. | <p>Roof structure<br/>High<br/>Early C20<br/>1909 Lutyens with</p> <p>Low<br/>Plasterboard linings<br/>Neutral/Negative<br/>MC20</p> | Low-Moderate Impact | <p>Partial view of existing ceiling to the West Wing north room. Cracks in the plasterboard joints are visible. These linings will be removed to allow the roof structure to be assessed/recorded/condition investigated and the roof void insulated. This is considered a positive impact which will benefit the building fabric and the internal environment.</p> |

| Reference | Proposal | Significance of affected fabric | Impact | Reasoning and mitigation |
|---|---|---|---|---|
| | | | | <p>Corridor ceiling</p> <p>Roof void access hatch and linings around rooflight to be removed along with ceiling linings.</p> <p>The coved/rolled plaster junction between the flat and sloping ceiling will be reinstated.</p> |

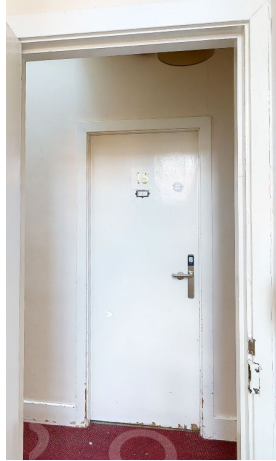
| Reference | Proposal | Significance of affected fabric | Impact | Reasoning and mitigation |
|---|---|---|---|---|
| | | | | <p>Typical fire rated door between corridor and dormitory room.<br/>All modern C20 doors/fire doors to be removed along with partitions.</p> |

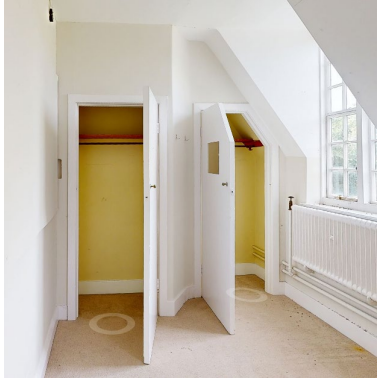
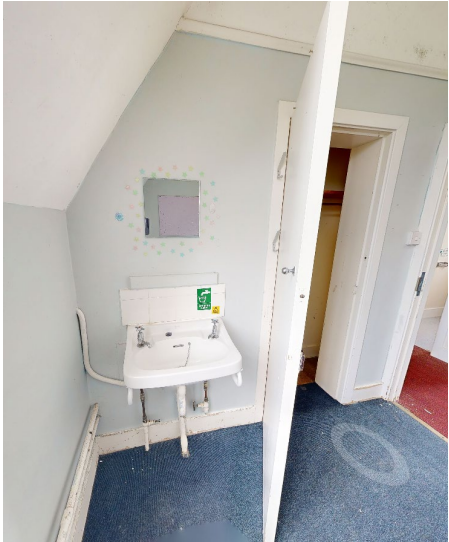
| Reference | Proposal | Significance of affected fabric | Impact | Reasoning and mitigation |
|---|---|---|---|---|
| D-Doors<br>4D.D2 | 2no painted flush panel C20 cupboard doors to Rooms 13 & 15 | Neutral/Negative<br>Late C20 alterations by school | Low Impact | <p>Cupboard doors Rm 13 to be removed</p> <p>Cupboard door in Room 15 to be removed</p> |

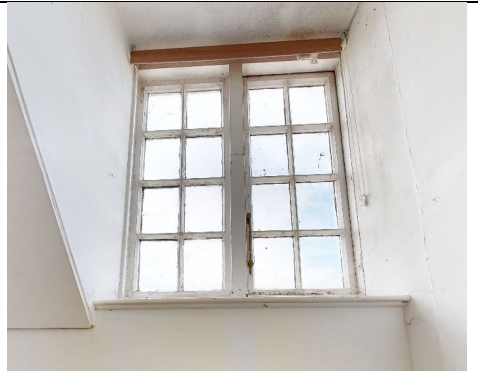
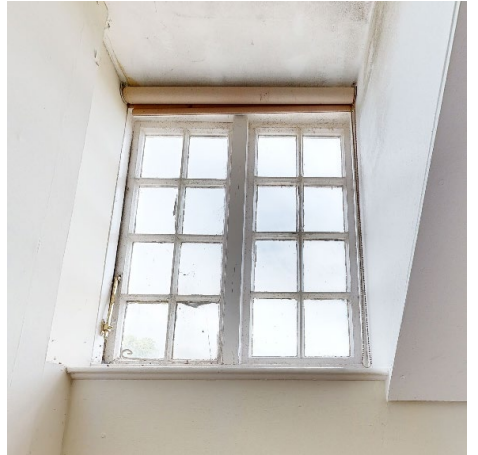
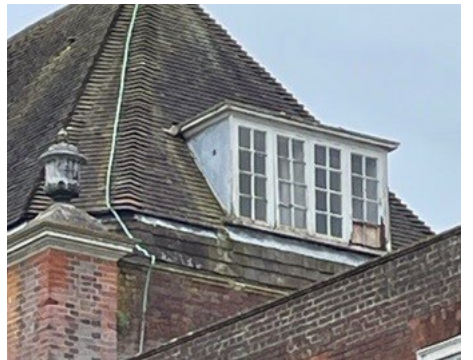
| Reference | Proposal | Significance of affected fabric | Impact | Reasoning and mitigation |
|---|---|---|---|---|
| E-Windows<br>4E.D1 | Removal of C20 timber dormer window Window 4E-W05 | Neutral | Low Impact<br>Benefit Enhance | <p>Left side of window W05</p> <p>Right side of window W05</p> |

| Reference | Proposal | Significance of affected fabric | Impact | Reasoning and mitigation |
|---|---|---|---|---|
| | | | | <p>External view of window W05</p> <p>Window is to be removed and replaced with a new window to match the sill height of the windows to the east and west. The reduced sill level will enhance aspect/views out of the room. Slim-line double glazing will improve the comfort of the internal environment and the viability of the historic building for future use.</p> <p>Refer to note A-Walls 4A.R2 for alterations to external construction to increase opening depth.</p> |

| Reference | Proposal | Significance of affected fabric | Impact | Reasoning and mitigation |
|---|---|---|---|---|
| E-Windows 4E.P1 | Install new replacement window in adjusted opening. | Low MC20 (1935) alterations | Low Impact<br><br>Benefit & Enhance | New timber window to match existing in adjusted opening. |

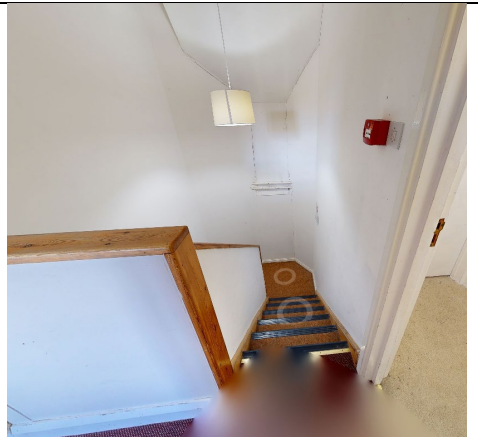
| Reference | Proposal | Significance of affected fabric | Impact | Reasoning and mitigation |
|---|---|---|---|---|
| H-Stairs<br>4H.D1 | Remove C20 stair and balustrade between 1 <sup>st</sup> and 2 <sup>nd</sup> floor levels. | Low<br>C20 (1935)<br>alterations by school | Low<br>Impact | <p>Existing C20 stair and balustrade to be removed</p> |

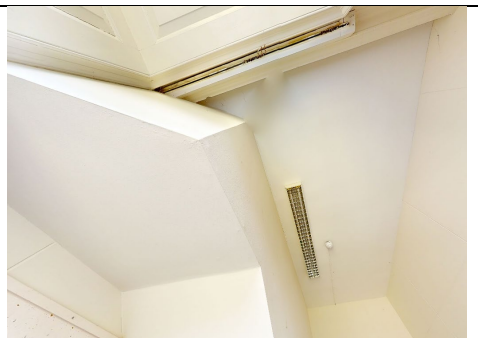
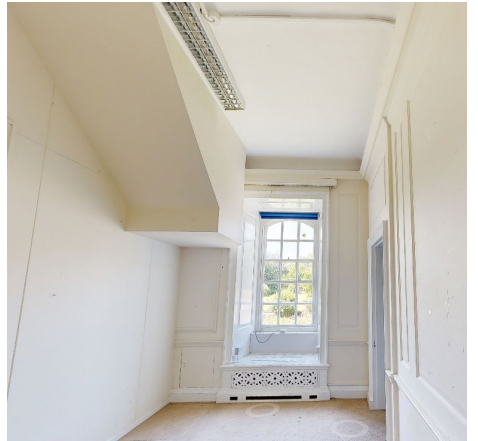
| Reference | Proposal | Significance of affected fabric | Impact | Reasoning and mitigation |
|---|---|---|---|---|
| H-Stairs<br>4H.P1 | Infill opening in existing floor following removal of stair between 1 <sup>st</sup> and 2 <sup>nd</sup> floor. | Low | Low<br>Impact.<br>Enhance | <p>Existing ceilings to 1<sup>st</sup> floor room divided by C20 stair and partition.<br/>Removal of the existing stair and infill of the 1<sup>st</sup> floor ceiling/2<sup>nd</sup> floor will restore the original 1909 Lutyens layout at both levels and remove the unsightly junction of the half-landing obstructing the windows.<br/>The new section of floor will be constructed to Building Regulations</p> |

| Reference | Proposal | Significance of affected fabric | Impact | Reasoning and mitigation |
|---|---|---|---|---|
| | | | | requirements for airborne and impact sound transmission. The ceiling at 1 <sup>st</sup> floor has been underlined to form a fire compartment to the 2 <sup>nd</sup> floor dormitory level. This compartmentation will need to be maintained to the underside of the new section of infill floor with a plasterboard lining. |

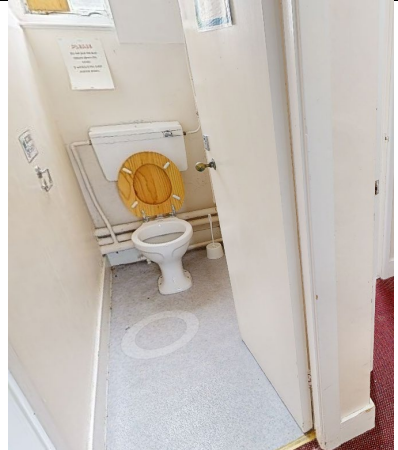
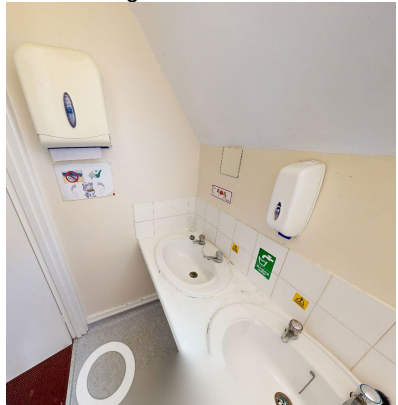
| Reference | Proposal | Significance of affected fabric | Impact | Reasoning and mitigation |
|---|---|---|---|---|
| J-Internal fixtures and fittings 4J.D1 | Removal of modern C20/C21 sanitaryware and associated fittings. | Neutral<br>Late C20 / C21 school insertions | Neutral Impact | <p>Existing WC to be removed</p> <p>Existing washroom to be removed</p> |

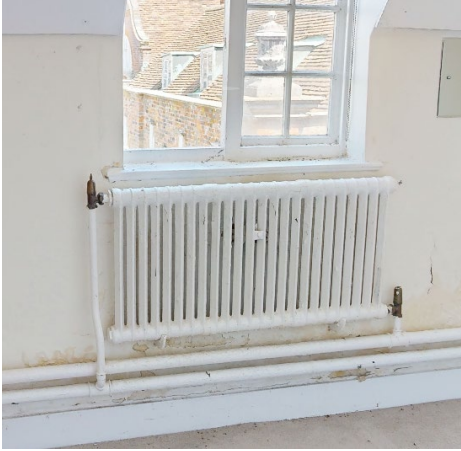
| Reference | Proposal | Significance of affected fabric | Impact | Reasoning and mitigation |
|---|---|---|---|---|
| J-Internal fixtures and fittings 4J.P2 (?) | Renovation / redecoration of MC20 cast iron wall mounted radiators (?) | Neutral<br>Retention of MC20 / C21 school insertions | Neutral impact | <p>All cast iron radiators to be removed and restored/redecorated and relocated within new layout as required.</p> |
