**641-KS-06-MB-SH-A-90940 – P01**  
**Temple Dinsley Levels B1, 0 & 1, GA – East Stair + Lift**

Basement Level B1 - East Stair + Lift – Plan of Significance

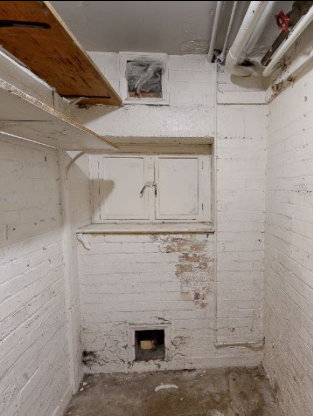
| Reference | Proposal | Significance of affected fabric | Impact | Reasoning and mitigation |
|---|---|---|---|---|
| A-Walls<br>ES-A.R3 | Infill high and low level vents in wall to store | Neutral<br>C20 alterations | Low<br>Impact | <p>Wall adjacent to proposed lift</p> <p>Window to be retained. Vents retained and infilled. Intervention is reversible.</p> |

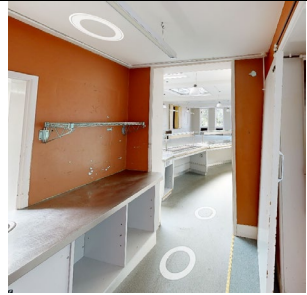
| Reference | Proposal | Significance of affected fabric | Impact | Reasoning and mitigation |
|---|---|---|---|---|
| | | | | <p>Existing opening/servery<br/> Opening to be increased in width to allow installation of proposed lift.<br/> Minimal loss of EC20 fabric necessary to provide lift access for residents/visitors</p> <p>Existing opening between servery and kitchen<br/> MC20 opening to be partially infilled to form new door to proposed corridor.<br/> No loss of fabric</p> |

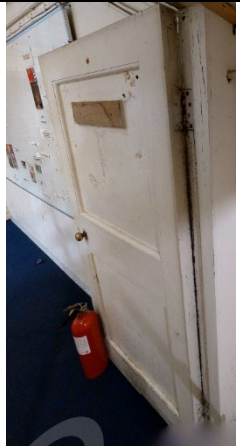
| Reference | Proposal | Significance of affected fabric | Impact | Reasoning and mitigation |
|---|---|---|---|---|
| D-Doors<br>ES-D.R1 | Repair and upgrade as necessary and redecorate 2no timber panel doors | High<br>C20 Lutyens | Low<br>Impact<br><br>Benefit & Enhance | <p>Door to proposed lift lobby<br/>ES-FD02</p> <p>Existing matching door to East Stair Store<br/>ES-FD03</p> <p>Existing doors and ironmongery to be retained.</p> <p>Allow to repair and upgrade 2no timber panel doors to be fire rated doors finished flame retardant and breathable paint.</p> <p>Ironmongery to suit fire door requirements with self-closing device tbc.</p> |

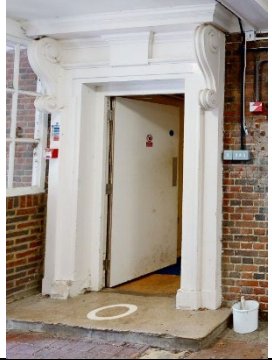
| Reference | Proposal | Significance of affected fabric | Impact | Reasoning and mitigation |
|---|---|---|---|---|
| D-Doors<br>ES-D.D1 | Removal of C20 flush panel door fire to stairwell | Neutral<br>Late C20 alterations | Neutral<br>Impact | |

| Reference | Proposal | Significance of affected fabric | Impact | Reasoning and mitigation |
|---|---|---|---|---|
| | | | | <p>Flush panel fire door</p> <p>Door will be replaced with external grade timber panelled door with simple ironmongery inspired by historic doors</p> |

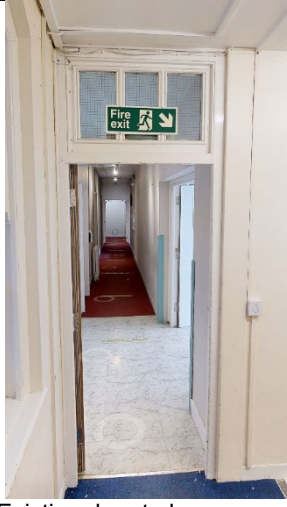
| Reference | Proposal | Significance of affected fabric | Impact | Reasoning and mitigation |
|---|---|---|---|---|
| D-Doors ES-D.D2 | Removal of C20 flush panel door with vision panel forming lobby to Level 0 landing including removal of glazed panel over. | Neutral<br>Late C20 alterations | Neutral Impact | <p>Existing door to be removed</p> <p>No loss of historic fabric.<br/>Allow for replacement with fire rated painted timber panelled door with vision panel and simple ironmongery inspired by historic doors.</p> |

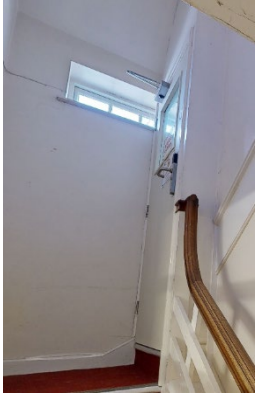
| Reference | Proposal | Significance of affected fabric | Impact | Reasoning and mitigation |
|---|---|---|---|---|
| D-Doors ES-D.D4 | Removal of C20 flush panel door on stairs between Level 0 and Level 1 | Neutral<br>Late C20 alterations | Neutral Impact | <p>Door to be removed</p> <p>No loss of historic fabric.</p> |

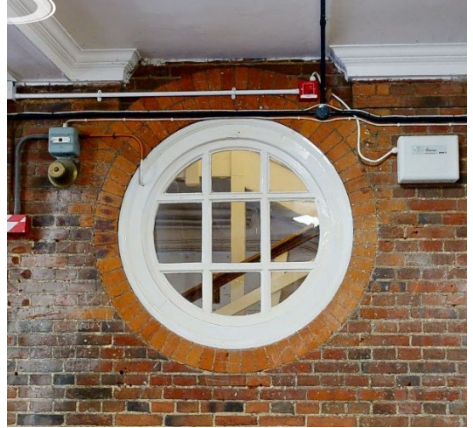
| Reference | Proposal | Significance of affected fabric | Impact | Reasoning and mitigation |
|---|---|---|---|---|
| E-Windows<br>ES-E.R1 | Renovation of 2no C20 round multi-pane timber windows to stairwell and store room | High<br>C20 (1909) Lutyens | Low<br>Impact<br><br>Benefit & Enhance | <p>Round windows (1 of 2no)<br/>ES WG01 &amp; WG02</p> <p>Timber multi-pane round windows will be repaired/renovated/redecorated and upgraded with slim-line double glazing which will improve the comfort of the internal environment and the viability of the historic building for future use. Splice repairs to be carried out where required. Resin for more localised repair. Perished putty replacement. Easing of window as required. The repairs will improve the appearance and longevity of the window.</p> |

| Reference | Proposal | Significance of affected fabric | Impact | Reasoning and mitigation |
|---|---|---|---|---|
| | | | | <p>which will improve the comfort of the internal environment and the viability of the historic building for future use. Splice repairs to be carried out where required. Resin for more localised repair. Perished putty replacement. Easing of window as required.</p> <p>The repairs will improve the appearance and longevity of the window.</p> |

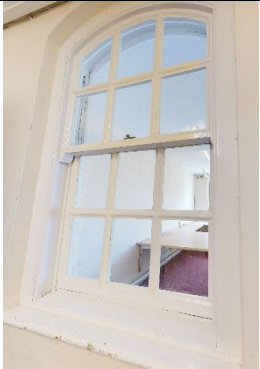
| Reference | Proposal | Significance of affected fabric | Impact | Reasoning and mitigation |
|---|---|---|---|---|
| E-Windows<br>ES-E.R2 | Upgrade internal window to Apartment 30 | Moderate<br>Late C19? C20<br>Lutyens | Low<br>Impact | <p>Internal window W03</p> <p>Allow to upgrade window to form compartment to Apartment 30 as necessary to comply with Building Regulations requirements for fire and sound.</p> <p>Intervention is reversible.</p> |

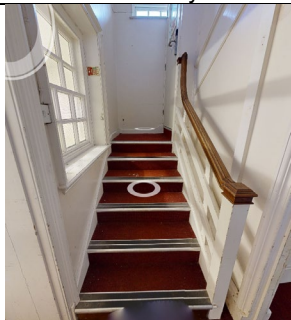
| Reference | Proposal | Significance of affected fabric | Impact | Reasoning and mitigation |
|---|---|---|---|---|
| H-Stairs ES-H.P2 | Upgrading of C20 stair and balustrade flight from Level 0 landing to Level 1 including removal of soffit and replacement of balustrading | Low C20 alterations | Low Impact | <p>Stairs from Level 0 landing to Level 1 landing</p> <p>Existing carpet covering and nosings to be removed to allow investigation of construction. Upgrading works will be carried out to the stair to comply with Building Regulations fire protection and impact sound requirements. Investigate linings to underside of stairs and upgrade as necessary to comply with Building Regulations. Repairs and redecoration to balustrade and handrail as necessary.</p> |

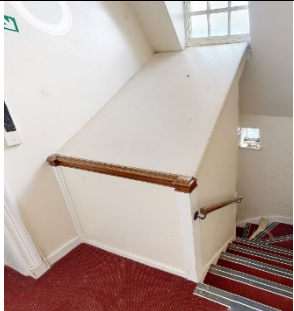
| Reference | Proposal | Significance of affected fabric | Impact | Reasoning and mitigation |
|---|---|---|---|---|
| | | | | <p>Existing stair enclosure</p> <p>Remove sloping soffit over stairs at landing Level 1 and reinstate balustrading.</p> |

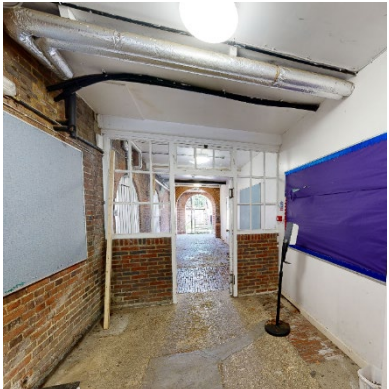
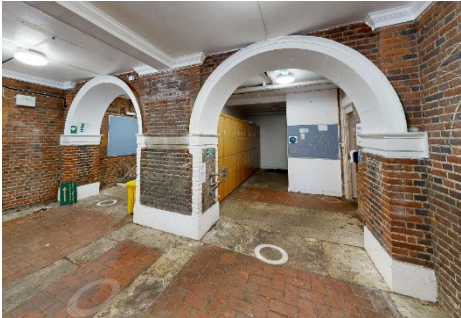
| Reference | Proposal | Significance of affected fabric | Impact | Reasoning and mitigation |
|---|---|---|---|---|
| U-East Annexe Undercroft ES-U.D1/R1/P 1 | Upgrading and repairs to Level B1 (Undercroft) | High<br>Early C20 Lutyens masonry & paving<br><br>Low<br>Late C20 alterations by school | Low Impact<br><br>Benefit & Enhance | <p>Proposed works to Undercroft:</p> <p>Remove Late C20 structure forming 'Tuck shop'.</p> <p>C20 structure to be removed</p> <p>Remove Late C20 brick wall, door and glazed screen over to south and north ends of undercroft.</p> <p>C20 south screen to be removed</p> <p>C20 north screen</p> <p>Remove C21 timber partition forming locker area and stores to north end of undercroft.</p> <p>Lockers and C21 partitions</p> <p>Form compartment walls proposed Apartment 23 as Impact Table.</p> |

| Reference | Proposal | Significance of affected fabric | Impact | Reasoning and mitigation |
|---|---|---|---|---|
| | | | | <p>Investigate construction of soffits to determine extent of lath and plaster/plasterboard linings and carry out repairs upgrading to comply with Building Regulations requirements for fire protection, thermal and sound insulation.</p> <p>Investigate construction of downstand beams and columns to determine requirement for upgrading to comply with Building Regulations requirements for fire protection.</p> <p>Carry out any necessary repairs to brickwork pointing, coving, stonework to arches.</p> <p>Remove painted timber gates, structural post and wood store framing to proposed access through to inner courtyard and carry out any remedial works necessary to masonry and soffit following installation of lift housing.</p> <p>Proposed access to courtyard</p> <p>Location for proposed lift (external side)</p> <p>Refer to Impact Statement for proposed alterations to existing walls relating to Apartment 22.</p> <p>Carry out necessary repairs to stone and brick paving. Remove areas of concrete and replace with paving appropriate to existing Lutyens design and materials.</p> |
