Ground Floor Vestibule – Plan of Significance

**641-KS-06-MB-SH-A-90900 – P01****Temple Dinsley Level 0, GA – Ground Floor - Common Areas - Vestibule**

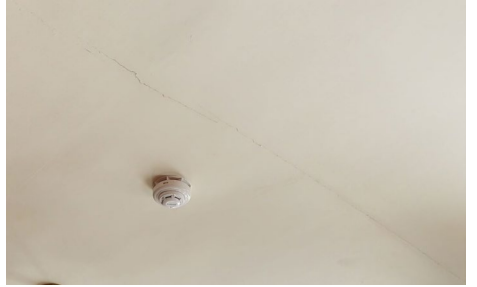
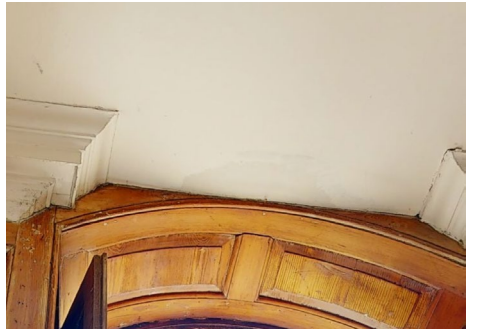
| Reference | Proposal | Significance of affected fabric | Impact | Reasoning and mitigation |
|---|---|---|---|---|
| C-Ceilings<br>WME-V-<br>C.R1 | Repair to continuous crack in plasterboard ceiling. | Low<br>Plasterboard linings<br>Neutral/Negative<br>C20 alterations | Low<br>Impact | <p>Crack in vestibule ceiling</p> <p>Damp on ceiling above window</p> <p>Floors are to be upgraded from above. Ceiling clining to be investigated to confirm presence of lath and plaster above plasterboard lining. C20 plasterboard ceiling will be retained to avoid distrubance to plaster coving. Pin back boards to either side of crack. Rake out crack and fill joint with flexible joint compound. Remove smoke alarm and associated cables and make good to ceiling.</p> <p>Investigate cause of damp and carry out repairs as necessary.</p> |

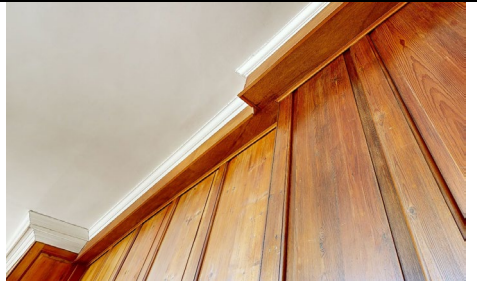
| Reference | Proposal | Significance of affected fabric | Impact | Reasoning and mitigation |
|---|---|---|---|---|
| | Removal of existing plywood boxing and C20 cove hiding existing drainage run. | Neutral/Negative<br>plywood boxing and cove<br>C20 alterations | Low<br>Impact | <p>C20 plywood boxing</p> <p>Remove boxing and investigate potential for drainage run to be re-routed.</p> |

| Reference | Proposal | Significance of affected fabric | Impact | Reasoning and mitigation |
|---|---|---|---|---|
| C-Ceilings<br>WME-V-<br>C.P1 | Form replacement boxing to match panelling design in softwood timber. | Neutral/Negative<br>plywood boxing and cove<br>C20 alterations<br><br>High | Low<br>Impact<br><br>Enhance | Replacement of boxing with an appropriate design and materials will visually enhance the Lutyens panelling |

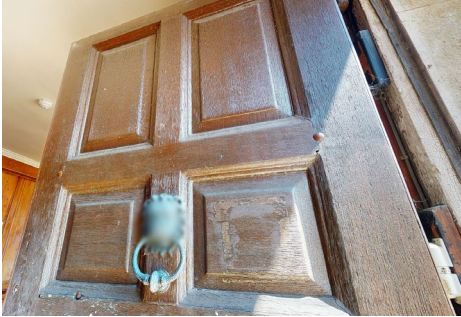
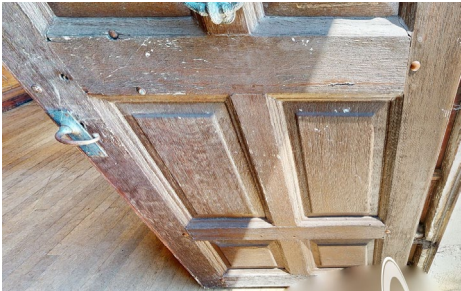
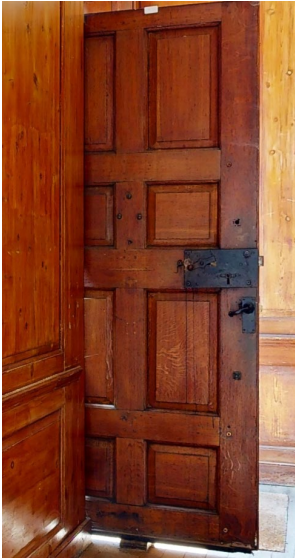
| Reference | Proposal | Significance of affected fabric | Impact | Reasoning and mitigation |
|---|---|---|---|---|
| D-Doors<br>WME-V-D.R1 | Oak panelled external entrance door to be refurbished | High<br>C18 | Low<br>Impact<br><br>Benefit | <p>Oak entrance door external side</p> <p>Oak entrance door internal side<br/>WMEV-D01</p> <p>Door to be removed from frame and existing ironmongery removed. External surface to be lightly sanded to remove existing weathered finish to a clean smooth surface. Apply exterior quality oil suitable for oak.<br/>Internal finish to be removed and replaced with flame retardant breathable varnish(?)<br/>Door to be re-hung with all original ironmongery/lock cases of historic value and modern security fittings tbc.</p> |

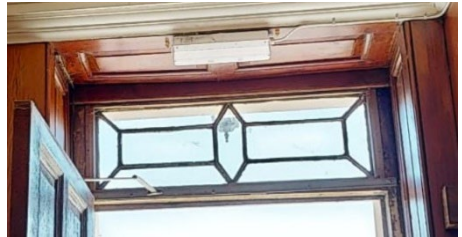
| Reference | Proposal | Significance of affected fabric | Impact | Reasoning and mitigation |
|---|---|---|---|---|
| | | | | <p>Glazed lead light panel at head of door appears to be in good condition and will be retained. Proposal to line internally with toughened glass panel for security purposes (?) will maintain internal view and daylight and will not affect the glazing. Fixing details tbc</p> |

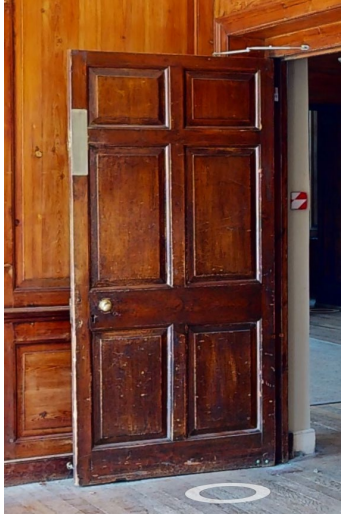
| Reference | Proposal | Significance of affected fabric | Impact | Reasoning and mitigation |
|---|---|---|---|---|
| D-Doors<br>WME-V-D.R2 | Oak panelled internal door between vestibule and entrance hall to be refurbished | High<br>C18 door | Low<br>Impact<br><br>Benefit | <p>Entrance Hall door<br/>WMEV-FD02</p> <p>Door to be removed from frame and existing ironmongery removed. Investigate existing finish and remove/clean with suitable product as necessary. Fill any deep scratches/dents to both sides of door with wood wax to match timber colour. Upgrade to be fire rated. Apply new flame retardant breathable varnish</p> |

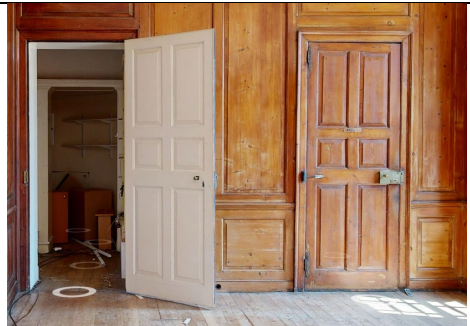
| Reference | Proposal | Significance of affected fabric | Impact | Reasoning and mitigation |
|---|---|---|---|---|
| D-Doors<br>WME-V-D.R3 | Pine (?) panelled internal doors to be refurbished | High<br>C18 doors | Low<br>Impact<br><br>Benefit | <p>2no internal doors east wall of vestibule</p> |

| Reference | Proposal | Significance of affected fabric | Impact | Reasoning and mitigation |
|---|---|---|---|---|
| | | | | <p>WMEV-D03 &amp; D04</p> <p>Pine panelled doors to be removed from frame and existing ironmongery removed. Investigate existing finish and remove/clean with suitable product as necessary. Fill any deep scratches/dents to vestibule side of doors only with wood wax to match timber colour. Apply new flame retardant breathable varnish(?)</p> <p>Re-fix original/historic ironmongery to vestibule side only. Spare ironmongery of historic value to be retained for use elsewhere. Doors to be permanently fixed into opening on original hinges.</p> |

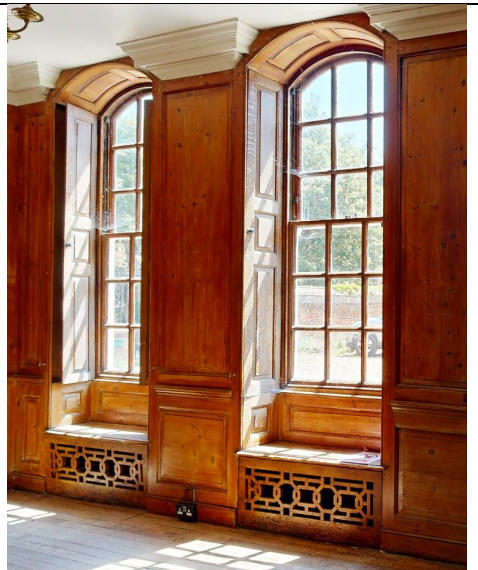
| Reference | Proposal | Significance of affected fabric | Impact | Reasoning and mitigation |
|---|---|---|---|---|
| E-Windows Vestibule WME-V-E.R1 | Renovation of 2no Early C20 timber sash windows and oak shutters | High Early C20 (1935) Lutyens | Low Impact<br><br>Benefit & Enhance | <p>Vestibule windows WMEV-W01 &amp; W02</p> <p>The existing timber multi-pane sash windows and shutters will be repaired/renovated/redecorated, internally with a flame retardant breathable varnish, external paint finish tbc. Splice repairs to be carried out where required. Resin for more localised repair. Perished putty replacement. Easing of window as required. Original sash fasteners and shutter knobs and hinges to be retained for re-use. New security ironmongery to comply with building regulations where required tbc. The repairs will improve the appearance and longevity of the window.</p> |

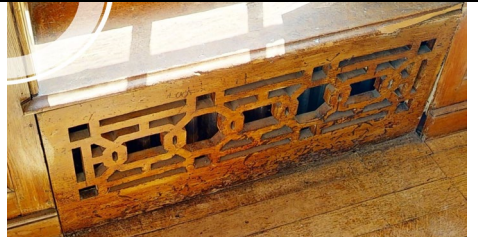
| Reference | Proposal | Significance of affected fabric | Impact | Reasoning and mitigation |
|---|---|---|---|---|
| J-Internal fixtures and fittings WME-V-J.D1 | Renovation / removal of C20 cast iron wall mounted radiator | Neutral | Neutral Impact | |

| Reference | Proposal | Significance of affected fabric | Impact | Reasoning and mitigation |
|---|---|---|---|---|
| | | | | <p>C20 cast iron radiators to be removed or renovated (?)</p> <p>Radiators to be removed and replaced or restored and replaced in existing location or relocated within new layout as required.</p> |
