**Natwest Hitchin  
12 High Street  
Hitchin  
Hertfordshire  
SG5 1BH**

## **Design & Access Statement**

April 2026

Our Reference: 26-035-BS-DAS

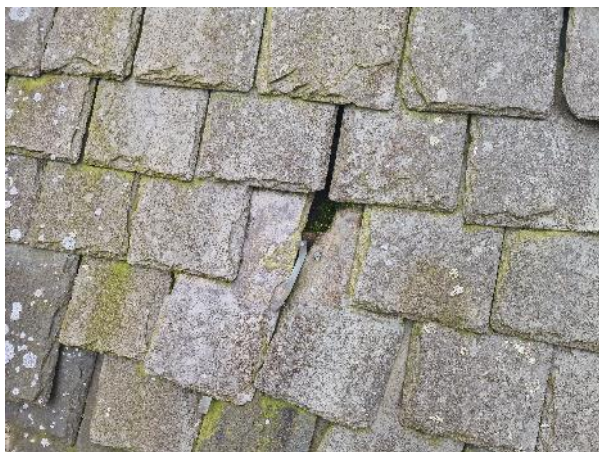
9. Damaged slates

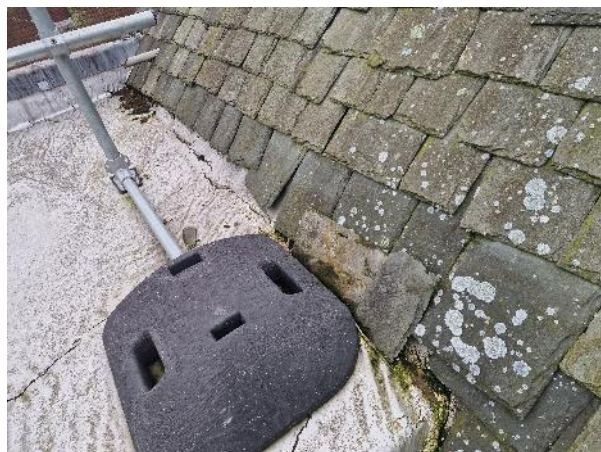
10. Loose slates

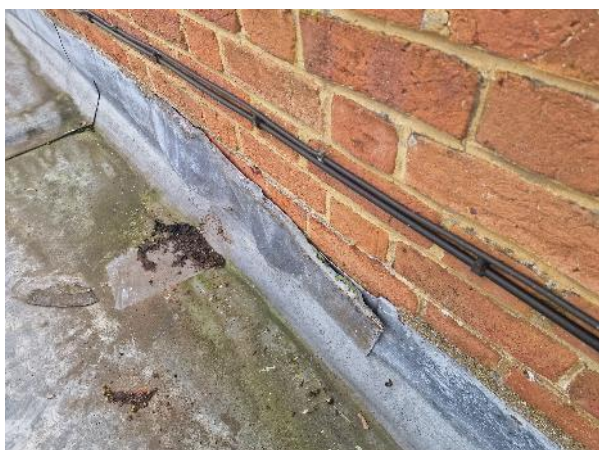
11. Poor flashing detail

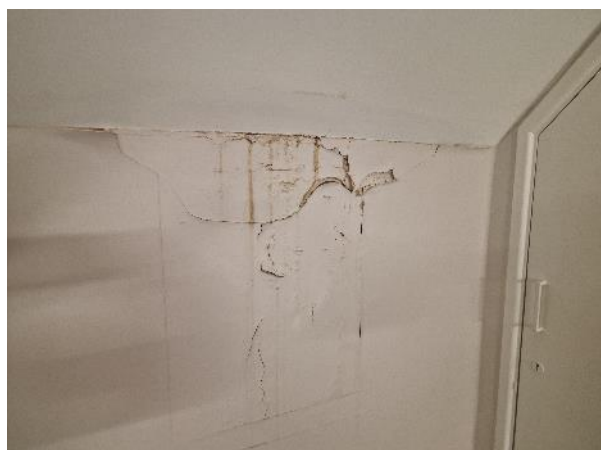
12. Water ingress from main roof

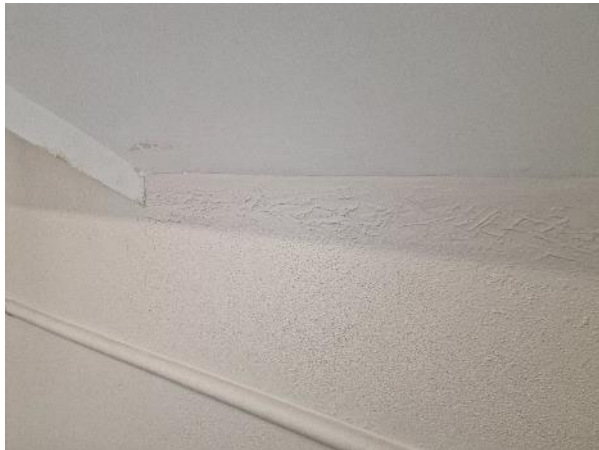
13. Water ingress from main roof

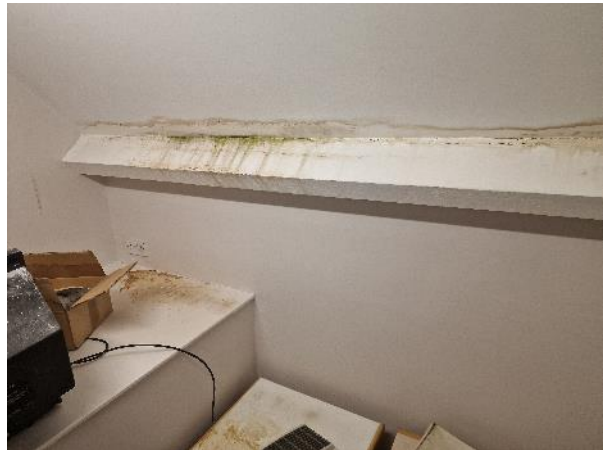
14. Water ingress from main roof

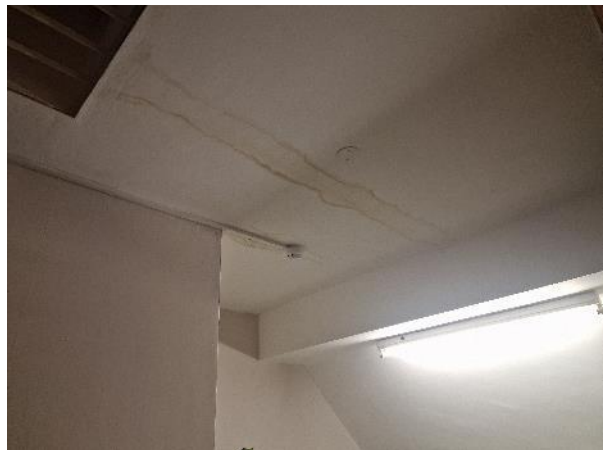
16. Water ingress from central crown

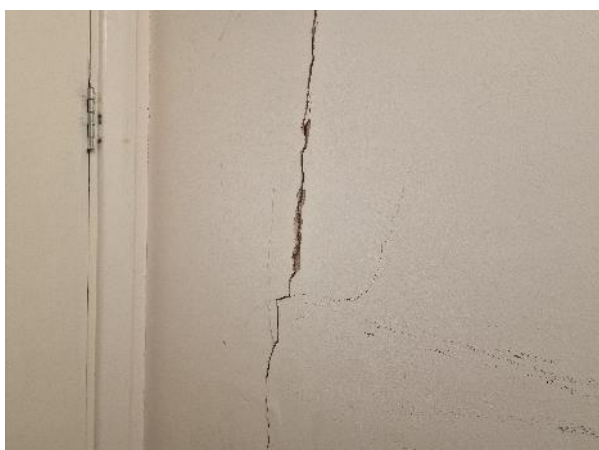
17. Cracking at first floor level

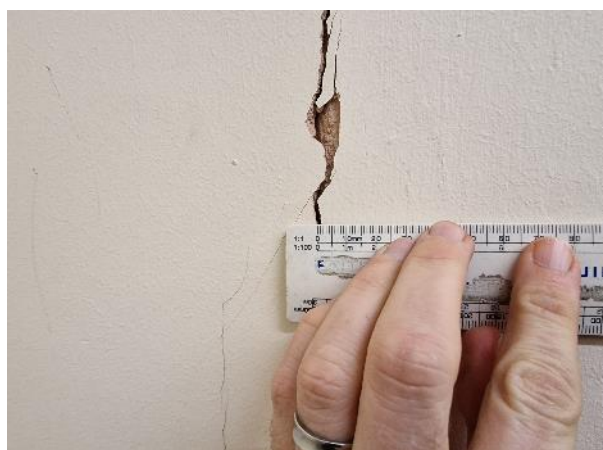
18. Cracking at first floor level

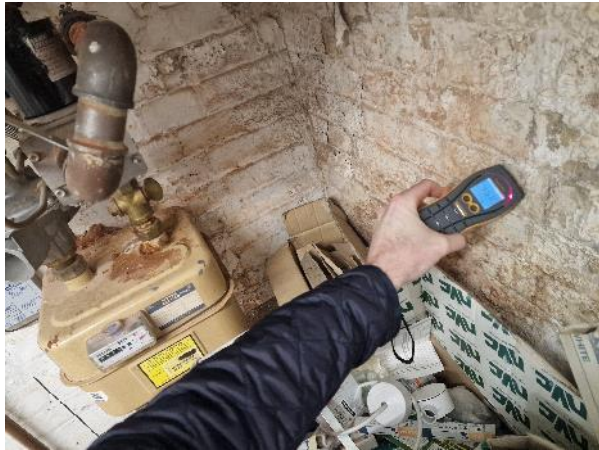
The water ingress at basement level is emanating from a combination of defective pavement lights and the high-water table, with refurbishment recommended. Damp proofing works are also required within close proximity to gas supply pipework.

19. Penetrating moisture ingress at basement level

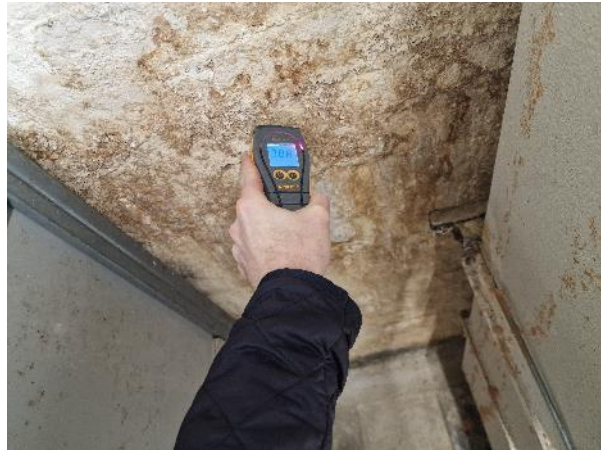
20. Penetrating moisture ingress at basement level

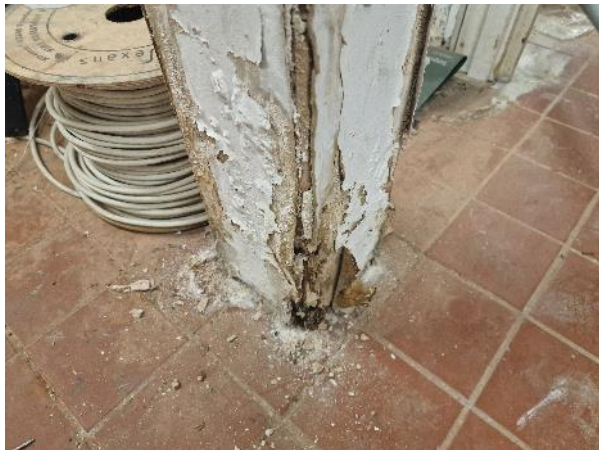
21. Timber decay to supporting post

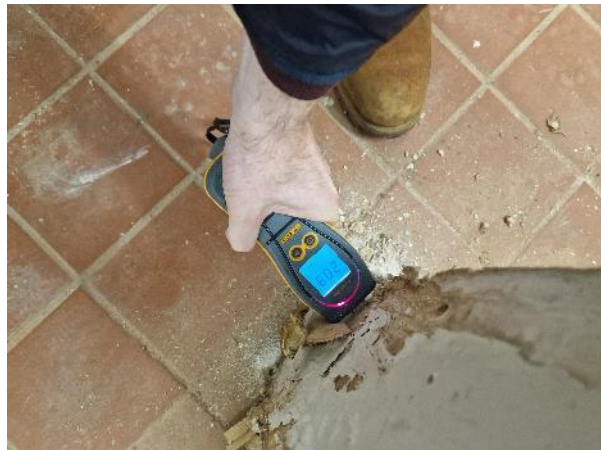
22. Timber decay to supporting post

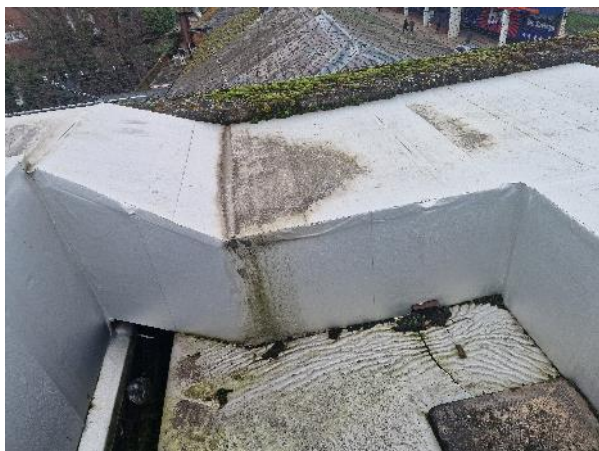
23. Defective ductwork

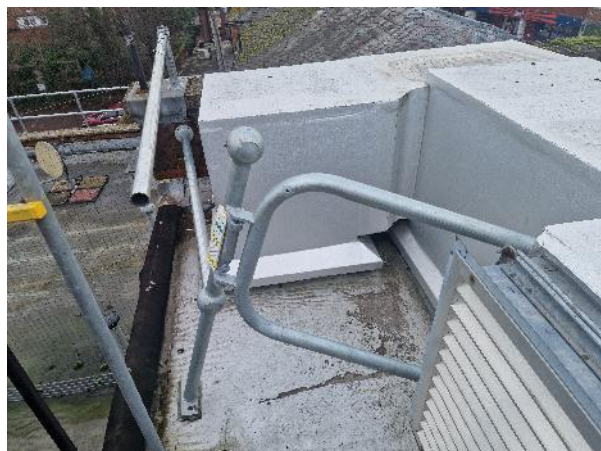
24. Defective edge protection
