# Design and Access & Heritage Statement

For secondary glazing in a listed building

**Gannock Farmhouse,  
Sandon**

**Ref: DAHS/2420**

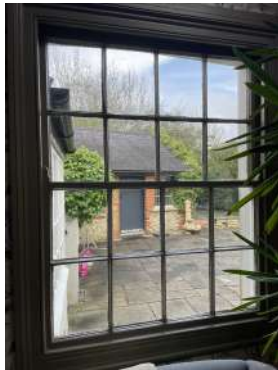
### W1 - Family room

| W1 | Description | Notes |
|---|---|---|
| Window frame | Appears to be original frame – early 20 <sup>th</sup> Century | Good condition |
| Window sashes | Original sashes from early 20 <sup>th</sup> Century | Good condition |
| Operation | Top and bottom painted shut | |

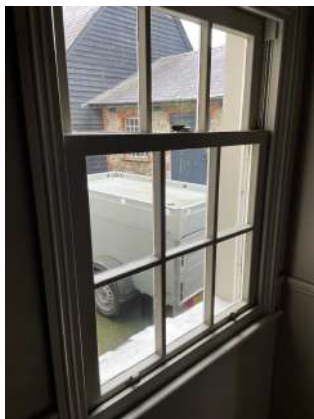
### W2 - Hall adjacent to boot room

| W2 | Description | Notes |
|---|---|---|
| Window sashes | Late 20 <sup>th</sup> /early 21 <sup>st</sup> Century sashes | Spring balance |
| Operation | Fully working bottom sash. | |

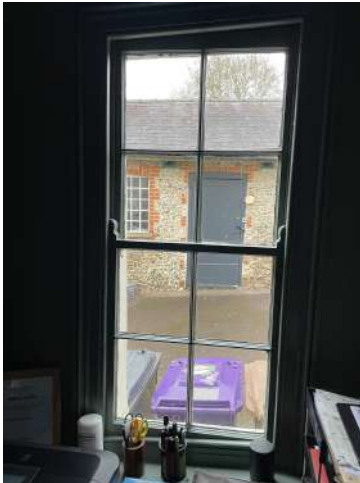
### W3 – Office

| W3 | Description | Notes |
|---|---|---|
| Window frame | Appears to be a 19 <sup>th</sup> Century frame. | Reasonable condition. |
| Window sashes | 19 <sup>th</sup> Century sashes | Reasonable condition. No quadrant fastener |
| Operation | Painted shut | |

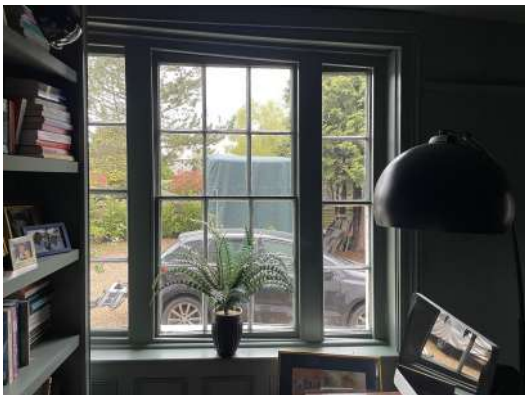
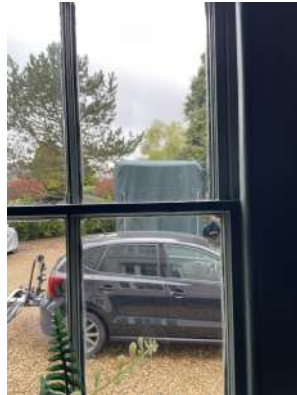
### W4 - Office

| W4 | Description | Notes |
|---|---|---|
| Window frame | Appears to be a 19 <sup>th</sup> Century frame. | Reasonable condition. Window has racked significantly in the past. |
| Window sashes | 19 <sup>th</sup> Century sashes | Reasonable condition. No quadrant fastener |
| Operation | Painted shut | |

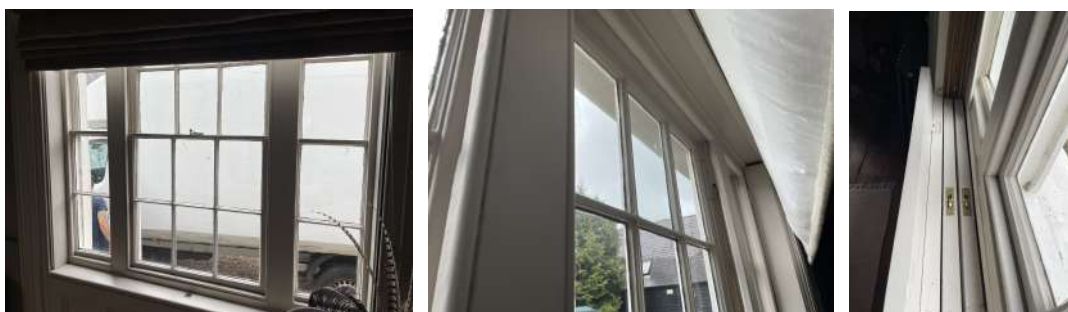
## W5 – Living room

| W5 | Description | Notes |
|---|---|---|
| Window frame | Presumed to be 19 <sup>th</sup> Century | Reasonable condition |
| Window sashes | Presumed to be 19 <sup>th</sup> Century | Some decoration required. External putty loose and coming away in places |
| Draught seals | Yes | Worn. |

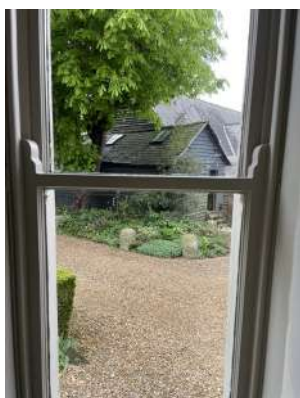
## W6 – Living room (part of bay window)

| W6 | Description | Notes |
|---|---|---|
| Window frame | Presumed to be later 19 <sup>th</sup> Century | Good condition |
| Window sashes | Presumed to be later 19 <sup>th</sup> Century | Good condition |
| Operation | Non opening | No sash cords |

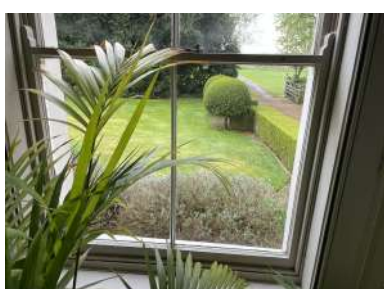
## W7 – Living room (part of bay window)

| W7 | Description | Notes |
|---|---|---|
| Window frame | Presumed to be later 19 <sup>th</sup> Century | Good condition |
| Window sashes | Presumed to be later 19 <sup>th</sup> Century | Good condition |

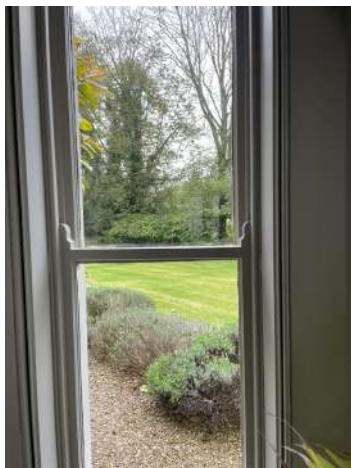
### W8 – Living room (part of bay window)

| W8 | Description | Notes |
|---|---|---|
| Window frame | Presumed to be later 19 <sup>th</sup> Century | Good condition |
| Window sashes | Presumed to be later 19 <sup>th</sup> Century | Good condition |
| Operation | Non opening | No sash cords |

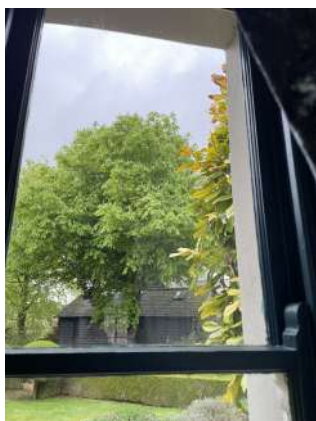
### W9- Dining room (part of bay window)

| W9 | Description | Notes |
|---|---|---|
| Window frame | Presumed to be later 19 <sup>th</sup> Century | Good condition |
| Window sashes | Presumed to be later 19 <sup>th</sup> Century | Good condition |
| Operation | Non opening | No sash cords |

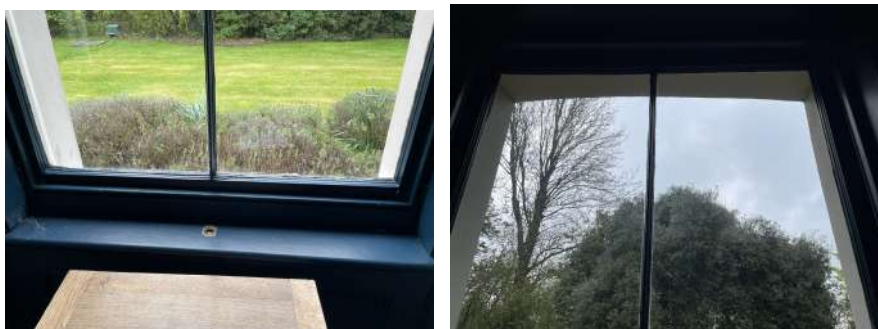
### W10 - Dining room (part of bay window)

| W10 | Description | Notes |
|---|---|---|
| Window frame | Presumed to be later 19 <sup>th</sup> Century | Good condition |
| Window sashes | Presumed to be later 19 <sup>th</sup> Century | Good condition |
| Operation | Painted shut | |

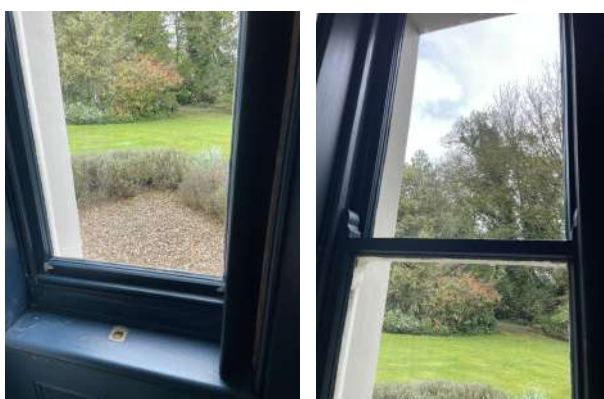
### W11 - Dining room (part of bay window)

| W11 | Description | Notes |
|---|---|---|
| Window frame | Presumed to be later 19 <sup>th</sup> Century | Good condition |
| Window sashes | Presumed to be later 19 <sup>th</sup> Century | Good condition |
| Operation | Non opening | No sash cords |

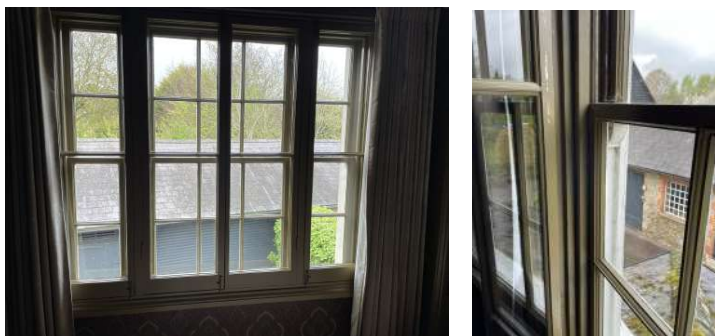
## W12 – Bedroom 4

| W12 | Description | Notes |
|---|---|---|
| Window frame | Presumed to be 20 <sup>th</sup> Century | Reasonable condition. |
| Window sashes | Presumed to be 20 <sup>th</sup> Century | Reasonable condition. |
| Shutters | None present | Secondary glazing casement windows |

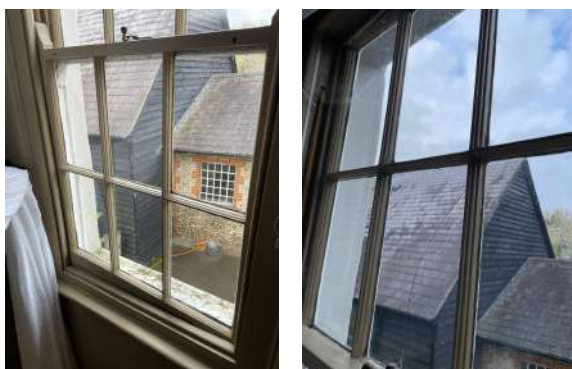
## W13 – Bedroom 3

| W13 | Description | Notes |
|---|---|---|
| Window frame | Presumed to be 19 <sup>th</sup> Century | Reasonable condition. The frame has racked in the past. |
| Draught seals | Yes | Worn |
| Glass | Original glass - Single glazing | One cracked pane in the upper sash. |

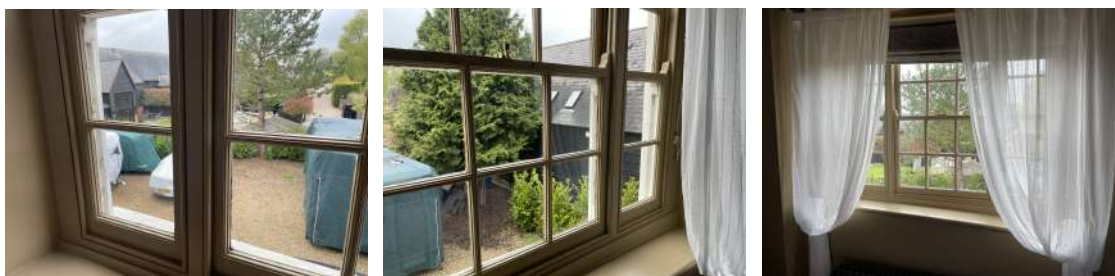
## W14 – Bedroom 3

| W14 | Description | Notes |
|---|---|---|
| Window frame | 20 <sup>th</sup> Century | Good condition. Fitted within a racked opening |
| Window sashes | 20 <sup>th</sup> Century | Good condition |

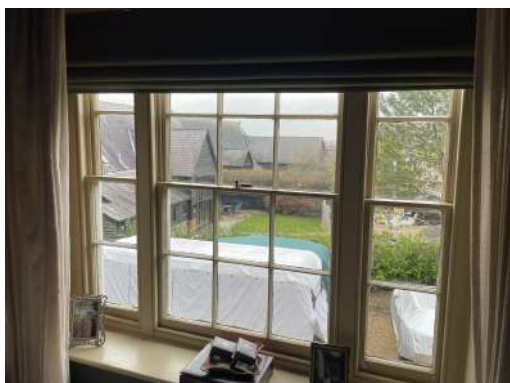
## W16 – Bedroom 2

| W16 | Description | Notes |
|---|---|---|
| Window frame | Presumed 19 <sup>th</sup> Century | Reasonable condition. |
| Window sashes | Presumed 19 <sup>th</sup> Century | Reasonable condition. |

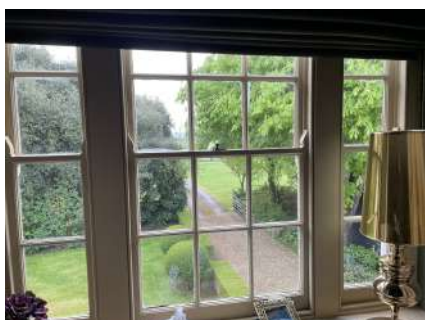
## W17 – Bedroom 2

| W17 | Description | Notes |
|---|---|---|
| Window frame | 20 <sup>th</sup> Century | Good condition |
| Window sashes | 20 <sup>th</sup> Century | Good condition. |

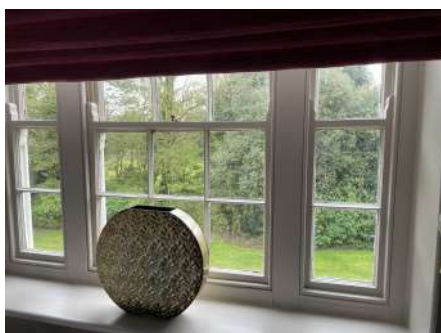
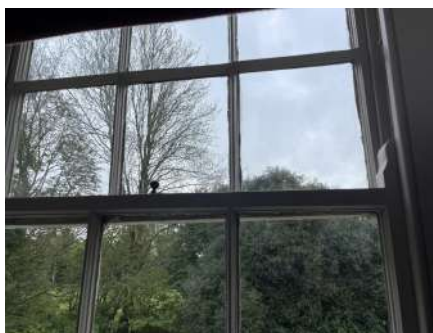
## W18 - Bedroom 1

| W18 | Description | Notes |
|---|---|---|
| Window frame | Presumed 19 <sup>th</sup> Century | Reasonable condition |
| Window sashes | Presumed 19 <sup>th</sup> century | Reasonable condition. |
| Glass | Original glass – single glazing | One cracked pane |

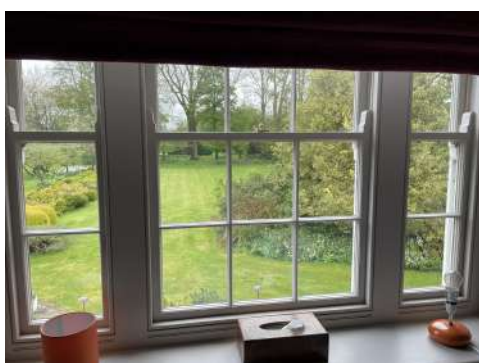
## W19 - Bedroom 1

| W19 | Description | Notes |
|---|---|---|
| Window type | Sash. Six upper panes and six lower panes to central window. Two upper panes and two lower panes to outer sidelights. | Window opening added in 2013 |
| Window frame | 21 <sup>st</sup> Century | Good condition |
| Window sashes | 21 <sup>st</sup> Century | Good condition. |

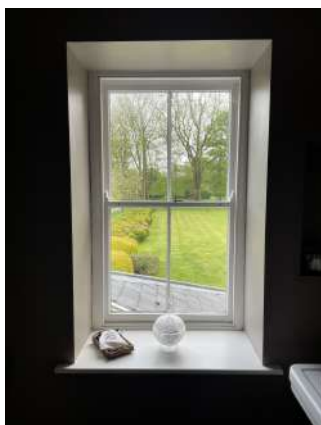
## W20 – Bedroom 1 En- Suite

| W20 | Description | Notes |
|---|---|---|
| Window type | Sash. Two upper panes and two lower panes | Window position moved in 2013. |
| Window frame | Presumed 19 <sup>th</sup> Century | Good condition |
| Window sashes | Presumed 19 <sup>th</sup> Century | Good condition |

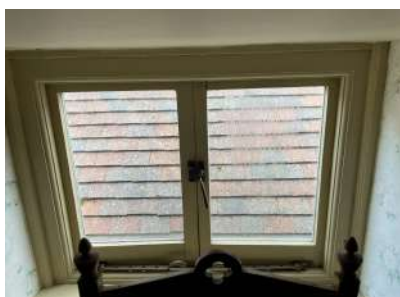
## W22 – Bedroom 5

| W22 | Description | Notes |
|---|---|---|
| Window frame | 20 <sup>th</sup> Century | Good condition |
| Window sashes | 20 <sup>th</sup> Century | Good condition |

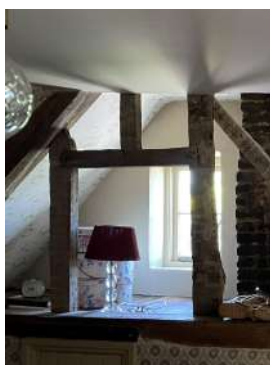
### W24 – Bedroom 5

| W24 | Description | Notes |
|---|---|---|
| Window frame | 21 <sup>st</sup> Century | Good condition |
| Window sashes | 21 <sup>st</sup> Century | Good condition |

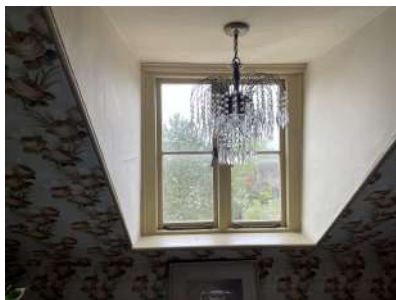
## W25 – Bedroom 5 Ensuite

| W25 | Description | Notes |
|---|---|---|
| Window frame | Late 20 <sup>th</sup> Century | Reasonable condition |
| Window sashes | Late 20 <sup>th</sup> Century | Reasonable condition |

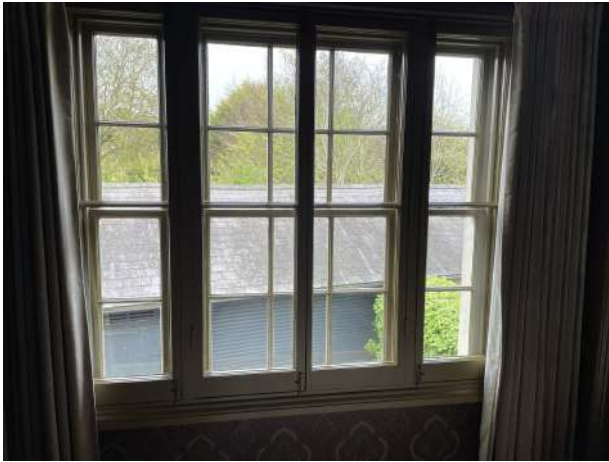
Window W12

It is proposed to remove the casement secondary glazing to windows W12 (bedroom 4) and W21 (shower room). These are 20<sup>th</sup>/21<sup>st</sup> Century additions so are not historic.

The secondary casement glazing is more successful in the bedroom than in the shower room and, while it does help improve the thermal performance and reduce draughts, its visual appearance detracts from the sash windows. It is therefore proposed to replace with new secondary glazing which will match elsewhere in the house as set out in the following proposals. This will provide a consistent appearance.

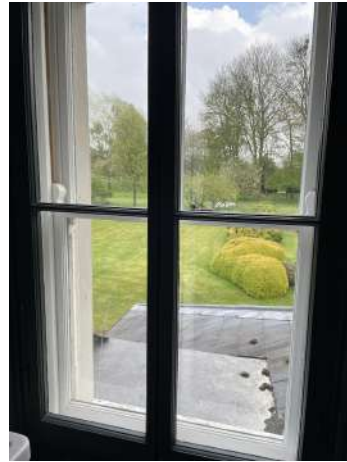
Window W21

| W21 | Description | Notes |
|---|---|---|
| Shutters | None present | Casement secondary glazing with cracked pane. |
