## ARBORICULTURAL IMPACT ASSESSMENT REPORT

Land West of Tuthill House,  
Kelshall Tops,  
Therfield,  
Hertfordshire

**OUR REF: SHA 1089 Rev D June 2024**

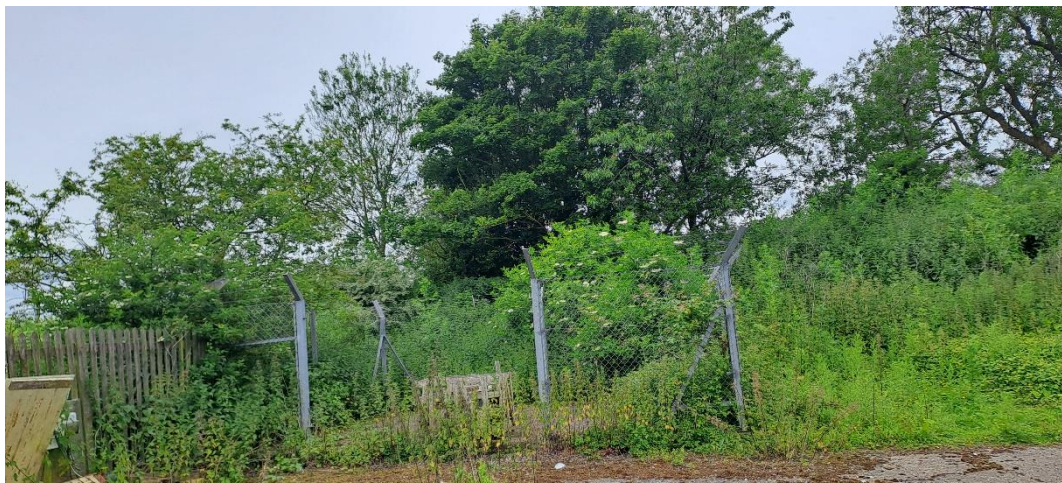
- 6.5. *Comments on specific trees and the arboricultural impact: Trees on the western boundary: T3 & T4 ash (category U under the BS – unsuitable for retention), T5 ash (category B – moderate value), T6 ash (C), T7 ash (U), T10 cherry (C) and T11 field maple (B).*  
This line of trees is growing adjacent to the western boundary of the site, immediately between a raised 2m high grassed bund and a public footpath. T2 is a large ash which has collapsed and only a large sucker remains.

T3 and T4 are smaller ash trees with poor shape and form with wounds, decay and dieback. Whilst not imminently dangerous, they are unsuitable for retention. T5 is a large prominent ash in a reasonable condition, but with some woodpecker holes indicating decay and old stubs and scars from historic storm damage and decay fungi *Inonotus hispidus* is present. T6 ash is a moderately sized tree with defects, including a large branch that has collapsed in the distant past and rooted. Tree works and further inspection are recommended in the tree surgery schedule at appendix 4. As these are offsite trees, this is a matter for the owner.

*Photo 1 of the western boundary looking from the site. June 2024.*

| Tree no. | Species | Proposed works | Reason |
|---|---|---|---|
| <b>T3 and T4</b> | Ash | Advisory: Remove tree and retain root. | For safety reasons as the tree is decayed. Not in connection with the proposal.<br><b>Responsibility of the owner and not in connection with the proposal.</b> |
| <b>T5 and T6</b> | Ash | Advisory: remove major dead wood. Carry out aerial inspection and remove any dead wood or defective branches. | For safety reasons<br><b>Responsibility of the owner and not in connection with the proposal</b> |

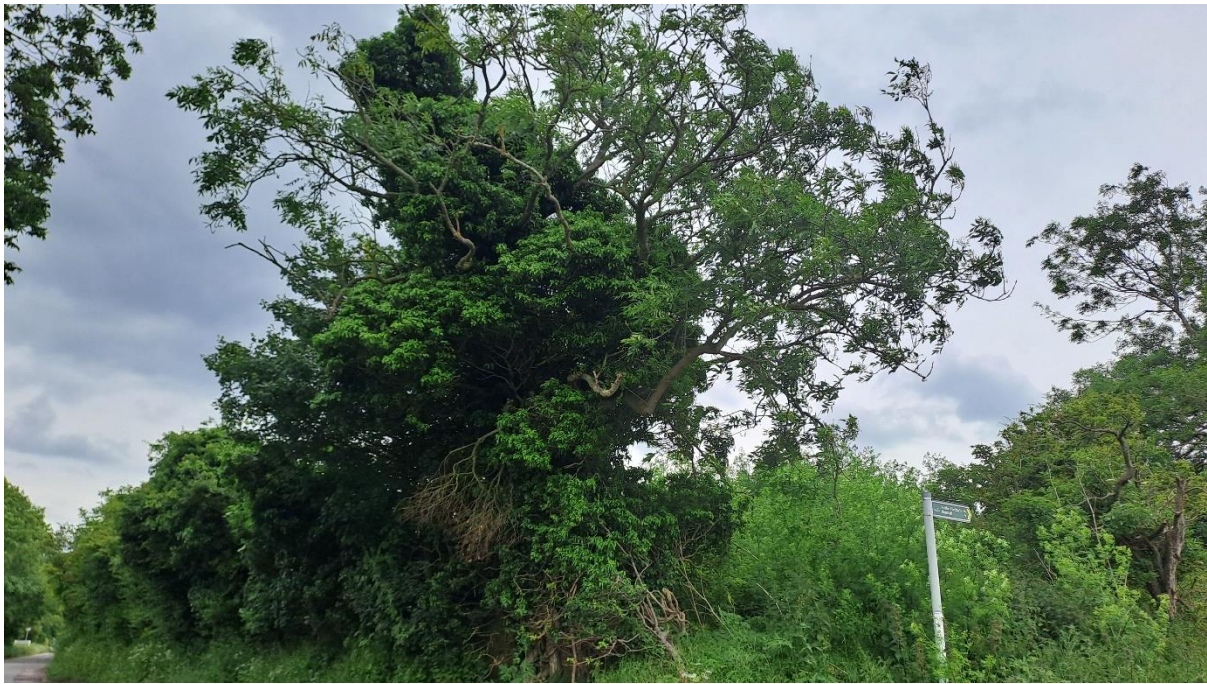
T7 is an ash tree with a large open cavity on the stem on the eastern and southern side. It appears that the tree is completely hollow with only a narrow band of live wood. There is a high risk of failure into the road, exacerbated by the dense ivy growth. The dangerous trees have been reported to Herts County Council Highways.

*Photo 2 of the hazardous tree, T7 ash. June 2024*

| Tree Number | Botanical Name<br>(Common name) | Age | Dia<br>(mm) | Stems | Height<br>(crown height) | Ult ht<br>(m) | N | E | S | W | Cond | Life<br>Exp | BS<br>Cat | RPR (m) | RPA (m <sup>2</sup> ) | Comments | Recommendations |
|---|---|---|---|---|---|---|---|---|---|---|---|---|---|---|---|---|---|
| T7 | Fraxinus excelsior<br>(Ash) | M | 900 | 1 | 9(4) | 15 | 5 | 1 | 4 | 6 | Poor | <10 | U | 10.8 | 366.48 | Poor shape & form. Declining. Ivy on tree. Unable to inspect stem due to Ivy. Decay present on stem. Cavity on stem. The Eastern and South eastern side of the trunk is a wide open cavity to where the trunk becomes two stems at 2m. Difficult to judge due to ivy, but it appears that the entire tree is hollow with a narrow band of live wood. Next to road. Tree failure highly propbable. | Remove tree and retain root. Works immediate. Owner to be informed on day of survey. |

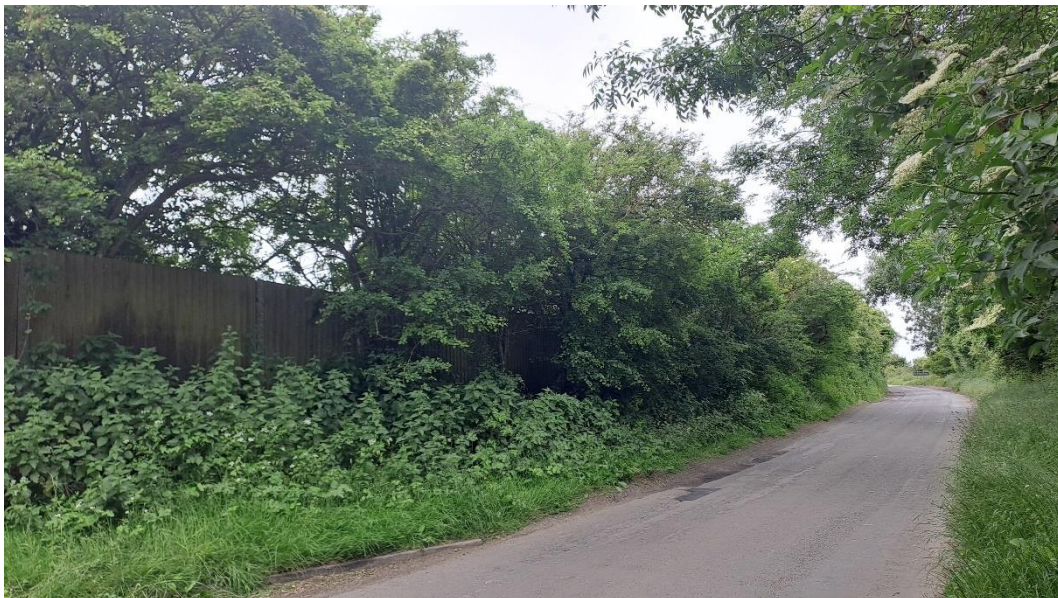
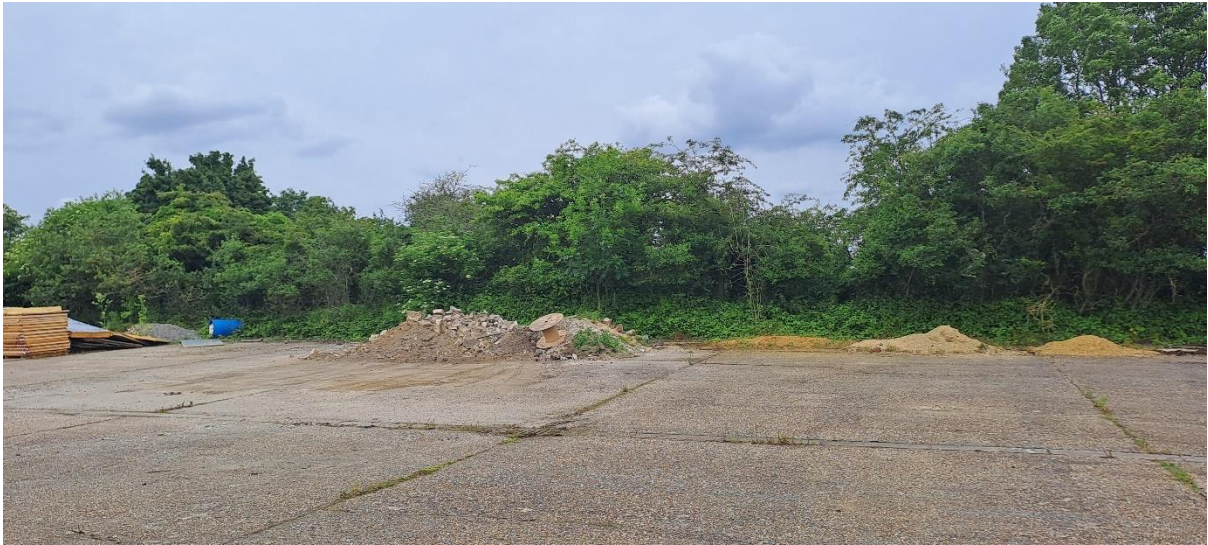
T8 is a modest twin stemmed hedgerow field maple with potential to mature, especially given that T7 will be removed. The group G9 is primarily individual hawthorn trees at maturity either side of the dilapidated fence. Within the site are a dense group of suckering blackthorn up to the edge of the concrete. If this was removed, they will continue to sucker into the site. There is occasional dogwood, elder and spindle bushes. There is potential to increase the quality and species diversity of this group and to manage the weaker specimens by pruning. The lowest quality area is in the centre. Never the less, the trees have collective landscape and ecological value and provide some screening.

*Photo 3 of G9 looking south-west. June 2024.*

*Photo 4 of the group G9 from the inside of the site, looking north east. June 2024.*

20m length in the group G9 will be removed and the remainder crown lifted to enable site splay visibility. All other trees can be retained, but I recommend that an area of blackthorn shown red hatched on the plan 2 below is removed to create reasonable side garden. The remainder will be retained and protected during works, but there is potential for active management with infill planting. This will be discussed with the ecologist and landscape architect post planning. I recommend a linear root barrier in front of retained blackthorn to prevent suckering and spreading.

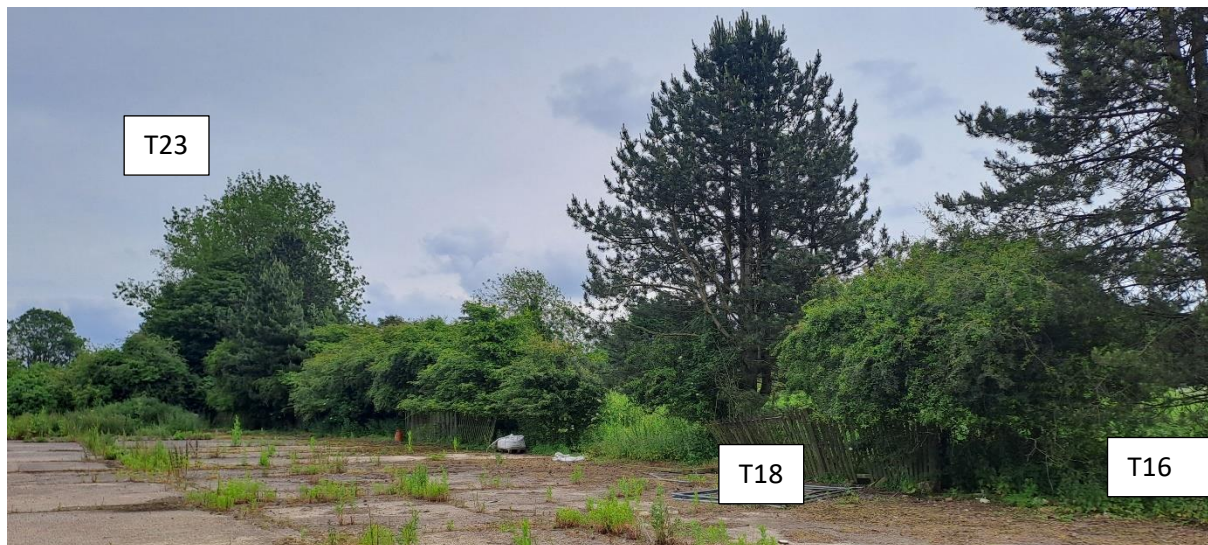
This attractive line of trees is just offsite, next to the southern boundary. The pines are the prominent trees, and have yet to reach full maturity. They provide softening and screening between the site and open countryside to the south. The groups of hawthorn are patchy but provide low level screening.

Photo 5 of T16 and T20 pine looking south with G19 hawthorn. June 2024.

All will be retained and the crown spreads and root protection areas are remote from the proposed buildings. The trees will be protected by tree protection fencing.

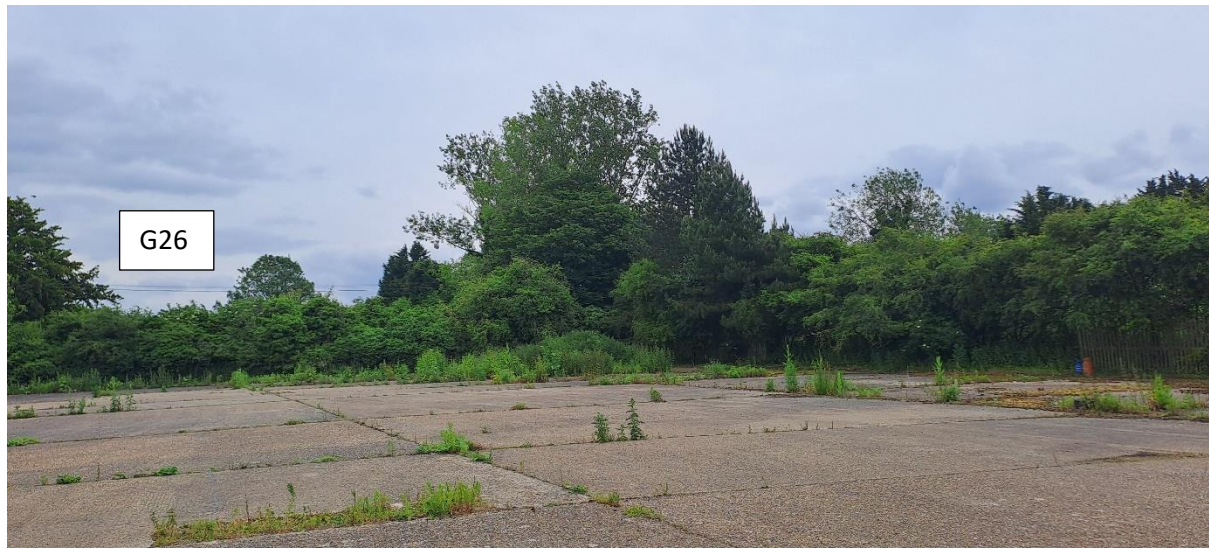
The group is a mix of unmanaged hawthorn and blackthorn which is swamped with ivy and has a poor structural form. It is just offsite and growing behind a dilapidated boundary fence, arching over the site. The ash tree is a self-sown semi-mature tree, growing close to the telegraph pole.

*Photo 6 of the low quality scrubby hedge G26 with offsite poplars in the background. Looking south-east. June 2024*

I recommend coppicing the hedge, removing all ivy and infill planting with native trees and shrubs between gaps. The area is shown to be protected by tree protection fencing to ensure that the ground is undisturbed for new planting. I recommend a root barrier to prevent the blackthorn from suckering into site. The ash is to be monitored for ash dieback disease and any dead wood removed for safety reasons.
