# Arboricultural Planning Report For:

Guysfield Care Home  
Willian Road  
Willian  
Letchworth Garden City  
SG6 2AB

| Report Date: | 24/06/2024 |
| Report Ref.: | 24 2574 |

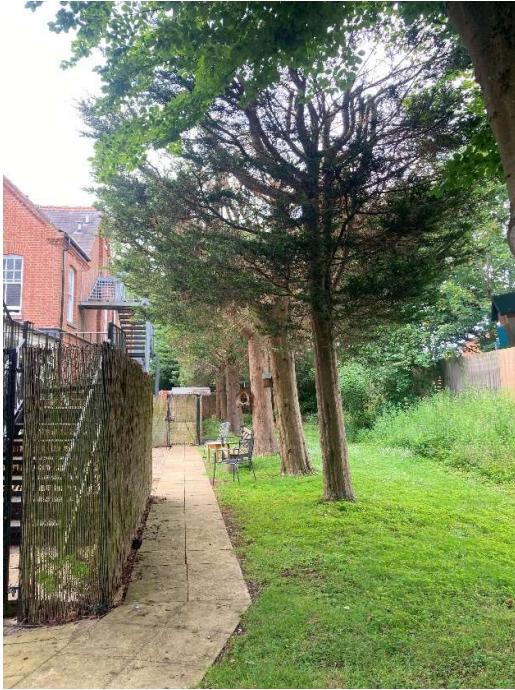
Photograph 1: looking west along group G29

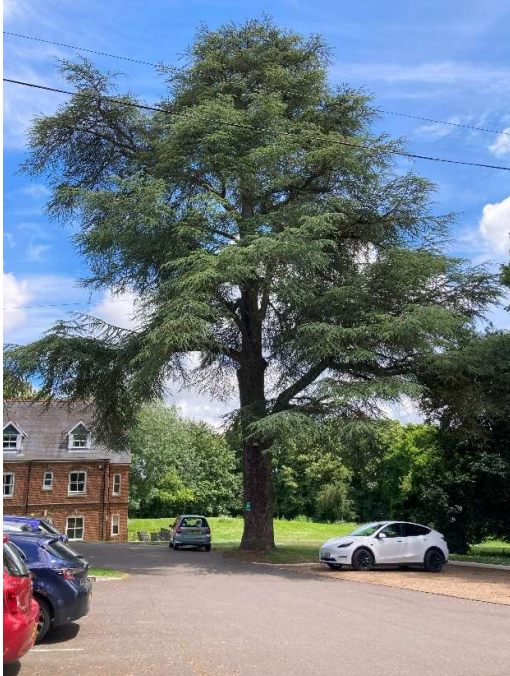
Photograph 2: Overview of tree T1

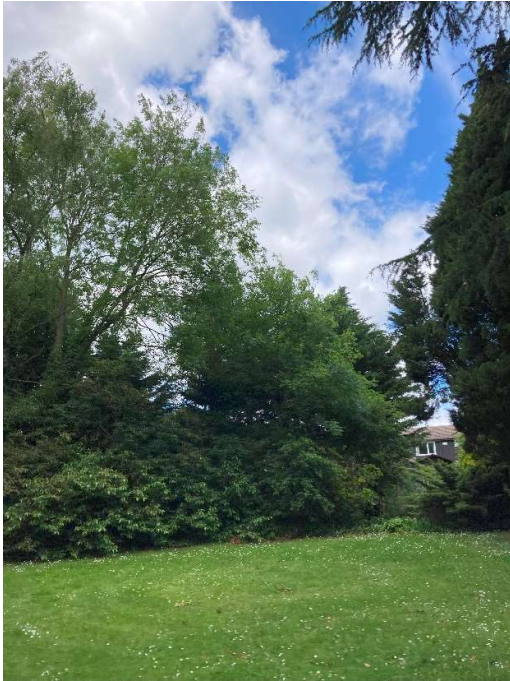
Photograph 3: Trees T17-20, G21 & part of T25 that are to be removed. G4 in the background.

| Tree Number | Common Species Name | Height (m) | Trunk Diameter and stem count | Crown Spread (m) | | | | Height of Crown | Age Class | Physiological Condition | Structural Condition | BS5837 Category | Comments/Preliminary Management Recommendations | RPA Radius (m) |
|---|---|---|---|---|---|---|---|---|---|---|---|---|---|---|
| T19 | Silver Birch (Betula pendula) | 17(3) | 260(1) | 2.00 | 3.00 | 6.00 | 3.00 | 3.00 | Over mature | Average | Average | U | Large areas of dark staining on main stem | 3.1 |

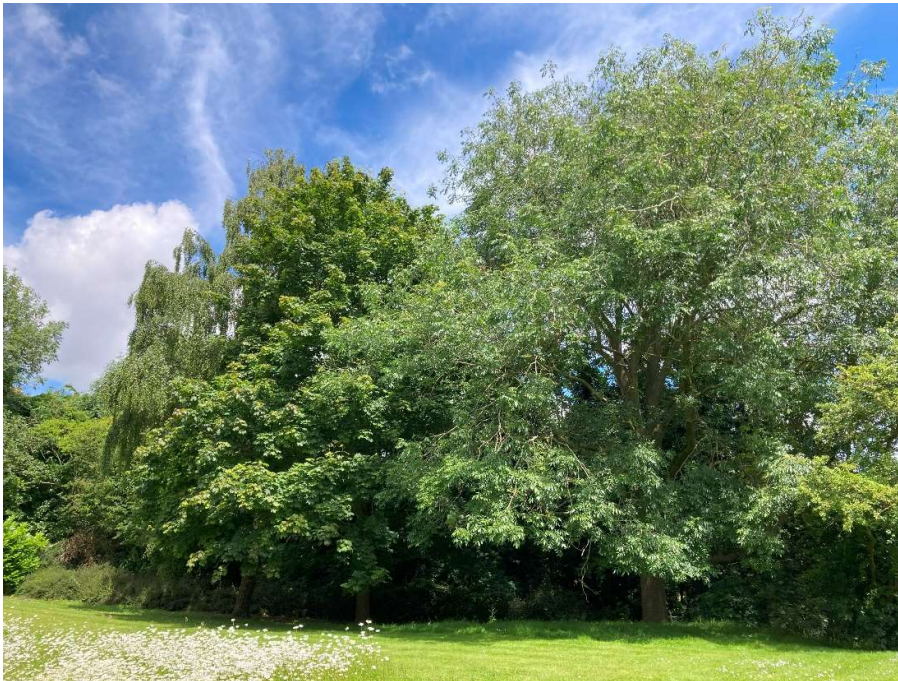
Photograph 4: Trees along eastern boundary.

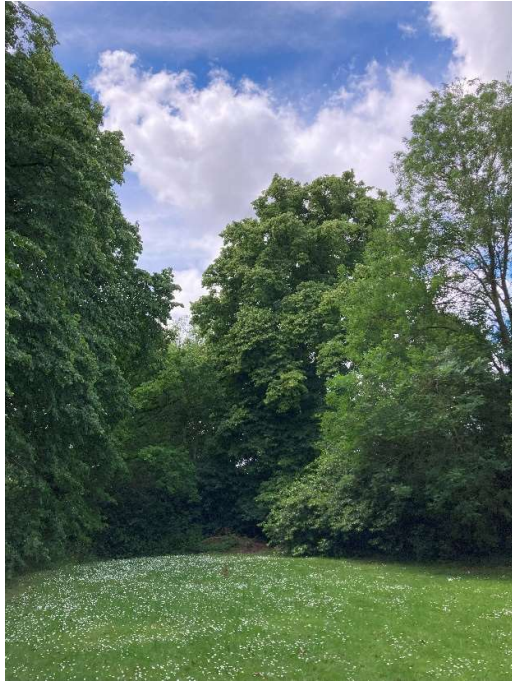
Photograph 5: Overview of trees growing in western corner T13 in the middle, T10 to the right

- 5.1.6 There are small incursions into the RPAs of trees T6, T9 & T13 from the proposed parking. Each area, as identified on the TPPs will be subject to supervised hand excavation to the required depth; root severance (if required) will be undertaken by the project arboriculturist only. If roots are found the installation of any foundations will incorporate a suitable membrane to protect surrounding soils and roots from potential concrete leaching.
