# **BS 5837:2012 Preliminary Arboricultural Impact Assessment**

**Wheatley Homes, Police Row, Therfield**

**July 2023**

**(Revised January 2024)**

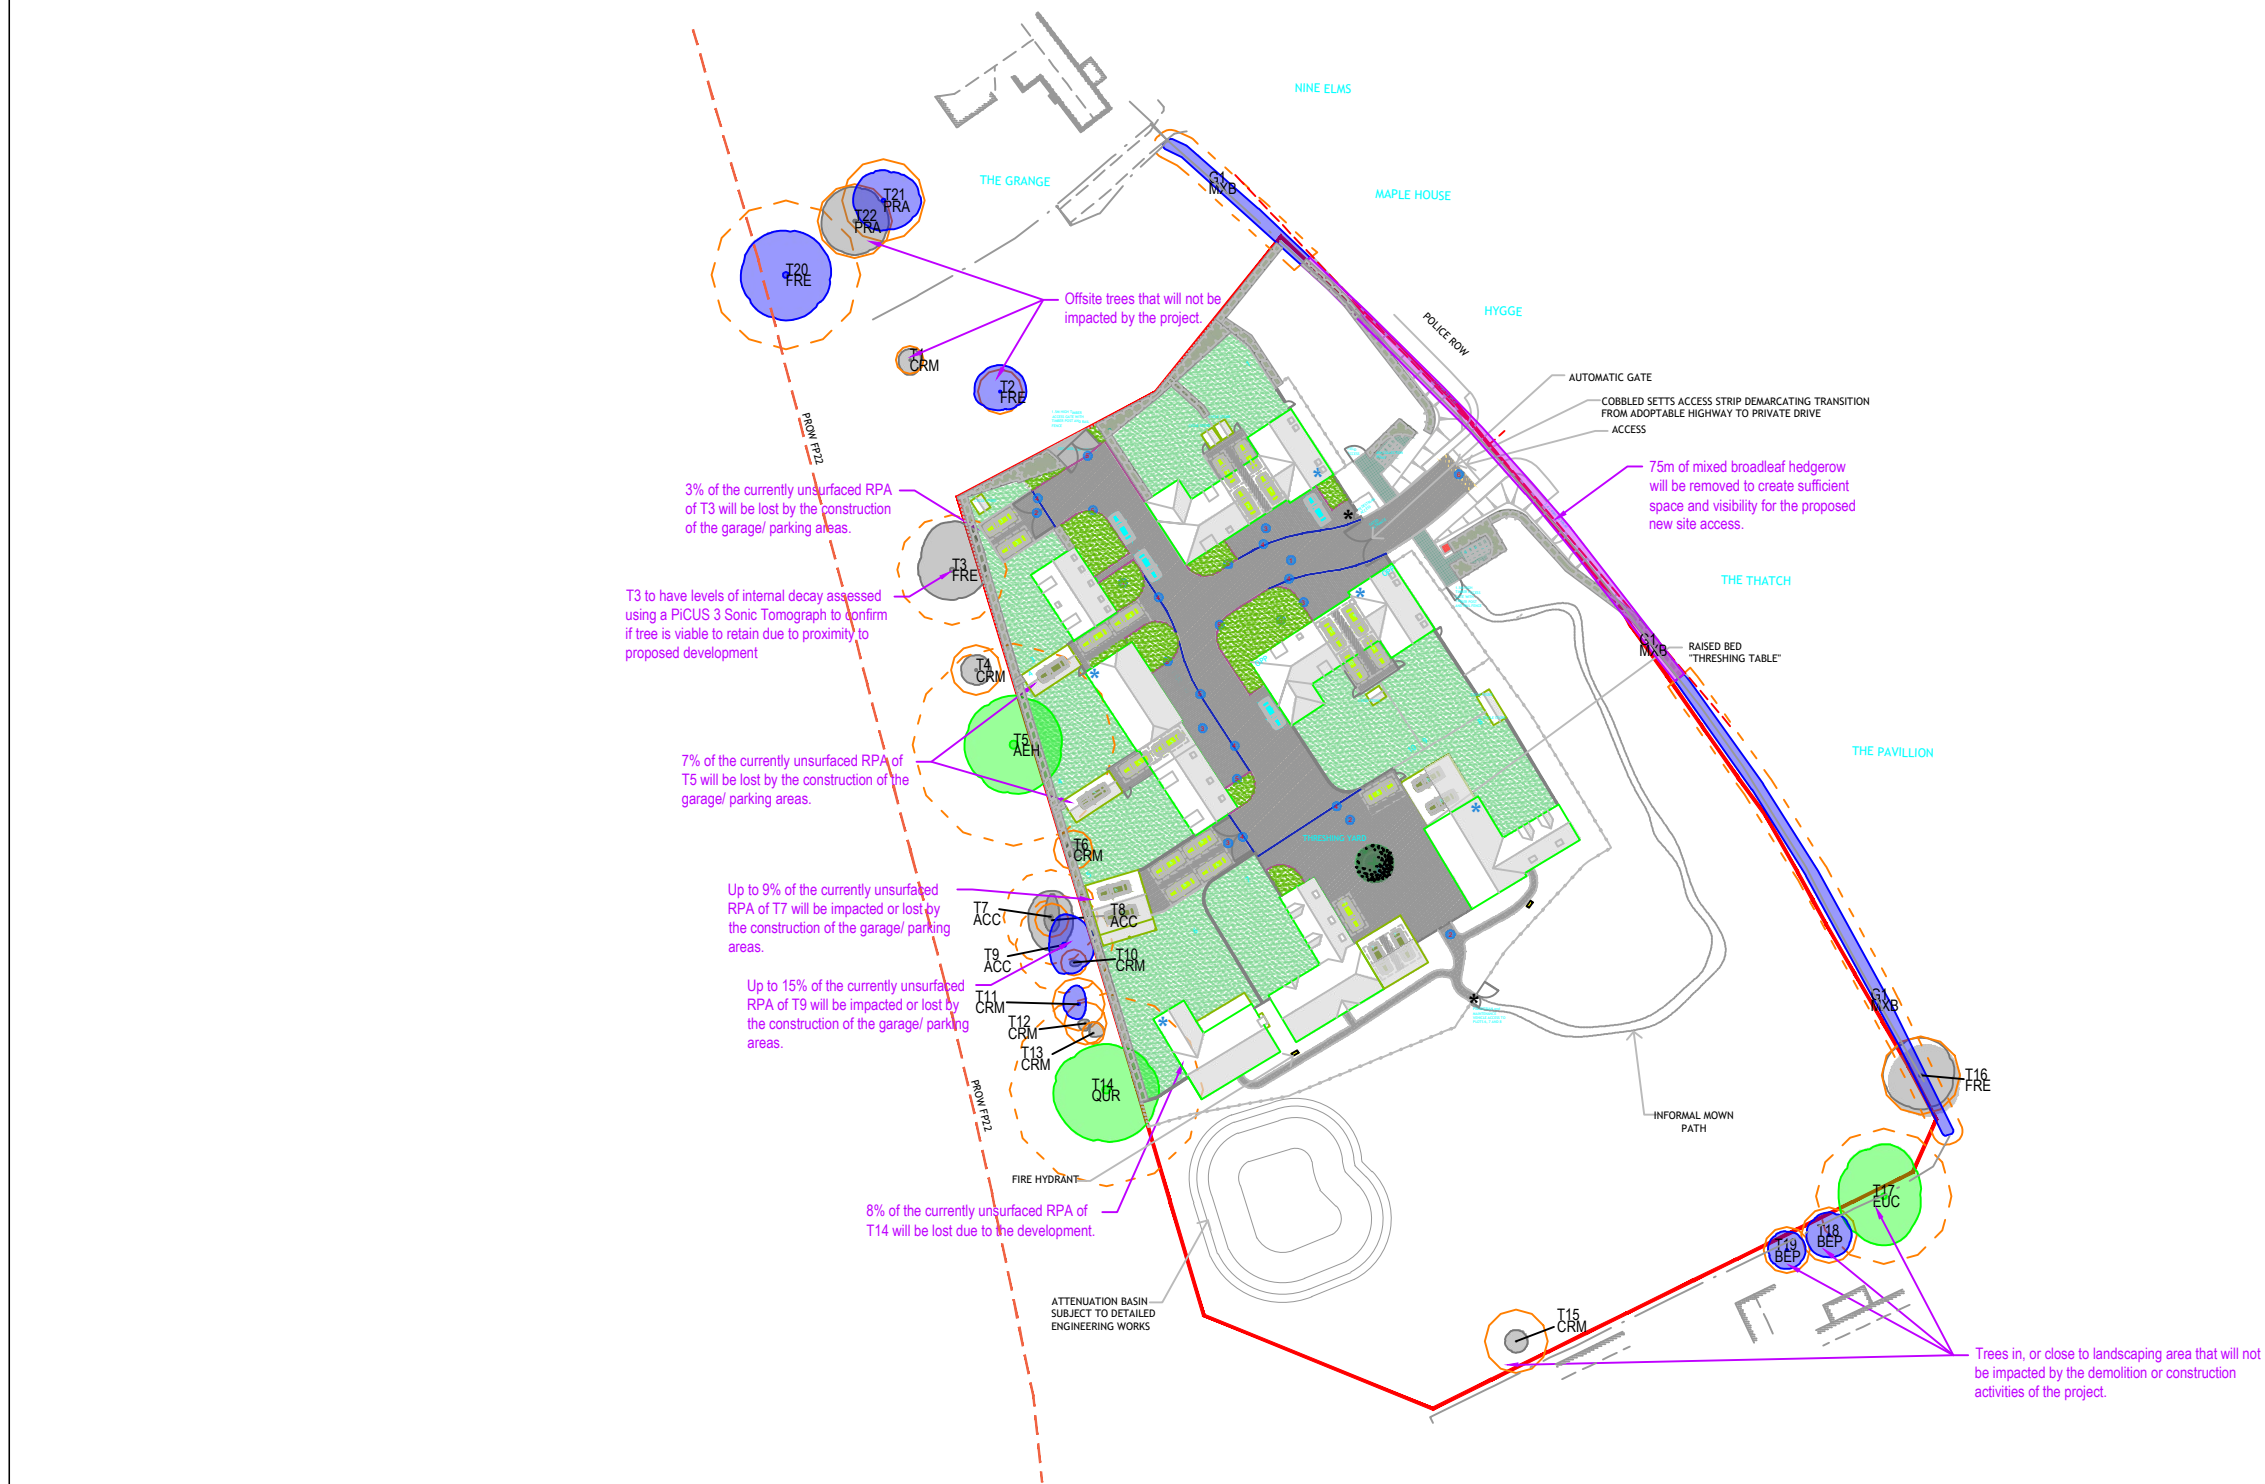
The chapter should be read alongside drawing [MH8843-002 rev B PAIA Plan](#) in Appendix D.

No trees will need to be removed to facilitate the completion of the proposed residential development in its current form. A 75 m section in the middle of hedgerow **G1** will need to be removed to allow construction vehicle access to the site, along with the completion of the new road to the residential properties once finished from Police Row.

Further investigation is required into the structural condition of **T3** to ascertain if it will be viable to retain, given its proximity to the proposed development. This investigation should use a PiCUS 3 Sonic Tomograph and be undertaken at the earliest opportunity prior to commencement of any other preparatory works.

There is a potential requirement for minor crown lifting on the east of **T5** and **T9**, creating sufficient space for construction activities. This will be confirmed after a pre-construction meeting with the appointed contractor, verifying the plant and machinery that will be used to complete the works.

The proposed development along the west side of the site encroaches into the RPAs of five offsite trees; **T3**, **T5**, **T7**, **T9** and **T14**. Where the construction or construction activities cause impact or loss of currently unsurfaced RPA, this has been detailed within the *Preliminary Arboricultural Impact Assessment Plan* in Appendix D. Details of the proposed Tree Protection that will be required can be found in the *Preliminary Tree Protection Plan* in Appendix E.

Currently the only arboricultural loss required for the proposed works is the removal of a 75 m section of hedgerow in the centre of **G1**. As this is a mature dense hedgerow of good quality, mitigation of the losses should be in the form of on-site planting of native species that are suited to cope with future climate change and local conditions.

The proposed planting of additional sections of hedgerow and additional standard trees detailed in the landscape proposal will provide adequate mitigation for the loss from **G1**,
