**PLANNING REFERENCE 17/01955/1 Conditions 6 and 7**

ARBORICULTURAL IMPACT ASSESSMENT AND METHOD STATEMENT REPORT

Ickleford Mill, Arlesey Road, Ickleford

**OUR REF: SHA 1948 Rev B**

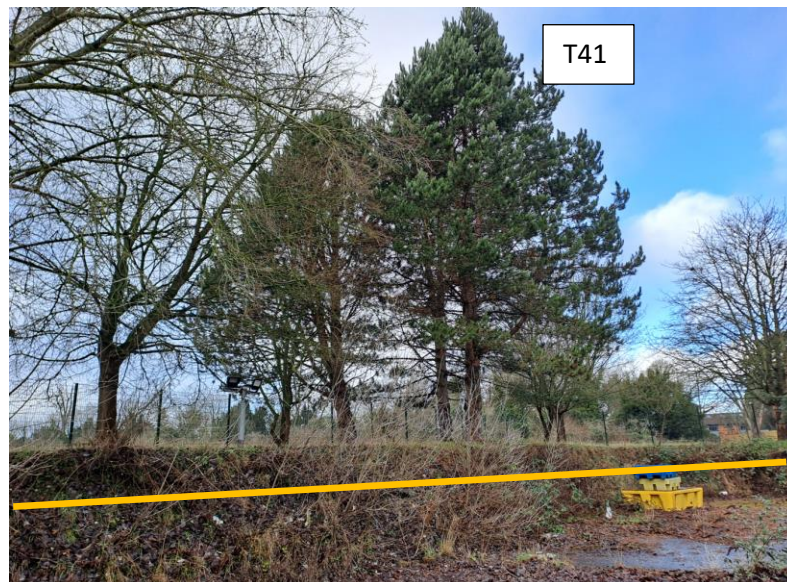
8.1 The trees on the northern and the western boundary (northern section) are on a raised bank. The bank is steep with a level change of 2m in some parts, and at the base the land is mostly laid to hard surface. Given the change in level, the facts that trees root generally in the top 600mm, raising the soil level up to the bank to reduce the steepness will not cause root asphyxiation or loss of physiological function. The tree protection fencing will be erected on the top of the bank to enable soil grading on, and up to, the bank. The raised areas will be planted with a native whip mix. The following photos and plans illustrate the proposed change.

*Photo 10 of north-western corner showing step bank and level change – annotated for proposed levels*

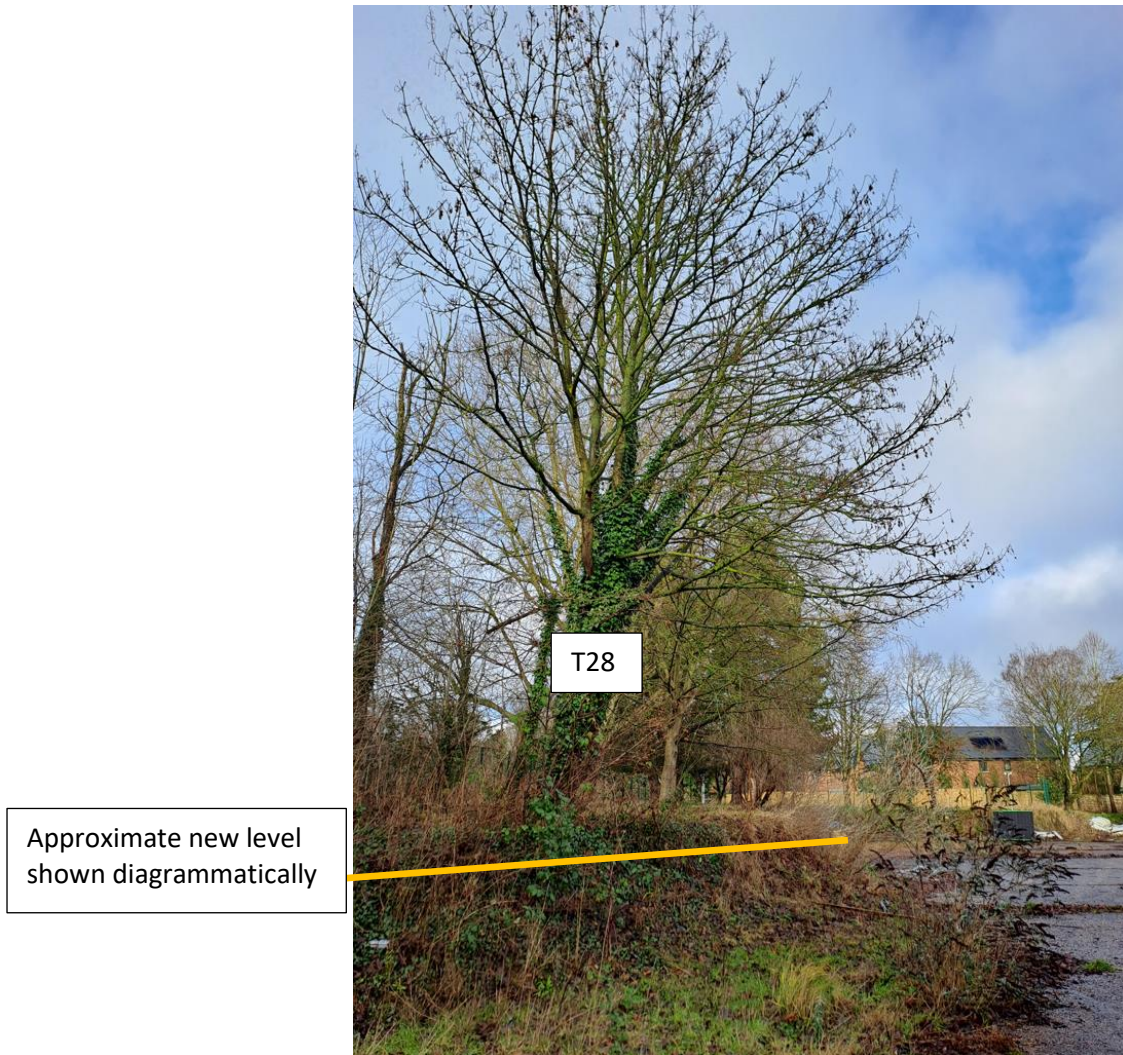
*Photo 11 of north-western edge showing step bank and level change – annotated for proposed levels at T28 looking north*

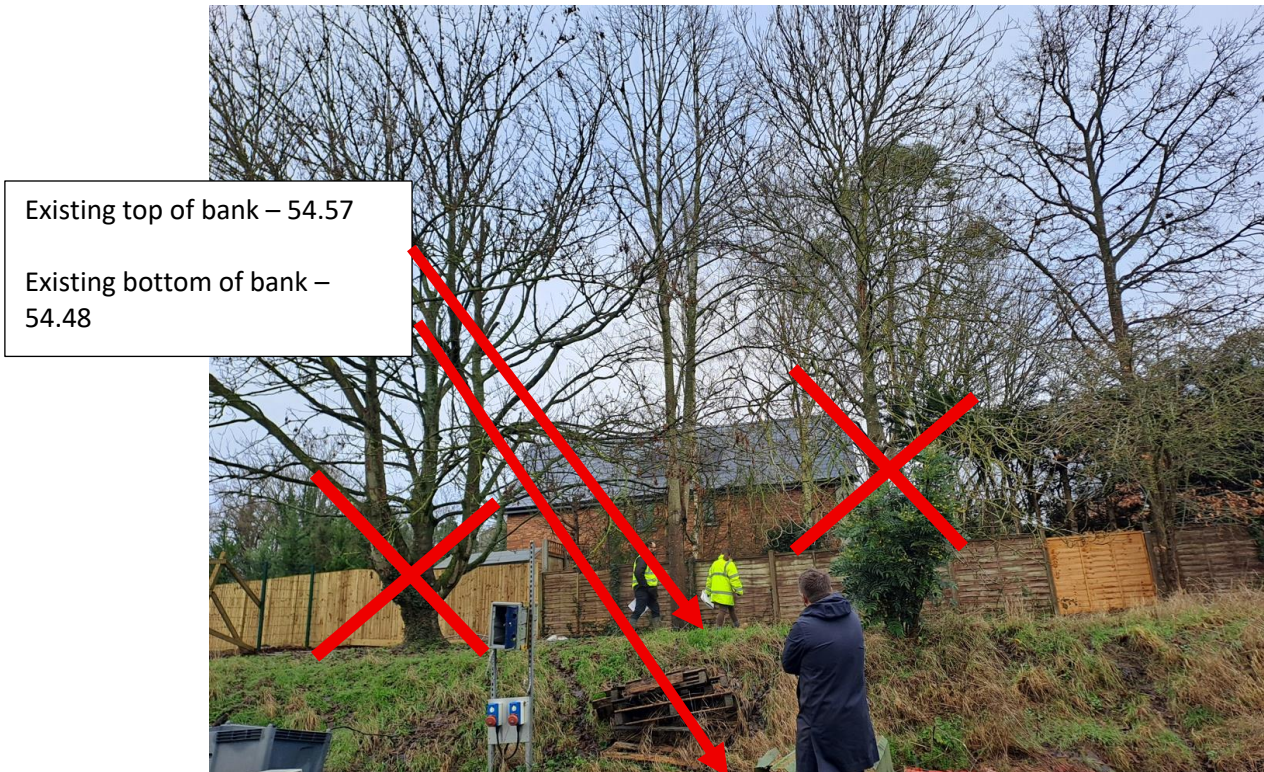
*Photo 13 of T49 and T51 looking north at the north-western part of the boundary.*

*Note trees with red X to be removed.*

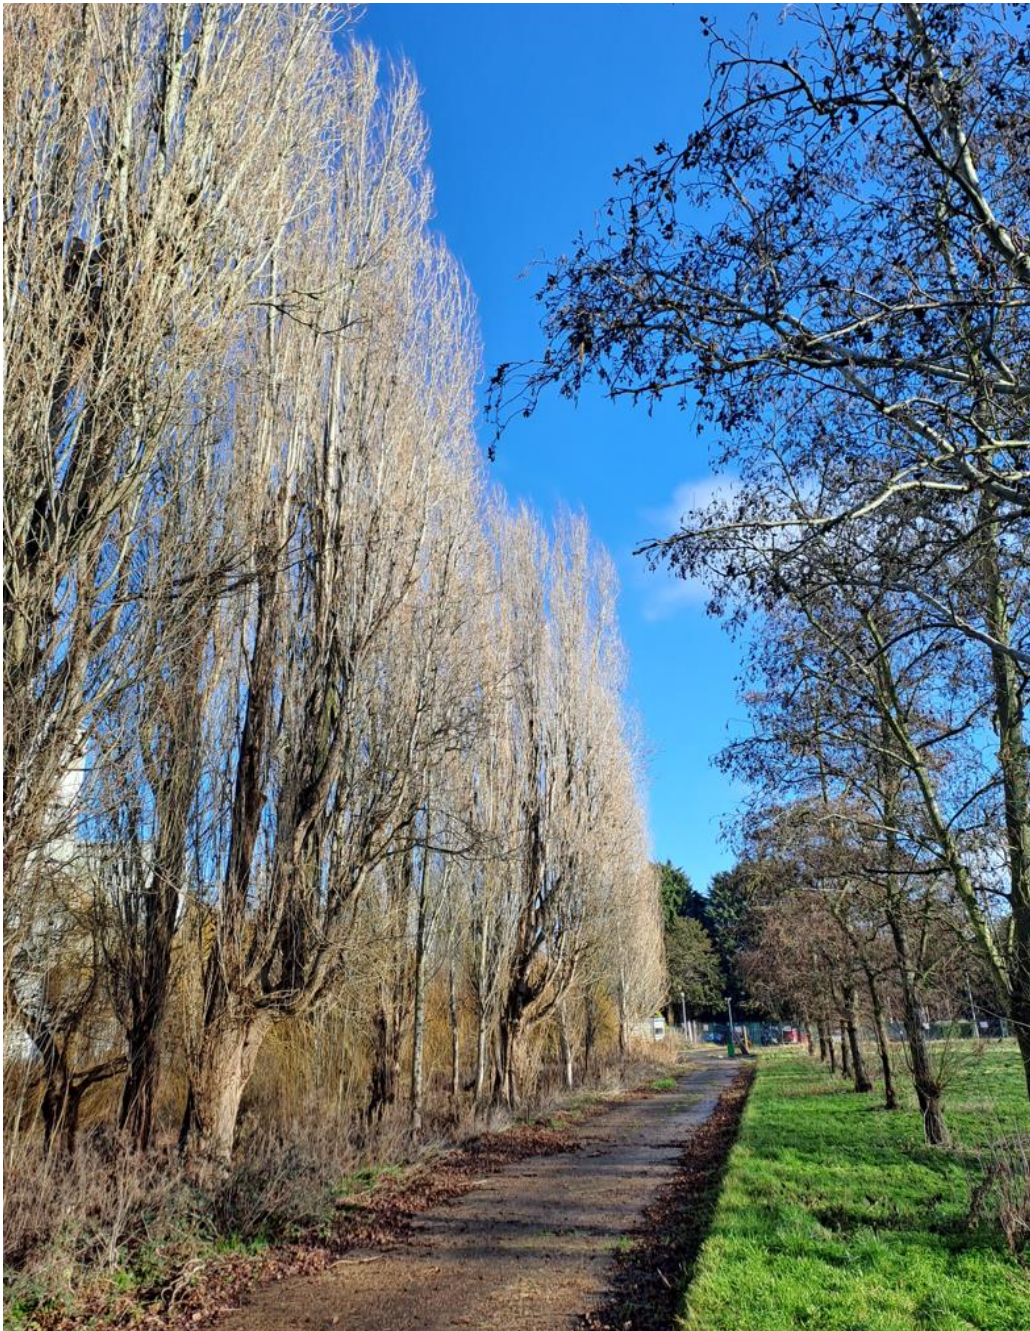
*Photo 14 of the poplars on the northern part of the existing path and alders on the southern side.*

*Looking east. Note that the removal of the path and replacement path with hoggin is beneficial as this surface is flexible and adjusts to tree root growth without causing cracking.*
