**TREE SURVEY & CONSTRAINTS PLAN  
IN ACCORDANCE WITH BS 5837:2012**

| Proj. No<br><b>11175</b> | <b>Land south of Hambridge Way, Pirton, Hitchin, SG5 3EQ</b> | |
| Client: | Blakeney Estates Ltd | |
| Date of Report: | 05/09/2024 | |

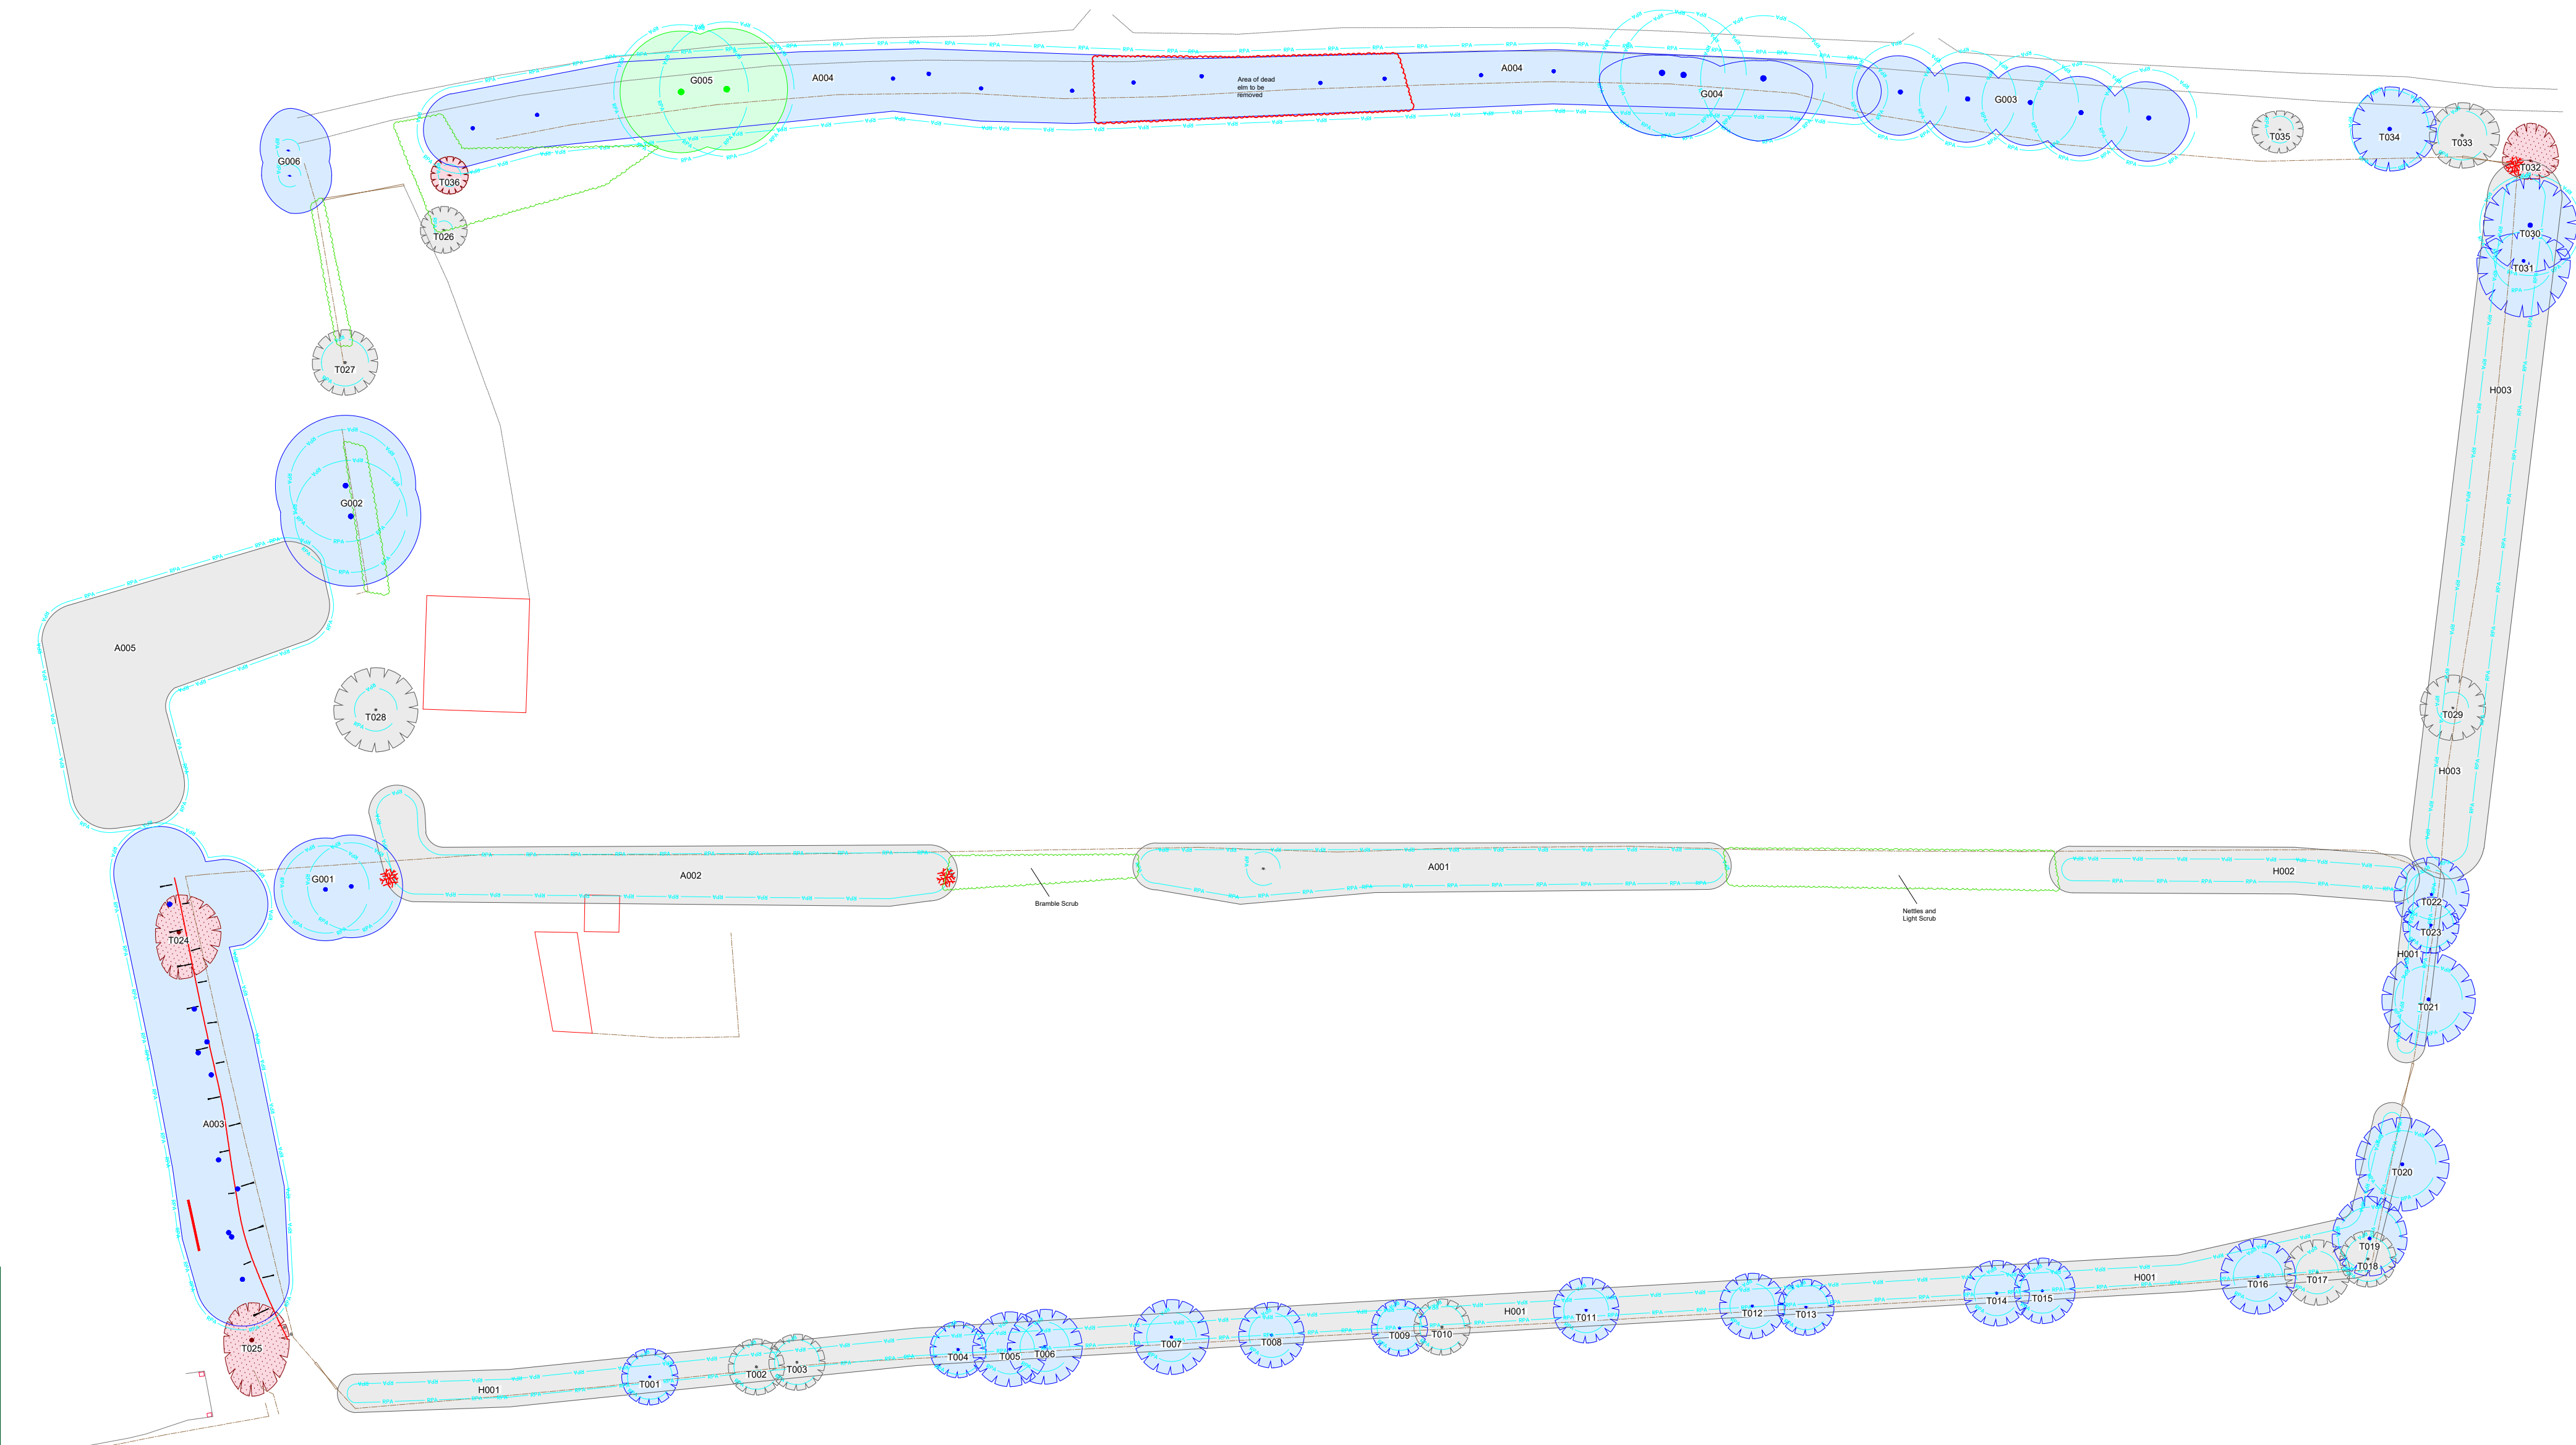
| Client: | Blakeney Estates Ltd | Drawing Title: | Constraints Plan |

Hayden's contacted North Hertfordshire District Council on 02/09/2024. We were informed that:

- No TPO's are present on site
- The site is not located within a conservation area
