## Marlborough Close Weston

# Settle Tree plotter data mapping

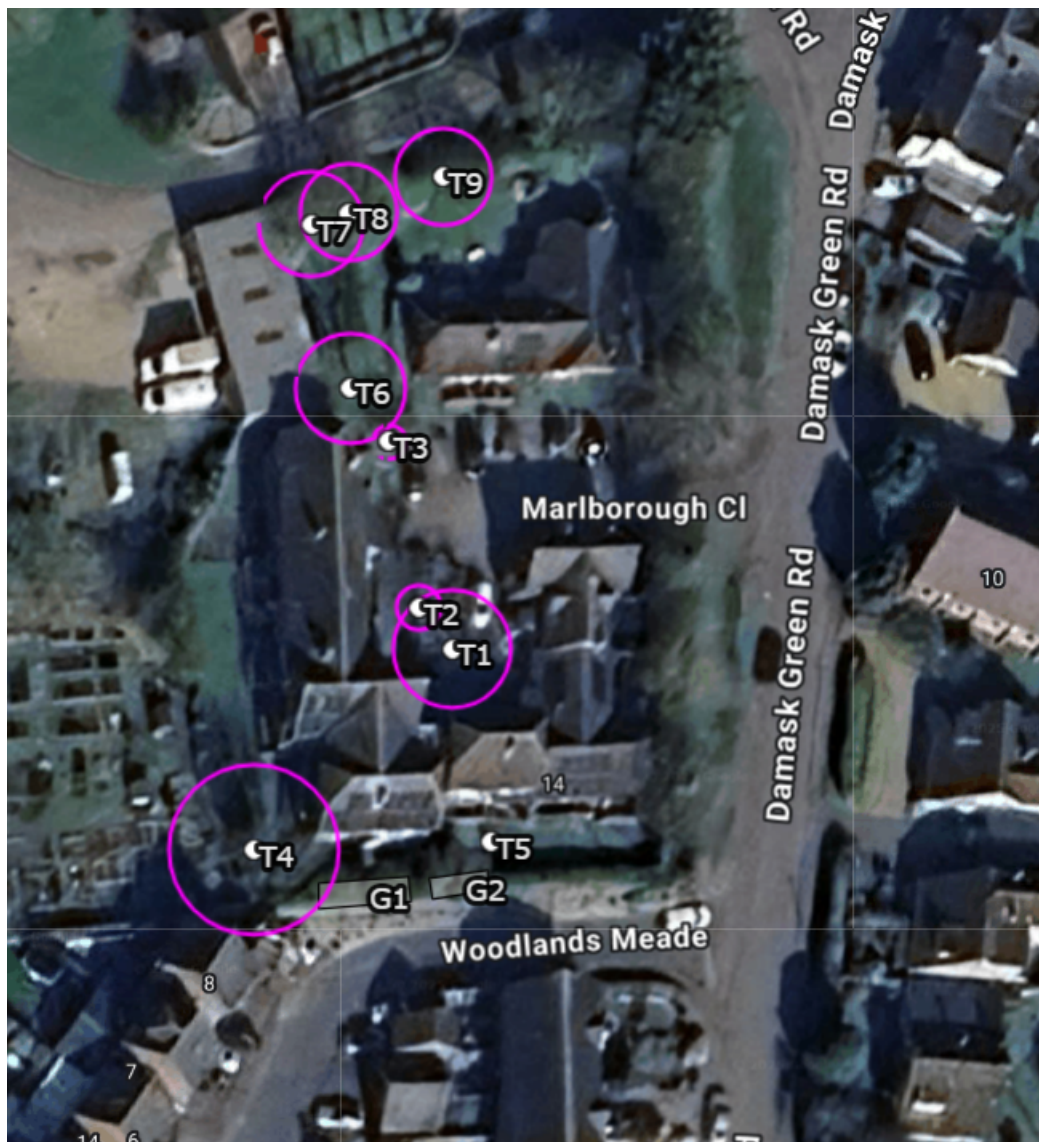
T1

| Observation Comments | Low branches overhanging parking spaces. |
| Root/Base Observations | Strimmer/Mower Damage |
| Crown Observations | Low Branches |

| Works Required | Yes |

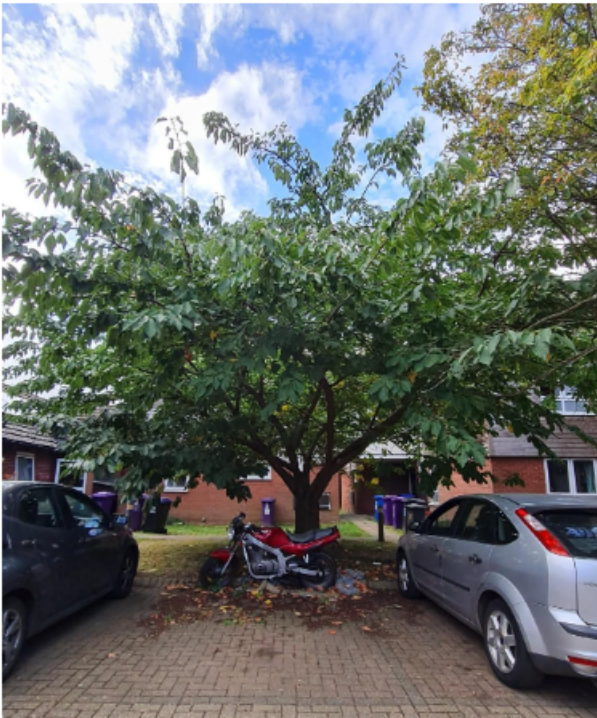
| VTA | BS5837 | OBSERVATIONS | MISC | CAVAT | BBVJV | ATLAS WORKPLACE ADDITIONAL DATA | | WORK RECORDS | HISTORY |
|---|---|---|---|---|---|---|--|---|---|
| | | | | | | Stem epicormic shoots encroaching over footway. | | | |
| | | Trunk Observations | | | | Epicormic growth | | | |

| VTA | BS5837 | OBSERVATIONS | MISC | CAVAT | BBVJV | ATLAS WORKPLACE ADDITIONAL DATA | | WORK RECORDS | HISTORY |
|---|---|---|---|---|---|---|--|---|---|
| | | Works Required | | | | Yes | | | |
