PIRTON, HERTFORDSHIRE, SG5  
3EQ

**Client Ref:** 340628 / P02158718  
**Report Ref:** GS-FOT-GFB-IDY-PNO  
**Grid Ref:** 515245, 231890

### PHOTOGRAPHIC RECORD

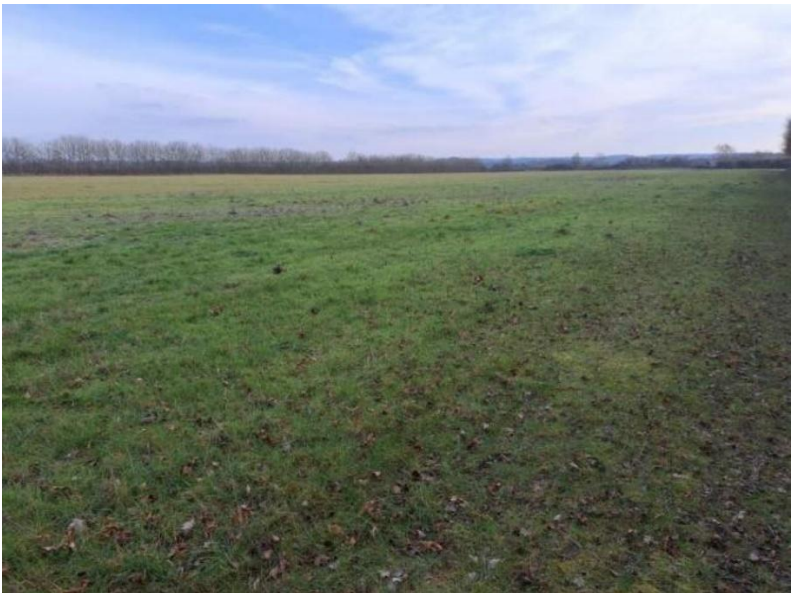
| PHOTOGRAPHIC LOG | | |
|---|---|---|
| <b>Description:</b><br>Main land use onsite:<br>Grassland | | |

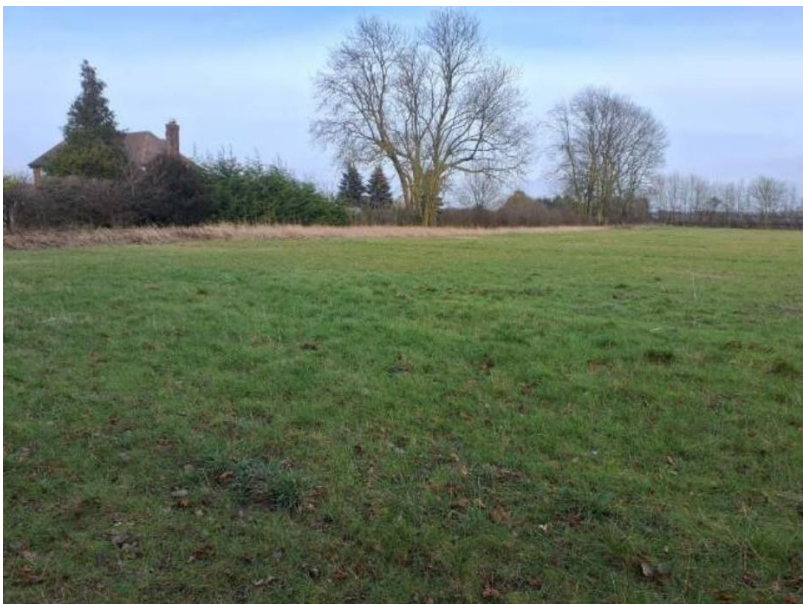
| <b>Description:</b><br>Boundary: Northern boundary showing hedgerow and adjacent residential property | | |

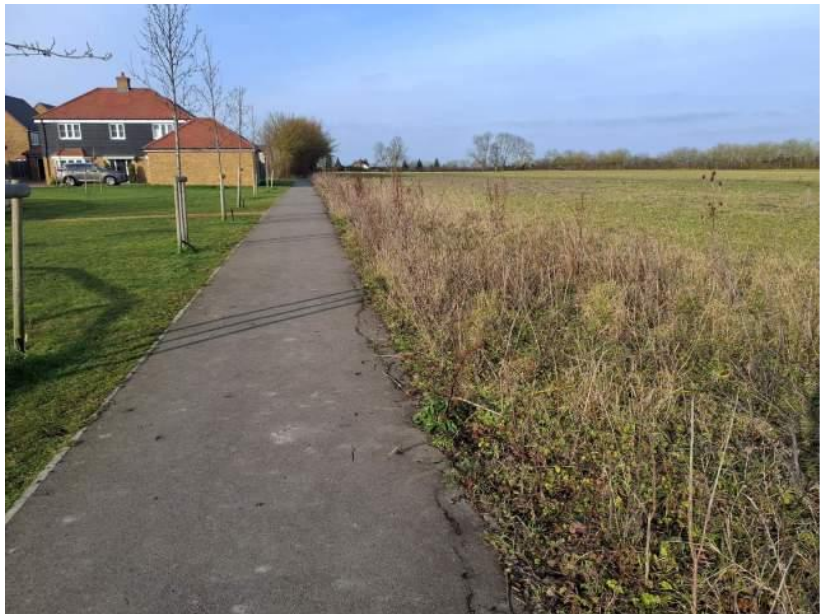
| <b>Description:</b><br>Boundary: Western boundary showing suds, play area and residential properties | | |

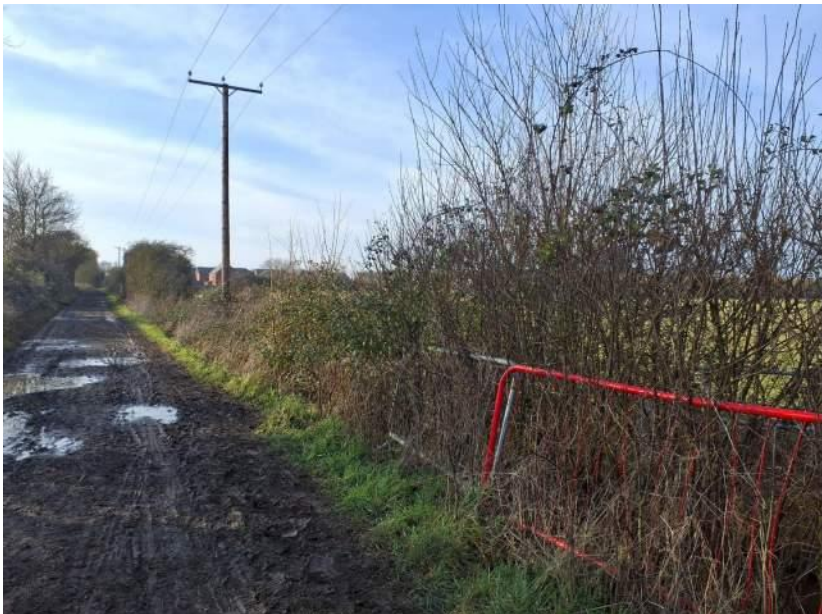
| <b>Photo No.</b><br><br>4 | <b>Date:</b><br><br>17/02/2025 |

| <b>Description:</b><br><br>Boundary: Southern boundary showing hedgerow and electricity overhead | |

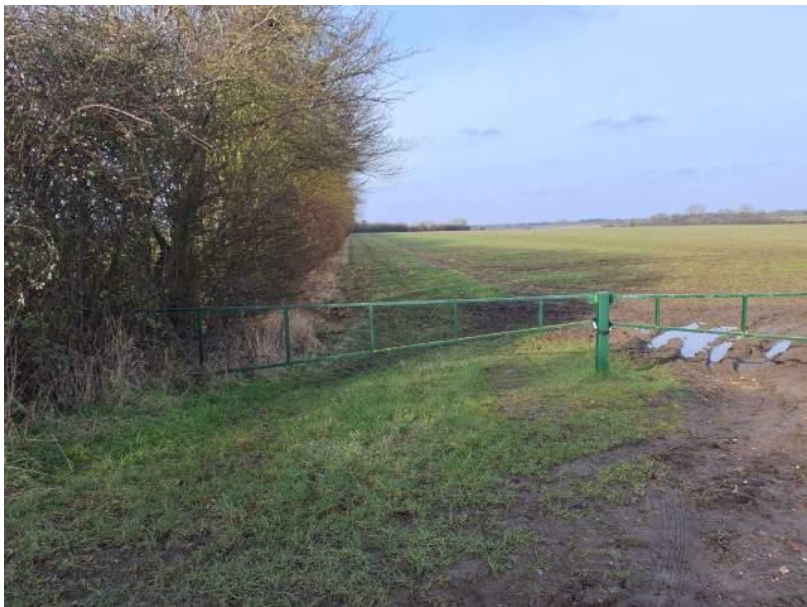
| <b>Description:</b><br>Boundary: Eastern boundary showing hedgerow and agricultural field to the east | | |

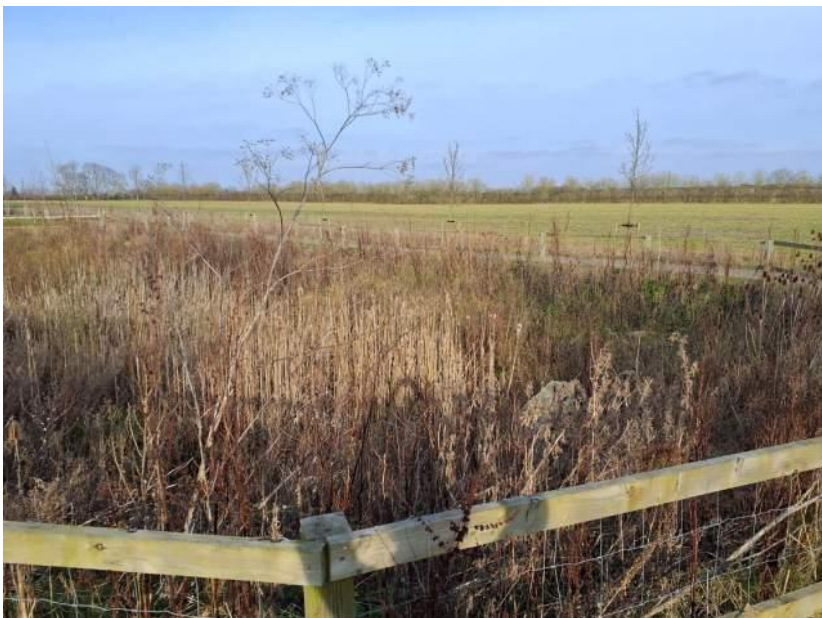
| <b>Description:</b><br>Surface water course: Suds southwest of the site | | |

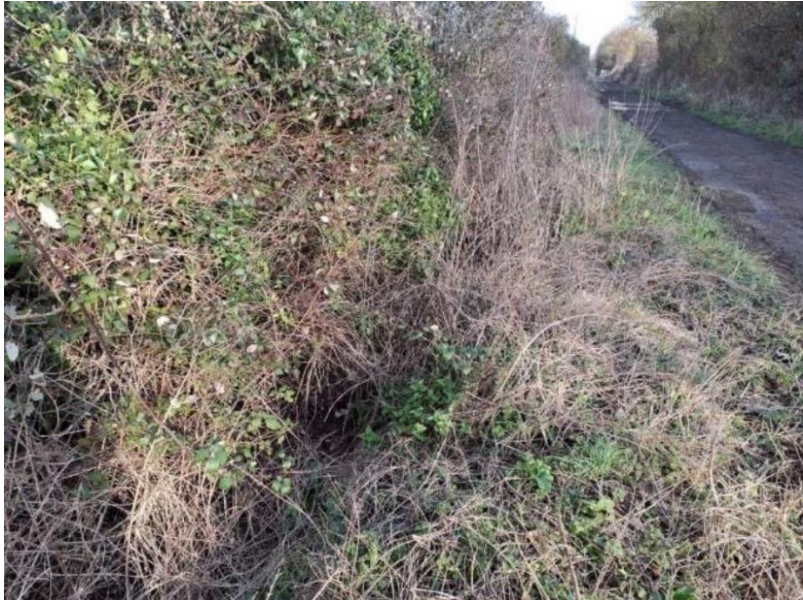
| <b>Description:</b><br>Surface water course: Dry ditch immediately south. | | |

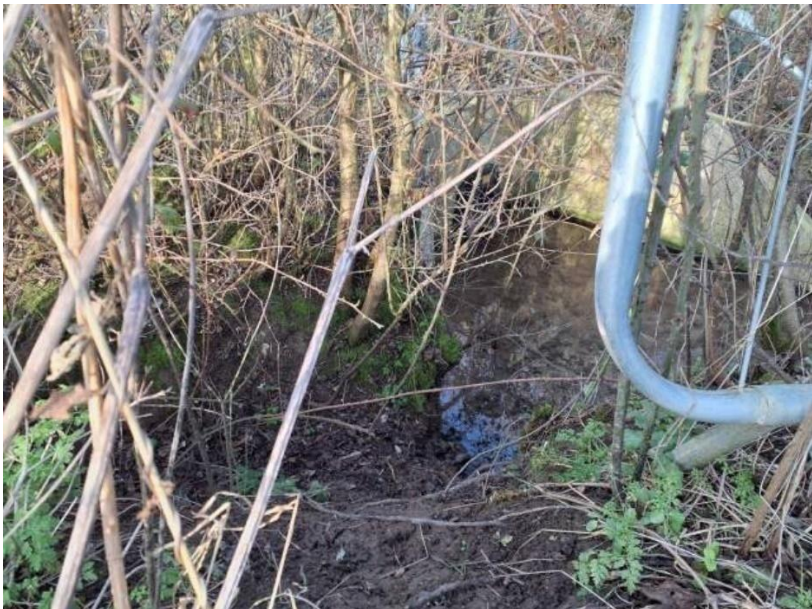
| <b>Description:</b><br>Surface water course:<br>Headwall at southeast corner of the site | | |

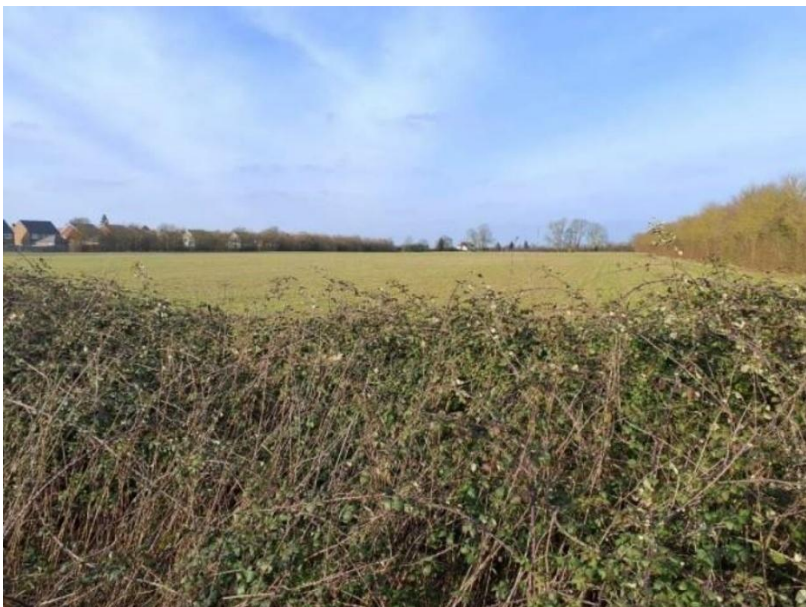
| <b>Photo No.</b><br><br>9 | <b>Date:</b><br><br>17/02/2025 |

| <b>Description:</b><br><br>Main site land use: view<br>looking north from southern<br>access track | |

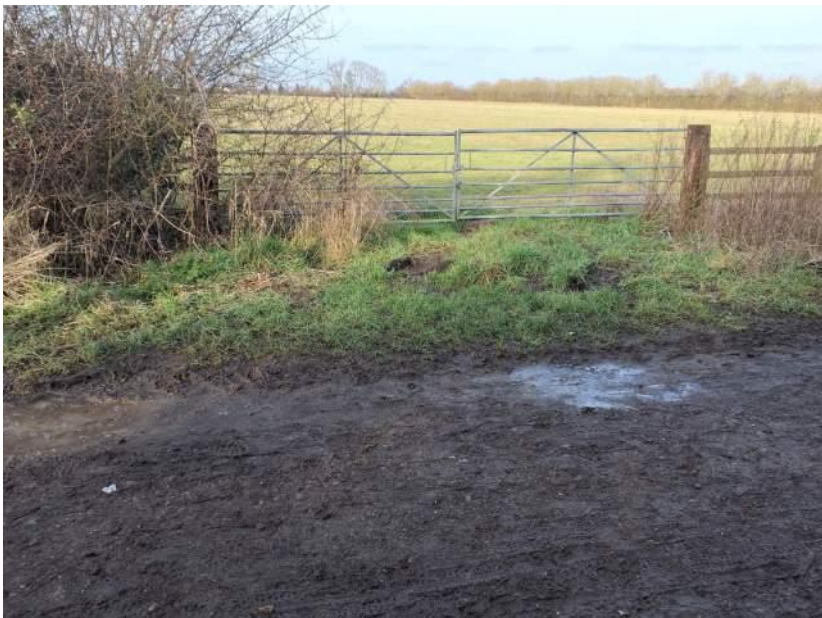
| <b>Description:</b><br>Site access: double gates<br>within southern boundary | | |
