# **BS 5837:2012**

## **Arboricultural Impact Assessment**

Unit 2,  
Glebe Road Industrial Estate,  
SG6 1BT

***MH10798***

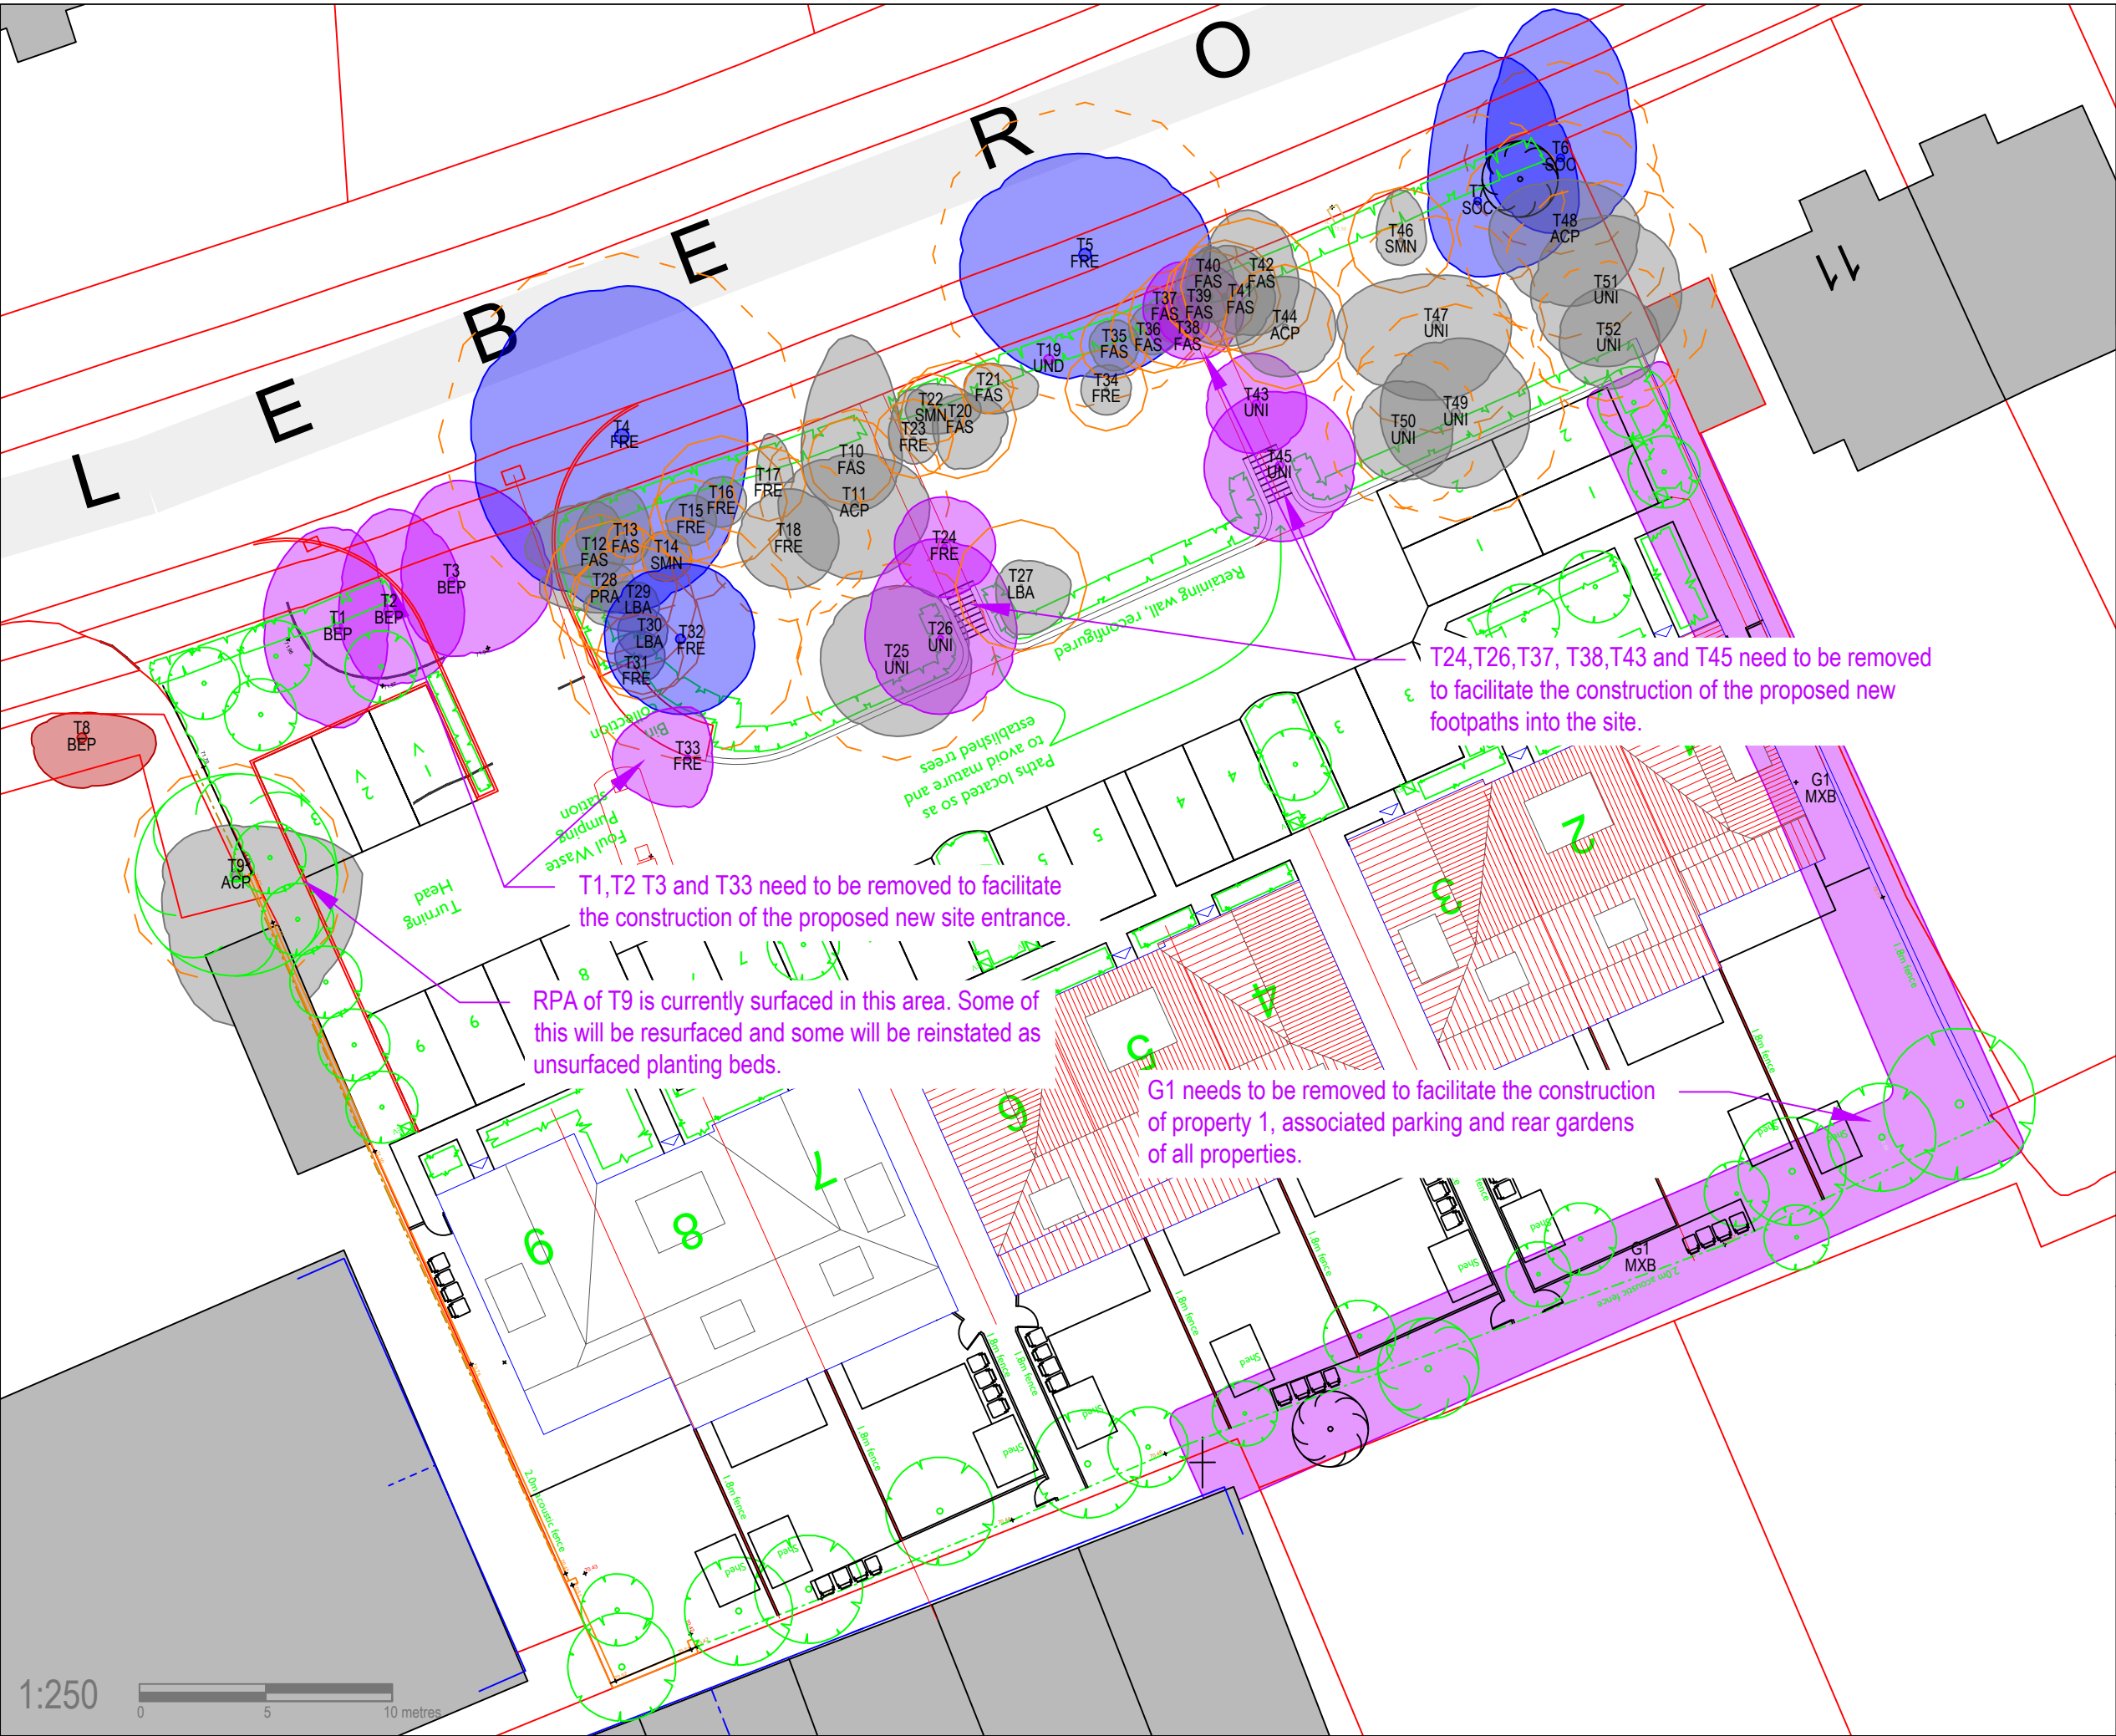
## Arboricultural Impact Assessment Plan

The current site plan (*Drawing: 3879-60-D*) provided by Wheatley Group, indicates that eleven trees and one group will require removal to allow for construction of the proposal as shown in the table below. Further details of the trees requiring removal can be found in the attached *Tree Schedule* (Appendix B) and drawing *MH10798-002 – Arboricultural Impact Assessment Plan* (Appendix D).

Due to the required loss of one semi-mature Category B group, nine individual semi-mature Category C trees, it is recommended that **two heavy standard sized silver birch trees (*Betula pendula*)**, **four standard sized silver birch trees (*Betula pendula*)**, **five selected standard sized field maple trees (*Acer campestre*)**, **ten selected standard sized beech trees (*Fagus sylvatica*)**, are planted for mitigation purposes. This number of trees will be sufficient compensation for the wildlife habitat and amenity value lost to allow the proposed development.
