## **Arboricultural Report**

For 41 Sollershott East, Letchworth, Hertfordshire

Prepared by Cristian Pinta,

on 18 December 2025

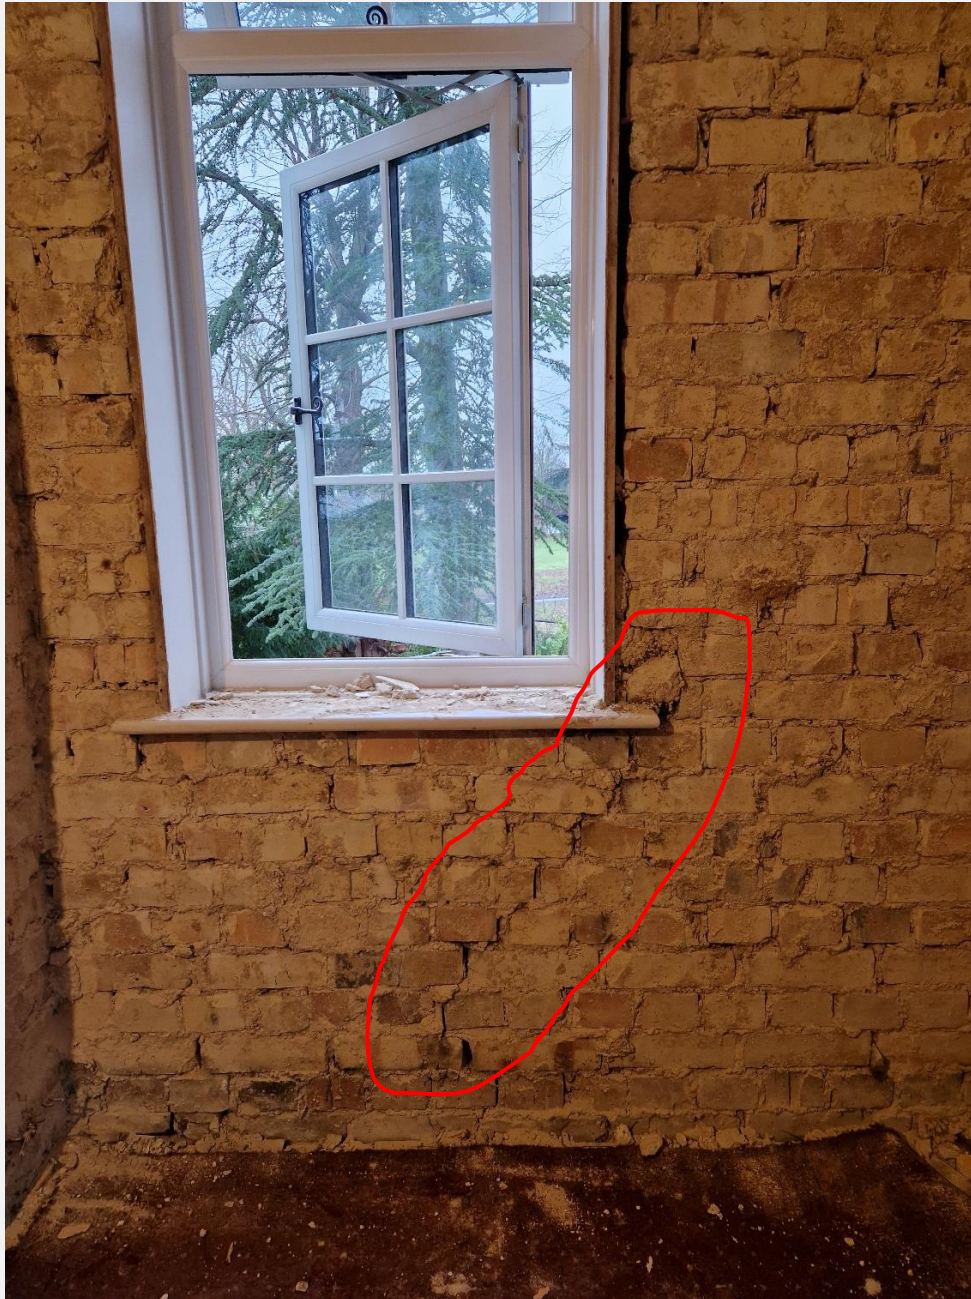
Finally, Cedar tree T007 has a very asymmetrical crown, being suppressed by nearby Lime tree and is leaning towards the property. Judging by the pattern and location of the stepped cracks in this building, whilst considering its age and shallow foundation on clay soil, I believe it is very likely that T007 is contributing to subsidence (see figure A below). This tree is, therefore, in my view, not suitable for long term retention in this location and will have to be removed.

*Figure A – stepped crack in the wall with offending Cedar in the background*

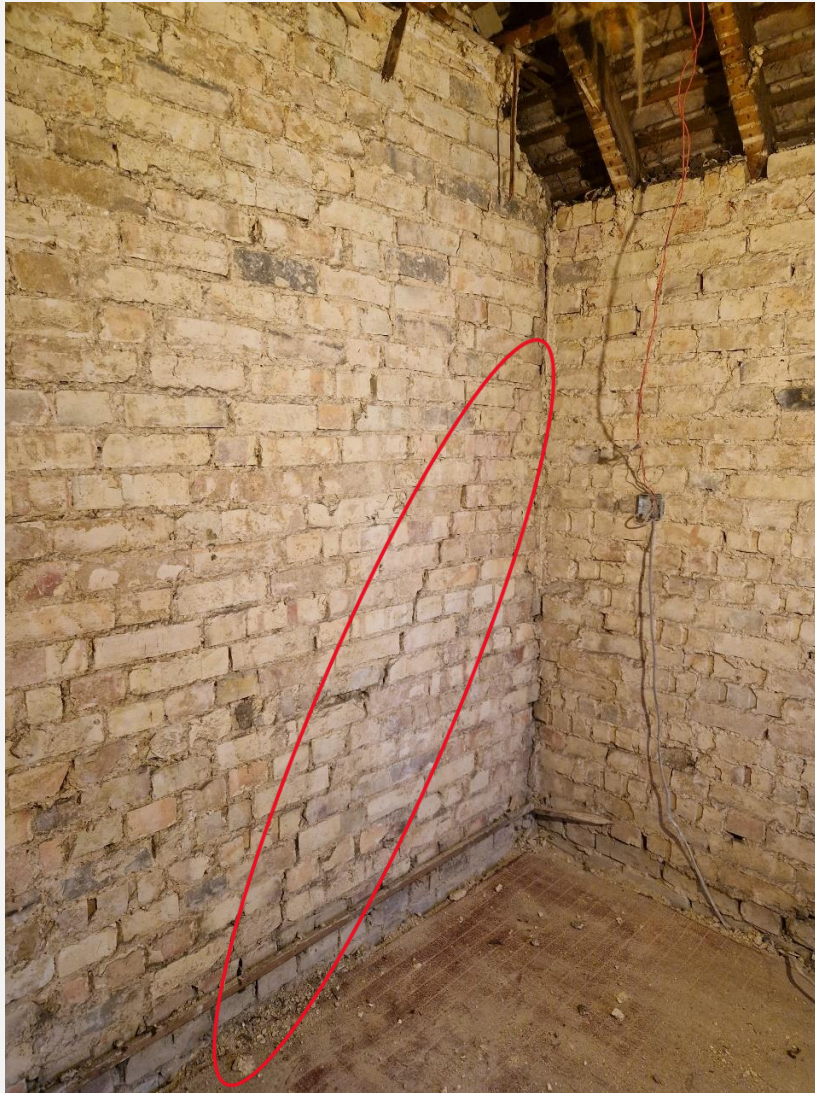
Another tree which is likely contributing to subsidence to this historical building is Beech T013. Whilst this category A tree is not currently proposed to be removed, it is plausible that future structural engineers' reports might prove its detriment and involvement in the damage, with a potential request, at the time, for removal. See Figure B below showing stepped cracks in the front room, nearest to T013.

*Figure B – Stepped cracking in the front room nearest T013*

For the purpose of this report however, T013 will be protected during construction as per discussion and TPP above.
